SEABROOK STATION UPDATED FINAL SAFETY ANALYSIS REPORT	Site Topography and Plot Plan	
	Rev. 12	Figure 2.4-1

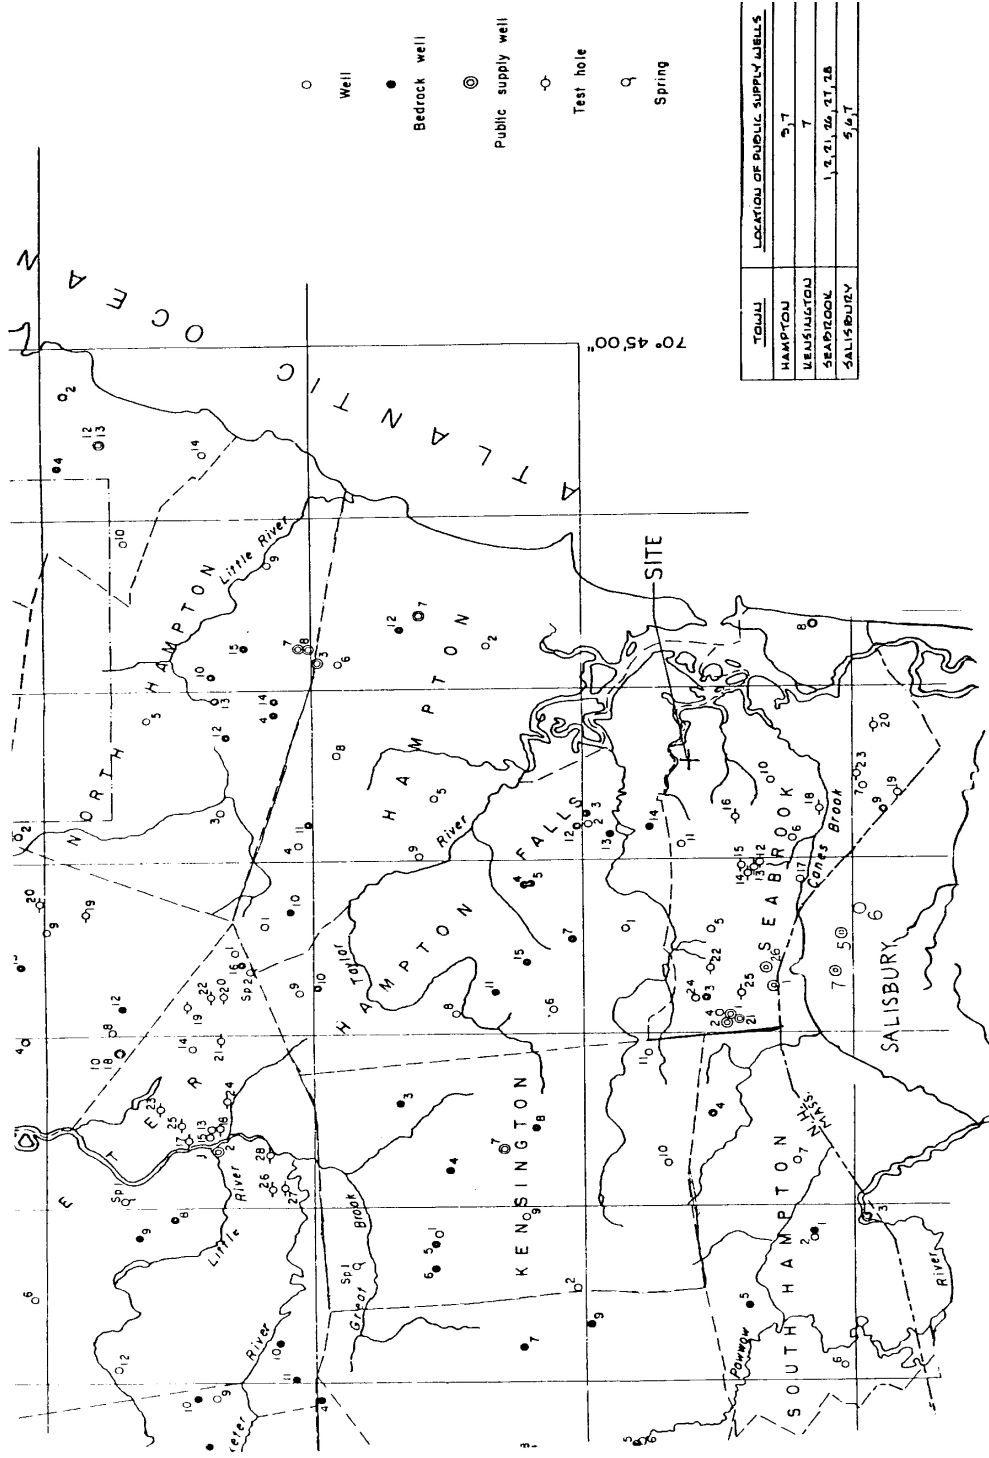
SEABROOK STATION UPDATED FINAL SAFETY ANALYSIS REPORT	Seabrook Area Wells	
		Figure 2.4-31
