SUBJECT: NRC OBSERVATIONAL SITE VISIT AT THE CANONSBURG,  
PENNSYLVANIA, DISPOSAL SITE

MONITORING VISIT

Report No.: WM-000042/22-001

Facility: Canonsburg, Pennsylvania, Disposal Site

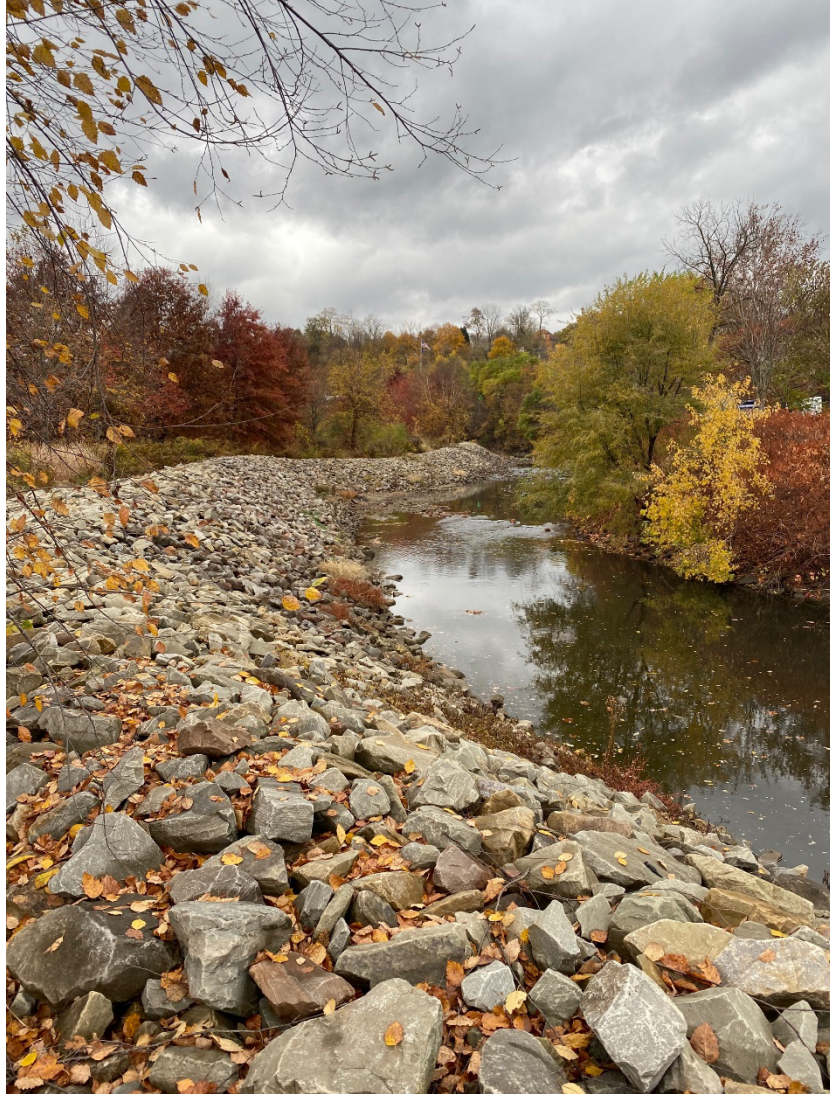
The DOE inspectors checked the disposal cell for evidence of erosion, settlement, slumping, displacement, and any other feature that would require maintenance or repair. The rock surfaces armoring the diversion ditch and the banks of the creek were found to be in good condition. The repairs to the riprap armoring of the stream bank made in 2017 still appear to be in good condition and the strategy to allow a buffer strip of high, dense grass along the stream bank continues to be effective.

Fig. 1: Canonsburg site – Riprap stabilization between site boundary fence and Chartiers Creek (looking north to northwest); image captured on October 26, 2022.
