SUBJECT: NRC OBSERVATIONAL SITE VISIT AT THE BURRELL,
PENNSYLVANIA DISPOSAL SITE

MONITORING VISIT

Report: WM-000042/22-002

Facility: Burrell, Pennsylvania Disposal Site

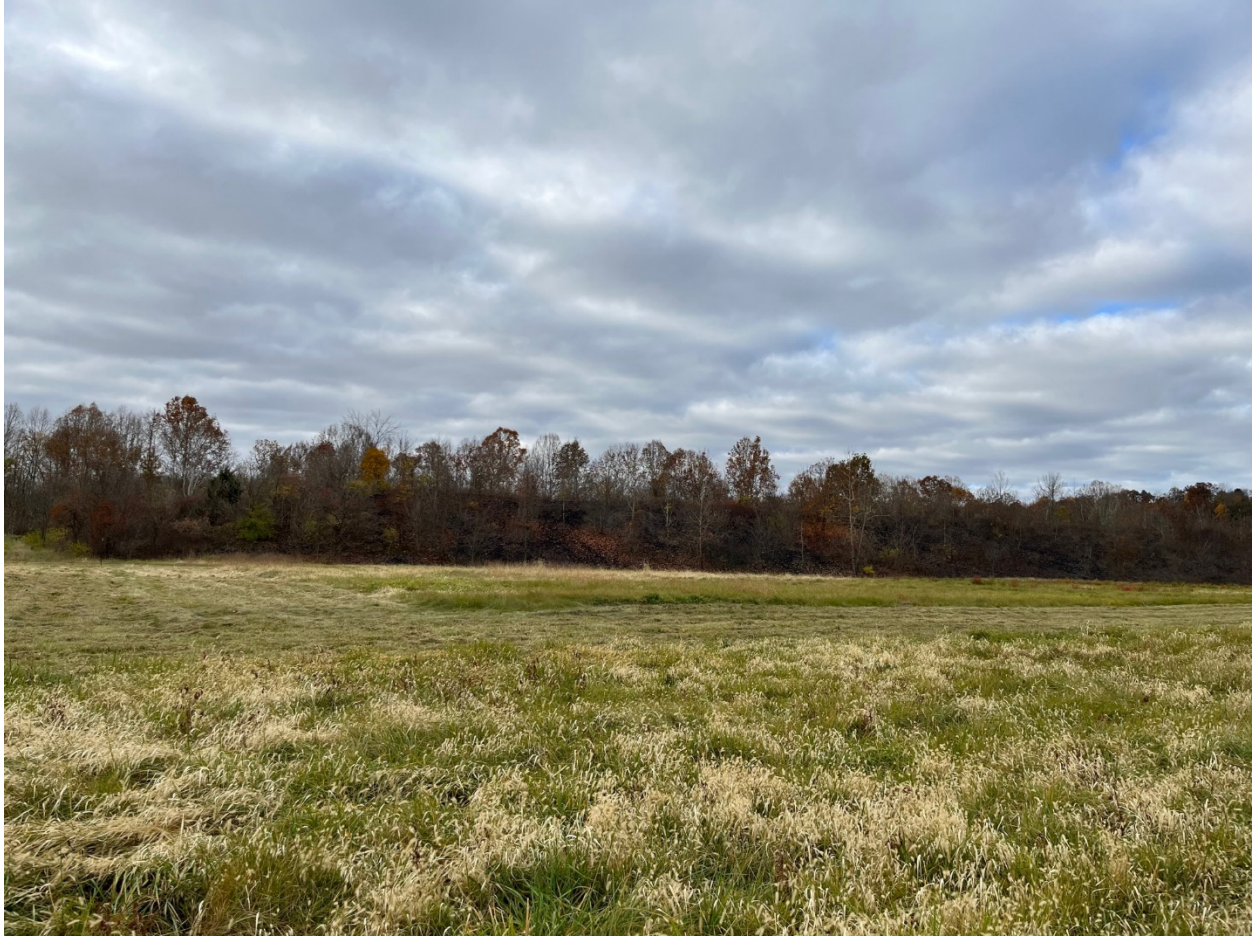
The NRC inspectors concluded that the DOE inspectors conducted the site inspection in accordance with the requirements specified in the LTSP dated April 2000. The disposal cell appeared to be structurally intact, and the cover was in good condition at the time of this visit. No threats to the integrity of the disposal cell were identified.

Figure 1: Burrell Disposal Cell (looking southwest); image captured on October 27, 2022
