Primary Water Stress Corrosion Cracking of High-Chromium Nickel- Base Welds – 2018

Nickel-base Alloy 690 and the associated weld Alloys 52 and 152 are typically used for nozzle penetrations in replacement heads for pressurized water reactor (PWR) vessels, because of their increased resistance to stress corrosion cracking (SCC) relative to Alloys 600, 82, and 182. The report presents the results of a confirmatory research program conducted with the purpose of evaluating the susceptibility of Nickel-base Alloy 52/152 and variant welds to stress corrosion cracking (SCC). Several areas have been of particular interest: heat to heat variability, the effect of welding parameters, and the effect of cold work on SCC CGR response. An Alloy 152 weld heat (WC04F6) used in the production of two early weldments by ANL Central Shops was found to be particularly susceptible to IG SCC. This data set was found to have an average SCC CGR approximately 17x lower than the disposition curve for Alloy 182. SCC CGR testing of an Alloy 152 mock-up produced by MHI for the Kewaunee reactor was found to occasionally result in elevated levels of IG fracture, especially at high stress intensity factors. The S

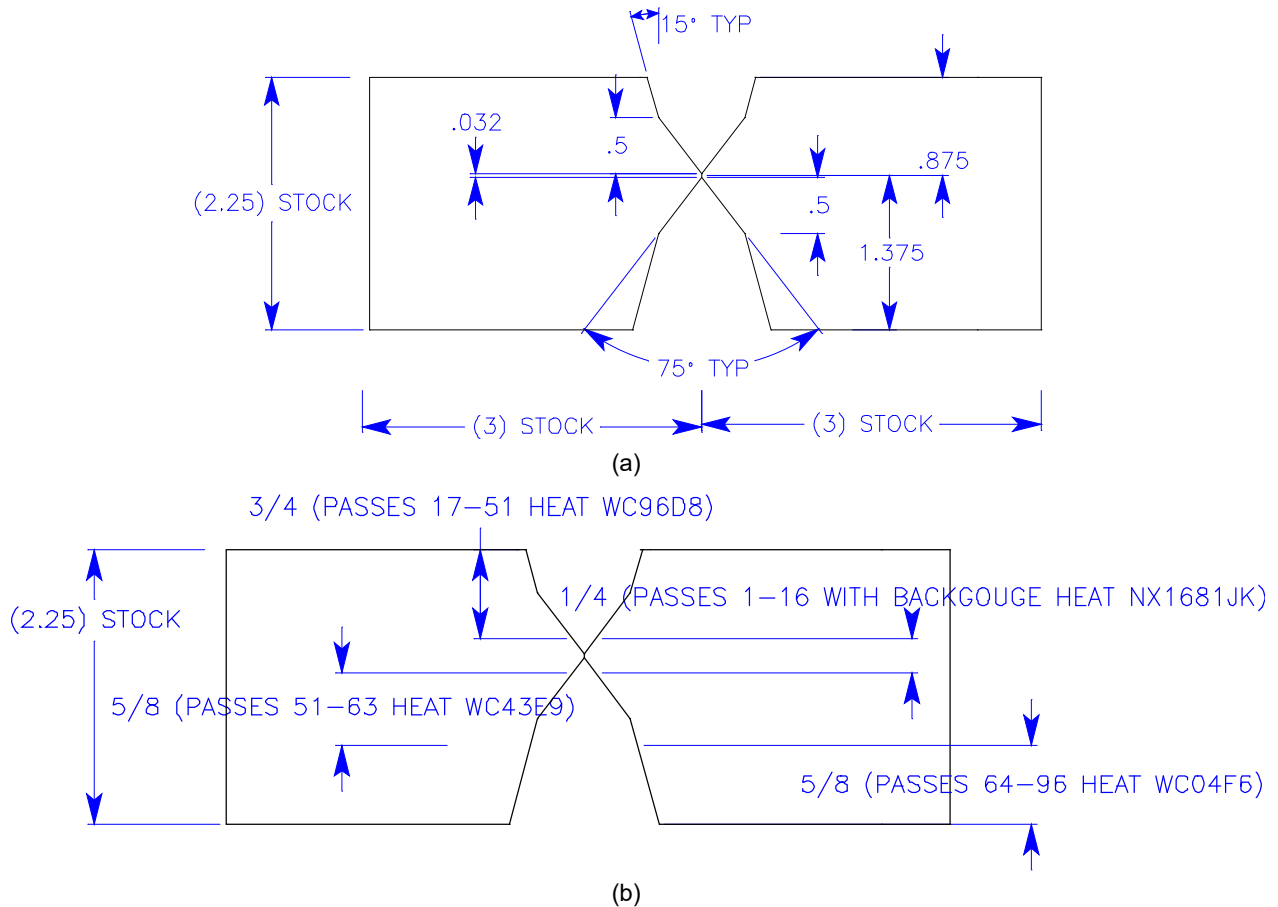
Figure 2 (a) Schematic of the weld joint design for the Alloy 152 double-J weld, and (b) weld passes and filler heats used.

The Alloy 152 shielded-metal-arc weld (SMAW) was fabricated at ANL Central Shops in a double-J geometry (Figure 2) following ASME Boiler and Pressure Vessel Code, Section IX. The double-J weld was produced by joining two Alloy 690 plates (Heat NX3297HK12) and was prepared by 96 weld passes. Root passes 1 to 5 were made by gas tungsten arc welding (GTAW) with Alloy 52 filler, and the other passes were made by SMAW with Alloy 152 filler. The conditions for each weld pass are listed in Table 1. During welding, the maximum inter-pass temperature was $\approx 120^{\circ}\text{C}$ (250°F), and the weld surfaces were cleaned by wire brushing and grinding, and were rinsed with de-mineralized water or alcohol. The chemical compositions of the Alloy 152 weld wire supplied by the vendor and those obtained by ICP-OES analysis of the as-deposited weld are given in Table 2.

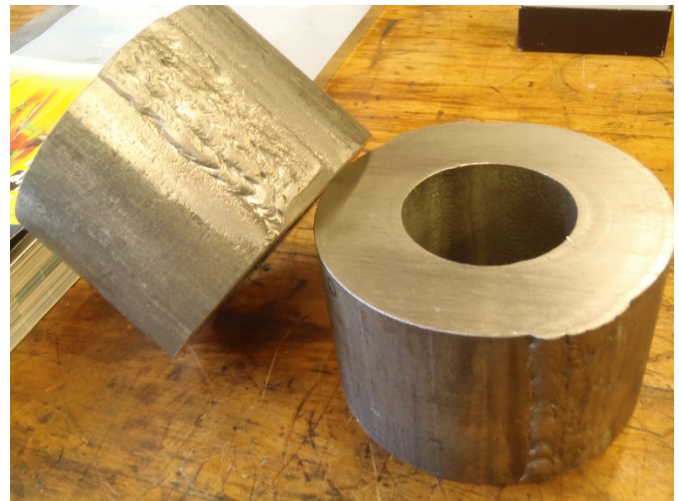
Figure 6 Fabrication of the welds used in the study of the effect of the welding parameters on SCC: (a) schematic for the weld groove (units in inch), and (b) machined weld groove; (c) schematic for two weld grooves (units in inch), and (d) completed welds.

Three welds were produced in sequence as described in Figure 6 and Figure 7. First, a groove was EDM cut, and the weld with “normal” parameters (weld A) was made. This corresponds to the procedure that was qualified to ASME IX by ANL (see Section 2.2). Then, a diametrically-opposed groove was EDM cut, and a weld with a higher current (weld B) was made. The travel speed was also increased, so the heat input for weld B was practically equivalent to that for weld A. Finally, the sequence was repeated to produce the “high heat input” weld C. As the request from the sponsor for all of these welds was to pass inspection, the allowable parameters limited the heat input of weld C to approximately 20% higher than those for the previous two welds. Table 7 summarizes the welding parameters and the resulting heat inputs for each of the three welds that were produced for this study.

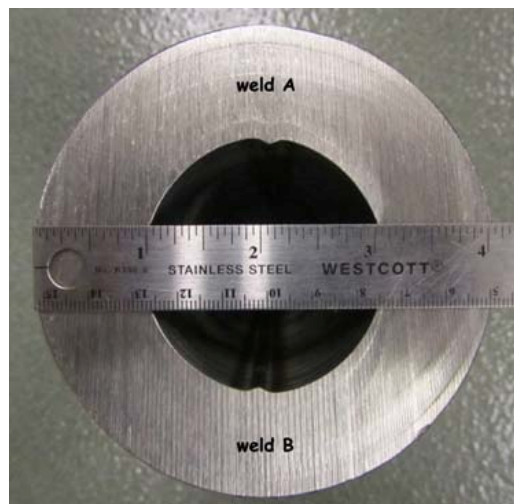
The Alloy 52 GTAW weld was produced by MHI on a piece of CRDM tubing in similar fashion to the ANL-produced welds described previously (See Section 2.4, Figure 7). As such, two apparently identical welds were produced with Alloy 52 heat NX4467JK on a CRDM tube made of Alloy 690 Heat S670743, Figure 10. The power ration for these welds was 191 W/mm², and the heat input was 9.6 kJ/cm. The interpass temperature was maintained below 134°C.

Figure 10 Alloy 52 welds produced by MHI on a piece of CRDM tubing.

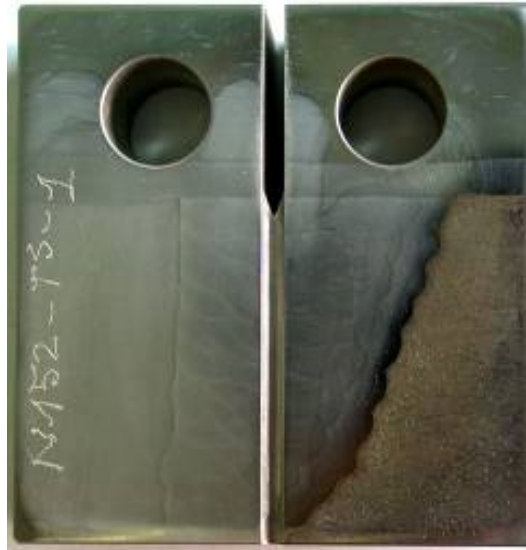
The objective of the test on specimen N152-TS-1 from the newly-produced Alloy 152 weld (designated N152) was to determine SCC CGRs at several stress intensity factors. In order to allow for testing at the higher stress intensity factors, the specimen was machined in a 1T CT configuration, similar to that used for the specimens from the A152 series discussed previously. Also, in order to reproduce the specimen location vs. weld geometry used previously, an additional piece of Alloy 690 was EB-welded on top of the existing weld, allowing the notch of the specimen to be positioned near the crown of the weld. The resulting test specimen is shown in 33.

Figure 34 Photograph of Alloy 152 weld specimen N152-TS-1.

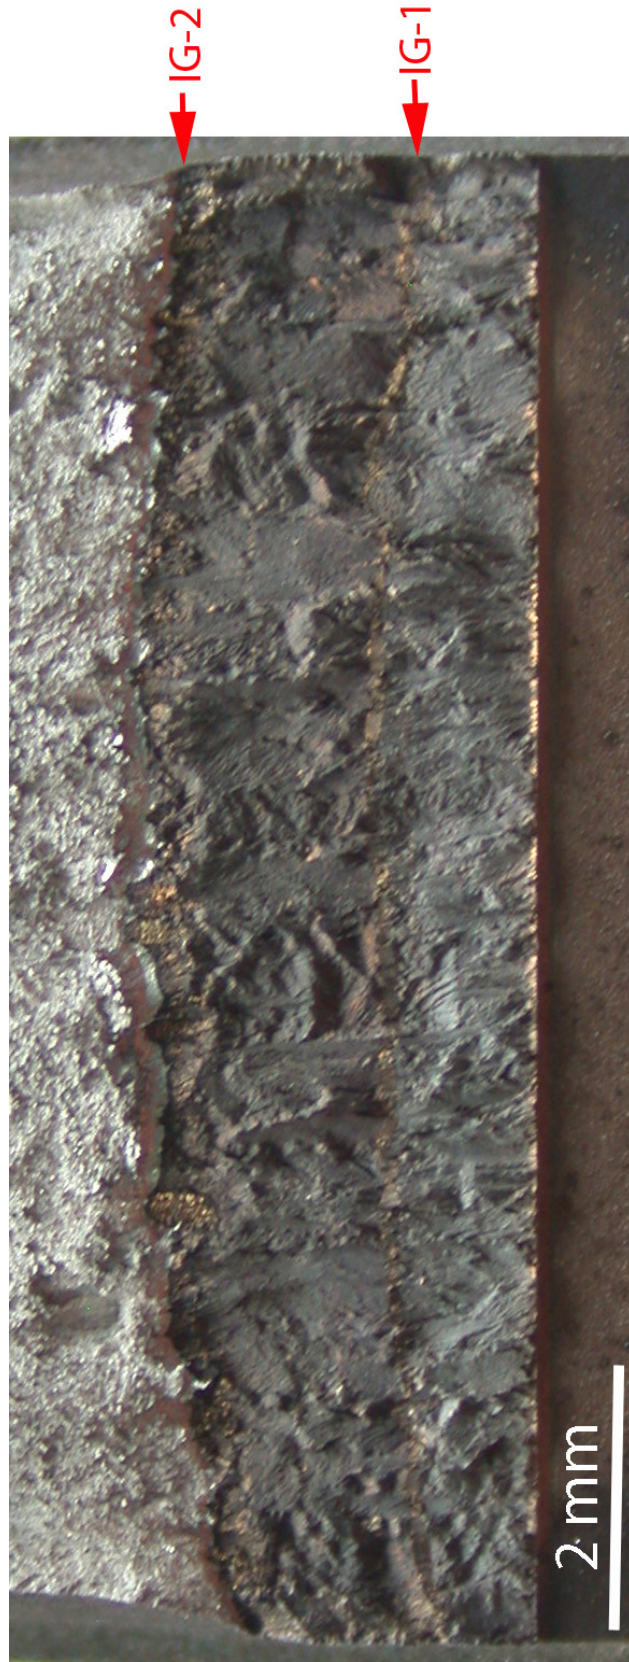
Figure 73 Fracture surface of specimen HC152-CR-1. Crack advance is from bottom to top.

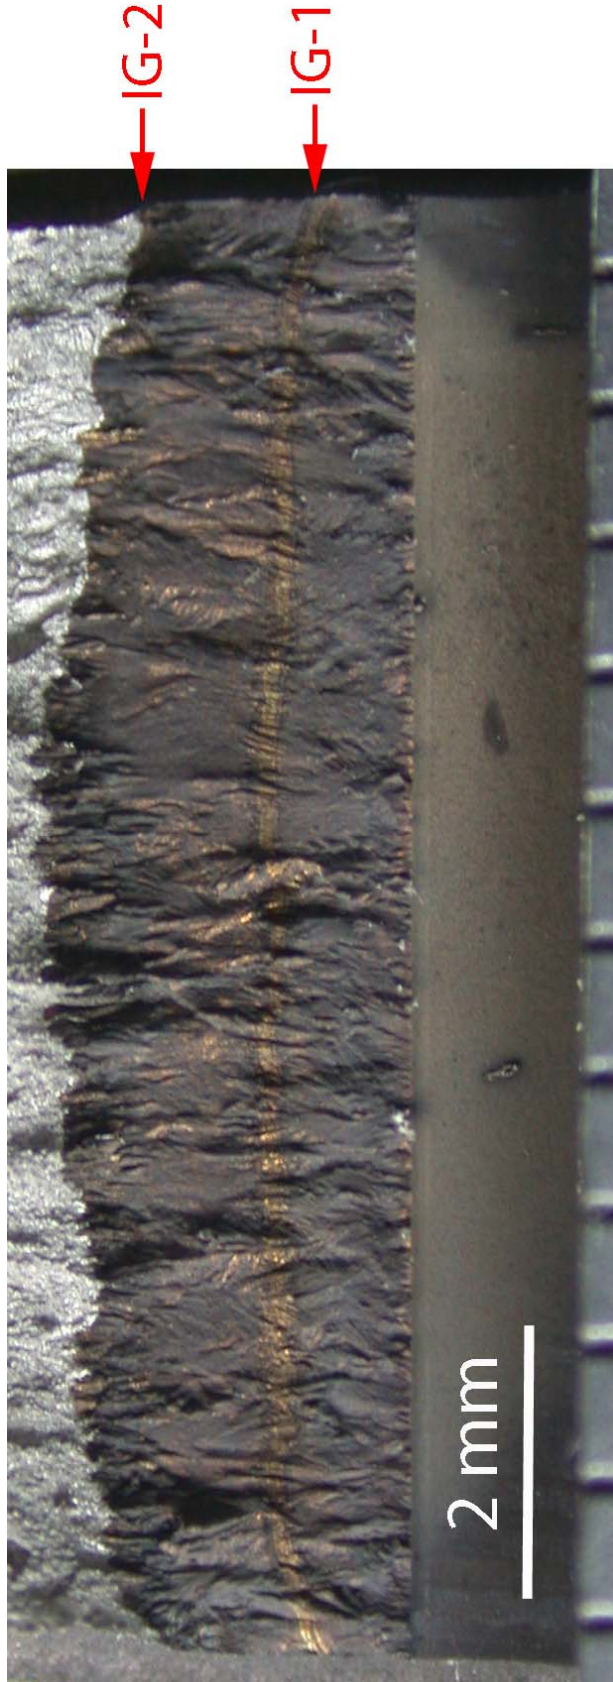
Figure 81 Fracture surface of specimen NC152-CR-1. Crack advance is from bottom to top.

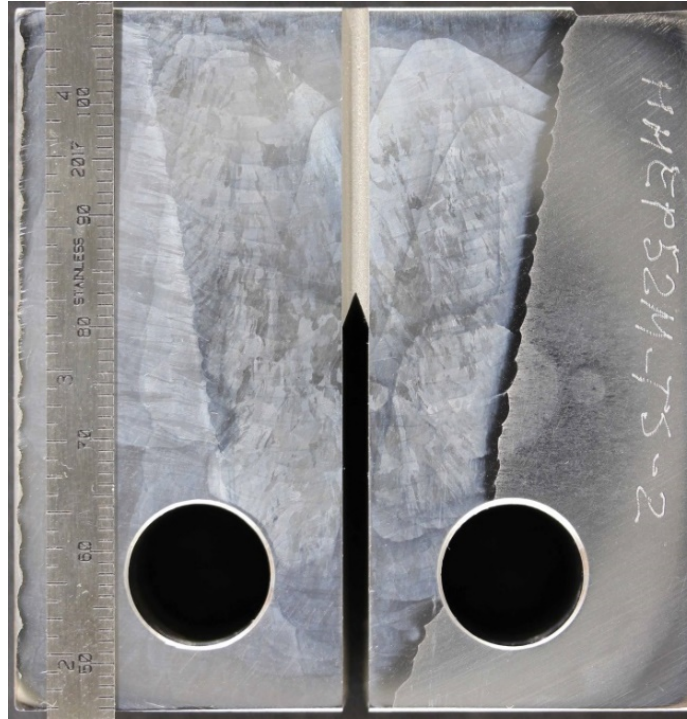
Specimen HHEP52M-TS-2 (Figure 90) was machined in the same general orientation as the first specimen presented in the previous section, but with a longer initial crack to avoid some of the artifacts observed in that test. Also, the SCC CGR response was only evaluated at a higher K (50 MPa m^{1/2}).

Figure 90 Specimen HHEP52M-TS-2 machined from the high heat input Alloy 52M weld produced by EPRI.

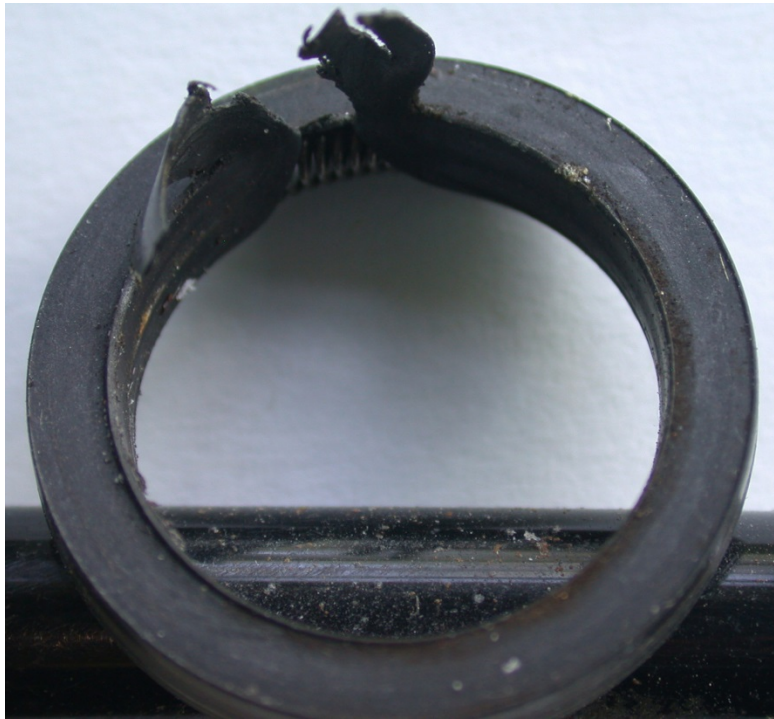
During test period 7, a sudden leak occurred at the pullrod seal. The loading system was tripped by the low position limit (actuator position) and control had transferred from “load” to “position” control (this is typical to prevent damage to the specimen). The max crack extension measured minutes after the leak was approximately 13.050 mm, substantially larger than the prior DC potential determinations, despite the decreasing load and temperature. The crack extension reading then decayed with the loss of pressure and temperature. The system cooled to room temperature (RT), and then the autoclave was opened up. Next, 700 lbs were applied to the specimen to open up the crack (max load was 990 lbs before the leak), and the DC potential settings were changed to the RT conditions established before the test in water. Crack extension was indeed approximately 13.050 mm. Given the above observations, we were able to determine that a ligament in the specimen broke resulting in a jolt in pullrod/loading system thus tripping the “position” limit. The same jolt caused the pullrod seal failure and subsequent loss of pressure.

After the system was opened up, the pull rod was removed and the seal examined. The rupture appears to be indeed consistent with a “jolt” from the pullrod, Figure 107.

Figure 107 The ruptured of the pullrod seal appears consistent with a “jolt”.

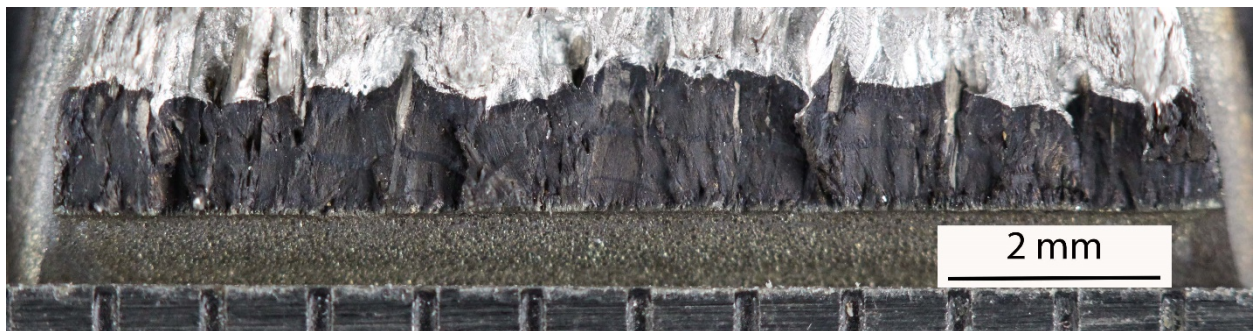
The fracture surface of the specimen is shown in Figure 111. The total measured crack is 1.17 mm which is 31% larger than the DC-potential measured extension just prior to the jolt (0.804 mm), and 17% larger than that measured immediately after the jolt (0.963). As such, there appears plausible that one or more ligaments broke suddenly causing a jolt in the load train, thus leading to the leak described previously. Several areas of interest are indicated with white arrows in Figure 112, and those were examined further. While region 1 only shows features consistent with corrosion fatigue (Figure 112b, c), regions 2 and 3 show areas consistent with ductile rupture (Figure 112b). The fracture mode on one such area (3) – spanning several hundred microns – is shown in Figure 113. Nevertheless, no correction was made to the data shown in Table 21.

The fracture morphology of this specimen was primarily TG, hence, the no growth conditions measured at constant load in test period 7 and estimated under cycle + hold in test period 7 appear to be valid.

Figure 111 Fracture surface of Alloy 52 specimen MC52-20CF-CR-1 tested in simulated PWR environment. Crack advance is from bottom to top.

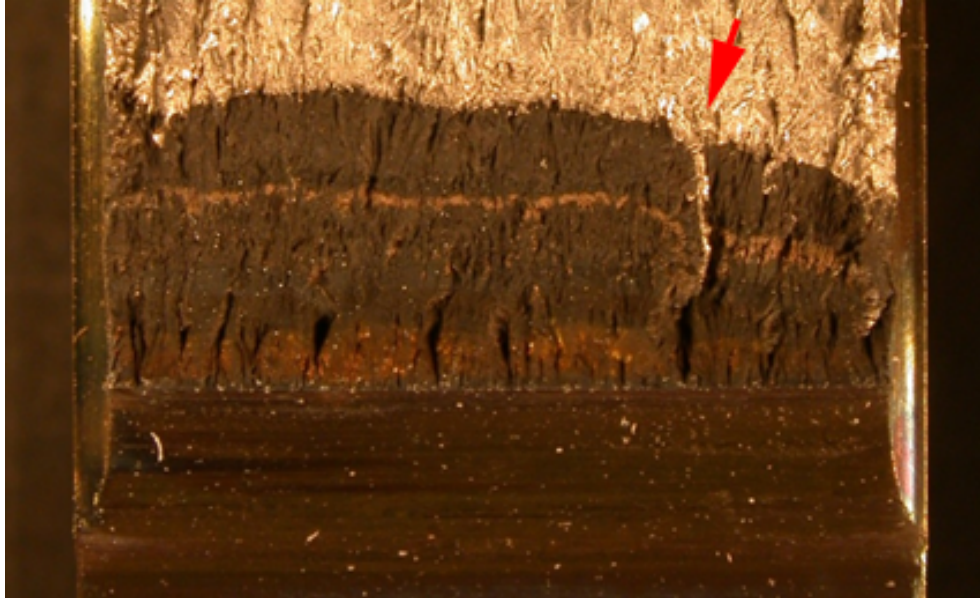
Another equally important observation is that approximately 25% of the sample (right side) did not engage at all, and the likely culprit seems to be the unbroken ligament shown with the red arrow in Figure 130a. The presence of such a large ligament must have affected the DC potential reading and the CGR response (both cyclic and SCC).

Figure 130 Fracture surface of Alloy 152 weld specimen C541 tested at GE and analyzed at (a) GE and (b) PNNL.

For the purpose of this comparison, only the specimen with the highest reported %IG will be discussed. This is specimen c541 tested at GE. According to the MRP-386 database [13], the proportion of IG on the fracture of this specimen is 75%. However, this specimen was also sent to PNNL for additional examination, Figure 130. The analysis by PNNL found the %IG in this specimen to be between 14-40%. While it is not the purpose of this discussion to re-analyze fractographic information, it is worth noting that if the PNNL analysis is right, under MRP-115 rules, such low levels of %IG would have screened out the respective test result.
