Beaver Valley Power Station, Unit No. 2
Docket No. 50-412, License No. NPF-73
10 CFR 50.55a Request 2-TYP-4-RV-06 for Alternative Repair Methods for Reactor
Pressure Vessel Head Penetrations

**Proposed Alternative
In Accordance with 10 CFR 50.55a(z)(2)**

Ambient Temperature Temper Bead Elimination of 48-hour
Hold Time from N-888 When Using Austenitic Filler Material

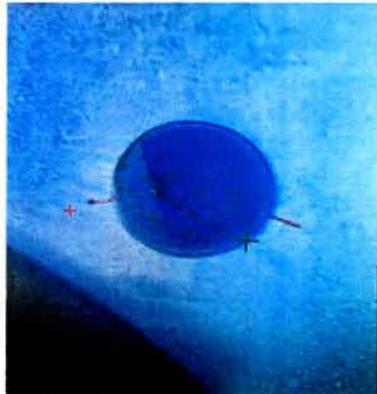
Energy Harbor conducts inspections of the Beaver Valley Power Station, Unit No. 2 (BVPS-2) reactor vessel head in accordance with ASME Code Case N-729-6 with conditions specified in 10 CFR 50.55a(g)(6)(ii)(D). Additionally, penetrations that have been previously repaired using the embedded flaw technique are inspected in accordance with the relief request previously approved by the NRC letter dated August 27, 2018 (ADAMS Accession No. ML18227A733). During the reactor vessel head inspections conducted during the spring 2023 refueling outage, unacceptable flaw indications were discovered in the head vent penetration tube material (SB-167, Alloy 600) and its J-groove attachment weld (Inconel 82/182, Alloy 600). Two special interest indications were identified by the eddy current inspection on the head vent penetration tube. One indication at the 38-degree circumferential location measures 0.200 inches long and the second indication at the 236-degree location measures 0.160 inches long. A subsequent liquid penetrant (LP) test confirmed the flaws. The first indication is contained within the tube metal, extending from the inside diameter (ID) in the direction of the outside diameter (OD). The second indication extends from the tube OD into the weld. Figures 1 and 2 show the described indications.

Figure 1 – Two indications identified at the surface of the Reactor Vessel Level Indication System vent line.

These indications could not be removed by grinding. As mentioned in Section 3 above, they will be repaired in accordance with the Code Case. Section 4(a)(2) of the Code Case requires final inspection by both volumetric and surface examination methods to be performed 48 hours after the three tempering layers are in place. Energy Harbor Nuclear Corp. requests relief to remove the 48-hour hold based on Attachment 2, which is a white paper based on PVP2023-107489, "Elimination of the 48-hour Hold for the Ambient Temperature Temper Bead Welding with Austenitic Weld Metal," as well as the volumetric inspection of the completed weld based on Precedent 1. With the indications being in a high radiological dose area, following the Code Case requirement without relief causes a hardship with no compensating increase in level or quality of safety.

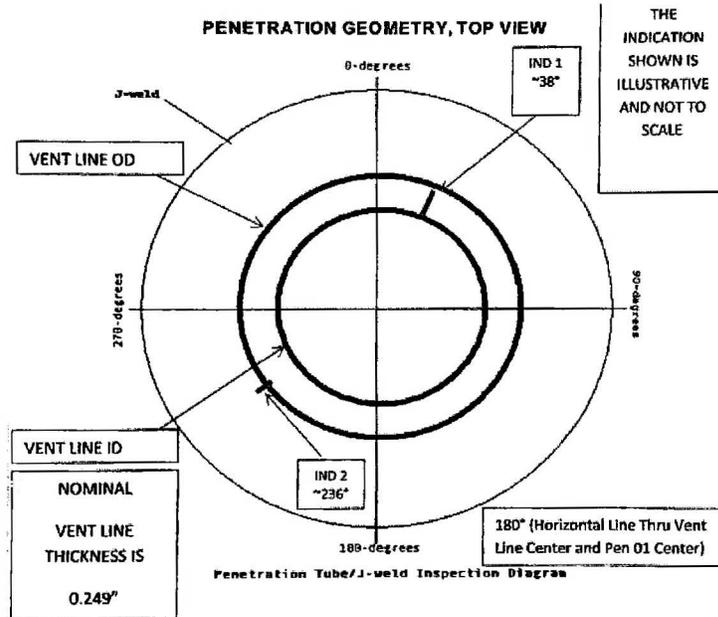
Figure 2 – Diagram from Inspection Report

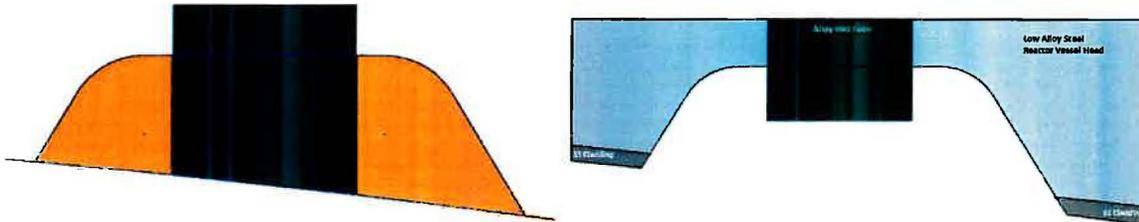
The original configuration of the weld can be seen in Figure 3 on the left side. The orange color depicts the original butter and J-groove weld material. The vent

penetration tube is shown in green. EDM will be used to remove the original weld material to slightly more than the original excavation as well as to remove approximately 1/2 inch of the end of the tube. The surface area of the exposed RVH material will not exceed the 500 in² requirement as listed in the Code Case. Following the excavation, a minimum of 1/32 inch of material will be removed by grinding to eliminate the recast layer produced by the EDM process.

Figure 3 – Picture on the left shows the existing tube, butter, and J-Weld. Picture on the right shows the final excavation after EDM.

The repair plan will include removal of the buttering, J-groove weld, and a portion of the vent piping using the Electro Discharge Machining (EDM) process. The excavation process uses an electrode that is slightly larger than the original weld prep to fully remove the existing weld material while maintaining the structural integrity of the component. The Ambient Temper Bead (Temper Bead) process, qualified in accordance with the Code Case using machine Gas-Tungsten Arc Welding (GTAW), will be used to apply weld metal to the excavation in the SA-553, Grade 1 reactor vessel head (RVH) material and remaining vent tube penetration length. Additional material will be applied in the area adjacent to the tube, and Temper Bead weld metal which forms a partial penetration groove, to supply the necessary weld throat to support service operation conditions.

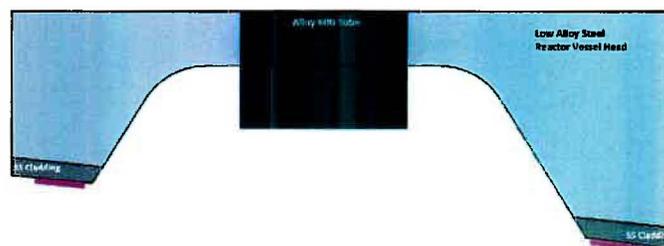
The first welds will be applied to the clad surface around the excavation using ER309L filler metal as shown in Figure 4. This is to provide isolation from contaminants in the cladding from affecting weld quality when applying Inconel 52M (ERNiCrFe-7A).

Figure 4 – Stainless Steel Buffer beads installed on Clad surface.

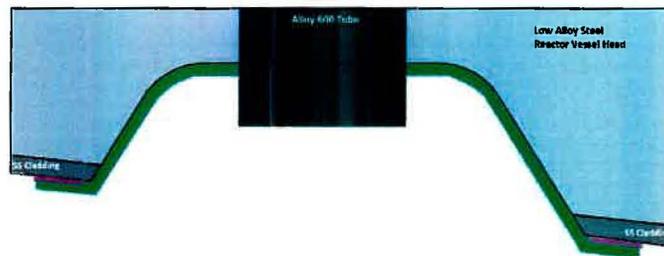
The first layer of Temper Bead will be applied in accordance with the requirements of the Code Case using Inconel 52M filler metal. This layer will start at the seal weld progressing around the excavation. The beads will progress down the excavation surface with approximately a 50 percent overlap. The final first layer beads will extend onto the surface of the previously deposited ER309L material as shown in Figure 5.

Figure 5 – First Layer Temper Bead

The LP examination will be performed on the first layer of Temper Bead in accordance with Section III acceptance criteria.

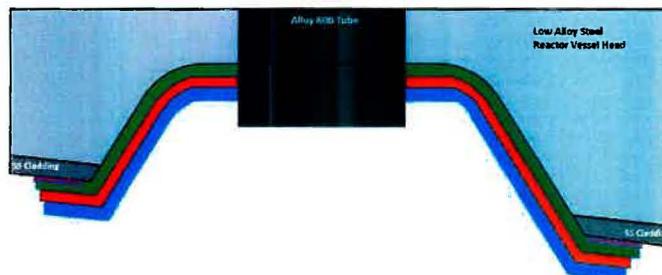
The second and third layers of Temper Bead will be applied following the same progression as the first layer with LP examination being performed after each layer as shown in Figure 6. The final LP examination will be performed as proposed without the 48-hour hold based on Attachment 2, which is a white paper based on PVP 2023-107489, "Elimination of the 48-hour Hold for Ambient Temperature temper Bead Welding with Austenitic Weld Metal," if relief is granted.

Figure 6 – Final Temper Bead weld layer illustration.

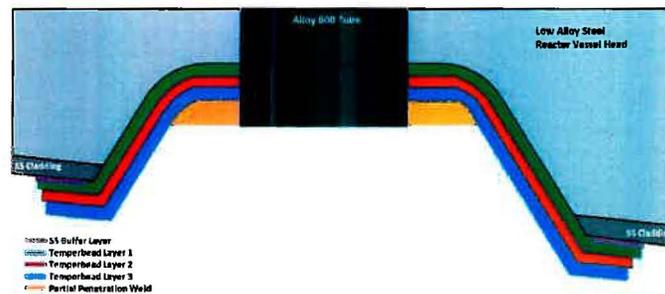
The final planned welding is to complete partial penetration groove weld formed by the remaining pipe section and applied Temper Bead as shown in Figure 7. The final weld will be flush with the end of the tube encapsulating the OD of the tube. A LP examination will be performed after 3/16 inch weld depth has been deposited. It is anticipated that only one inspection will be required prior to final examination. Should additional examinations be required, they will be performed at each 3/16 inch deposit layer thickness as specified.

Figure 7 – Final Weld Configuration.

Final inspection will include both a LP examination in accordance with Section III acceptance criteria and a VT-1 visual exam in accordance with the requirements of the Code Case, Section 4(b), performed on the completed weld.

With three layers of Temper Bead applied to the surface of the excavation, the final thickness of the material deposited will exceed 3/16 inch.

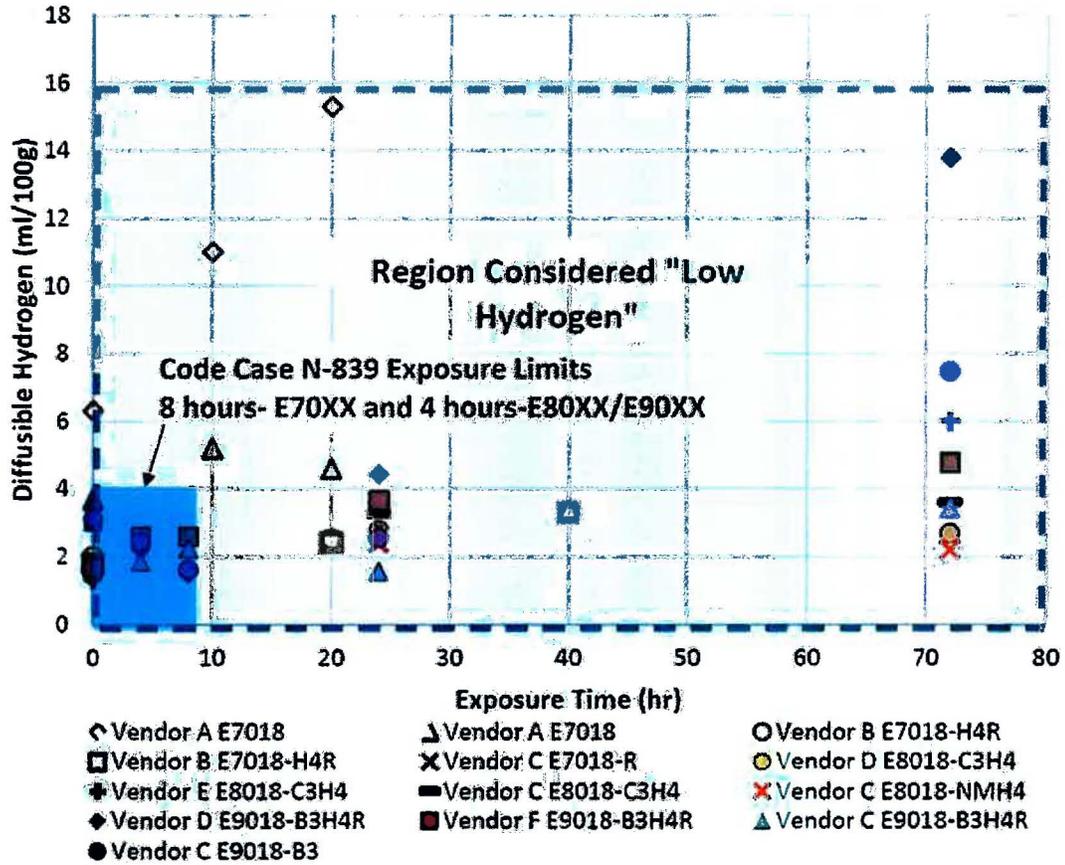
Figure 1 shows EPRI diffusible hydrogen test results for the thirteen lots of low hydrogen electrodes. All H4R electrodes exhibited less than 16ml/100g of diffusible hydrogen at 72 hours of exposure. Figure 2 shows that new electrodes without exposure have less than 2ml/100g diffusible hydrogen. Only one of the electrodes tested at the extremely aggressive 27°C and 80% Relative Humidity (HR) 72-hour exposure had diffusible hydrogen greater than 4 ml/100g. This demonstrates that exposure limits in the field of 24 hours or less is adequate to assure electrodes maintain the H4R limit. Ferritic electrodes were verified to have less than 4ml/100g diffusible hydrogen [6]. Testing verifies that ambient temperature is acceptable, post-weld hydrogen bakeout is not needed, and a 48-hour hold at ambient temperature prior to performing final NDE is unnecessary and diffusible hydrogen levels will be below any susceptibility threshold that supports HIC.

Figure 1. Results of EPRI diffusible hydrogen testing at 27°C 80% Relative Humidity (HR) for zero to 72 hours of exposure [6]

temperature, and relative humidity. Extensive testing by the EPRI Welding and Repair Technology Center shows there is an extremely low probability of HIC with H4 and H4R electrodes. EPRI performed diffusible hydrogen analysis per AWS A4.3 via gas chromatography on thirteen commercially available electrodes. Electrodes with AWS E7018, E8018 and E9018 from multiple vendors exposed at 27°C at 80% relative humidity (HR) for exposure times from 0 to 72 hours. Many of the electrodes did not have "R" moisture resistant coating.

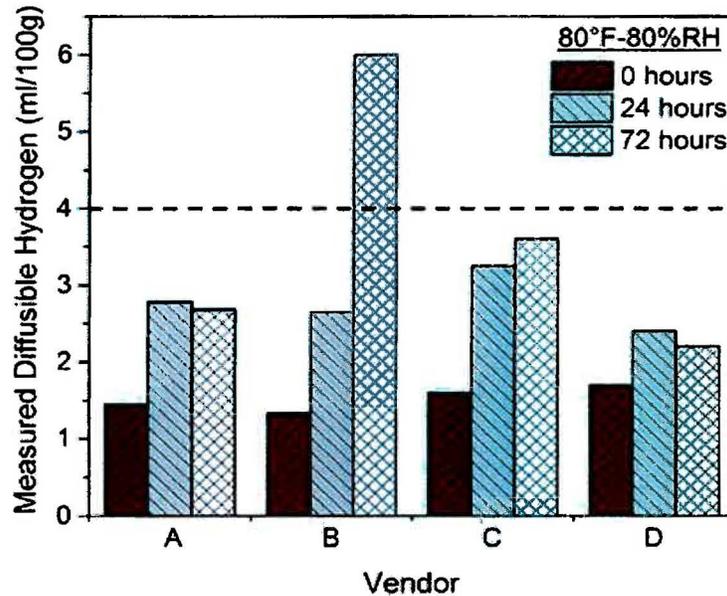
Figure 2. Graph showing slight increase of diffusible hydrogen after exposure of 24 and 72 hours [6]

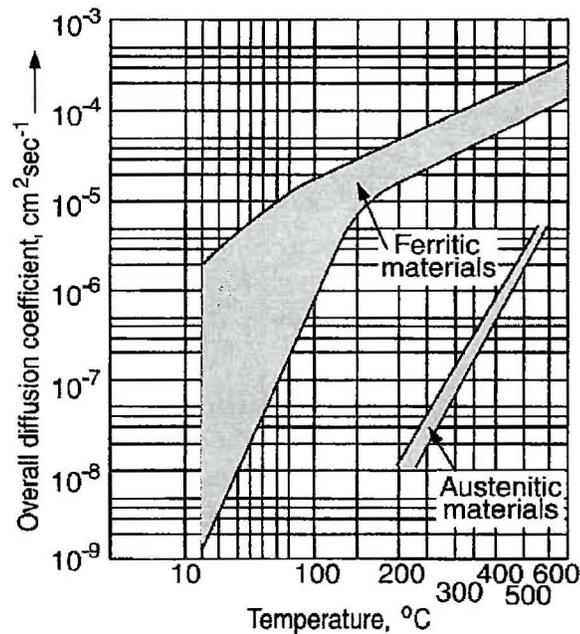
Figure 3 - Hydrogen solubility in ferritic and austenitic materials as a function of temperature

Diffusivity and solubility of hydrogen in ferritic, martensitic, and austenitic steels is an important factor to consider. Materials having face-centered-cubic (FCC) crystal structures such as austenitic stainless steels (300 series) and nickel base Inconels generally are not considered to be susceptible to hydrogen delayed cracking as discussed in the microstructure section, above. Additionally, due to the temperatures expected during the welding of the temper bead layers, and during the welding of any non-temper bead layers, the temperature should be sufficient for the hydrogen to diffuse out of the HAZ, either escaping the structure or diffusing into the austenite, where it can be held in much greater quantities. The diffusion rate is clearly from the ferrite to the austenite and whatever hydrogen remains will reside in the austenite, which has little to no propensity to hydrogen related cracking.

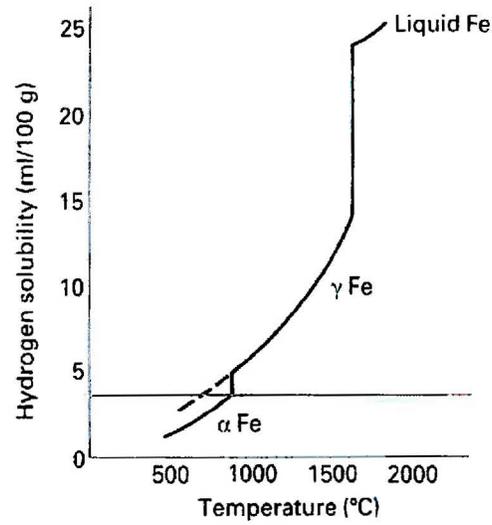
Figure 4 shows the overall difference in hydrogen diffusion between ferritic and austenitic materials. The diffusion of hydrogen in ferritic material is orders of magnitude greater compared to austenite. Again, the obvious advantage regarding HIC prevention is the hydrogen is slow to diffuse out of the austenitic material. When comparing how hydrogen behaves in ferritic versus austenitic weldments the hydrogen stays within the austenitic material, whereas in ferritic welds, it tends to diffuse into the base material. For a weld made with ferritic electrodes, the H^+ is absorbed in the molten weld puddle and as the weld solidifies, it transforms from austenite to ferrite and the H^+ is rejected and diffuses into the HAZ of the base material. When the HAZ transforms from austenite to martensite, the H^+ becomes trapped in the brittle microstructure and causes cracking, Figure 5. However, with an austenitic electrode, H^+ is absorbed in the molten weld puddle and there is no solid state transformation in the solidified weld metal so the H^+ stays in the austenitic weld material. No diffusion of the H^+ into the brittle martensite, thus avoiding the possibility of HIC, Figure 6. Schematics in Figure 5 and Figure 6 are adapted from Lippold and Granjon as shown in draft chapters 2 & 4 for Temper Bead Welding Process in Operating NPP's, International Atomic Energy Agency, [1, 8].

Figure 4 - Diffusion Coefficient of hydrogen in ferritic and austenitic materials as a function of temperature

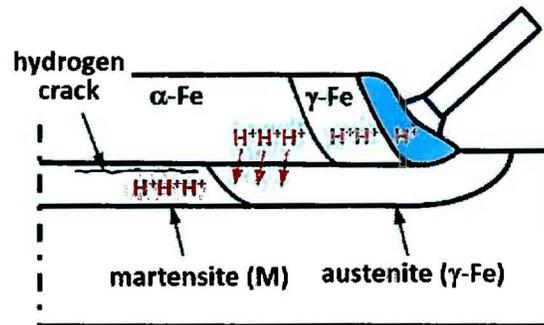
Figure 5 - Hydrogen movement with ferritic electrodes [8]

Use of fully austenitic weld metal on ferritic base material is a technique that has been used for decades to install welds on ferritic base materials with high potential of HIC. Austenitic filler materials are used in applications where preheat or post weld bake out is not possible because hydrogen (H^+) has high solubility, Figure 3, and low diffusivity, Figure 4, in austenite relative to other phases and acts as a trap for hydrogen to prevent HIC. Figure 3 show the solubility of hydrogen in α -Fe and γ -Fe. Note that α -Fe is at the saturation limit at ~ 4 ml/100g of hydrogen. At temperatures above $\sim 1700^\circ C$, the solubility of hydrogen in austenite (γ -Fe) is nearly five times that of ferrite (α -Fe). The benefit regarding HIC is the hydrogen stays in the austenite and is not available to promote HIC.

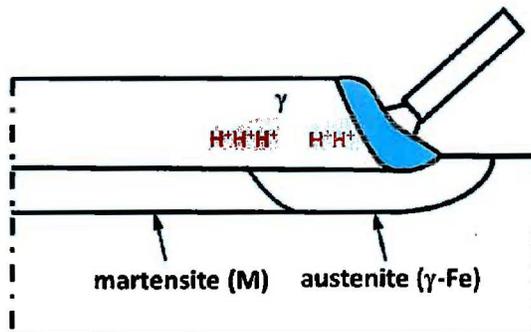
Figure 6 - Hydrogen movement with austenitic electrodes [8]
