**From:** Cary, Richard H. <Richard.Cary@pseg.com>  
**Sent:** Thursday, May 11, 2023 6:19 PM  
**To:** nmfs.gar.incidental-take@noaa.gov; EndangeredSpecies Resource  
**Cc:** Corbett, Heather [DEP]; Fehring, Shana [DEP]; Neilan, Brian [DEP]  
**Subject:** [External\_Sender] Salem Generating Station - Incidental Take Report: Sturgeon 5/11/2023  
**Attachments:** Sturgeon Incidental Take Report for 05-11-2023.pdf

Attached are the Incidental Take Report and Data Collection Forms for a deceased Atlantic sturgeon collected on 5/11/2023 from the Salem Generating Station cooling water intake trash bars. The deceased specimen is being held for study pending direction from NOAA/NMFS. This incidental take is authorized under Biological Opinion GAR-2020-02842.

# STURGEON DATA COLLECTION FORM

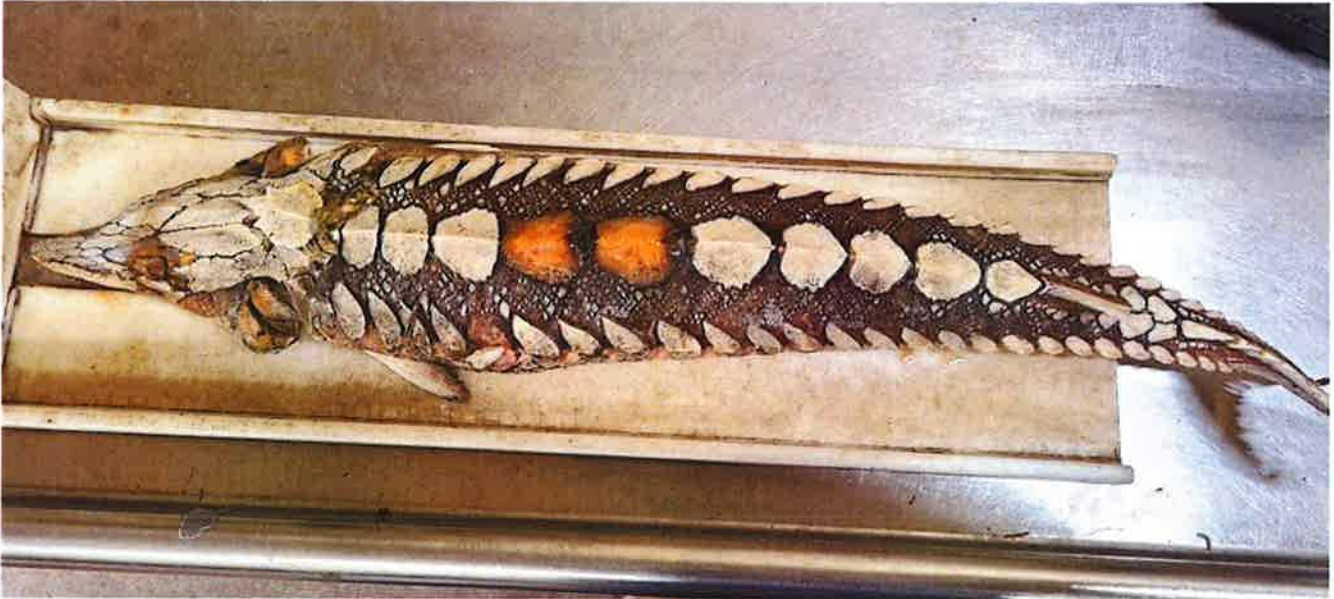
A dorsal view showing the size and condition of a deceased Atlantic sturgeon (*Acipenser oxyrinchus*), retrieved at approximately 10:30AM on 05/11/2023 from the Salem Circulating Water Intake by Salem Yard Crew personnel during routine trash rack cleaning at Salem Nuclear Generating Station (05/11/2023).

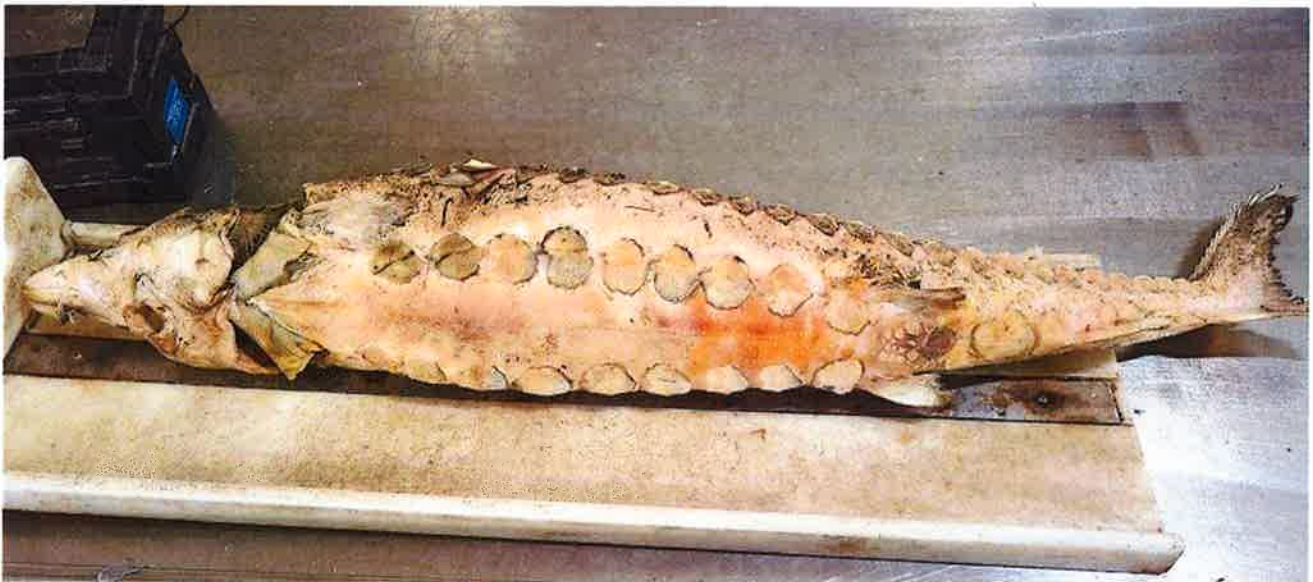
A ventral view of the specimen showing the extent of decomposition, with degraded fin rays on the caudal, anal, and pectoral fins, as well as erosion of the gills and operculum and surface tissue of the head. Neither external nor internal tags were indicated during processing (05/11/2023).

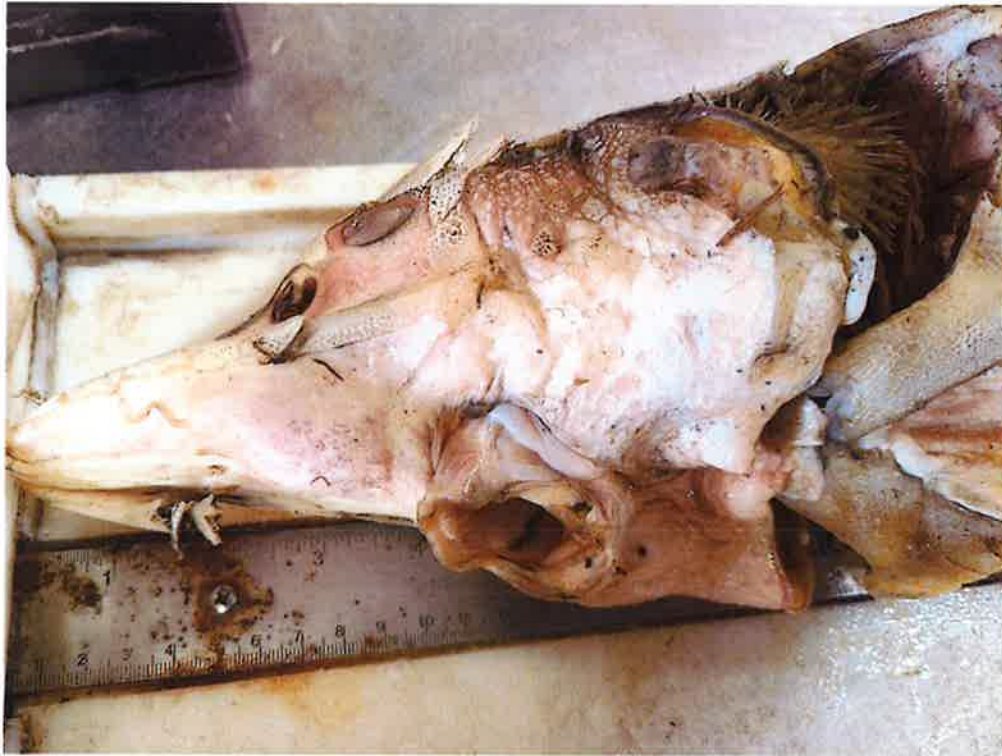
Dorsolateral view of the head, showing the characteristic small mouth and elongated rostrum. Severe decomposition has resulted in erosion of the surface skin on the head, and erosion of the operculum on both the right and left sides are indicated (05/11/2023).

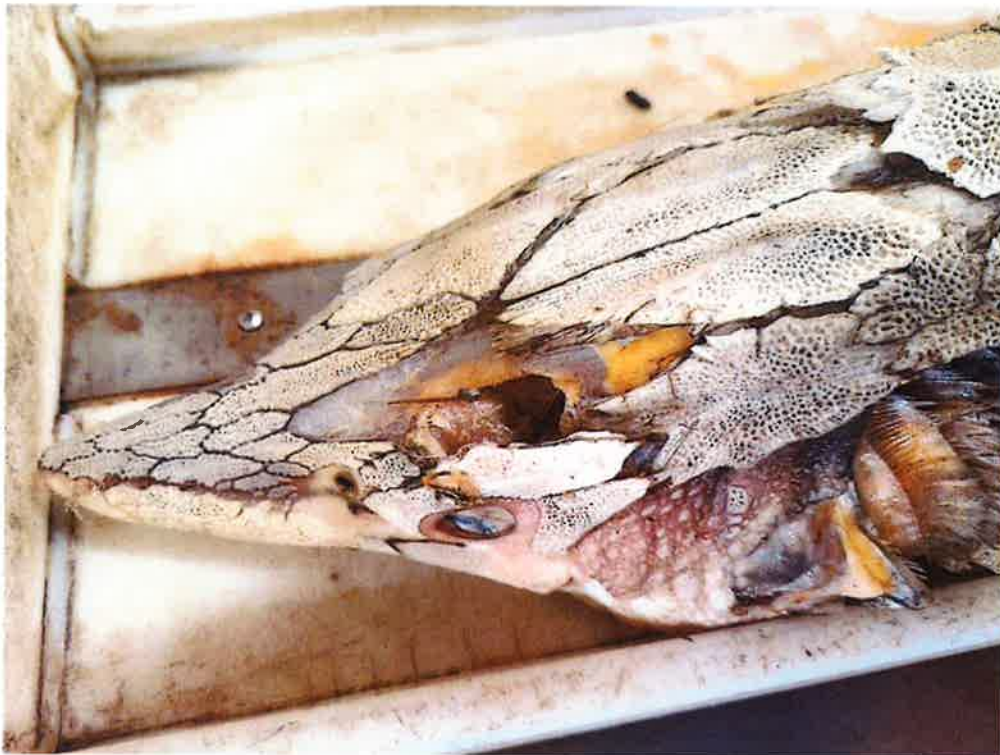
Dorsal view of the head, showing exposed bones and missing bony plates of the skull (05/11/2023).
