APPENDIX B – Part 1 (Sea Turtle)

Incident Report Sea Turtle Take – PSEG Salem Generating Station

**Salem SGS Incidental Take Report - Sea Turtle
Attachment 1**

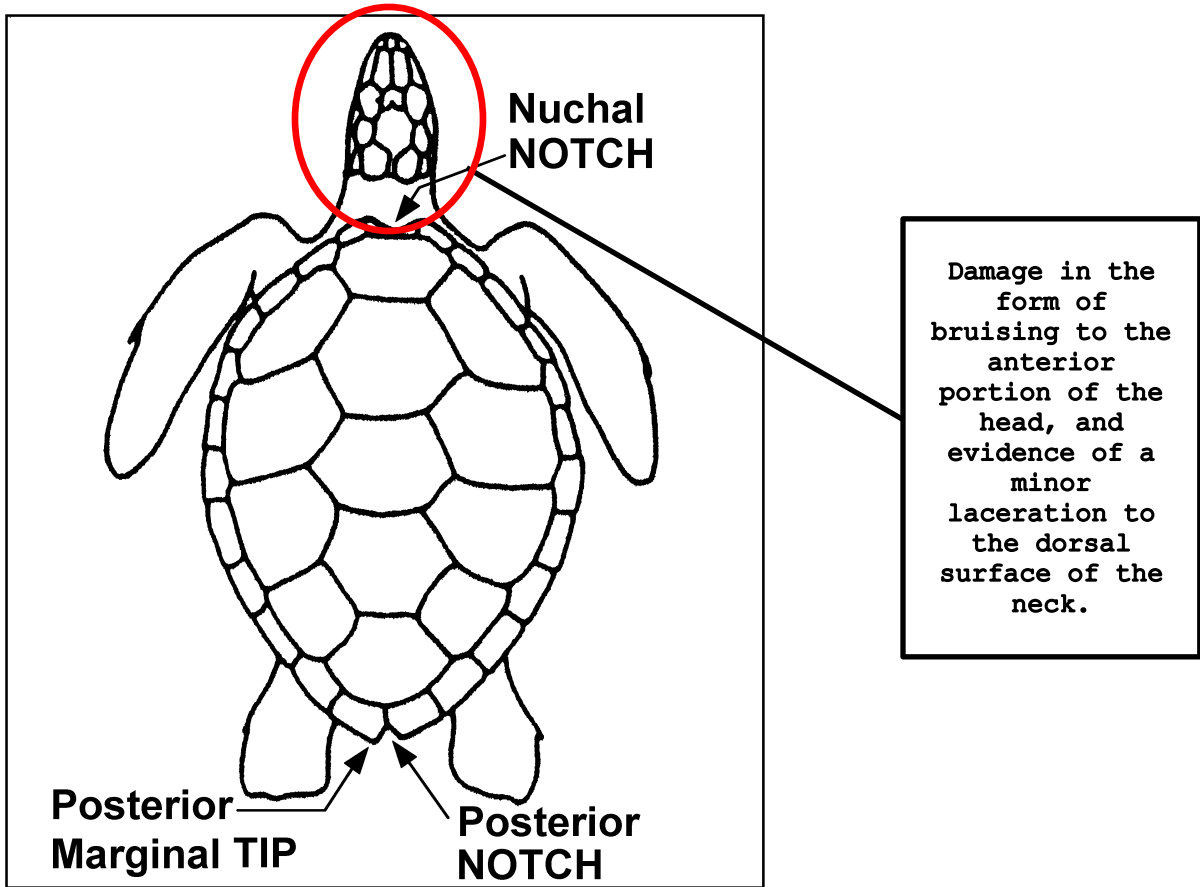
Draw wounds, abnormalities, tag locations on diagram and briefly describe below.

Specimen was in very poor condition at the time of retrieval, with damage to the head and neck, in addition to the effects of advanced decomposition. External tags were not found, and an internal PIT tag was not indicated.

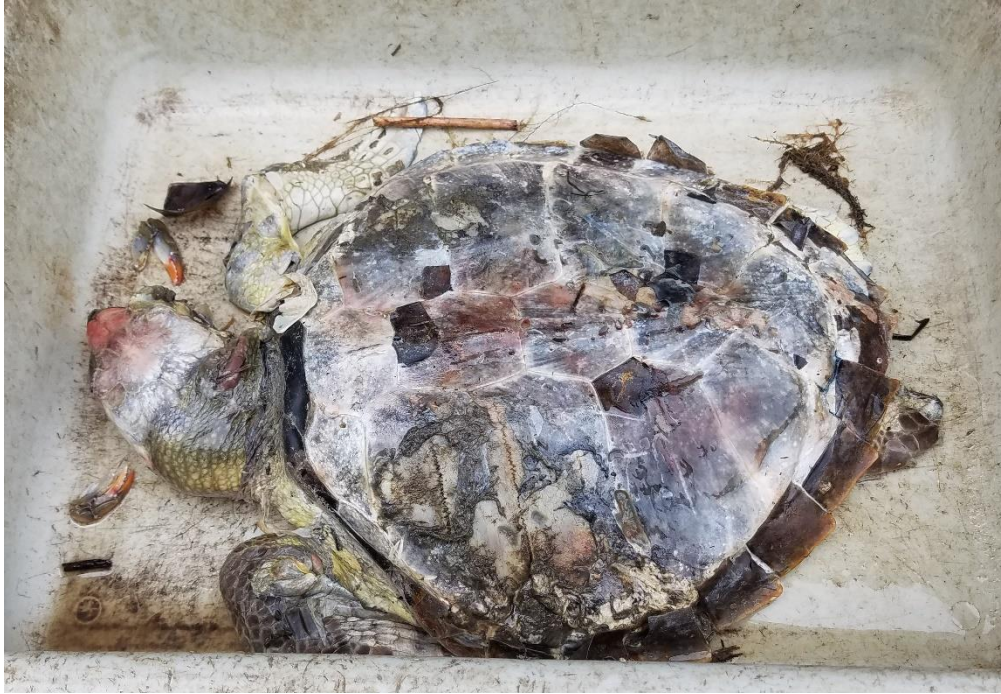
Dorsal view of a deceased, Kemp's ridley sea turtle, collected from Salem CWIS intake on 06-20-2023 by Salem Yard crew personnel. Specimen was in a state of advanced decomposition, and evidence of damage was observed to the head and neck in the form of bruising and a minor laceration (06/20/2023).

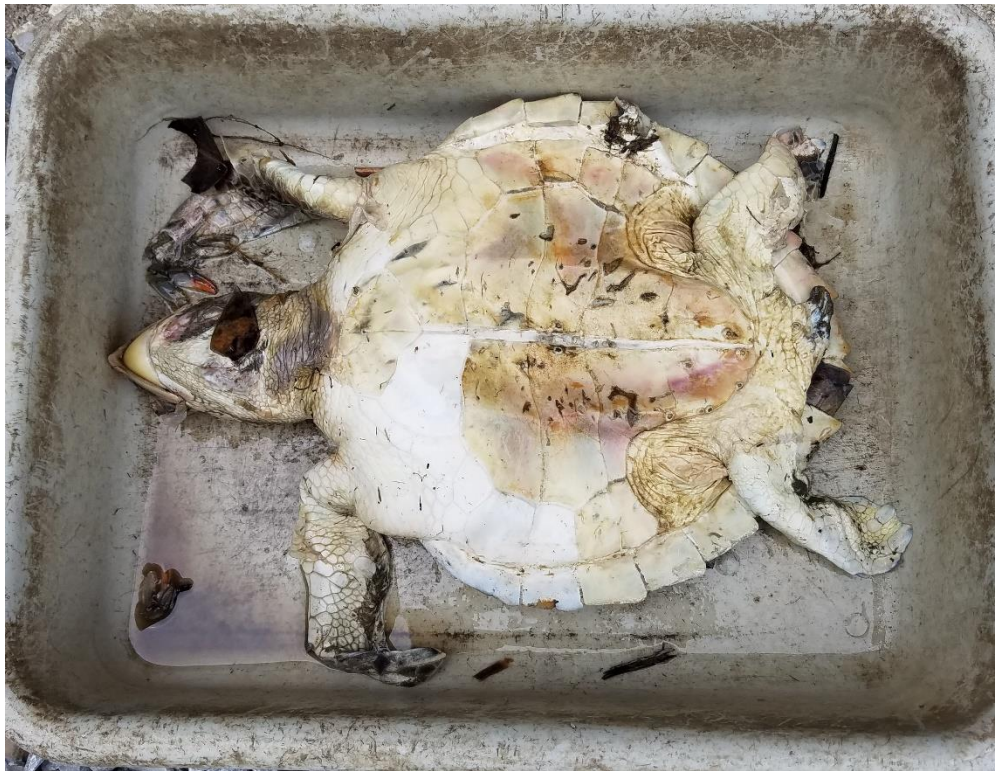
A ventral view of the specimen, showing the condition of the plastron. Discoloration of the skin, missing scutes, and foul odor indicated an advanced stage of decomposition (06/20/2023).

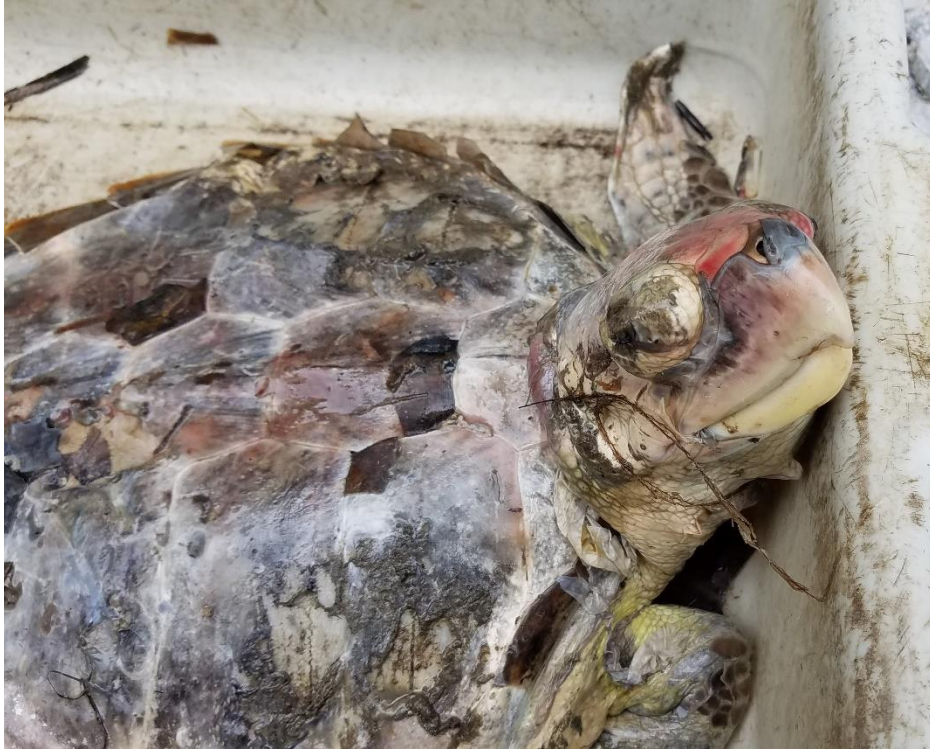
Dorsal view of the head, showing minor bruising to the anterior portion of the head. A minor laceration was observed at the base of the neck (06/20/2023).

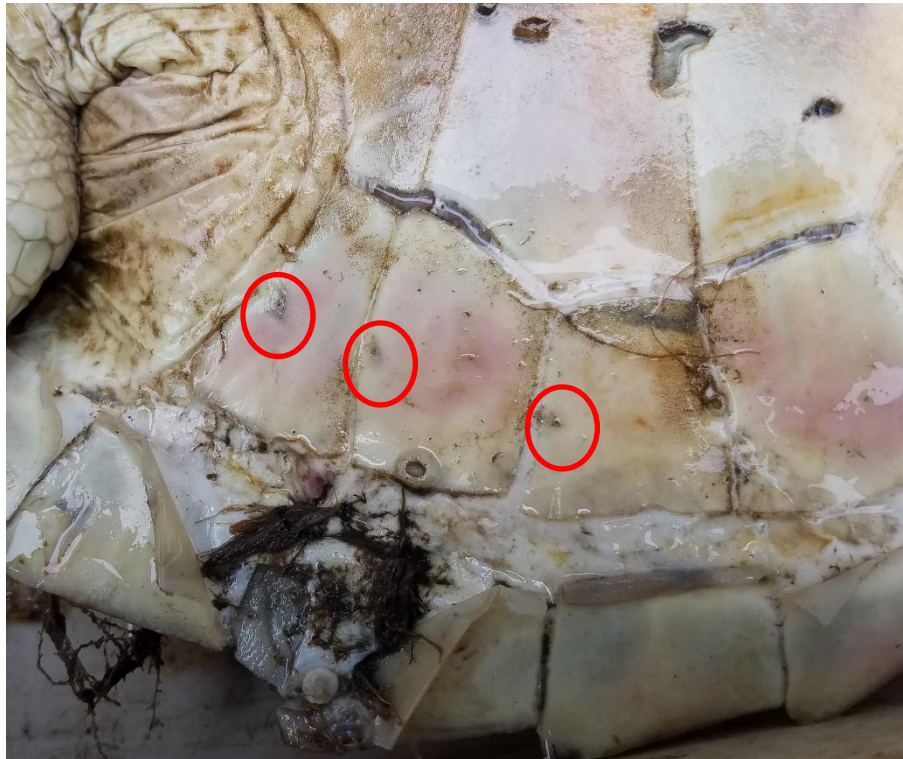
The existence of distinct pores near the margins of the inframarginal scutes (identified by the red circles in photo) on both sides of the plastron, verify the identity of the specimen as a Kemp's ridley turtle [06/20/2023].
