Steam Generator Inspection Reliability Assessments on Primary Side Cracking in U-Bends

International Steam Generator Tube Integrity
Program—Assessment of SG Inspection
Techniques and Reliability

Date Published: August 2023

Argonne National Laboratory
9700 South Cass Avenue
Lemont, IL 60439

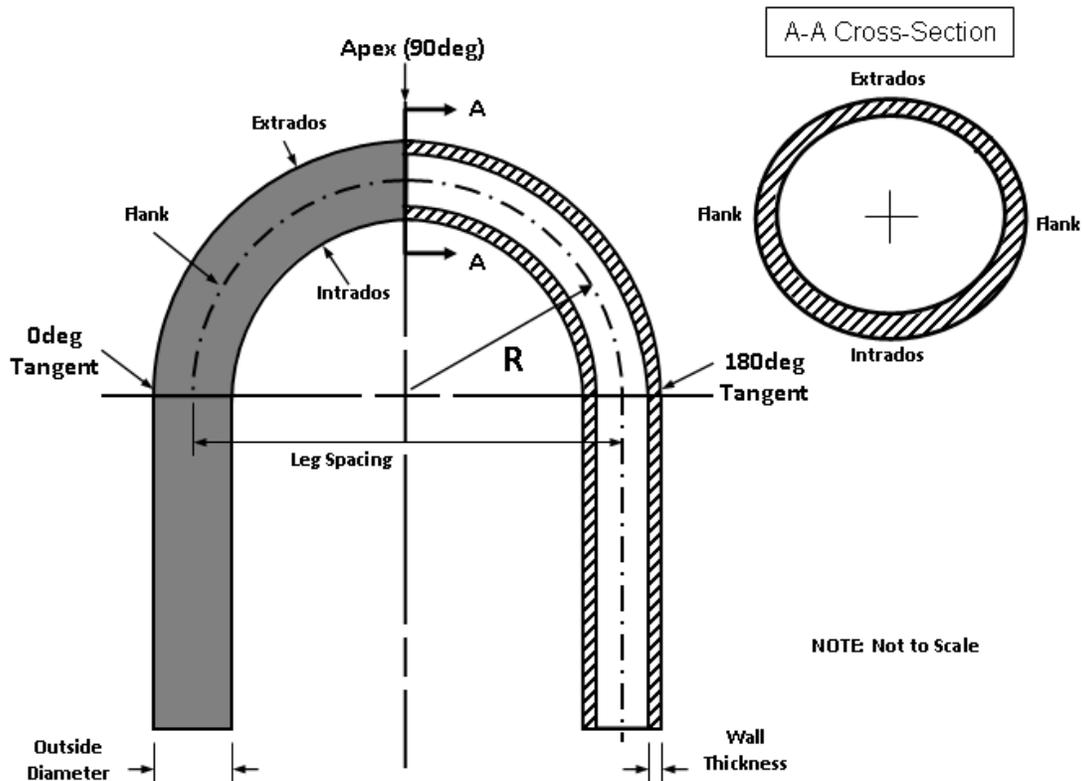
Figure 2-1. Schematic of U-bend tubing showing the locations of extrados, intrados, flank, apex, and tangent.

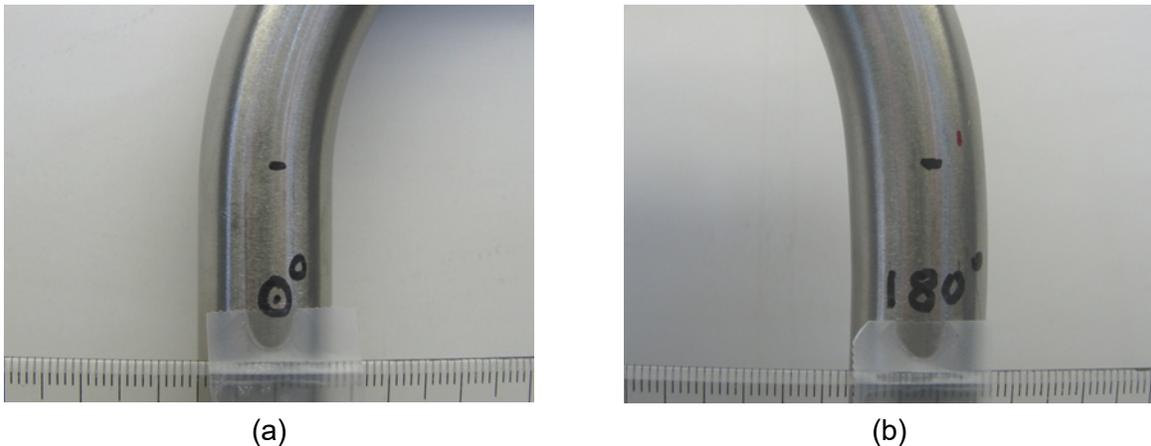
Figure 2-5. Photographs showing sections of a representative 19.1-mm OD U-bend tube near (a) 0deg and (b) 180deg tangents. Visible in the photo of the 180deg tangent are light dent at the extrados and bulge at the intrados.

Figure 2-5 shows photos of the U-bend regions near “0deg” and “180deg” tangents for a 19.1-mm OD tube. One tangent identified as “0deg” throughout this report has a well-defined tangential point, whereas the other tangent identified as “180deg” shows no definite point of the tangency. The “180deg” tangent area shows a slight dent at the extrados and a bulge at the intrados, although they may not be visually discernible in the photos. This observation suggests that there are irregular shapes at one tangent zone. Based on the information provided by the vendor, this phenomenon is rather typical in U-bends with a small bend radius, suggesting that low-row U-bends in actual SGs would also have this geometric irregularity.

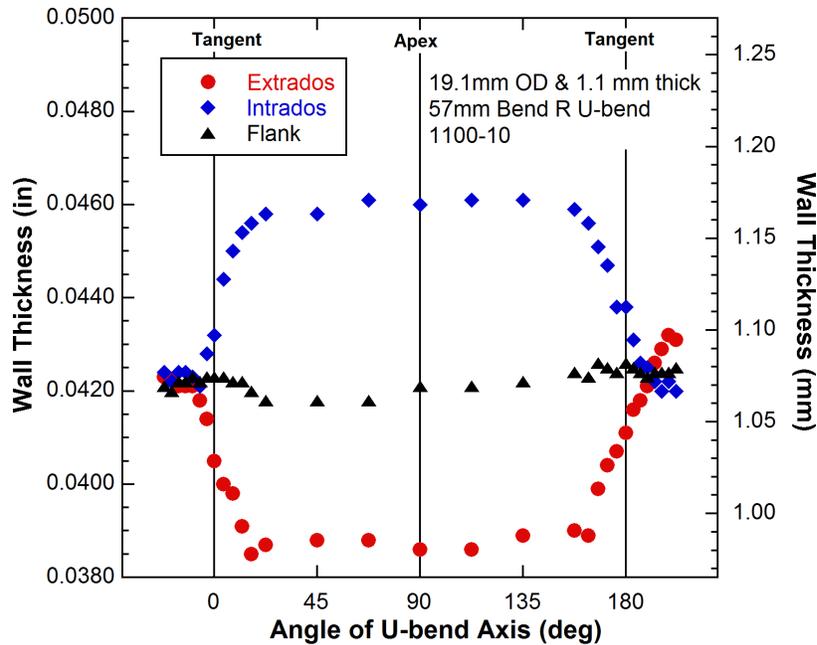
Figure 2-7. Wall thickness profiles of 19.1-mm OD and 57-mm bend radius U-bends (1100-10) along the angle of U-bend axis.

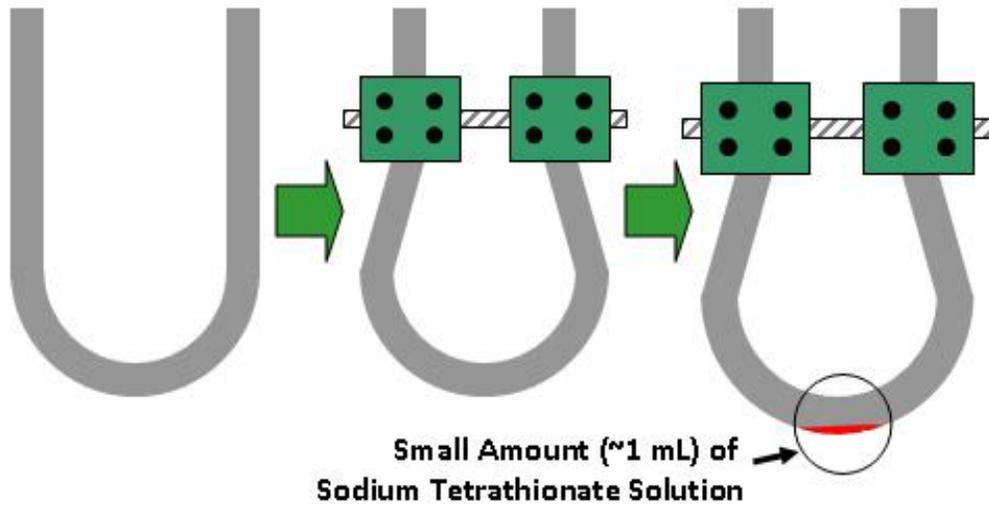
Figure 2-10. Schematic of displacing U-bend legs with clamps and the location of chemical exposure area.

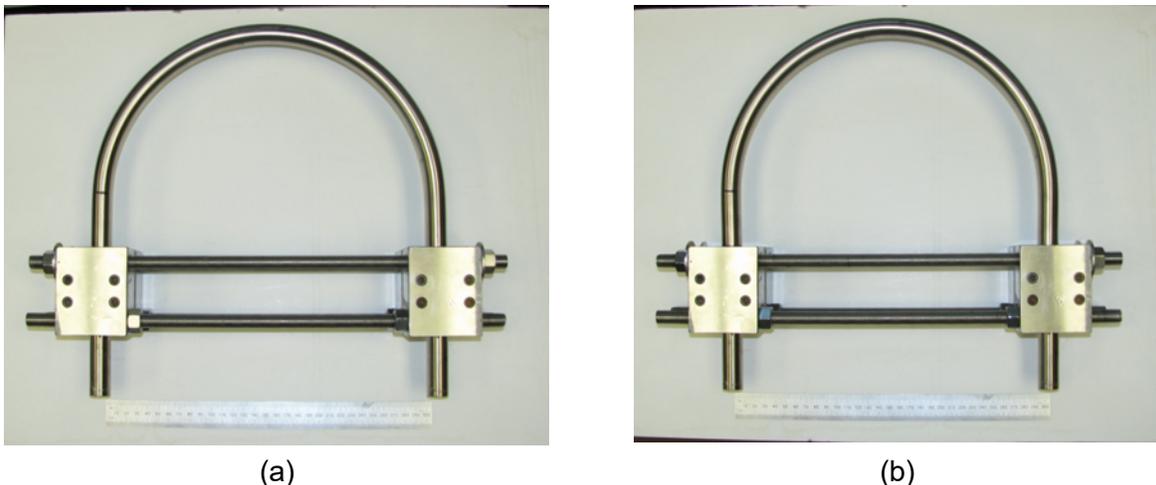
Figure 2-13. 152-mm bend radius U-bend with clamps (a) before and (b) after the inward leg displacement. Note that the ruler in the photos is 300 mm long.

As a first trial, as-received U-bend specimen 07-04 with a 19.1-mm OD and 152-mm bend radius was displaced with the total leg displacement of around 25 mm (1 in.), that is, 13 mm (0.5 in.) for each U-bend leg. The apex region was exposed to corrosive chemicals to induce circumferential PWSCC. After the total exposure time of 4.5 days to 1 M sodium tetrathionate ($\text{Na}_2\text{S}_4\text{O}_6$) solution, the U-bend specimen was examined with the +Pt rotating probe. However, the EC examination did not show any flaw indications. After this first trial, subsequent U-bend specimens were heat treated to sensitize their microstructure and thus, in effect, reduce their residual stress.

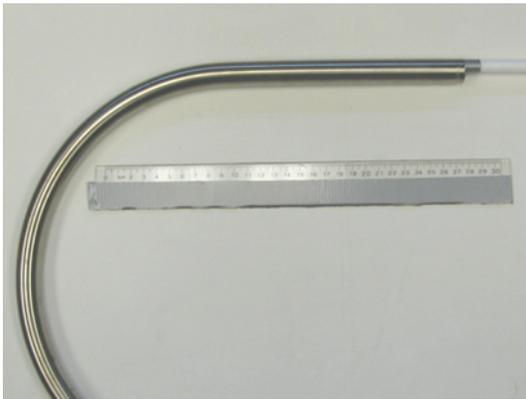
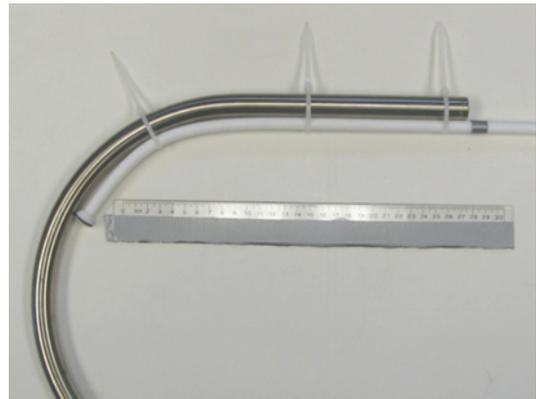
Figure 2-14. Photographs showing (a) the Teflon insert with O-ring, (b) U-bend with the inserted Teflon insert, and (c) the Teflon insert and rod placed with the U-bend to show the approximate location of the Teflon plug in the U-bend after the insertion. (Note that the ruler is 300 mm long.)

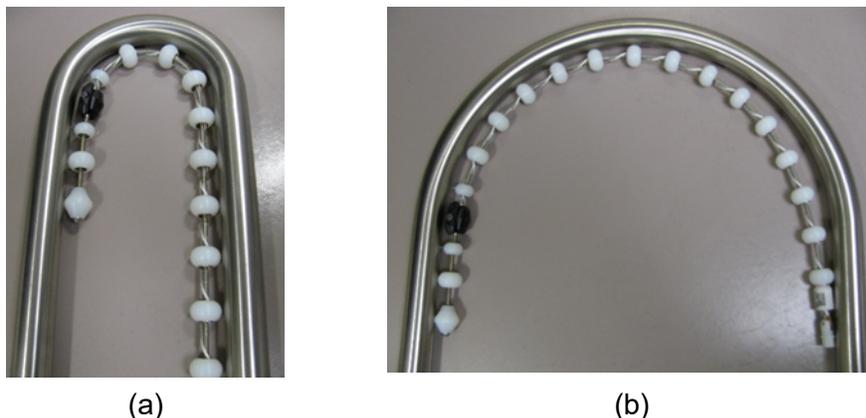
Figure 3-1. Photographs of detachable flexible rotating probe with a mid-range +Pt coil, placed along the intrados of (a) a 57-mm and (b) a 152-mm radius U-bend tube specimen at Argonne.

Eddy current examinations were performed on all U-bend specimens during the crack production process. The NDE method served both as a means to guide the crack manufacturing process and for sizing of cracks afterwards. Although a number of different EC examination techniques—including those that employ bobbin, rotating, and array probes—were implemented to acquire data on U-bend specimens, the results presented in this report pertain only to data acquired with a flexible +Pt rotating probe manufactured by Zetec, Inc. Results of analyses associated with the other EC examination techniques will be the subject of future studies. The main components of the inspection system used in this work include a MIZ-85iD-1 remote eddy current testing instrument, a 10D4 pusher, and EC probe. Probe motion control and data acquisition are implemented under the EddyNet™ software environment. Data collected earlier in this work were obtained using a MIZ-30 eddy current testing instrument. The flexible +Pt probe is designed to traverse the smallest-radius U-bends, which are the innermost (i.e., lowest row number) tubes within the tube bundle of a recirculating SG. Figure 3-1 shows photos of the flexible rotating probe used for inspection of U-bend tubes at Argonne. The probe head houses a single mid-range +Pt coil.

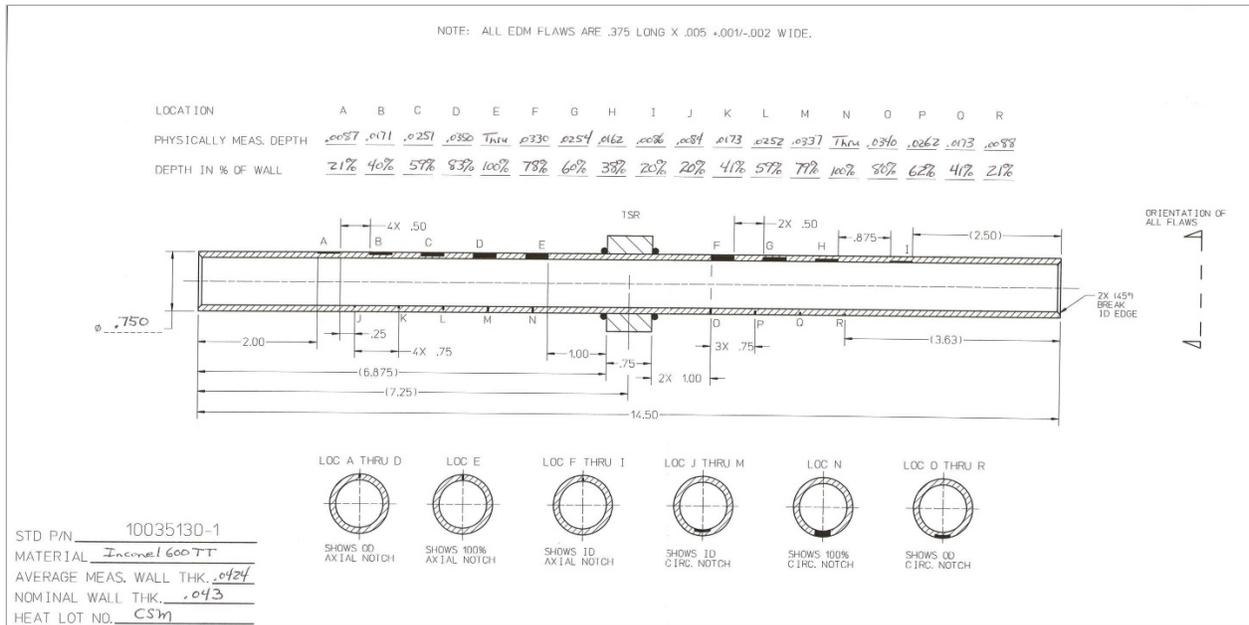
Figure 3-2. Drawing for EDM notch standard tube used for calibration of rotating probe data. The tube has 18 notches of OD and ID origin with axial and circumferential orientation.

Crack depth is estimated by applying a phase-based calibration curve that is generated using signals from ID-originated EDM notches on the calibration standard tube and includes data points for 0% and 100%TW depths. Separate calibration curves are generated for the axially and the circumferentially oriented flaws. The phase-based calibration curve for the axial channel is generated in the main analysis window. The calibration curve for the circumferential channel is generated using the circumferential lissajous from the C-scan analysis window. While all of the analysis channels are independently calibrated, the flaw sizing results reported here are all based on data from the 300-kHz channel. The estimates of flaw depth represent the depth measured at or near the maximum amplitude of flaw signal.

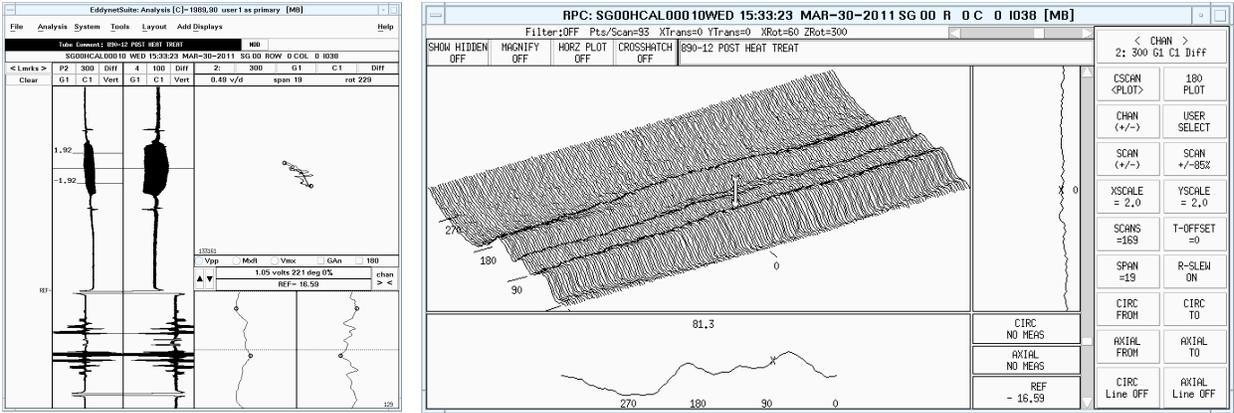
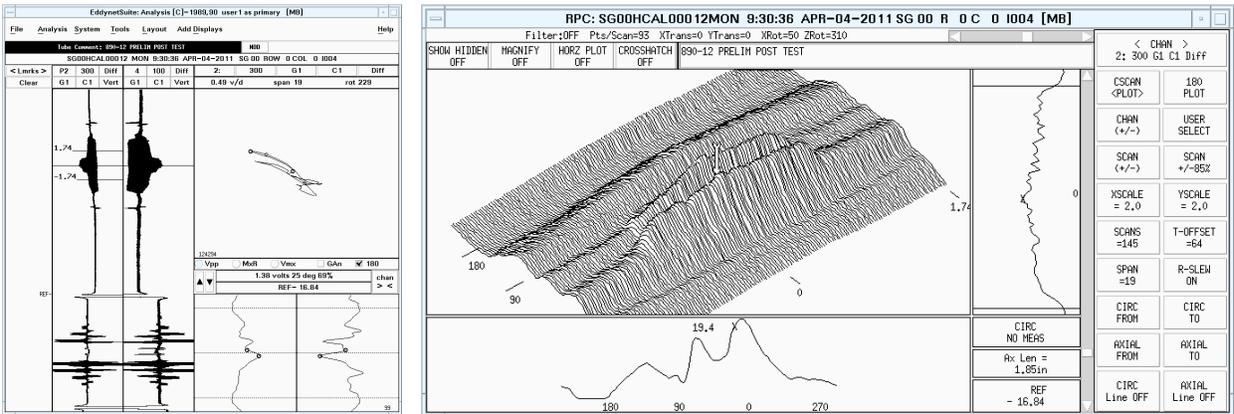
Figure 3-3. Representative +Pt probe data for a 57-mm-radius U-bend specimen 890-12 (a) before and (b) after the chemical exposure process.

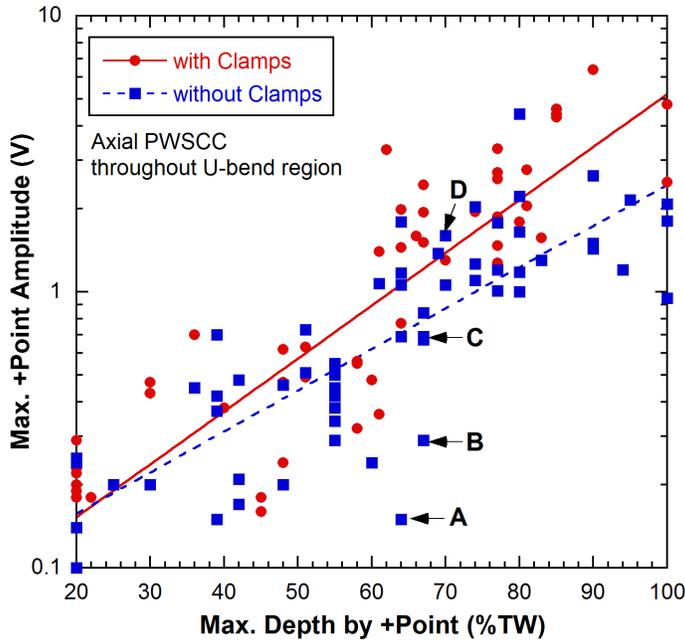
Note: Data points A, B, C, and D denote the four axial PWSCCs selected for evaluating the range of variability in signal amplitude.

Figure 3-5. Maximum signal amplitude for axial PWSCCs in U-bend specimens, with and without the clamps, as a function of maximum depth estimated using data from +Pt probe examinations.

At a given crack depth, the measured signal amplitude based on +Pt data in some cases shows significant variability. To further evaluate the range of variability in signal amplitude, four axial PWSCCs at U-bends were selected for that purpose. The data points for those cracks are denoted by the symbols A through D in Figure 3-5. The cracks all had comparable NDE depth estimates (64–70%TW) but varied significantly in their signal amplitude (0.15–1.5 v). Figure 3-6 shows the isometric plot of rotating probe data for the four axial cracks in the U-bend region. The data were collected after the clamps were removed. Because of its low S/N, PWSCC A was barely detectable, and the estimated length of the crack was ~4 mm (0.15 in.). The PWSCC B was composed of multiple short crack segments, and the longest segment was greater than 4 mm. The PWSCC C appeared to be composed of multiple axial cracks; however, the EC signals from the crack segments could not be clearly resolved because of the limited spatial resolution of the probe. The proximity of the cracks can be observed from the axial cross-section of the isometric plot shown in Figure 3-5(c). The EC signal from PWSCC D, which was relatively large, suggests the presence of a single crack longer than 25 mm (1 in.). It is apparent that the crack length affects the signal amplitude at the given crack depth. However, based on the data from the four axial PWSCCs examined here, no simple correlation exists between the crack length and the signal amplitude when dealing with complex forms of cracking. It should be noted that the crack depths in Figure 3-5 were estimated based on analysis of EC data. However, a more reliable assessment of NDE sizing capability should be based on the actual crack depths determined by DE. To that end, Section 4 presents the results on the correlation of flaw size estimated by NDE with that obtained by DE.

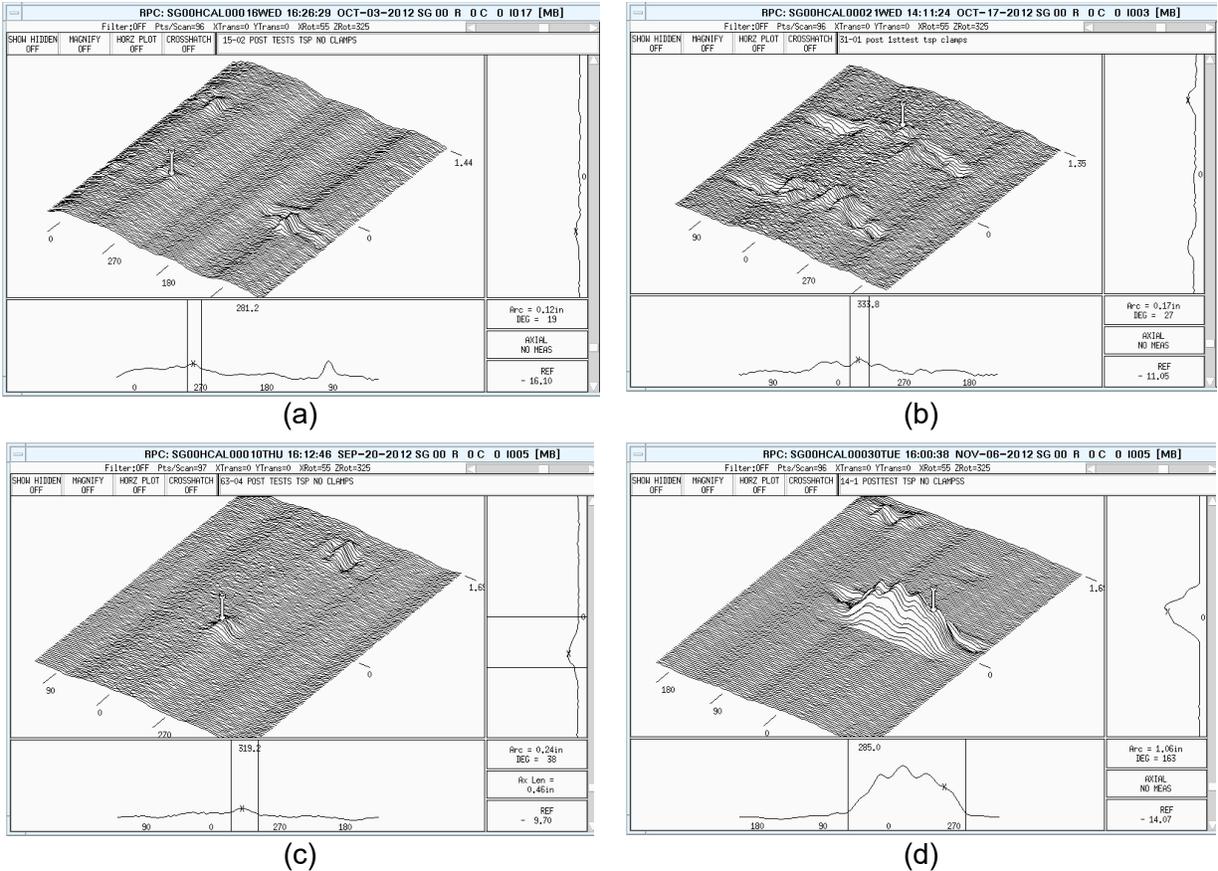
Note: The crack signals are (a) at location E in specimen 15-02, (b) at location B in specimen 31-01, (c) at location A in specimen 63-04, and (d) at location E in specimen 14-01.

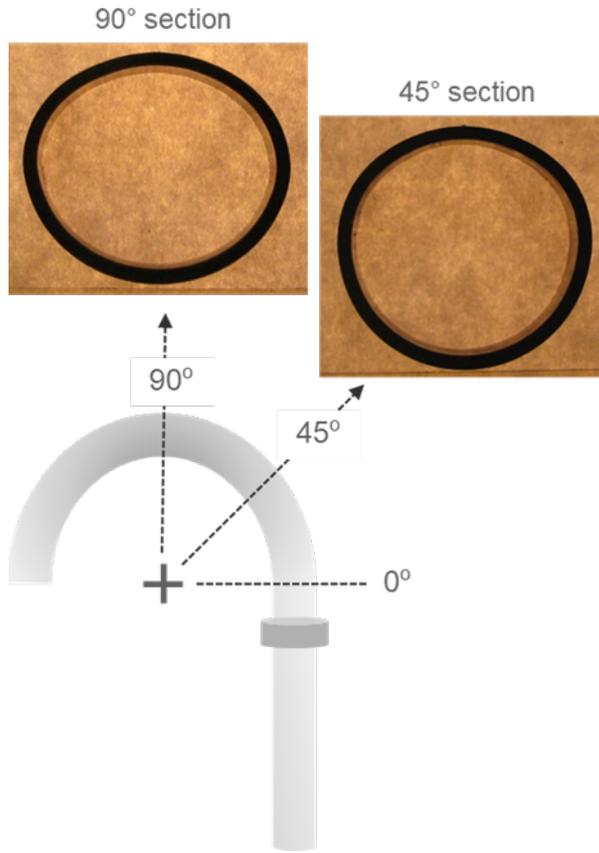
Figure 3-11. Cross-sectional view of U-bend specimen 890-12 cut at 45° and at 90° bend locations as denoted in the figure. The top of each cross-section is extrados and the bottom is intrados. Also shown in the figure is the configuration of test setup for EC inspection of the U-bend section, which includes an in-line calibration standard with a 270° TSP collar.

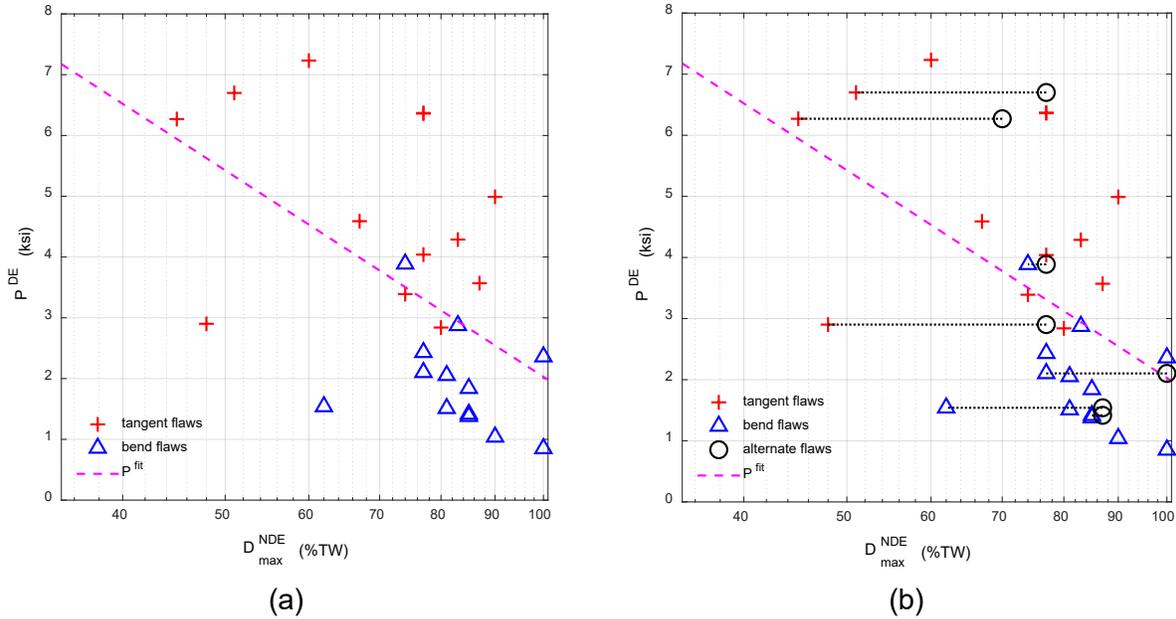
Figure 4-3. (a) Correlation plot of failure pressure vs. NDE maximum depth for axial PWSCC in 57-mm-radius U-bends and (b) the same plot as (a) with the added points (circles) for the predicted flaw to fail based on the NDE parameter.

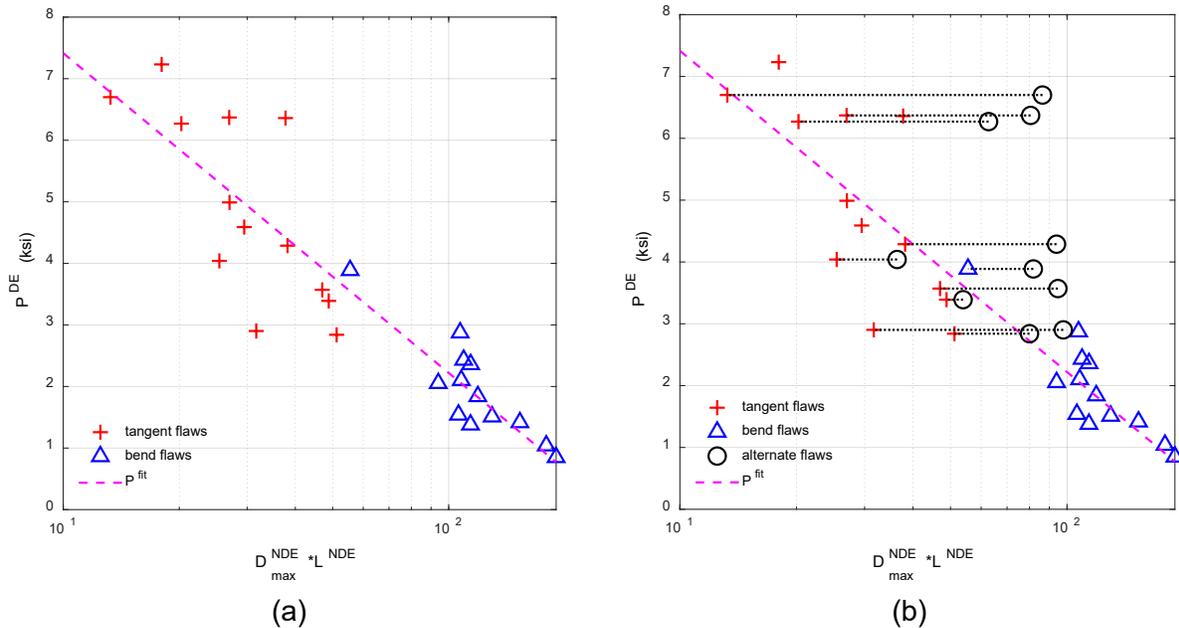
Figure 4-4. (a) Correlation plot of failure pressure vs. NDE crack area (depth * length) for axial PWSCC in 57-mm-radius U-bends and (b) the same plot as (a) with the added points (circles) for the predicted flaw to fail based on the NDE parameter.

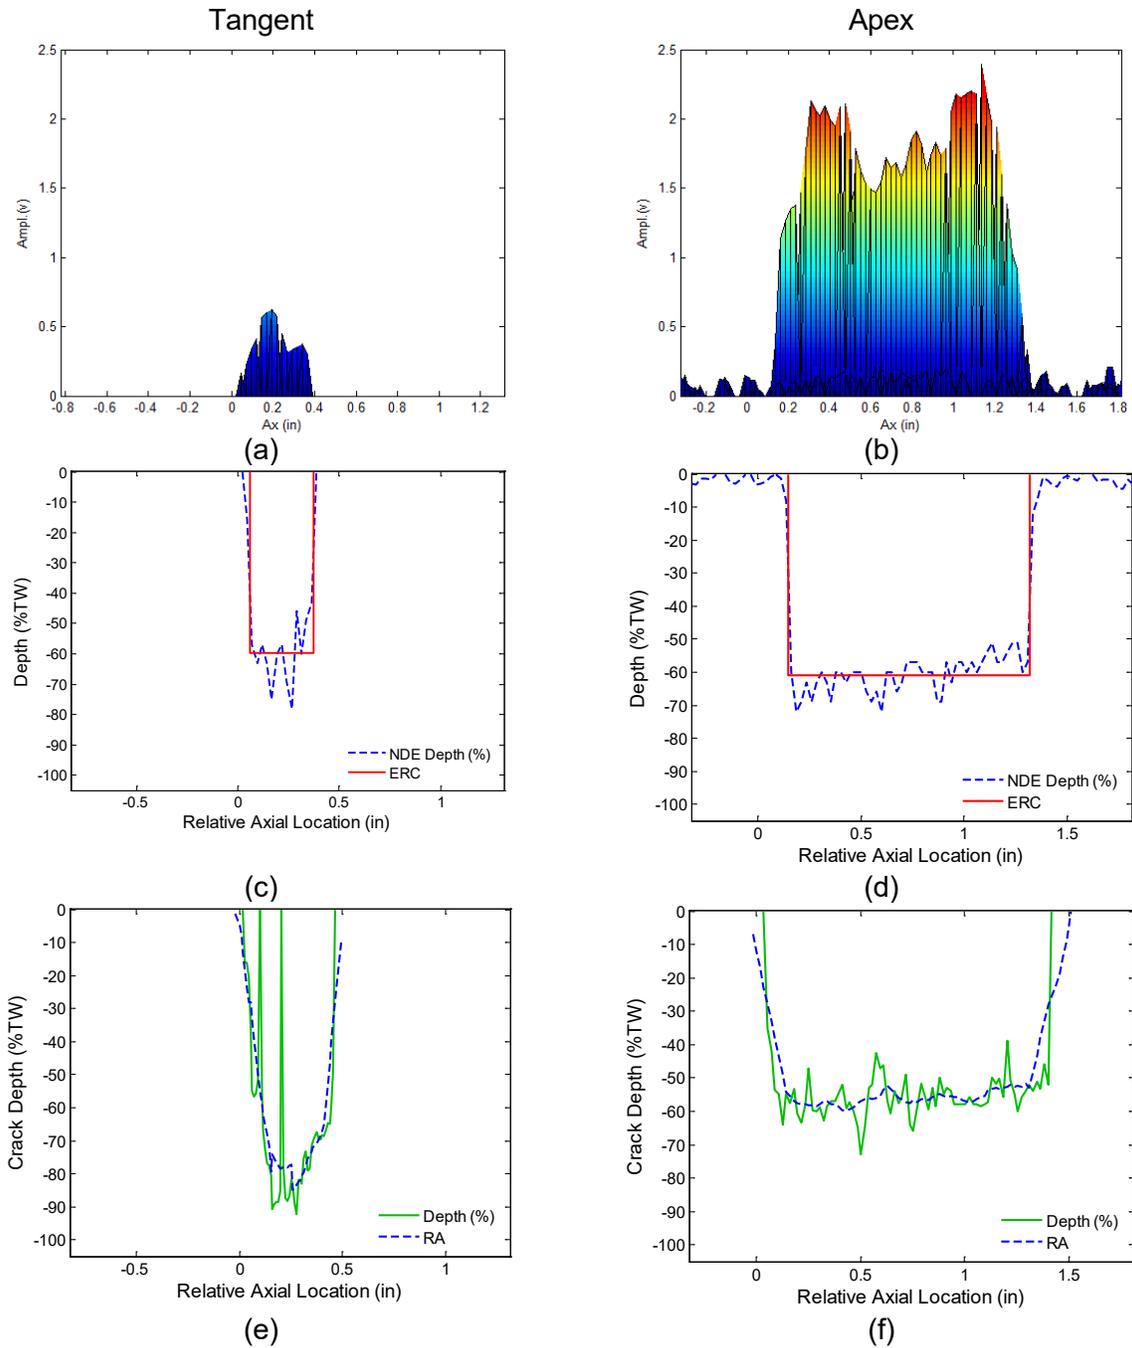
Note: Shown above are (a, b) EC signal amplitude profiles, (c, d) NDE depth profiles, and (e, f) fractography depth profiles for the crack at the tangent and at the apex, respectively. The crack at the tangent failed before the one at the apex.

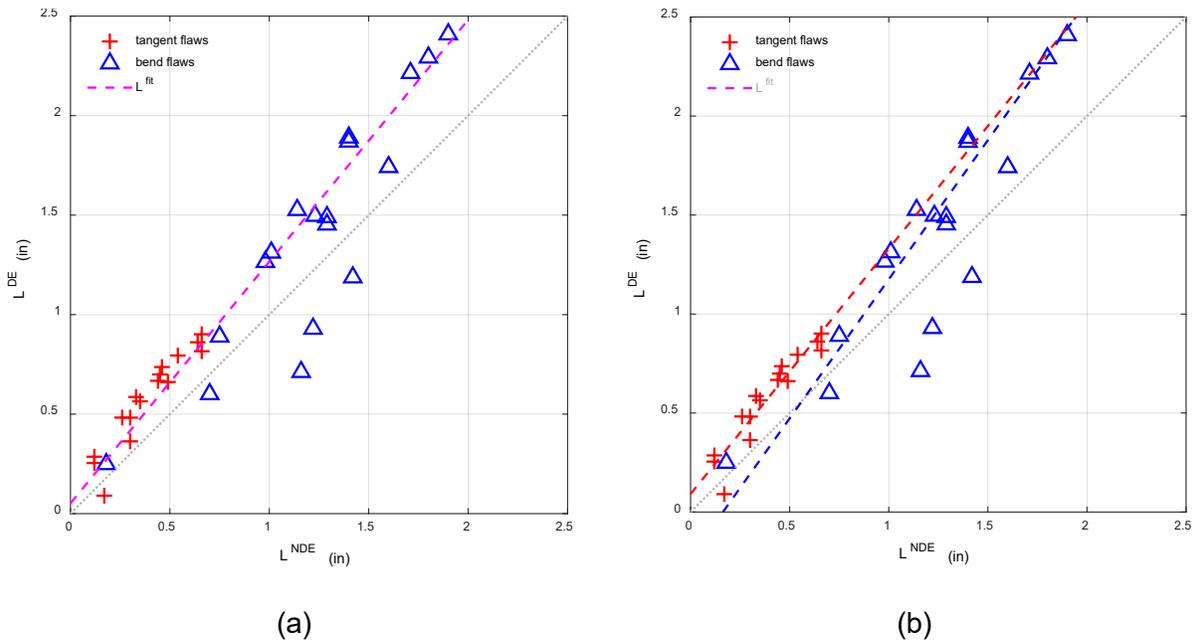
Figure 4-10. (a) Correlation plot of DE vs. NDE crack length with a single line fitted to all data points and (b) the same plot as in (a) with separate lines fitted to tangent and U-bend (above tangent) data points.

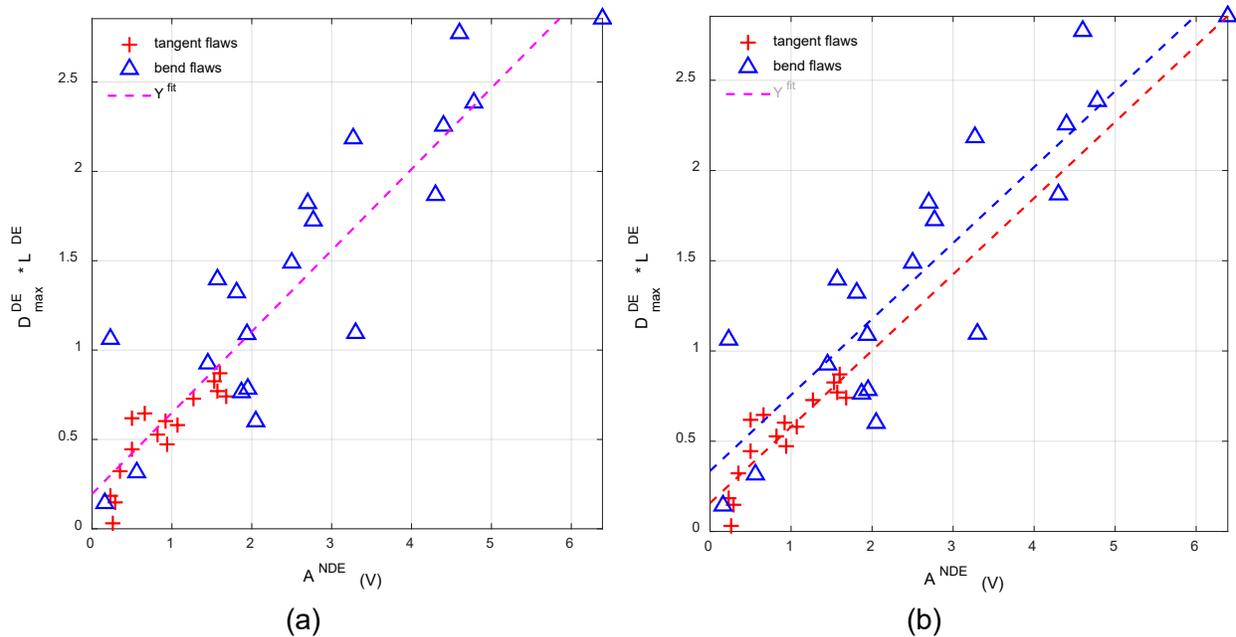
Figure 4-15. (a) Correlation plot of DE crack area vs. NDE signal amplitude with a single line fitted to all data points and (b) the same plot as in (a) with separate lines fitted to tangent and U-bend (above tangent) data points.

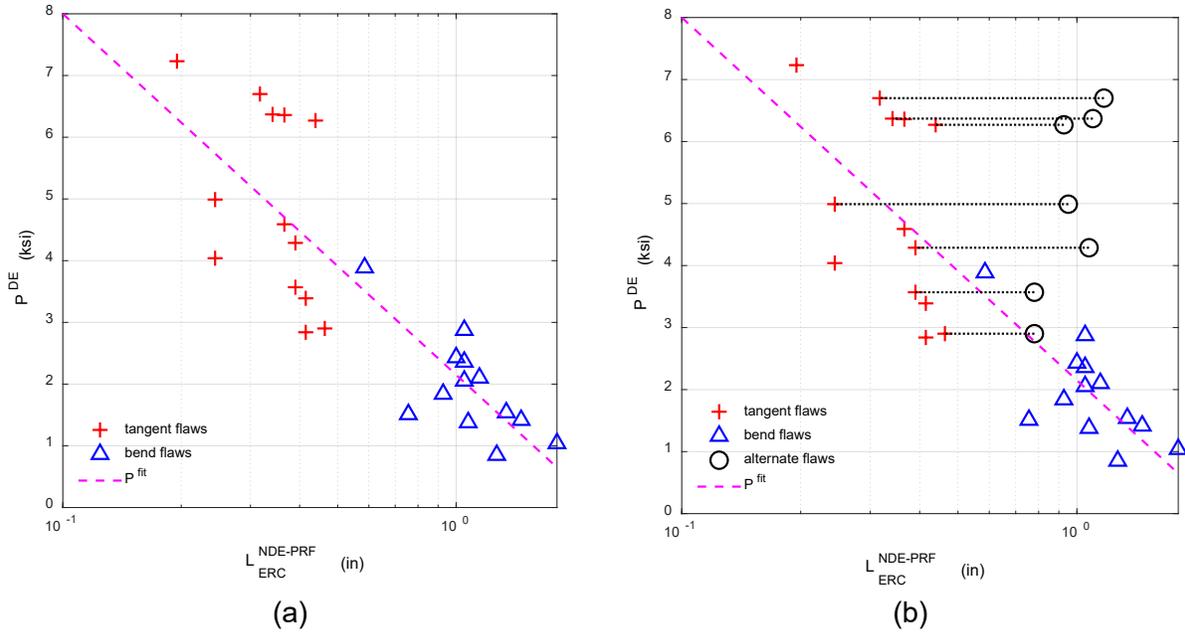
Figure 4-16. (a) Correlation plot of failure pressure vs. NDE crack length obtained from NDE depth profile and (b) the same plot as in (a) with the added points (circles) for the predicted flaw to fail based on the NDE parameter.

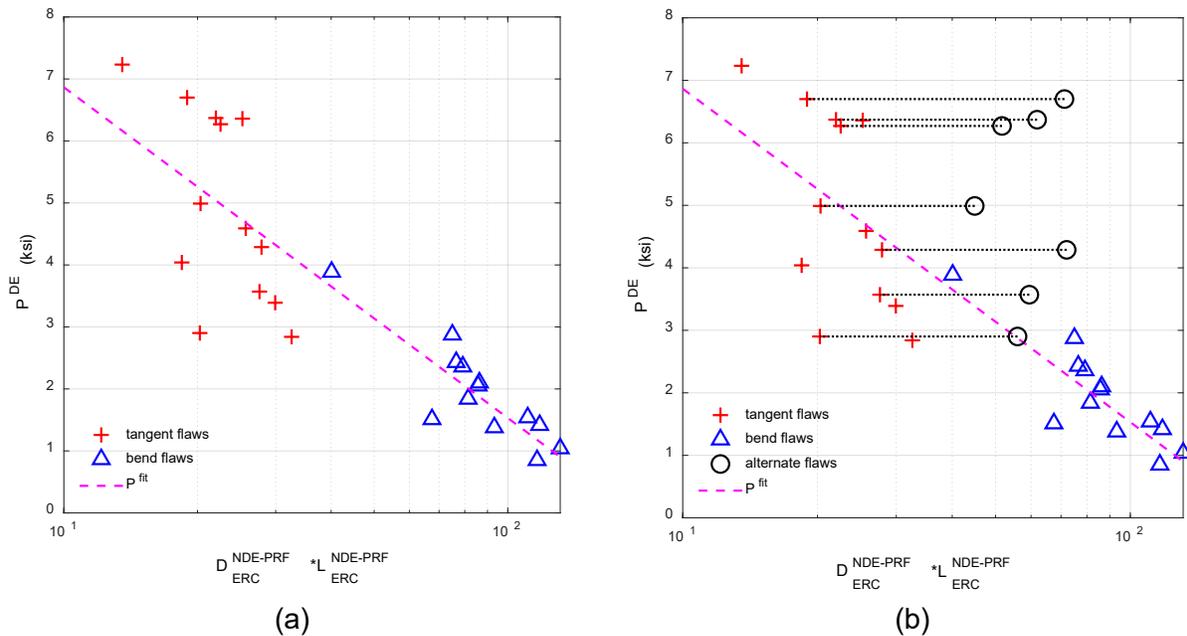
Figure 4-17. (a) Correlation plot of failure pressure vs. NDE crack area (depth * length) obtained from ERC depth profile and (b) the same plot as in (a) with the added points (circles) for the predicted flaw to fail based on the NDE parameter.

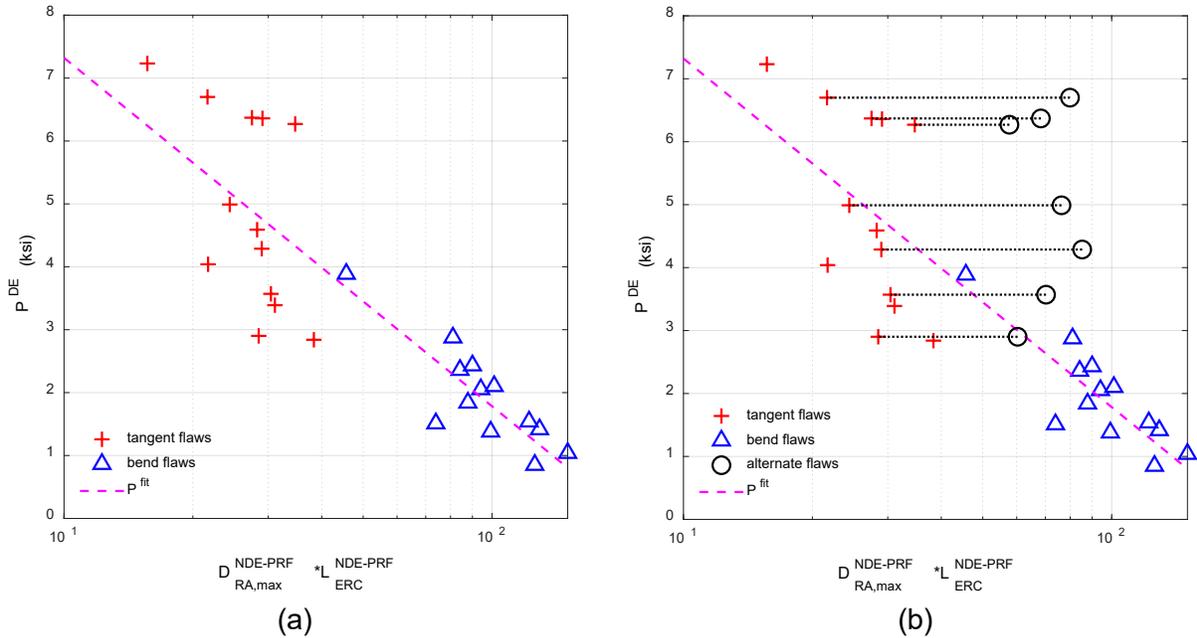
Figure 4-18. (a) Correlation plot of failure pressure vs. NDE crack area (depth * length) with maximum depth obtained from NDE depth profile and length obtained from ERC profile and (b) the same plot as in (a) with the added points (circles) for the predicted flaw to fail based on the NDE parameter.

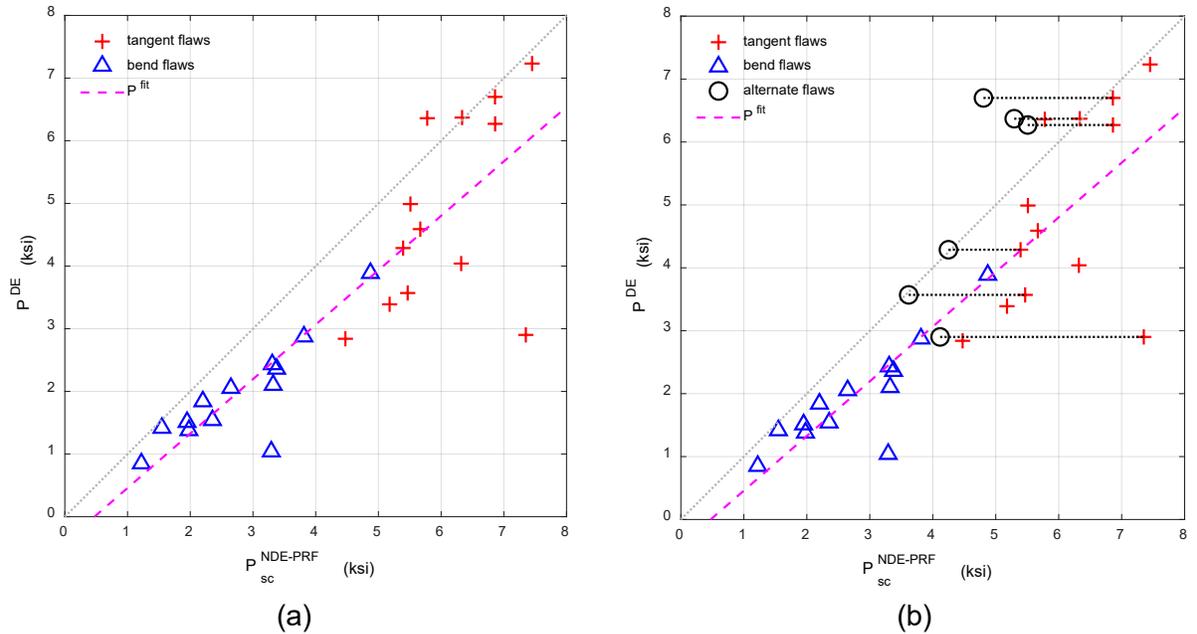
Figure 4-19. (a) Correlation plot of measured failure pressure vs. NDE-based failure pressure (ligament rupture) using ERC profile and (b) the same plot as in (a) with the added points (circles) for the predicted flaw to fail based on the NDE parameter.

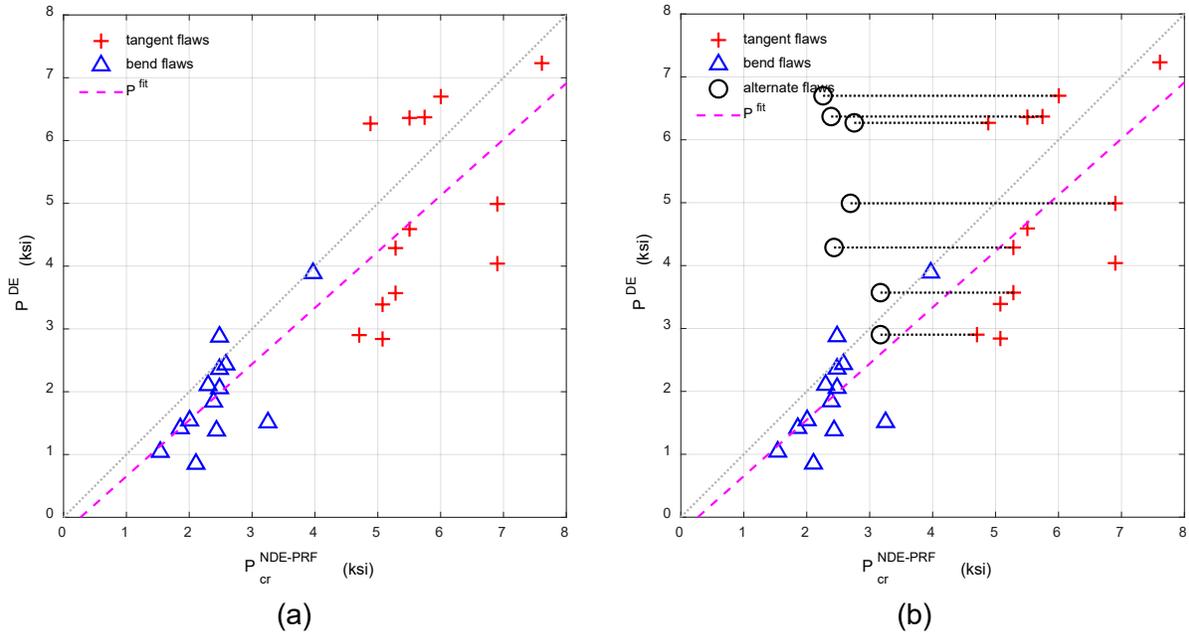
Figure 4-20. (a) Correlation plot of measured failure pressure vs. NDE-based failure pressure (burst) using ERC profile and (b) the same plot as in (a) with the added points (circles) for the predicted flaw to fail based on the NDE parameter.

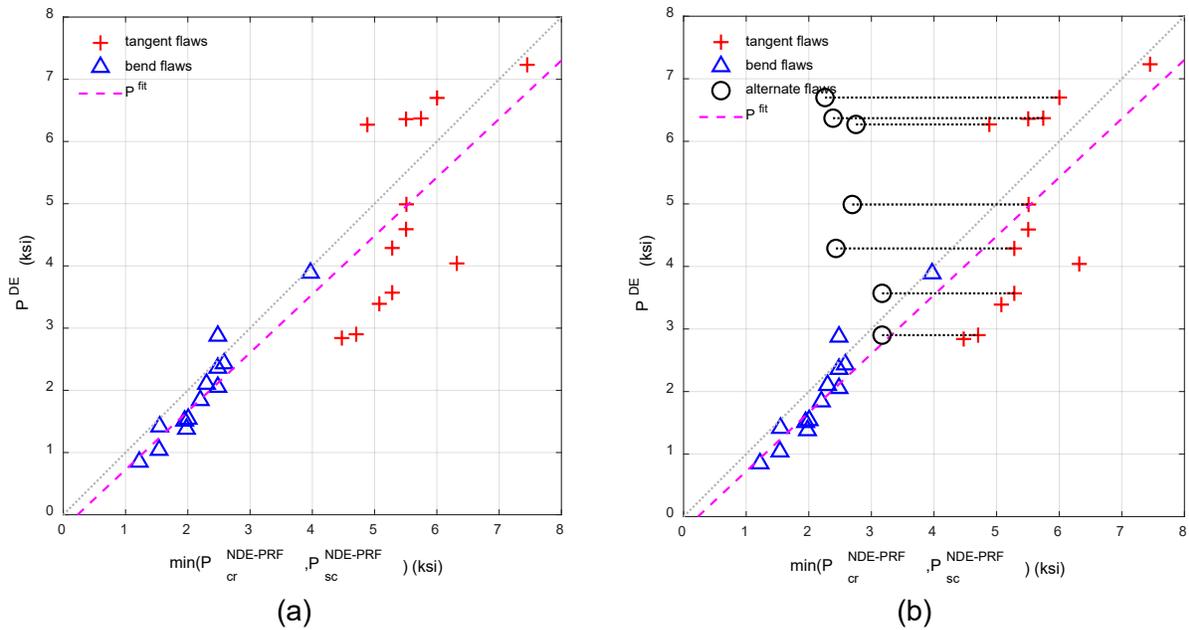
Figure 4-21. (a) Correlation plot of measured failure pressure vs. NDE-based failure pressure (lower value of ligament or rupture burst) using ERC profile and (b) the same plot as in (a) with the added points (circles) for the predicted flaw to fail based on the NDE parameter.

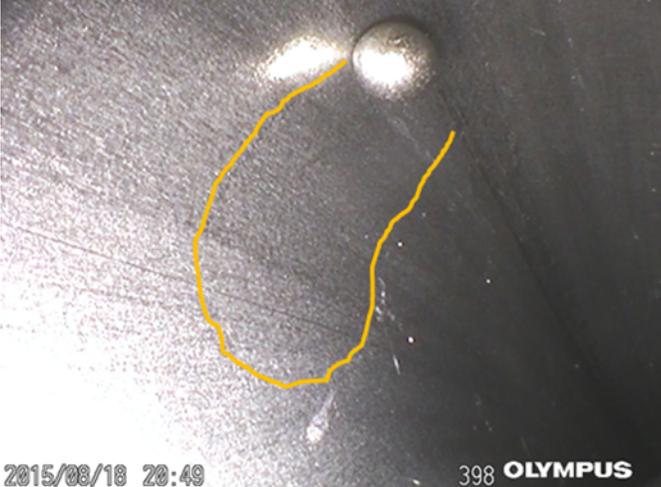
<p>890-15 (90°, Ex) (#5)</p>

<p>C-shape crack #5 from 9.47", 185° to 9.52 165° To 9.56" , 185°</p>

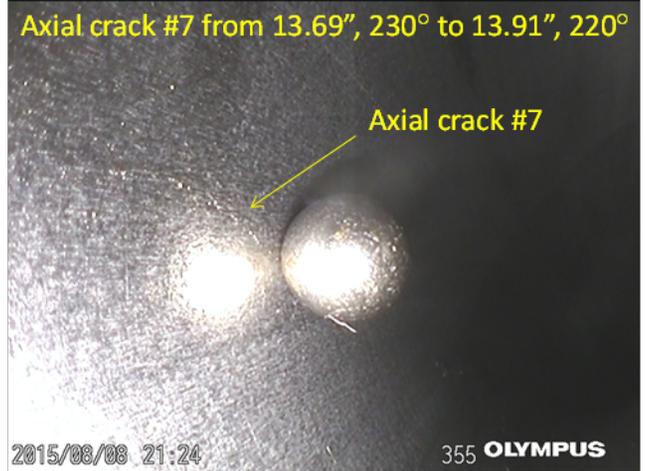
U-bend ID*	Pre-test ECT*	Pre-pressurization Visual
<p>1100-07 (180°, 45°- off Ex) (#7)</p>

<p>Axial crack #7 from 13.69", 230° to 13.91", 220°</p> <p>Axial crack #7</p> <p>2015/08/08 21:24 355 OLYMPUS</p>
<p>1100-08 (90°, Ex) (#1)</p>

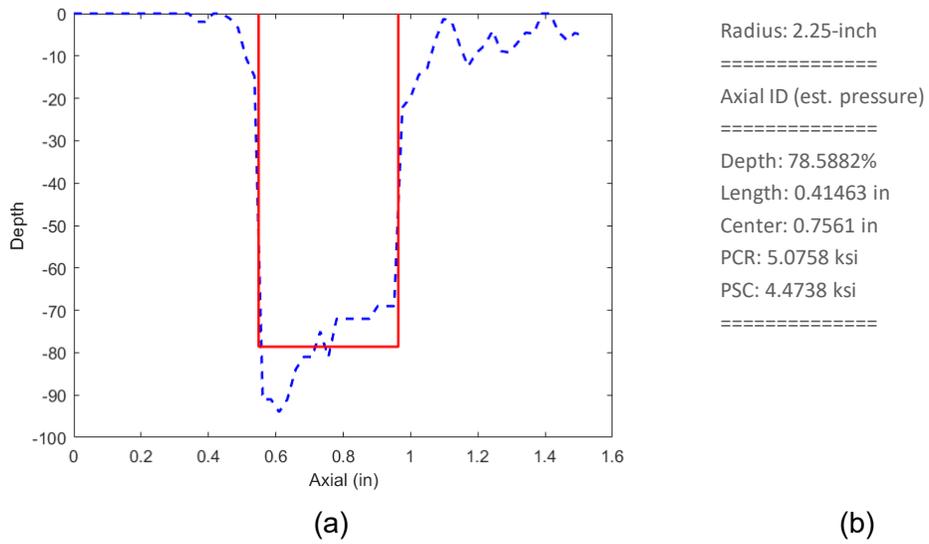
Figure F-1. Data analysis results for an axial PWSCC in specimen 1100-06 showing (a) EC (dashed line) and ERC (solid line) depth profiles and (b) output of the ERC tool using the Argonne data analysis software.

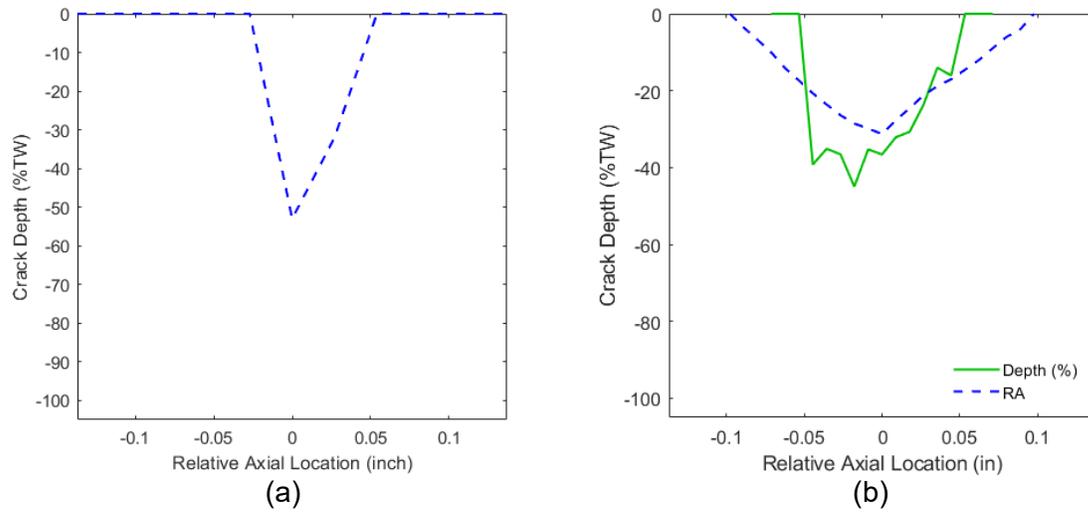
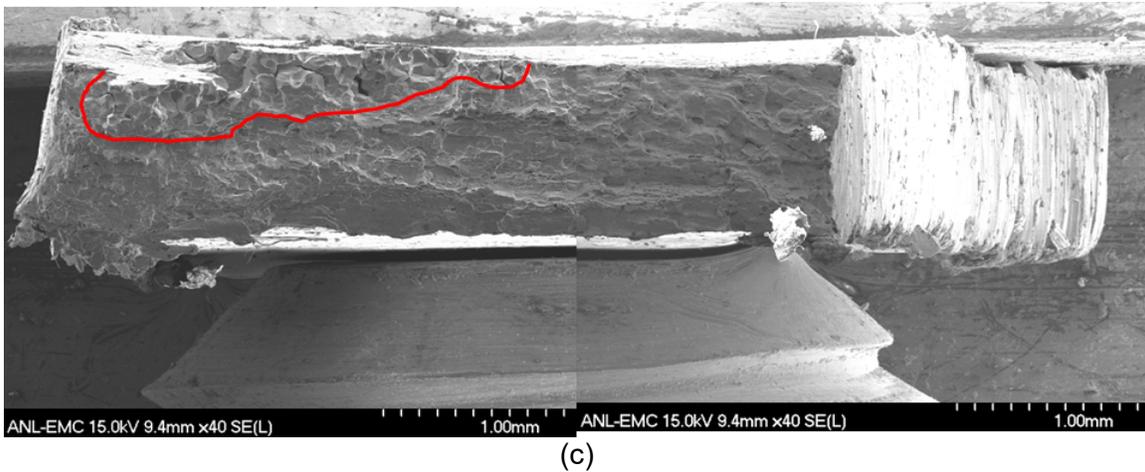
Note: This axial PWSCC was found at location F, between flank and extrados, of U-bend specimen 07-02.

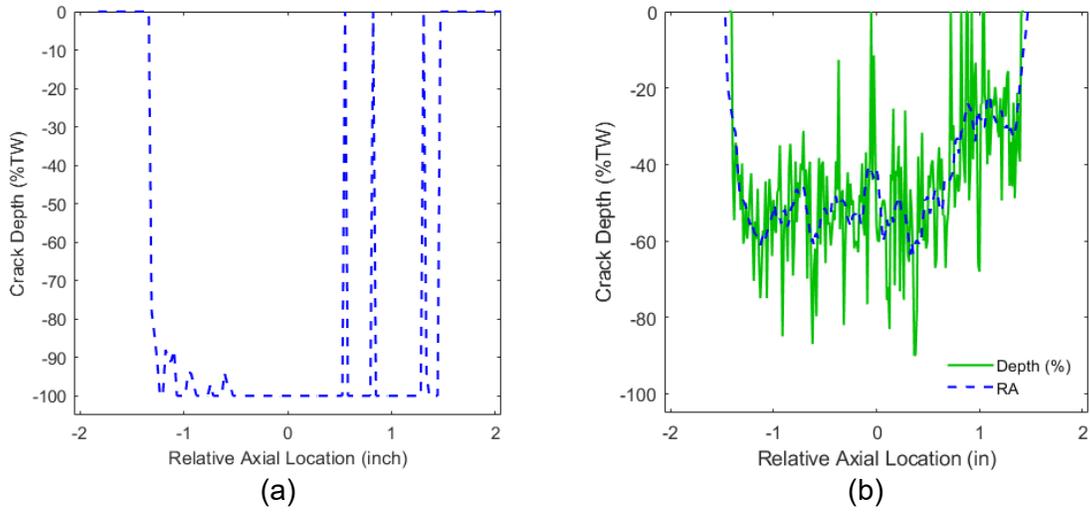
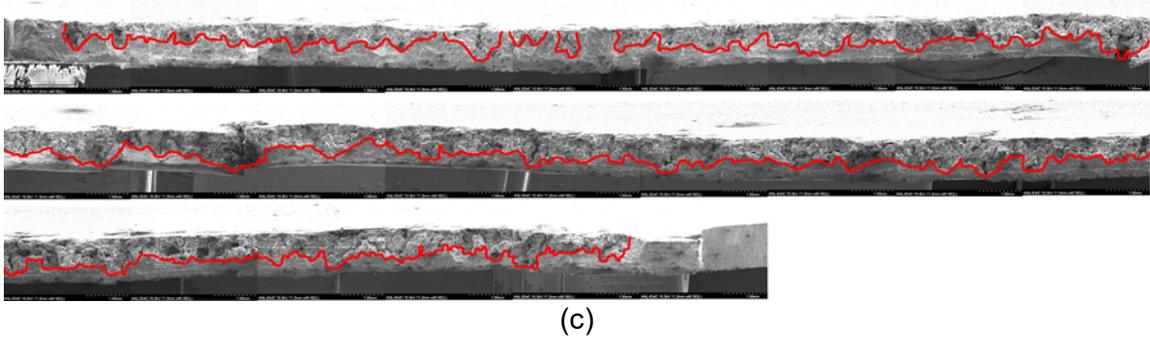
Note: This PWSCC was found at location B, between flank and extrados, of U-bend specimen 07-02. Video examination indicated the presence of an axially extended series of closely spaced short circumferential cracks.
