Steam Generator Inspection Reliability Assessments on Primary Side Cracking in U-Bends

International Steam Generator Tube Integrity
Program—Assessment of SG Inspection
Techniques and Reliability

Date Published: August 2023

Argonne National Laboratory
9700 South Cass Avenue
Lemont, IL 60439

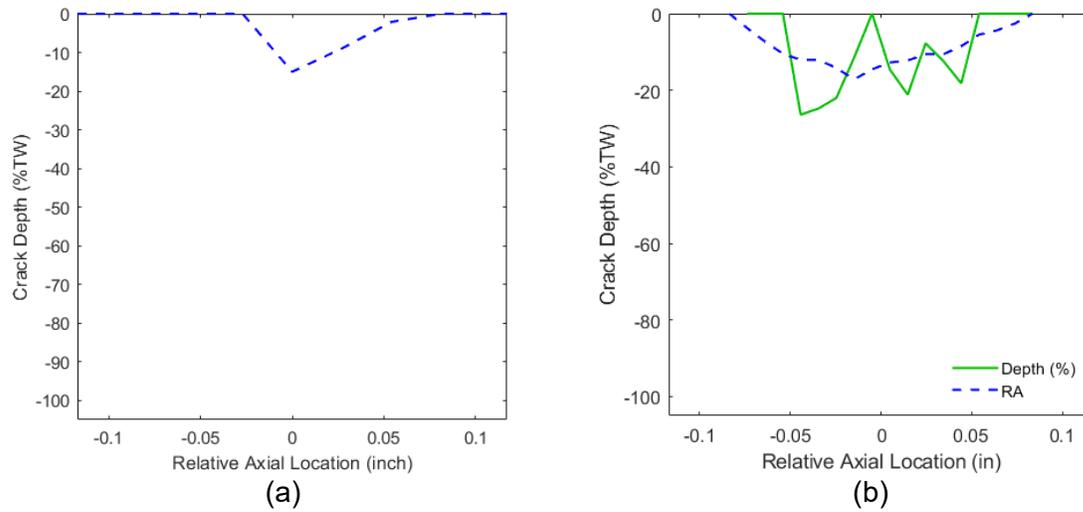
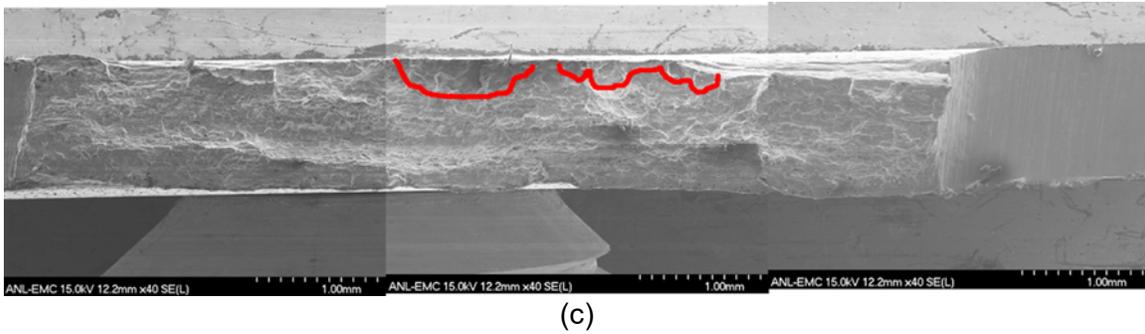
Note: This axial PWSCC was found at location E, between flank and extrados, of U-bend specimen 07-03.

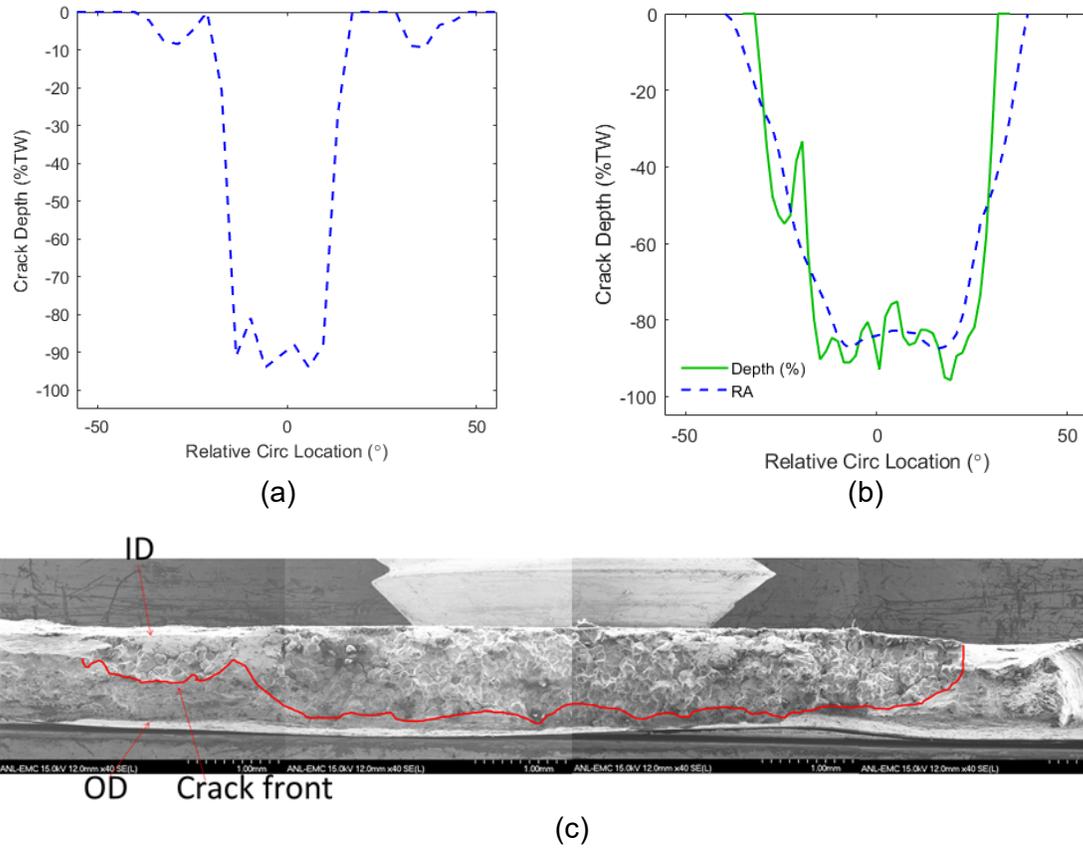
Note: This circumferential PWSCC was found at location F, between flank and extrados, of U-bend specimen 07-03.

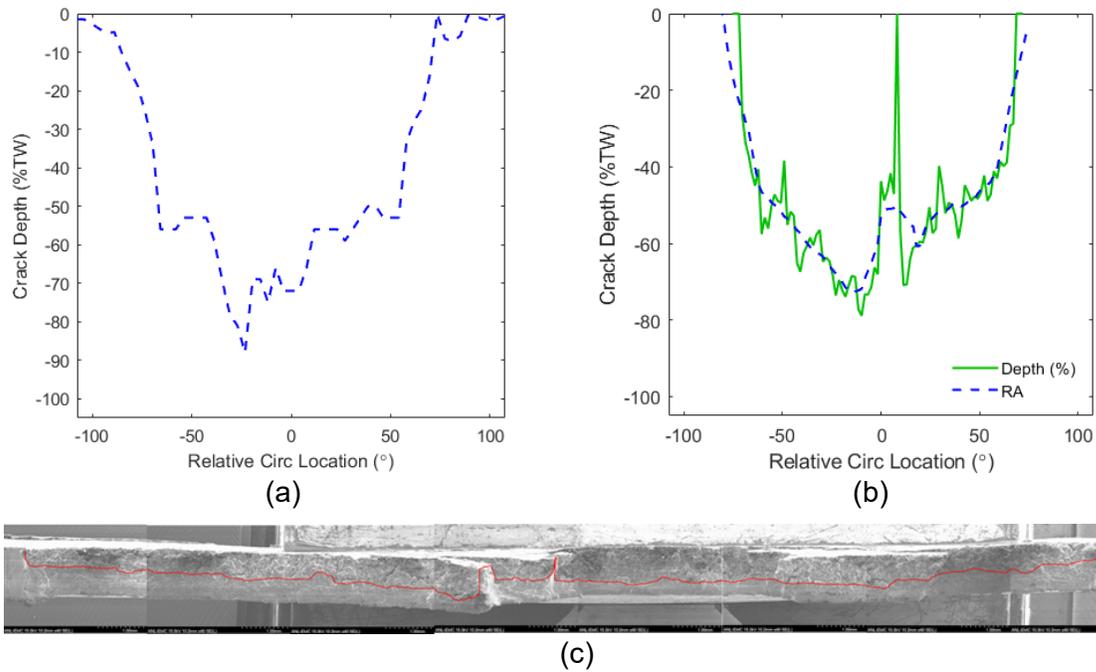
Note: This circumferential PWSCC was found at location E, intrados region, of U-bend specimen 14-01.

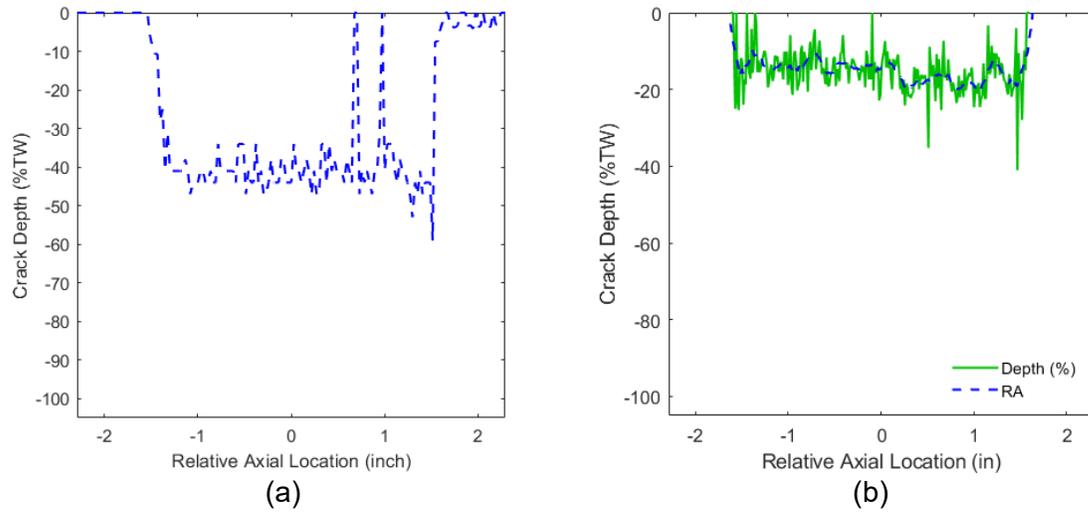
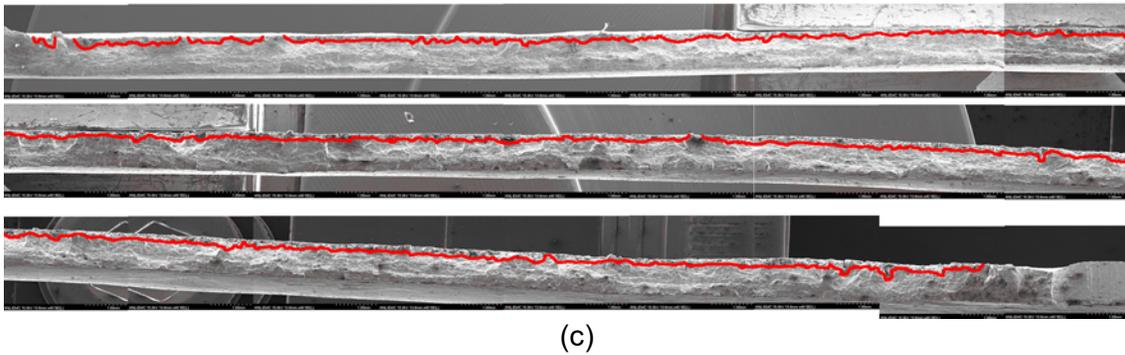
Note: This PWSCC was found at location B, between flank and extrados, of U-bend specimen 14-01. Video examination indicated the presence of an axially extended series of closely spaced short circumferential cracks.

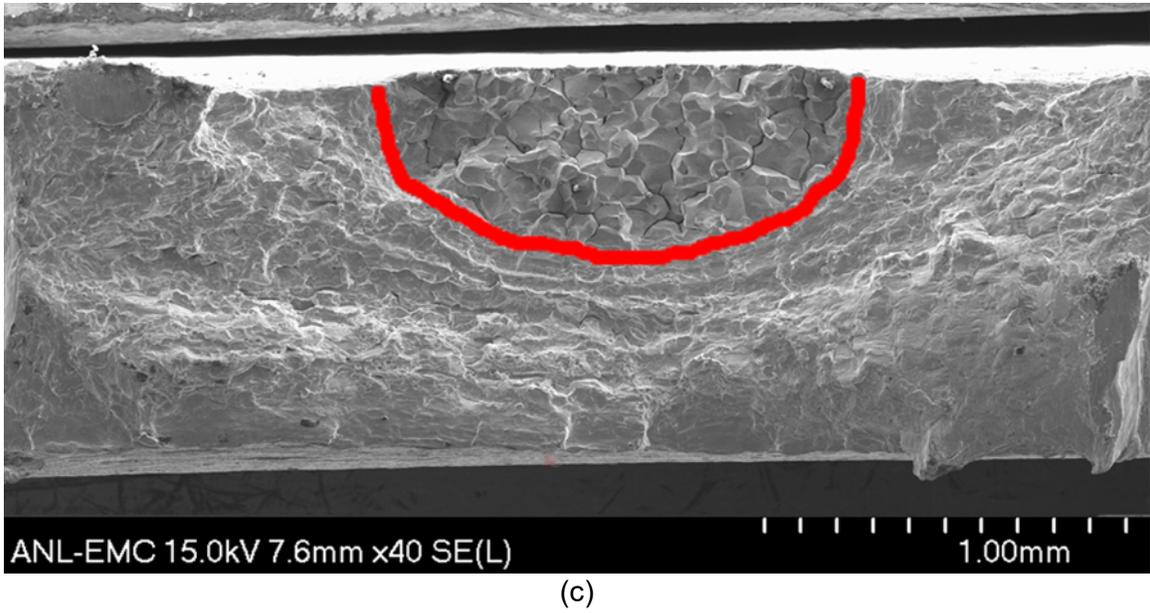
Note: This circumferential PWSCC was found at location F, between flank and extrados, of U-bend specimen 15-02.

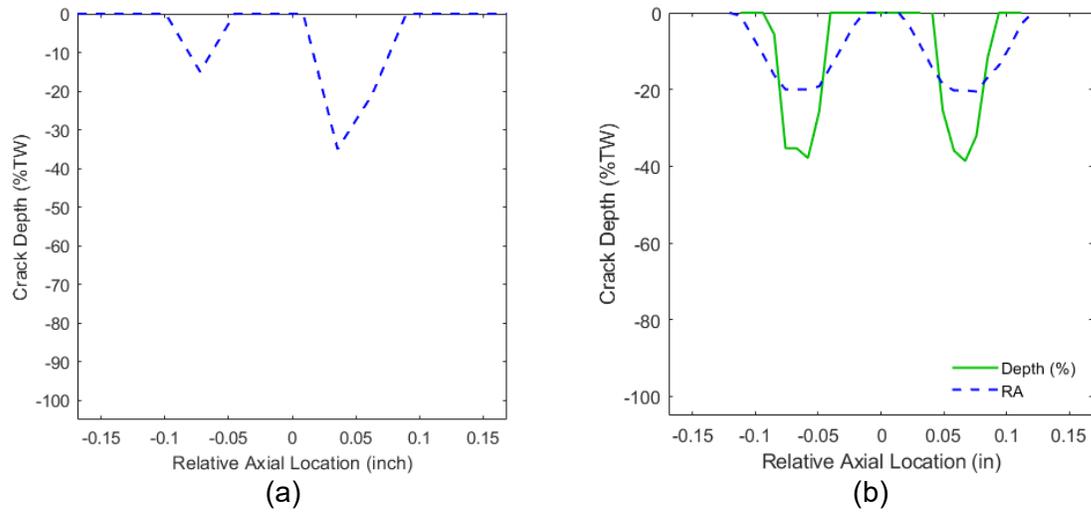
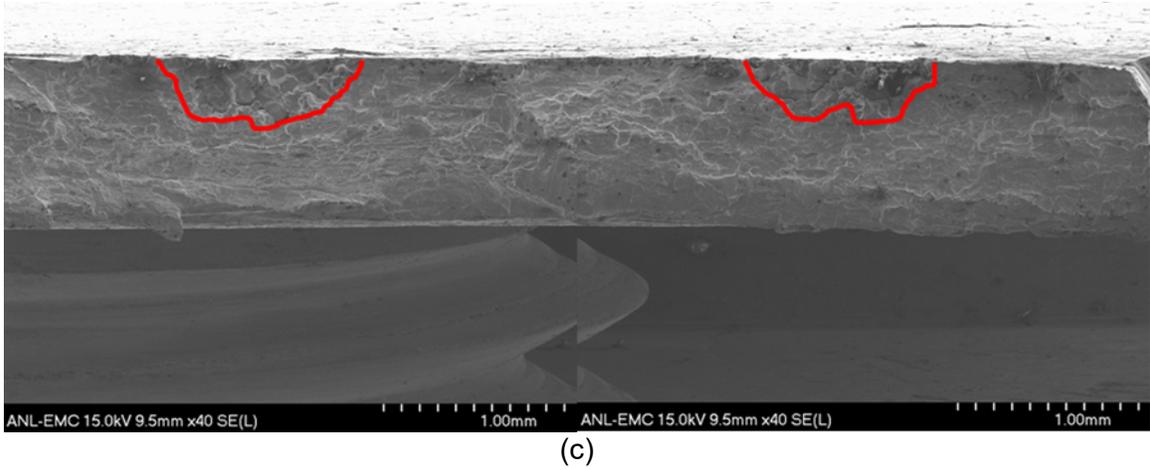
Note: These axial PWSCCs were found at location F, between flank and extrados, of U-bend specimen 15-02.

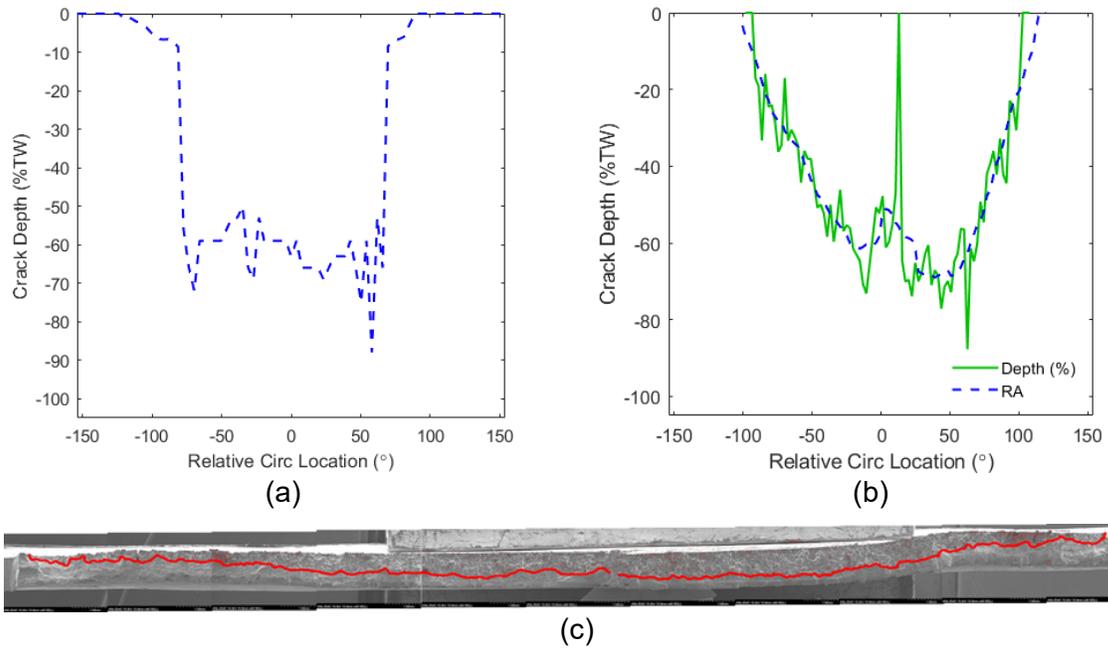
Note: This circumferential PWSCC was found at location D, intrados region, of U-bend specimen 20-01.

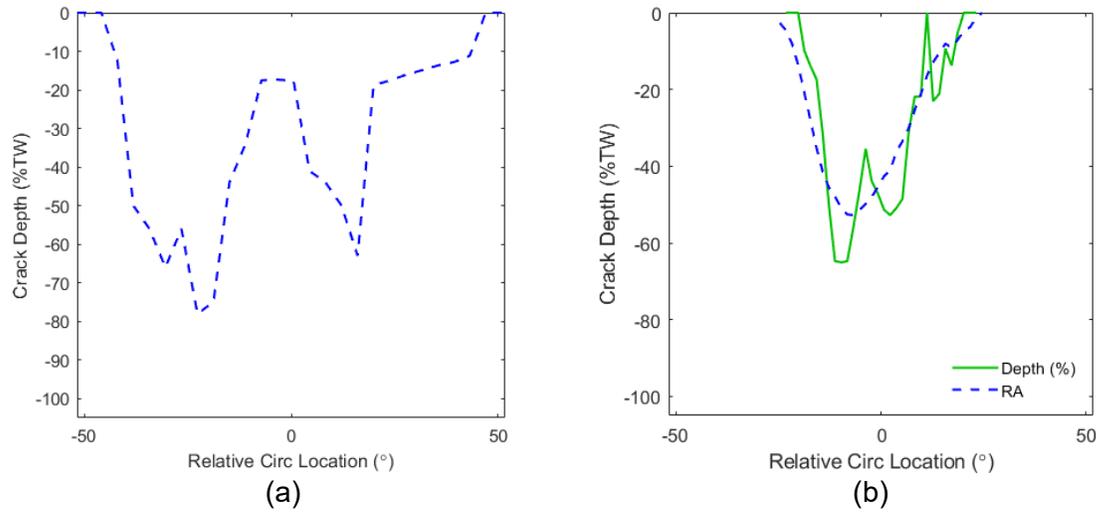
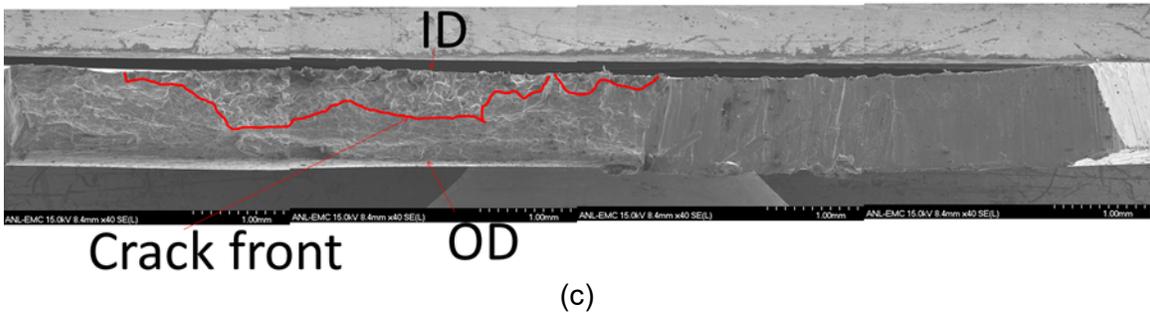
Note: This circumferential PWSCC was found 1.0-in. above the 180° tangent, in the flank region, of U-bend specimen 22-01.

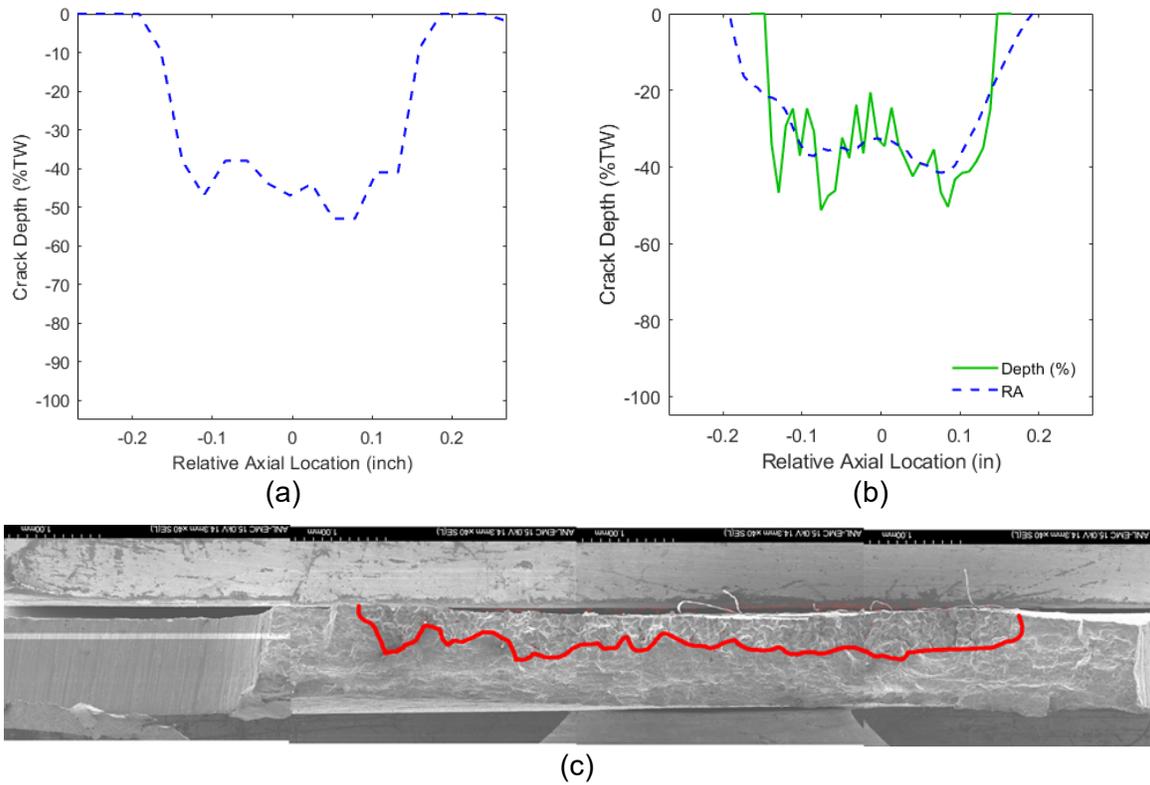
Note: This axial PWSCC was found at location D, between flank and intrados, of U-bend specimen 23-01. Video examination indicated the presence of a circumferentially extended network of axial cracks.

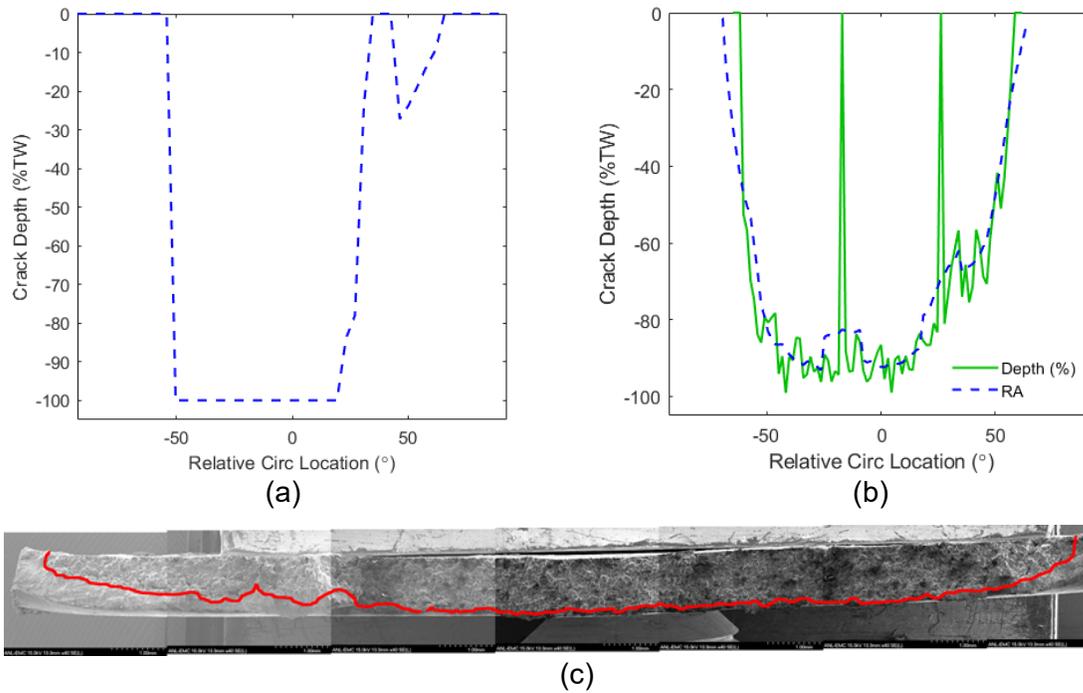
Note: This circumferential PWSCC was found at location A, intrados region, of U-bend specimen 25-01.

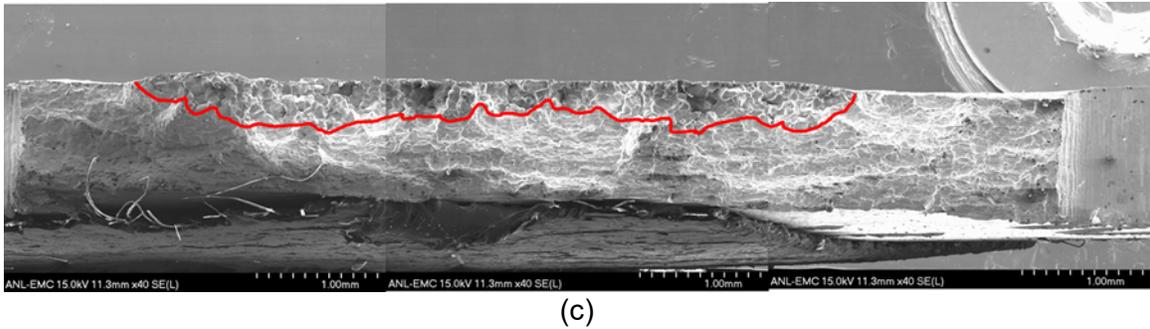
Note: This axial PWSCC was found at location D, between flank and intrados, of U-bend specimen 29-01.

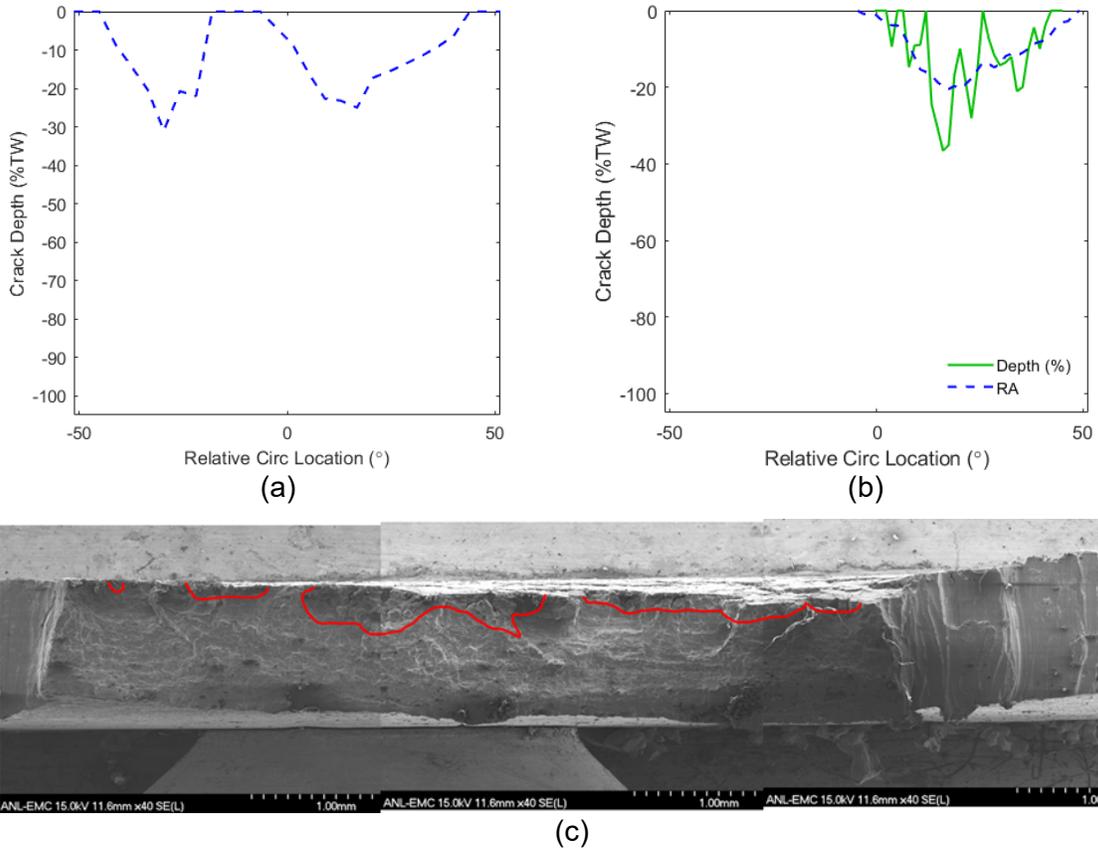
Note: This circumferential PWSCC was found at location B, between flank and intrados, of U-bend specimen 52-01.
