Joel T. Maul
Senior Program Manager for Liquid Waste
U. S. Department of Energy
Savannah River Site

**FOLLOW-UP TO SUMMARY OF APRIL 28, 2022, NRC/DOE TELECONFERENCE
TO DISCUSS TECHNICAL REVIEW REPORT RELATED TO TANK 12H**

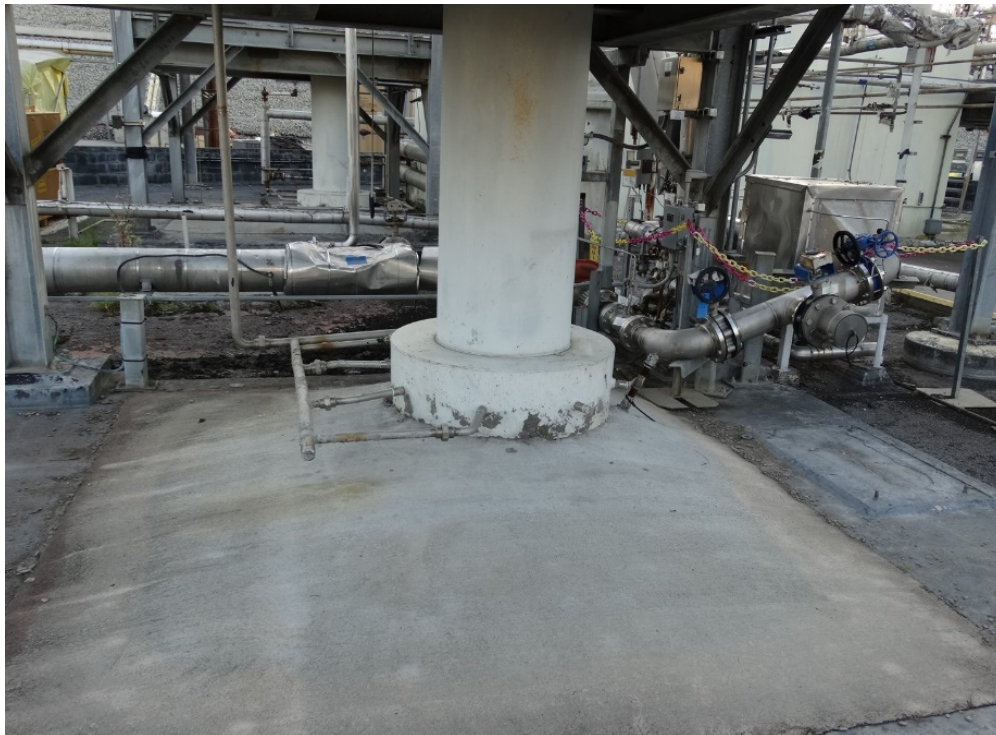
Figure 1: Tank 12 Riser 3 Spray Chamber

Response: Grout was being placed into Riser 3 when liquid was reported exiting Riser 7. Spray chamber information provided in Attachments 3 and 4 of this letter (Drawings D180209 and W727076). Figure 1 provides an external photo of Riser 3 with the grouted in place spray chamber. A photo of Riser 7 during the closure process is provided in Figure 2 to show the associated riser cover port plugs.

NRC Summary of DOE Verbal Response: The spill occurred on 3/7/2016. The spray chambers 6-8 ft in height were left in place during Tank 12H grouting making it more difficult to observe rising grout levels in Tank 12H risers. While filling in Riser 3, the grout backed-up into the Riser 3 spray chamber above the tank level. This was realized when a pipe cleaning "pig" had floated up into the riser and was seen moving around at the elevation of the spray chamber flush ring. Riser 7 was not as sealed as other risers. The grout exited from Riser 7 through the path of least resistance onto the tank top. NRC staff inquired about the volume of grout that spilled on to the tank top. When recalling the incident during the meeting DOE estimated that it was approximately 200 sq ft. DOE contained the over-flow grout with spill kits and cleaned up the area. DOE capped the area with grout.

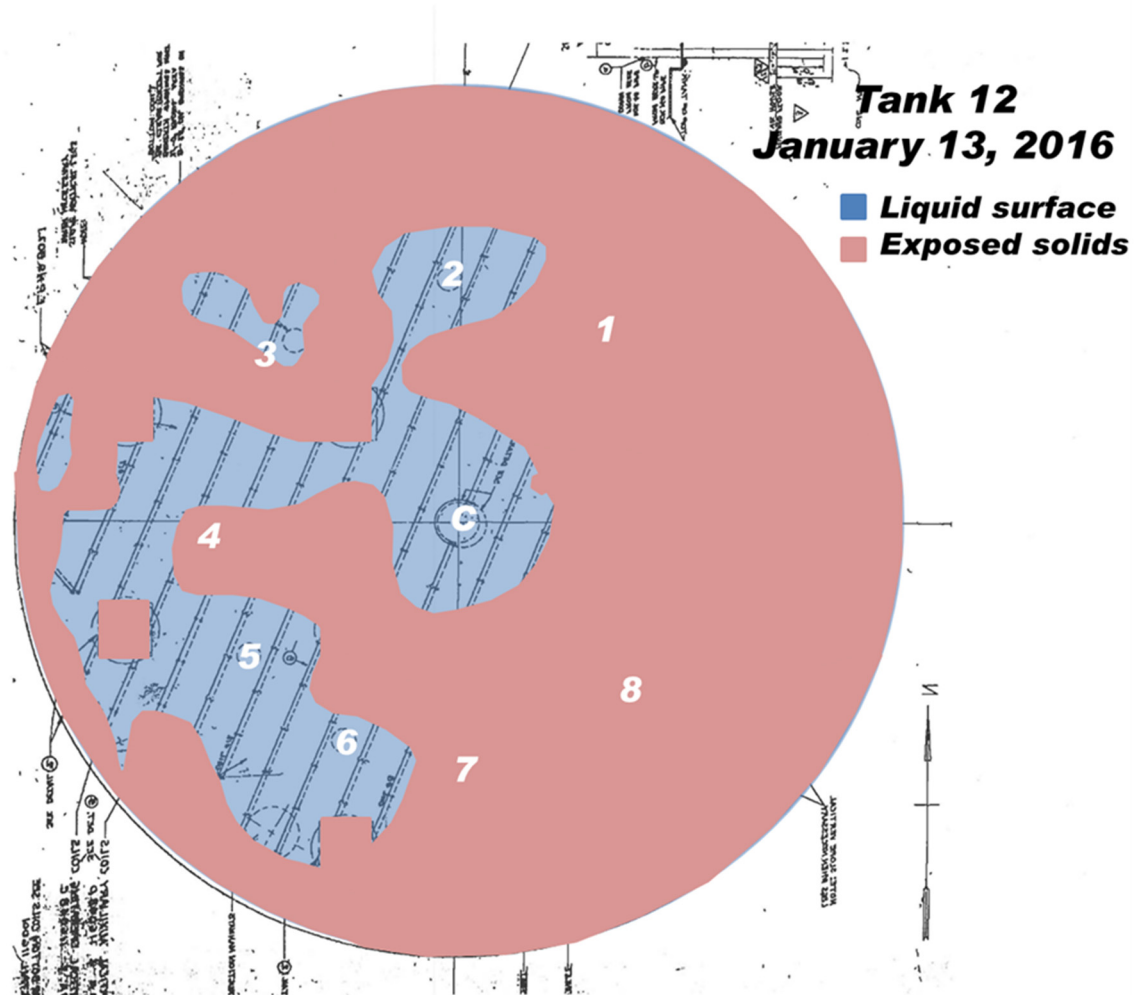
Response: Attachment 2 provides a map of the standing water about one week prior to the initiation of grouting. The depth of any standing water was not provided. A map made in October 2014, prior to sampling (U-ESR-H-00125, Attachment O), noted 1.5" of water below Riser 1 and 2.0" to 2.5" below Riser 5. The map provided as Attachment 1 of this document shows the area under Riser 1 was dry when grouting of Tank 12 was initiated in Riser 1 on 1/19/2016. On 1/19/2016, a total of 20 trucks were discharged into Riser 1. The plan for the second day of grouting was to discharge into Riser 5. A visual inspection of the tank on the morning of 1/20/2016 showed the grout from the first day had made its way under Riser 5 and there was no standing water directly under Riser 5. Testing of the effect of adding grout into standing water has been performed in the past with 4" of standing water, significantly higher than what was seen in Tank 12H. While grouting directly into 4" of standing water caused segregation to occur and increased likelihood that the grout would not meet requirements for compressive strength, "standing water (in the tank primary or annulus) does not necessarily result in unsatisfactory grout, provided grout placement is controlled in such a manner as to ensure that the excess water does not hamper grout curing or cause excessive segregation." (SRR-CWDA-2012-00051, NRC ADAMS Accession #ML13078A206) Visualization throughout the grouting process by camera inspection allows for placement of grout in locations with the lowest amount of standing water possible.
