# Mitigation of Material Degradation Associated with Long Term Operation

Darren Barborak  
Technical Executive  
Welding & Repair Technology Center (WRTC)

NRC Workshop on Structural Materials - Session 7 on Mitigation  
October 1-4, 2024

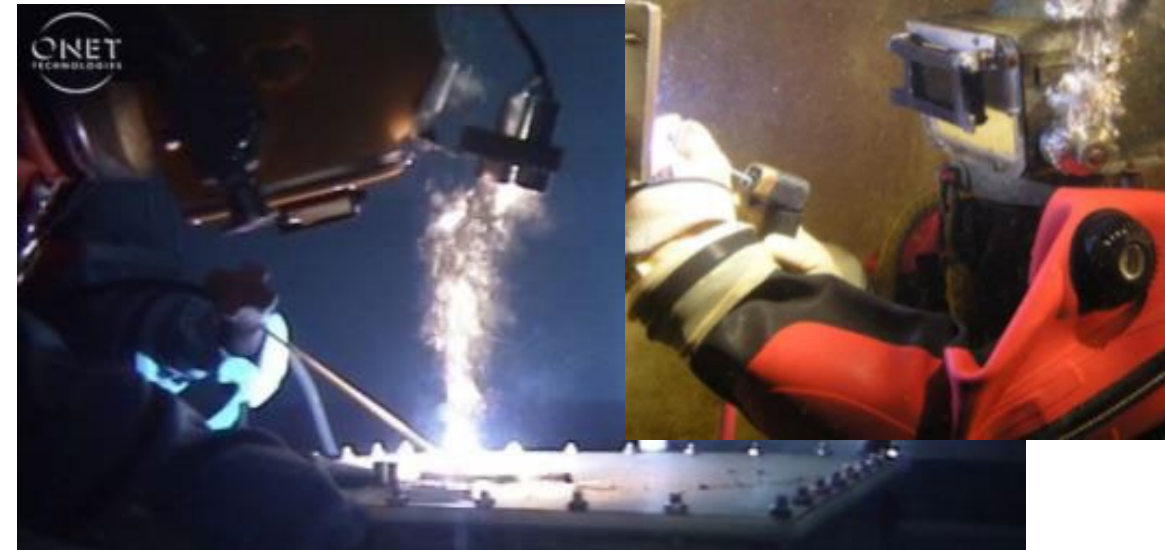
## Divers Performing Underwater Welding Repairs

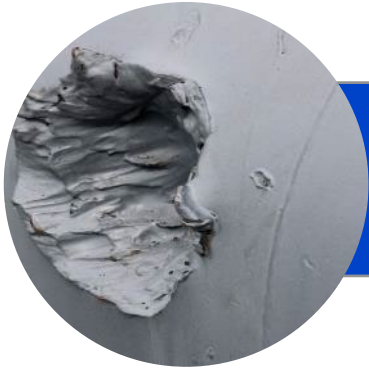
Mechanical  
Damage

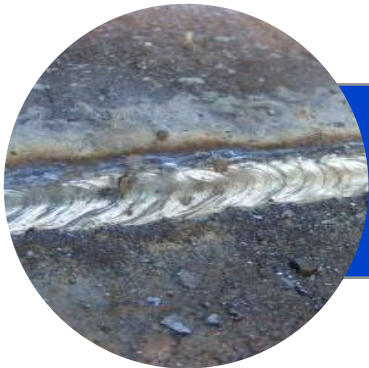
Latent Weld  
Defect

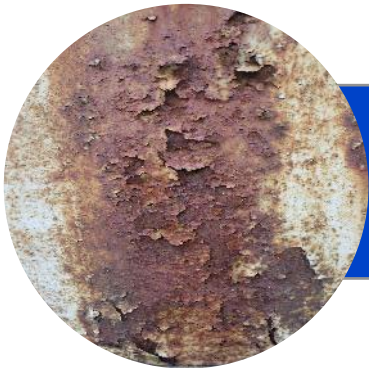
Corrosion

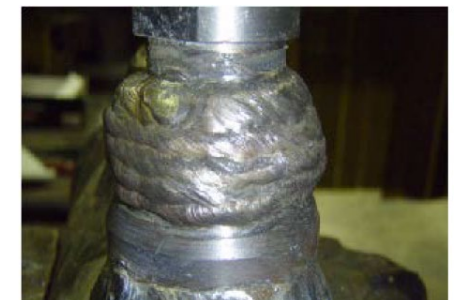
Socket weld overlay

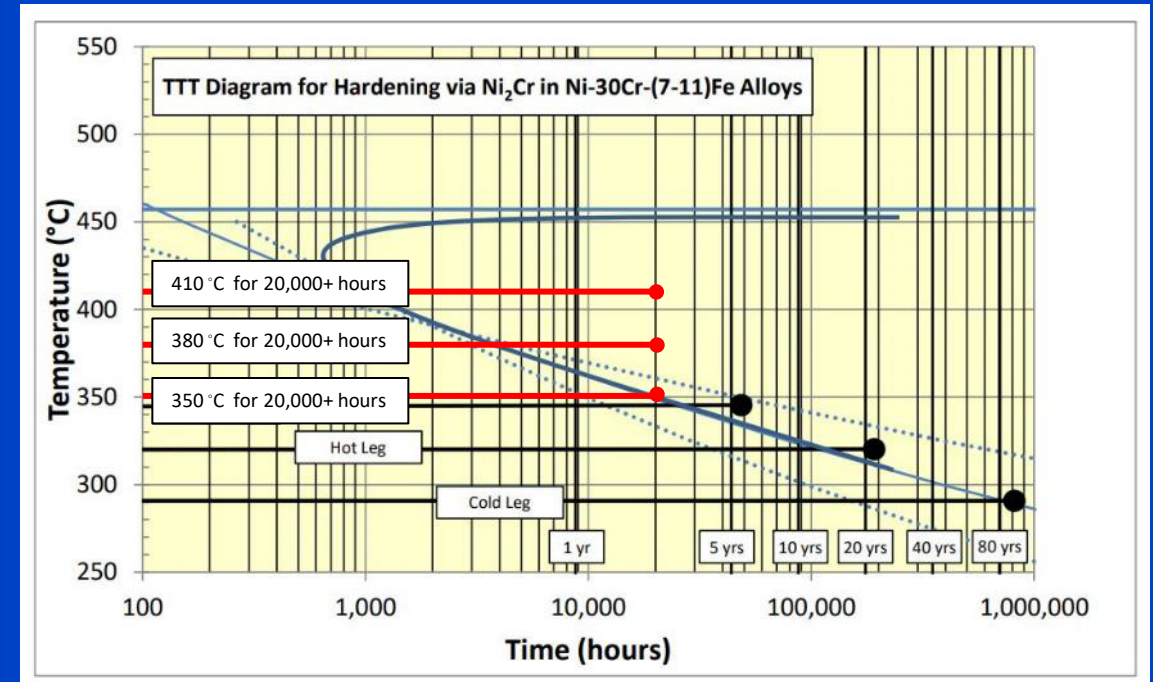
TTT Diagram with Proposed Times and Temperatures

- Temperatures
  - 410 °C for 20,000+ hours
  - 380 °C for 20,000+ hours
  - 350 °C for 20,000+ hours
- Interruptions
  - 1,000 hours (completed)
  - 5,000 hours
  - 10,000 hours
  - 20,000 hours
- Hardness measurements will be conducted at each interruption
- Microscopy to be conducted if a significant increase in hardness is detected
- Mechanical test samples also being aged
