# Concrete harvesting activities in the Netherlands

Hybrid Workshop on International Concrete Harvesting, 4<sup>th</sup> October NRC HQ, TWFN Auditorium, Rockville MD, US

The presentation covers **tests** (mainly mechanical) performed on **concrete cores** taken from structures of the **High Flux Reactor (HFR)** at Petten, Netherlands.

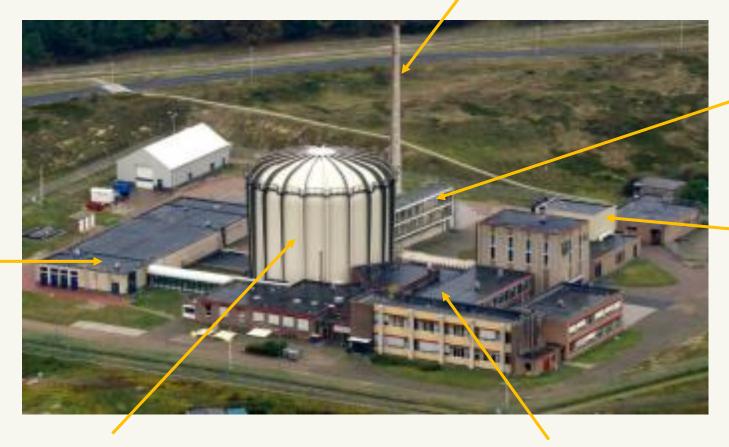
# Main plant layout of HFR

Primary

Pump building

Air treatment building

NDT building

Reactor containment building

Reactor auxiliary building

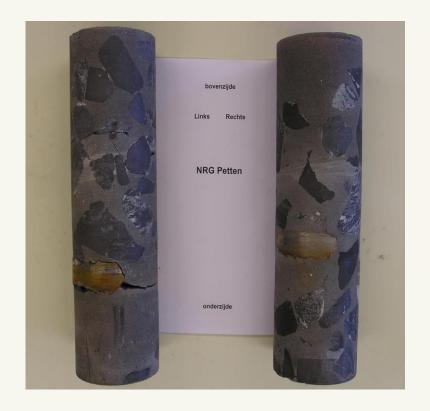
• **2009:** Two concrete cores were drilled out from the ceiling of subpile room.

Material property	Test No.	Value	Unit
Cylinder compressive strength	1 2	32.3 36.5	MPa
Density	1 2	3490 3740	kg/m³
Porosity	1 2	12.3 14.3	%

Based on its mass, appearance and magnetism, it was suspected that the aggregate used is **Greigite** and not **Barite**, **Magnetite** and **Hematite** were was previously assumed.

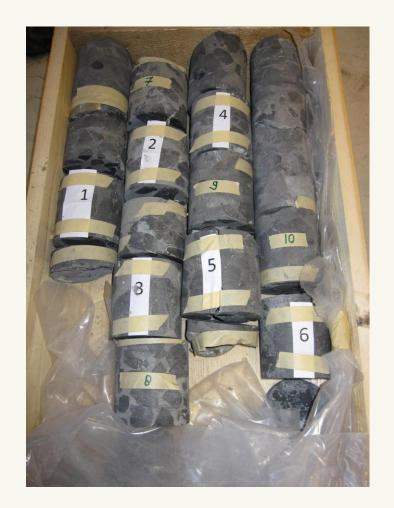
- **2010:** A vertical drilling was carried out over approximately 1.9 m of the total 2.235 m thickness of reactor floor.
- The floor was drilled from the bottom in 4 steps (cores).
- Ten cylinders were sawn off from the four drilled cores from the reactor floor.
- Six cylinders were used to determine the tensile strength.
- **Four** cylinders were used to determine the **compressive** strength and volumetric weight.
- The large range of compressive strength is given by the voids present in the concrete.

Property	Value	Unit
Split tensile strength	1.99 2.73 3.22 3.72 2.90 3.48	N/mm²
Average Split Tensile Strength	3.01	N/mm²
Design value concrete tensile strength	0.99	N/mm²
Volumetric weight	3709 3825 3548 3607	kg/m³
Cylinder compressive strength	27.3 34.2 45.8 44.6	N/mm²

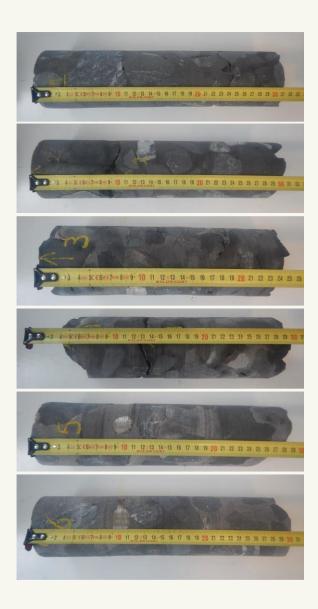
• 2017: Six cores were used from pipe corridor (two from walls and four from ceilings).

Property	Unit	Value (walls)	Value (ceiling)
Volumetric weight	kg/m³	3620 3560	3320 3640 3390 3540
Cylinder compressive strength	N/mm <sup>2</sup>	24.9 20.7	17.5 50.5 54.6 62.6
