From: Heun Jr, Ronald B. <Ronald.HeunJr@pseg.com>
Sent: Wednesday, January 29, 2025 1:48 PM
To: nmfs.gar.incidental-take@noaa.gov
Cc: EndangeredSpecies Resource; Dyson, Danielle [DEP]; Heather.Corbett@dep.nj.gov; Brian.Neilan@dep.nj.gov
Subject: [External_Sender] Salem Generating Station - Incidental Take Report Atlantic Sturgeon 1/29/2025
Attachments: Sturgeon Incidental Take Report for 01-29-2025.pdf

Appendix C, Part 2A (Sturgeon)

Site of Collection: PSEG Salem Generating Station, SGS Unit 1; CWI 11A

STURGEON DATA COLLECTION FORM

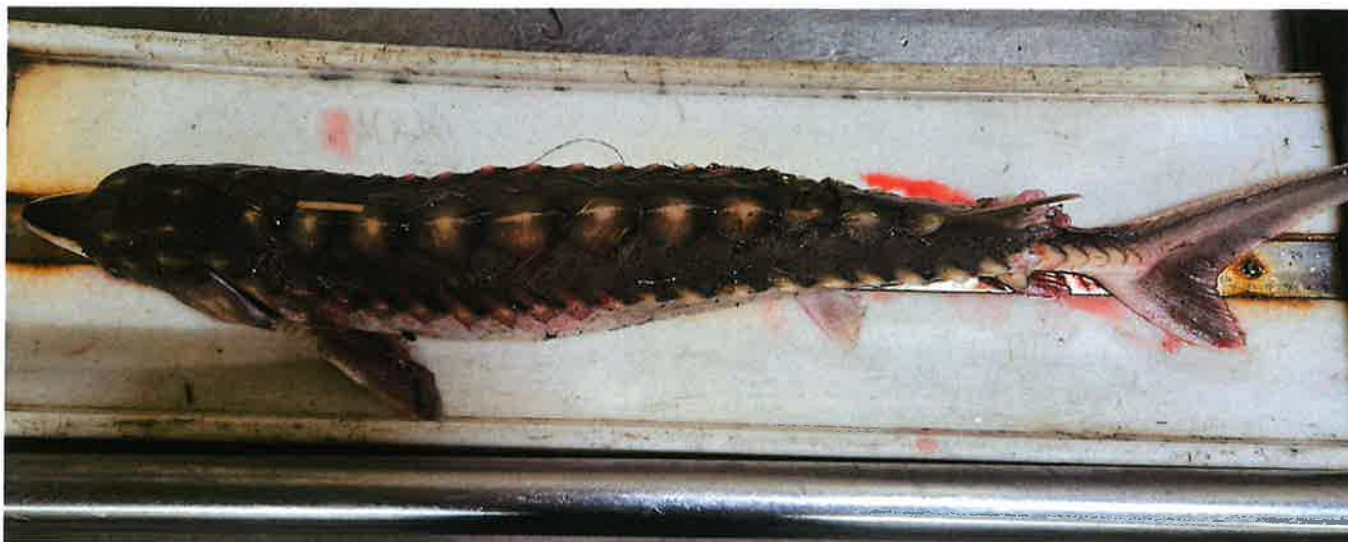
A dorsal view, showing the size and condition of a deceased Atlantic sturgeon (*Acipenser oxyrinchus*) retrieved at approximately 09:55 AM on 01/29/2025 from the Salem Circulating Water Intake by Salem Yard Crew personnel, during routine trash rack cleaning at Salem Nuclear Generating Station (01/29/2025).

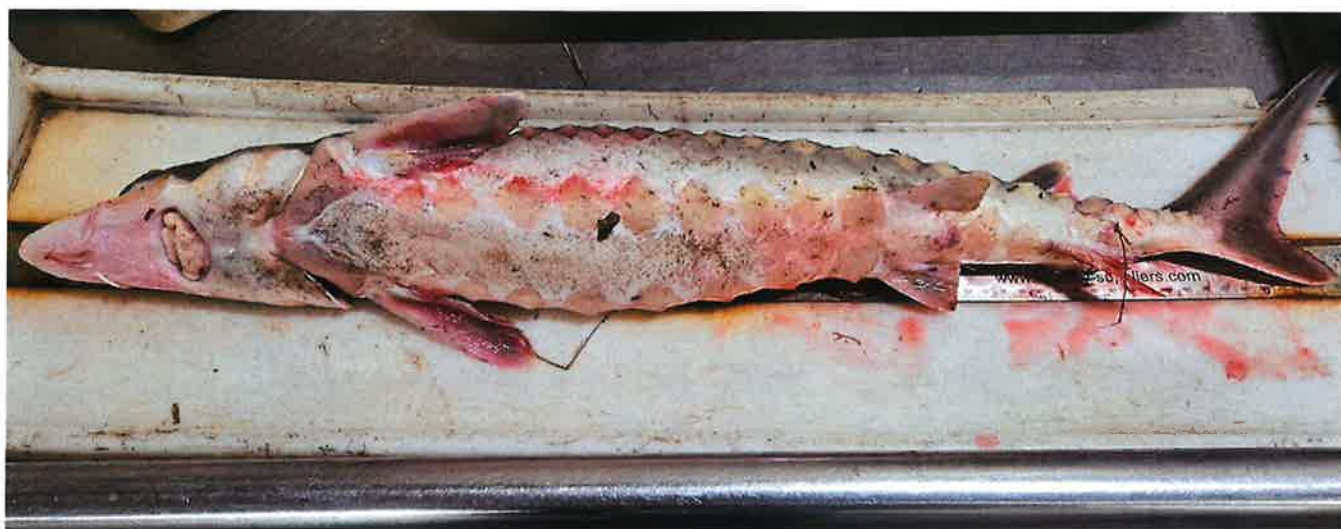
A ventral view of the specimen, showing the overall condition. A severe laceration was observed to the caudal peduncle, as well as some minor bruising of the pectoral fins and scutes along the torso, immediately posterior to the pectoral fins (01/29/2025).

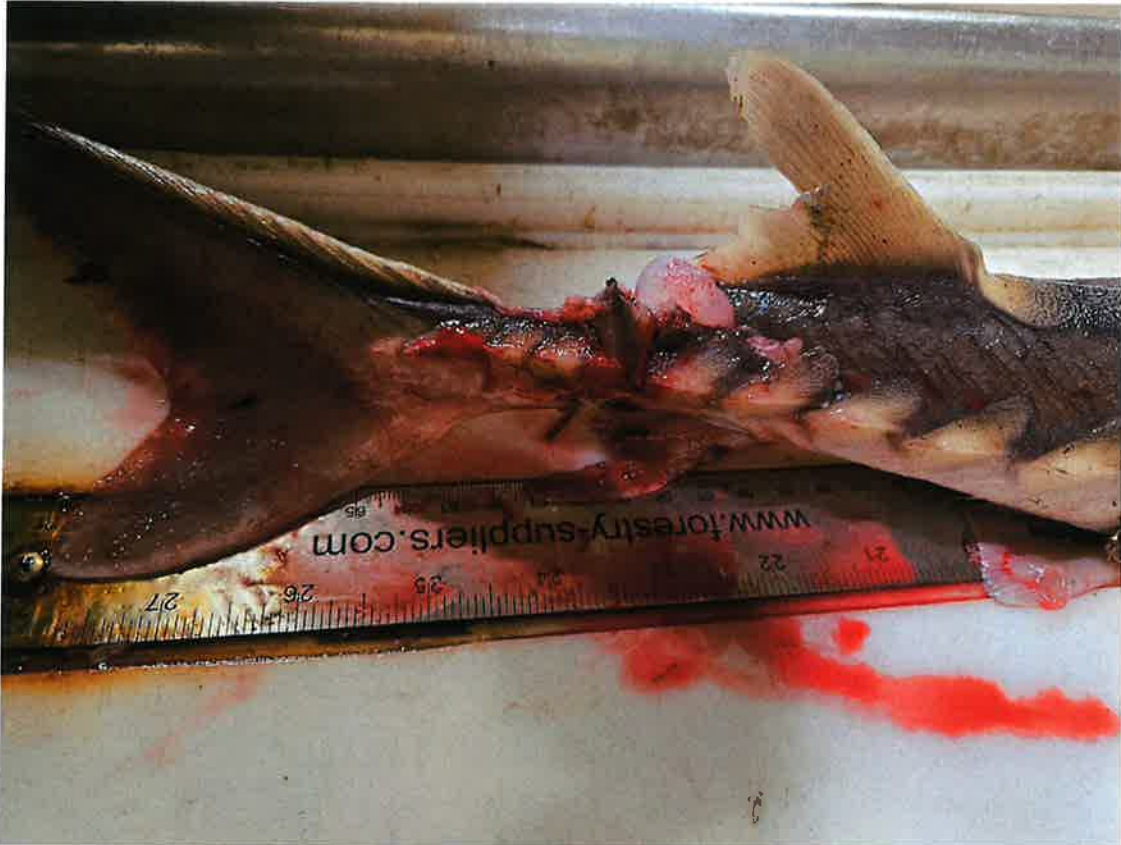
Describe any wounds / abnormalities (note tar or oil, gear or debris entanglement, propeller damage, etc.). **Please note if no wounds / abnormalities are found.** At the time of processing, the specimen was recently deceased, and exhibited damage in the form of a severe laceration to the caudal peduncle (refer to illustration and specimen photographs), as well as some minor bruising to the pectoral fins and surrounding area. No other injuries indicating a cause of death were observed.

A close-up view of the laceration observed to the caudal peduncle (01/29/2025).

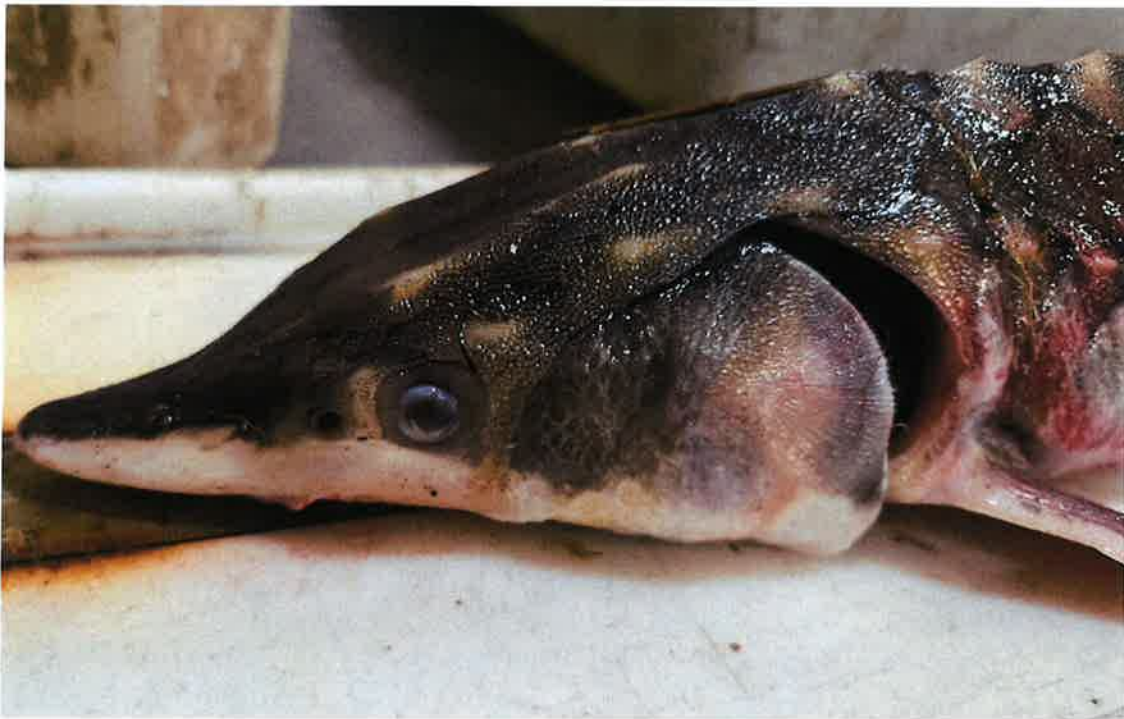
A left, dorsolateral view of the head showing the characteristic elongated rostrum (01/29/2025).

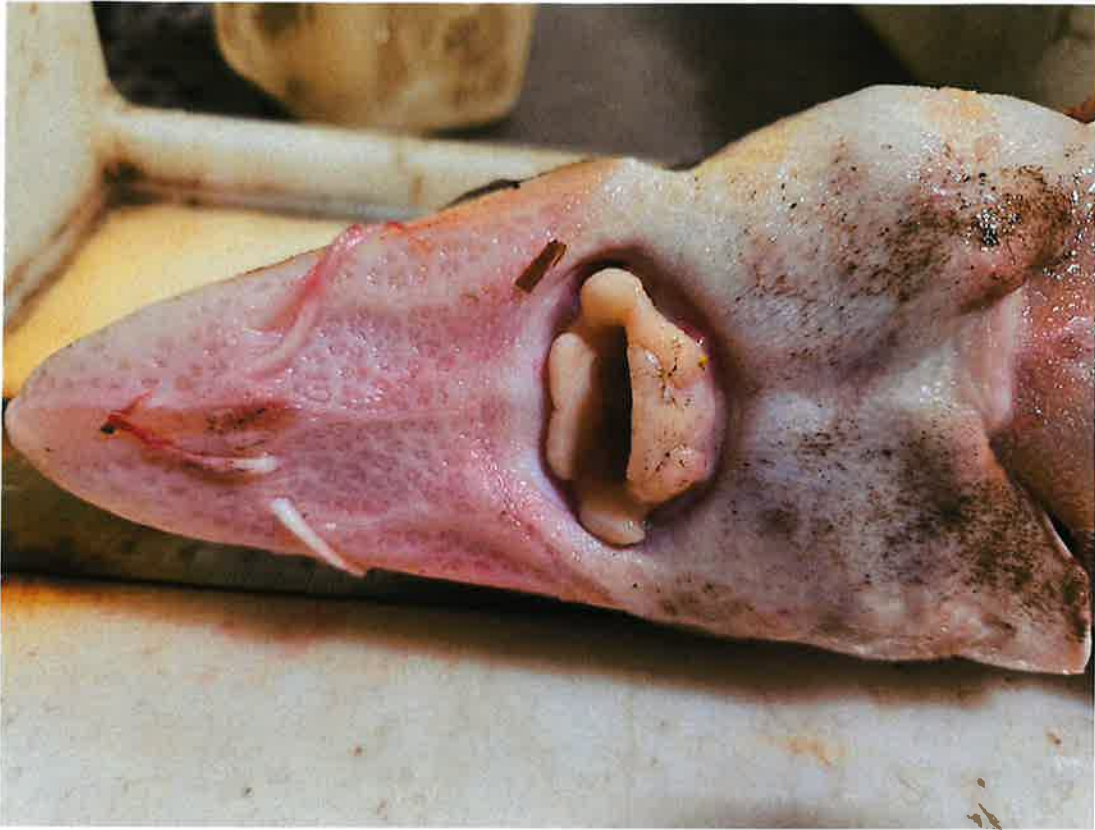
A ventral view of the head, showing the characteristic elongated rostrum and small mouth (01/29/2025).
