From: Heun Jr, Ronald B. <Ronald.HeunJr@pseg.com>
Sent: Tuesday, February 25, 2025 9:18 AM
To: nmfs.gar.incidental-take@noaa.gov
Cc: EndangeredSpecies Resource; Dyson, Danielle [DEP];
Heather.Corbett@dep.nj.gov; Brian.Neilan@dep.nj.gov
Subject: [External_Sender] Salem Generating Station - Incidental Take Report Atlantic
Sturgeon 2/24/2025
Attachments: Sturgeon Incidental Take Report for 02-24-2025.pdf

Appendix C, Part 2A (Sturgeon)

Site of Collection: PSEG Salem Generating Station, SGS Unit 1; CWI 11A

STURGEON DATA COLLECTION FORM

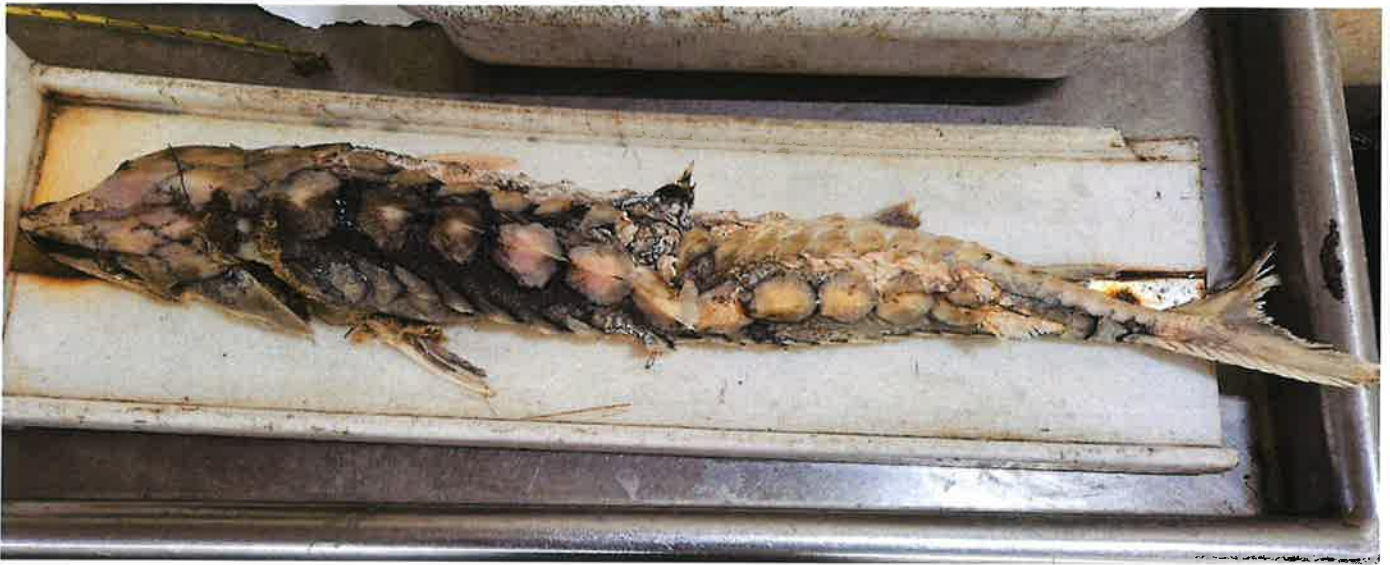
A dorsal view, showing the size and condition of a deceased Atlantic sturgeon (*Acipenser oxyrinchus*) retrieved at approximately 09:55 AM on 02/24/2025 from the Salem Circulating Water Intake by Salem Yard Crew personnel, during routine trash rack cleaning at Salem Nuclear Generating Station (02/24/2025).

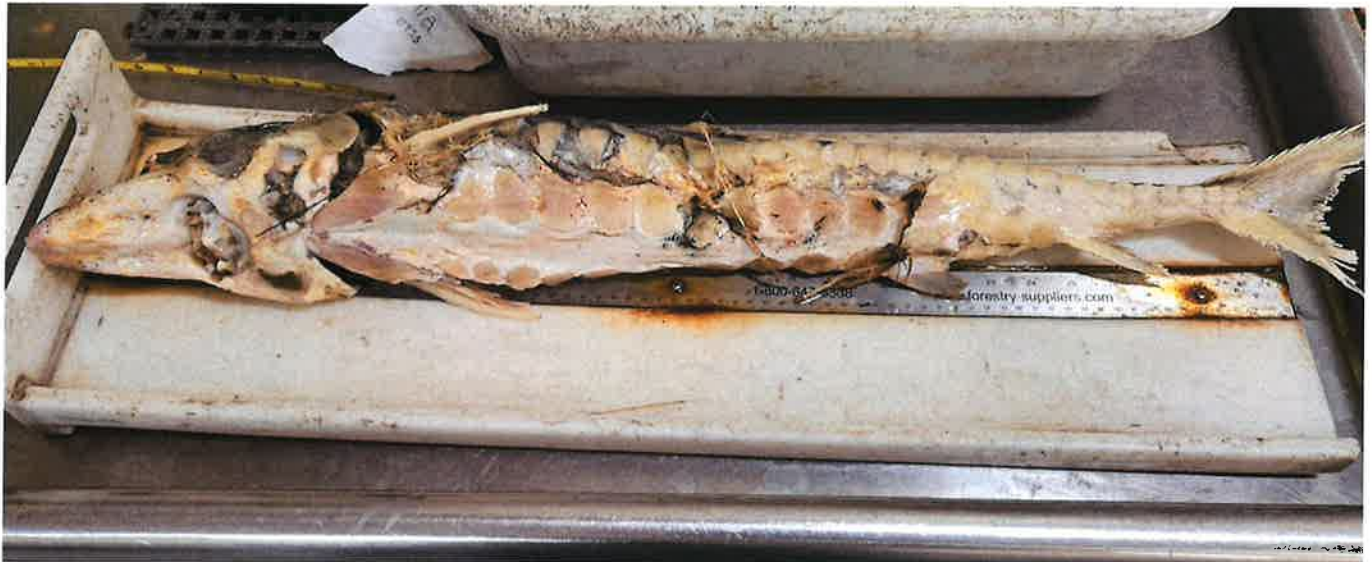
A ventral view of the specimen, showing the overall condition. In addition to a severe laceration located mid-torso, and missing operculum on the right side, the specimen also shown evidence of severe decomposition, indicated by missing skin on the head and degraded pectoral and caudal fins (02/24/2025).

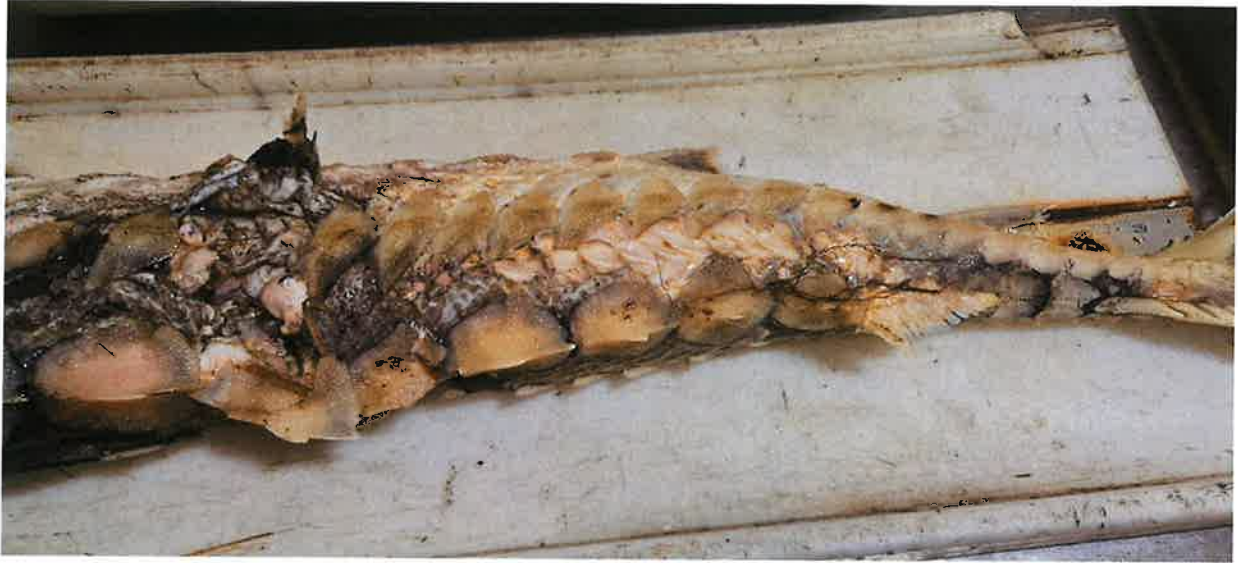
View showing the location of a large laceration to the mid torso, exposing internal tissue (02/24/2025).

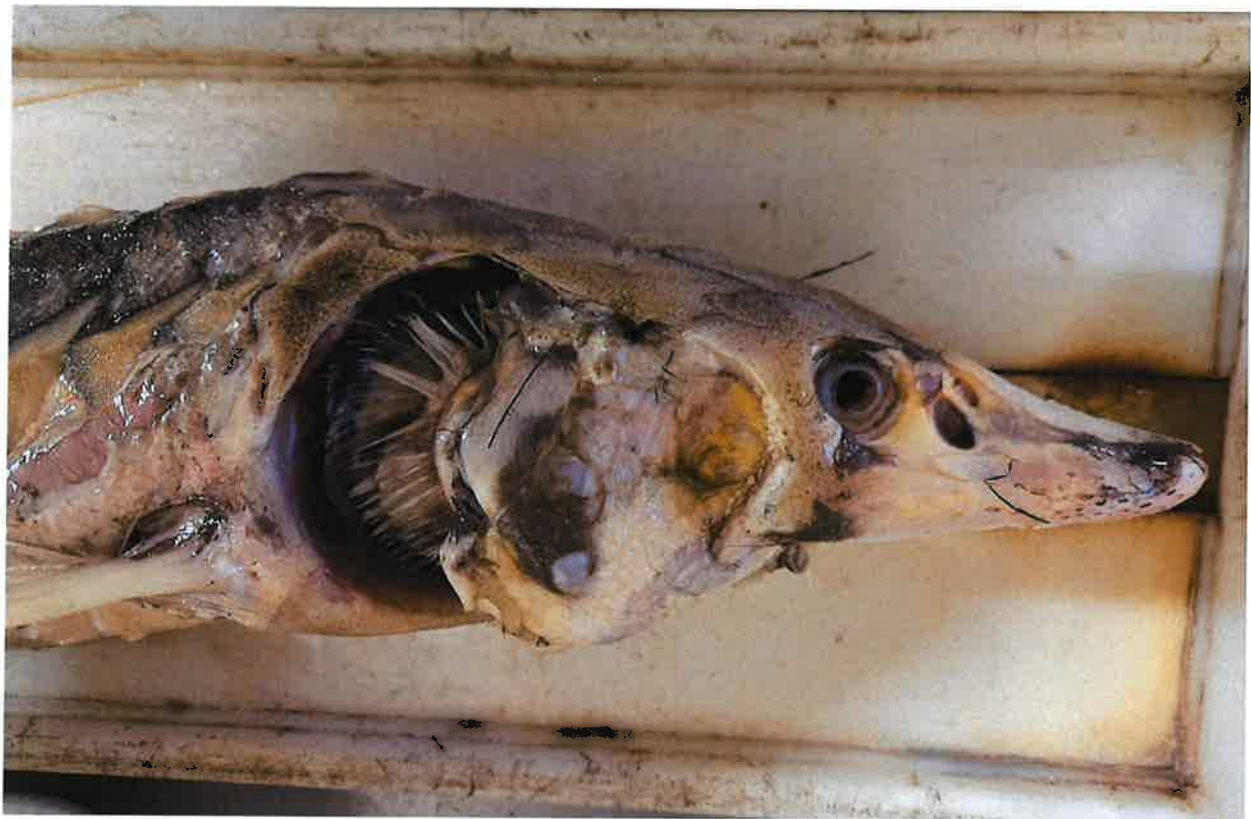
A dorsolateral view of the right side of the head, showing missing operculum (02/24/2025).

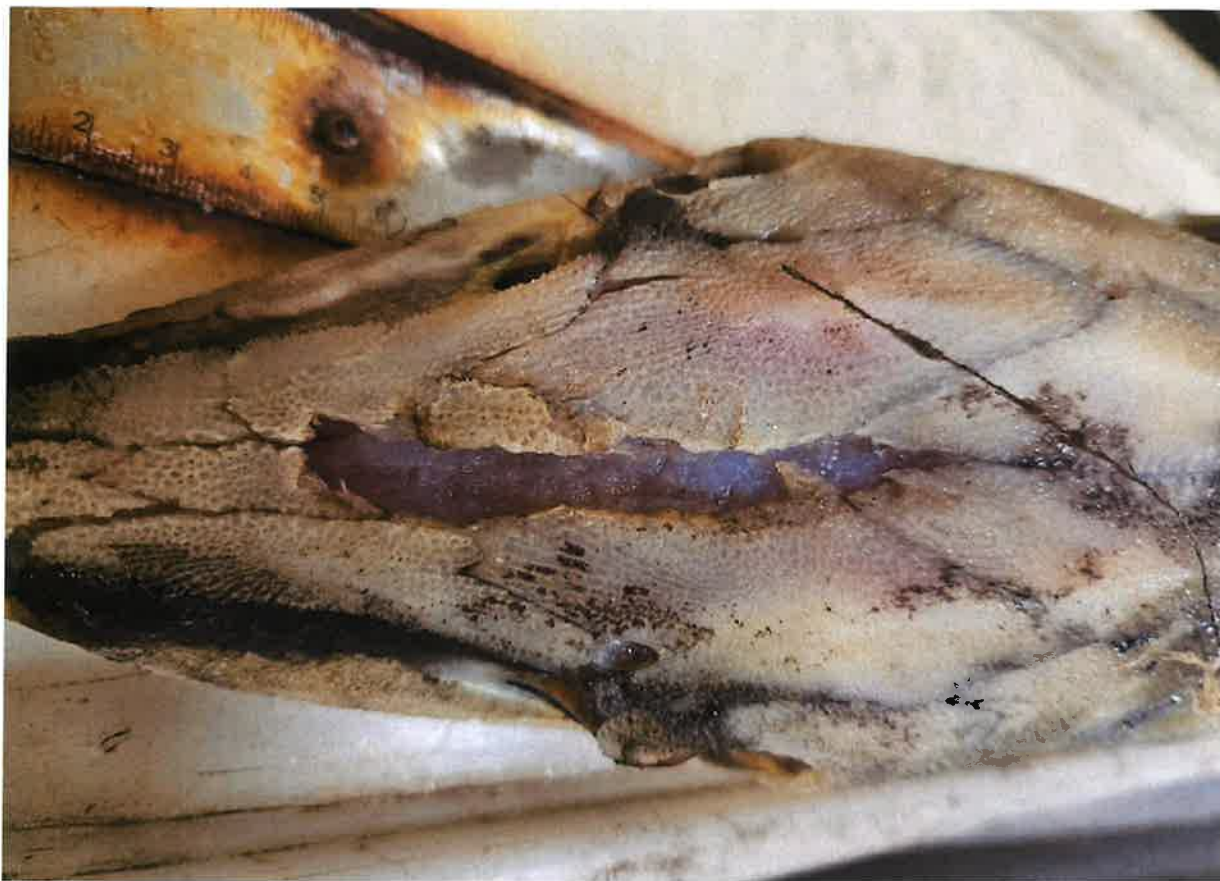
A dorsal view of the head, showing a large section of missing bone from the top of the skull (02/24/2025).

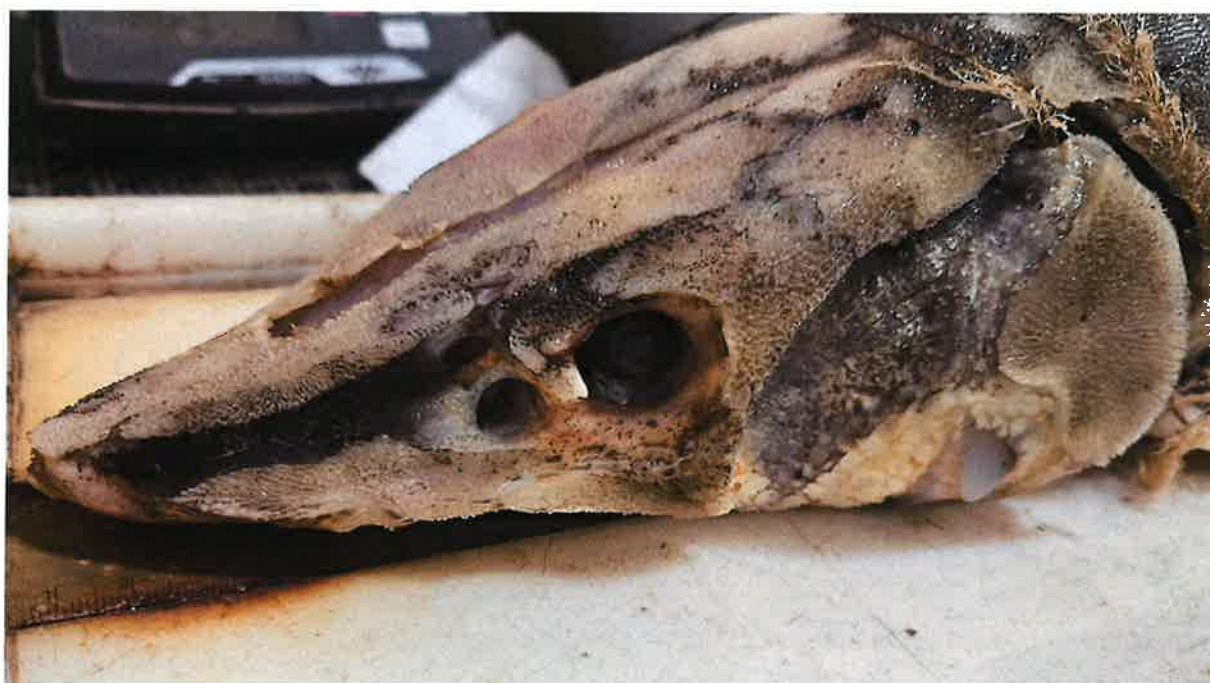
A dorsolateral view of the head, showing the lack of surface skin, as well as the section of missing bone on the dorsal surface of the skull (02/24/2025).

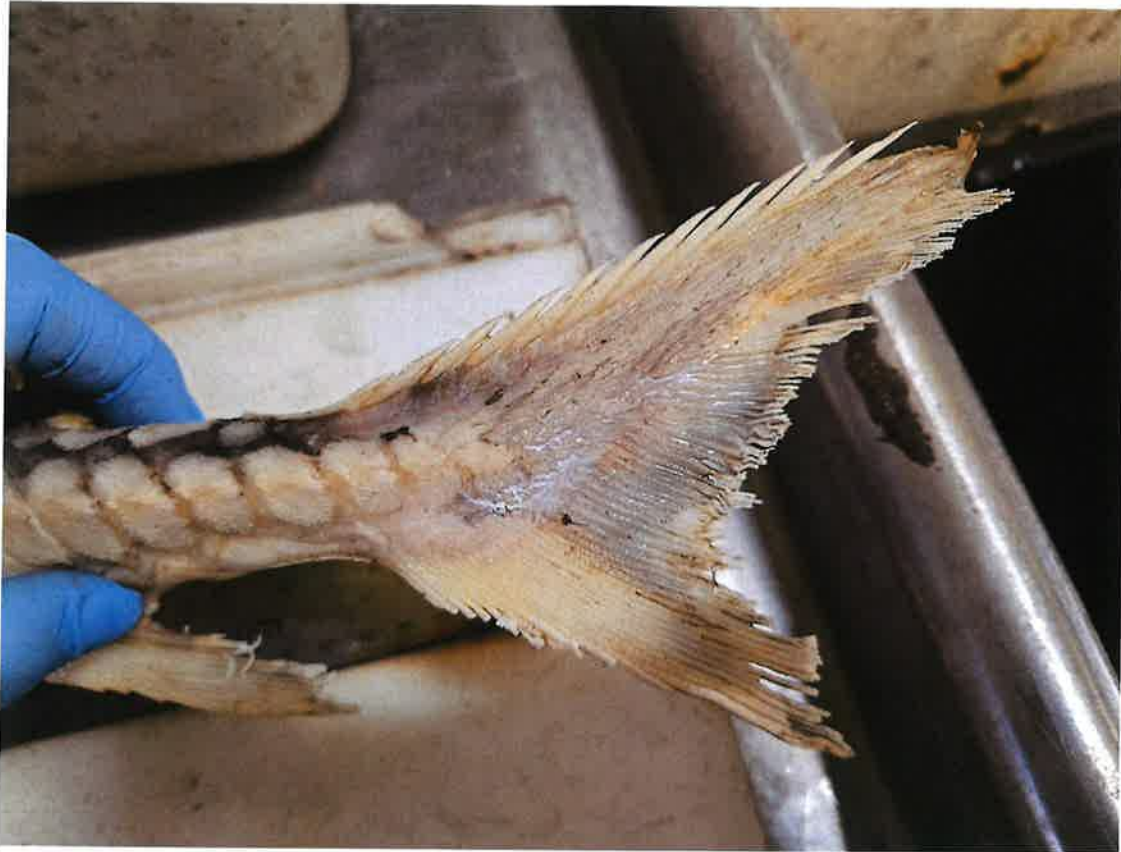
Specimen revealed the effects of severe decomposition, as indicated in the photo by the degraded condition of the caudal fin (02/24/2025).

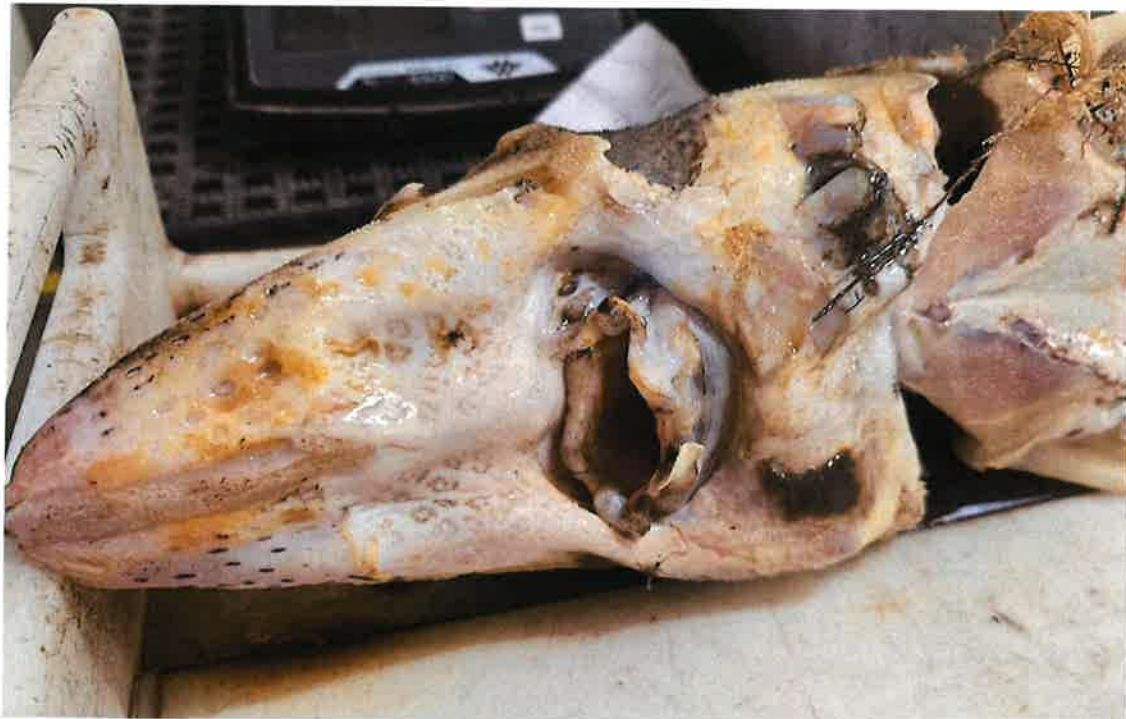
A ventral view of the head, showing the characteristic elongated rostrum and small mouth (02/24/2025).
