# OYSTER CREEK GENERATING STATION SITE RADIOLOGICAL CHARACTERIZATION REPORT

Revision 1  
April 24, 2023

This Characterization report provides detailed information about the radiological conditions of open land areas and building structures within the OCNGS site boundary. It includes information about the types and levels of radioactive materials.

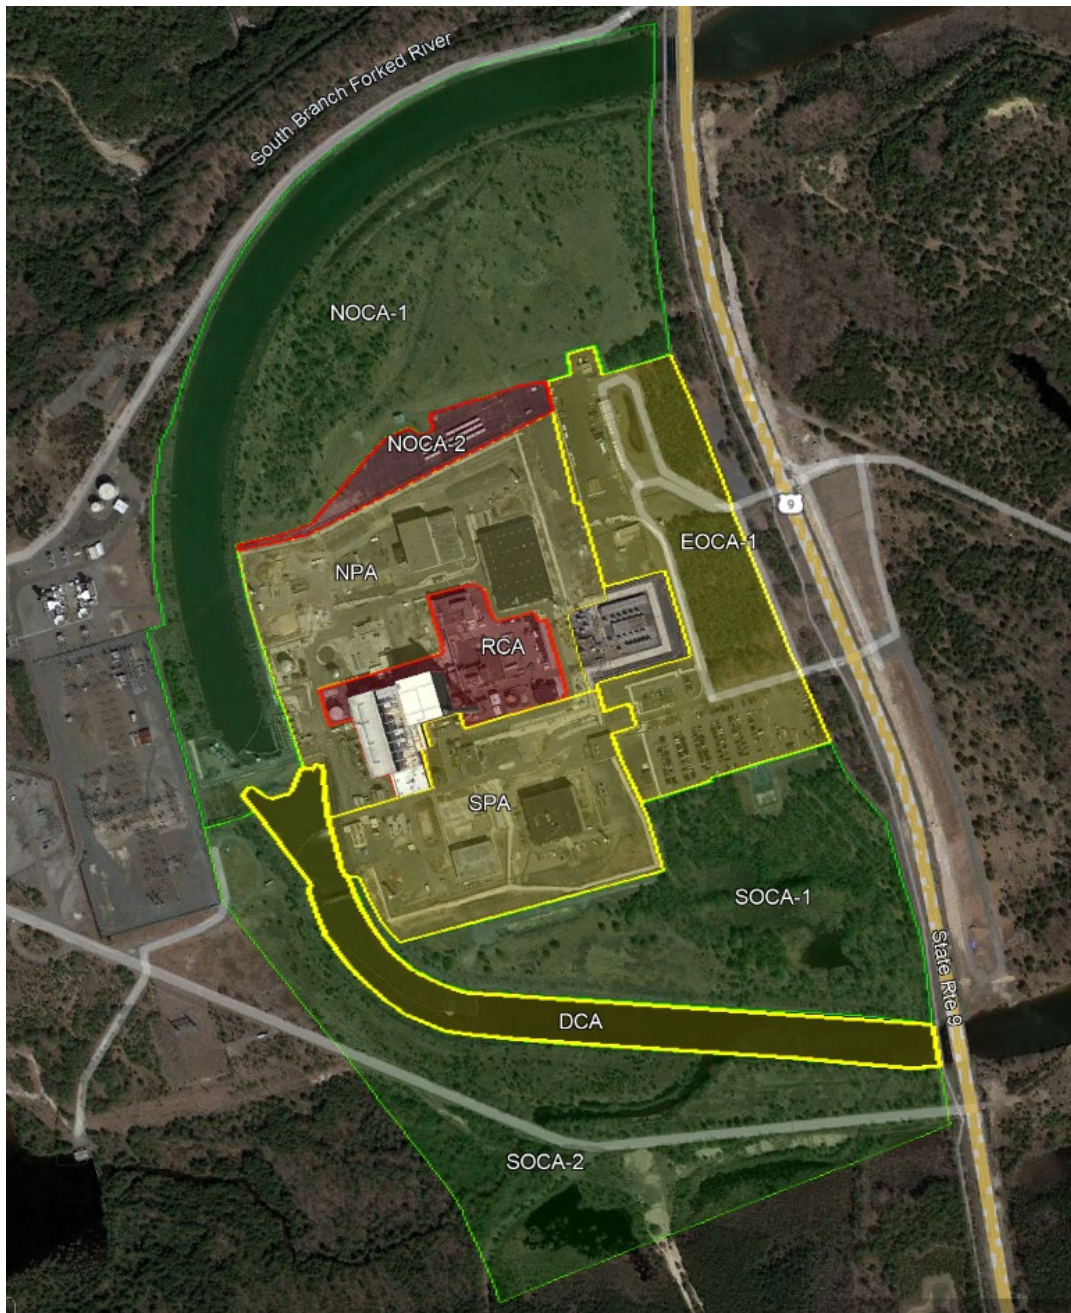
Figure 1-2 Site Characterization Organization

Figure 1-2 shows the BHI engineering site radiological characterization organization and the HDI interface.
