Attached is the Incidental Take Report and Data Collection Form for a deceased Kemp's ridley sea turtle collected on 6/12/2025 from the Salem Generating Station during routine raking of the circulating water intake trash bars. The deceased specimen was transferred to a representative from the Brigantine MMSC for further evaluation. This incidental take is authorized under Biological Opinion GAR-2020-02842.

APPENDIX B – Part 1 (Sea Turtle)

Incident Report Sea Turtle Take – PSEG Salem Generating Station

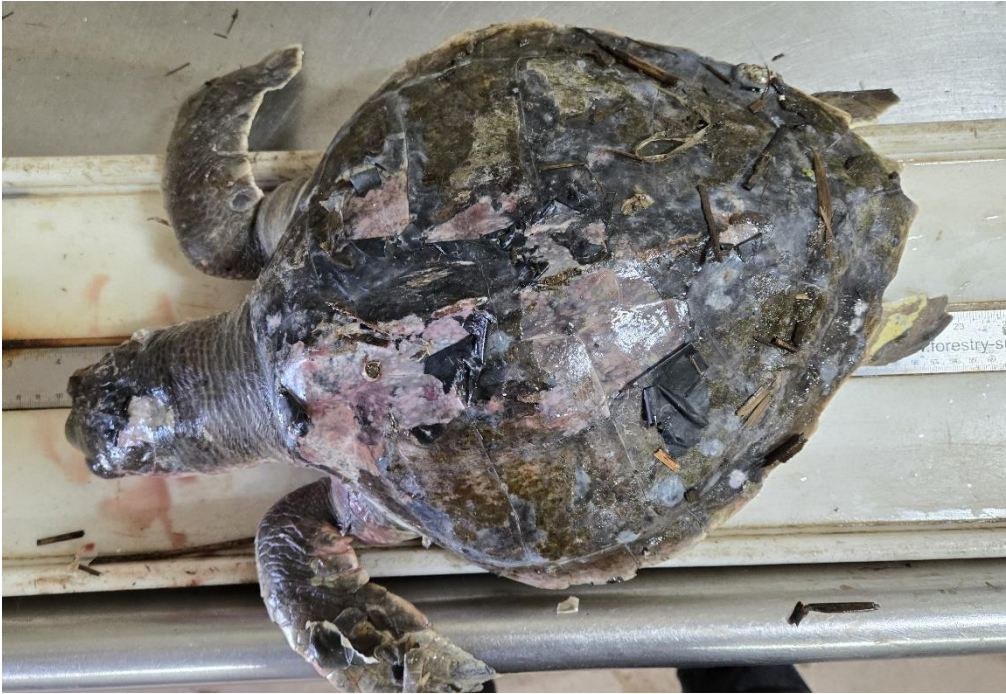
Dorsal view of the deceased, Kemp's ridley sea turtle, collected from Salem Generating Station CWI on 06-12-2025 by Salem Yard crew personnel during routine trash rack Cleaning (06/12/2025).

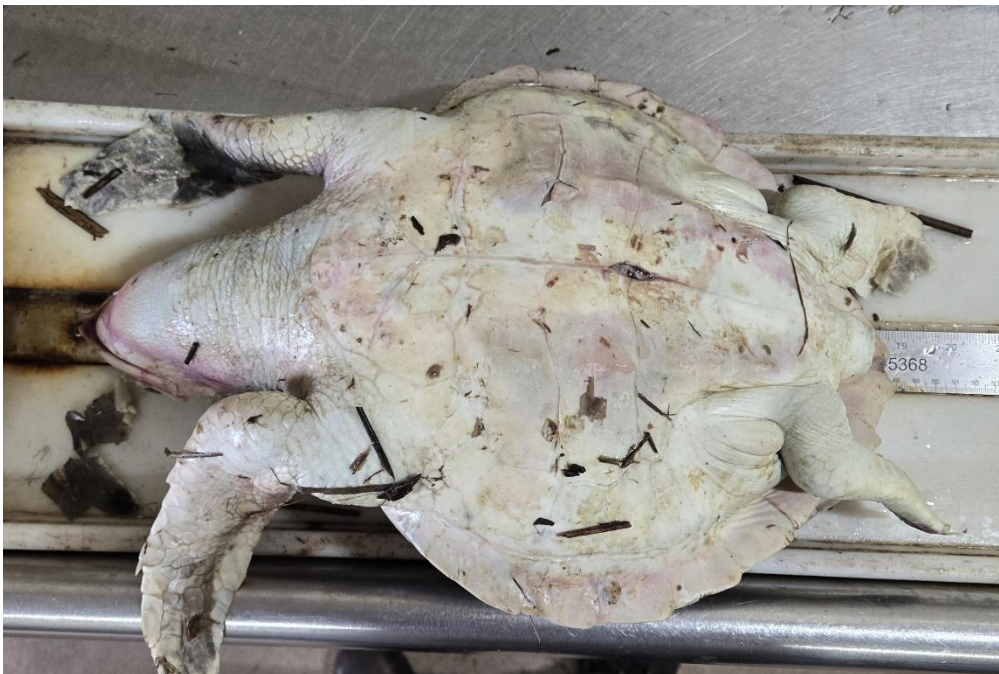
A ventral view of the specimen, showing the condition of the plastron. Except for a small puncture wound, located between the lower, central scutes, no significant signs of injury were observed. However, indicators of advanced decomposition were present (06/12/2025).

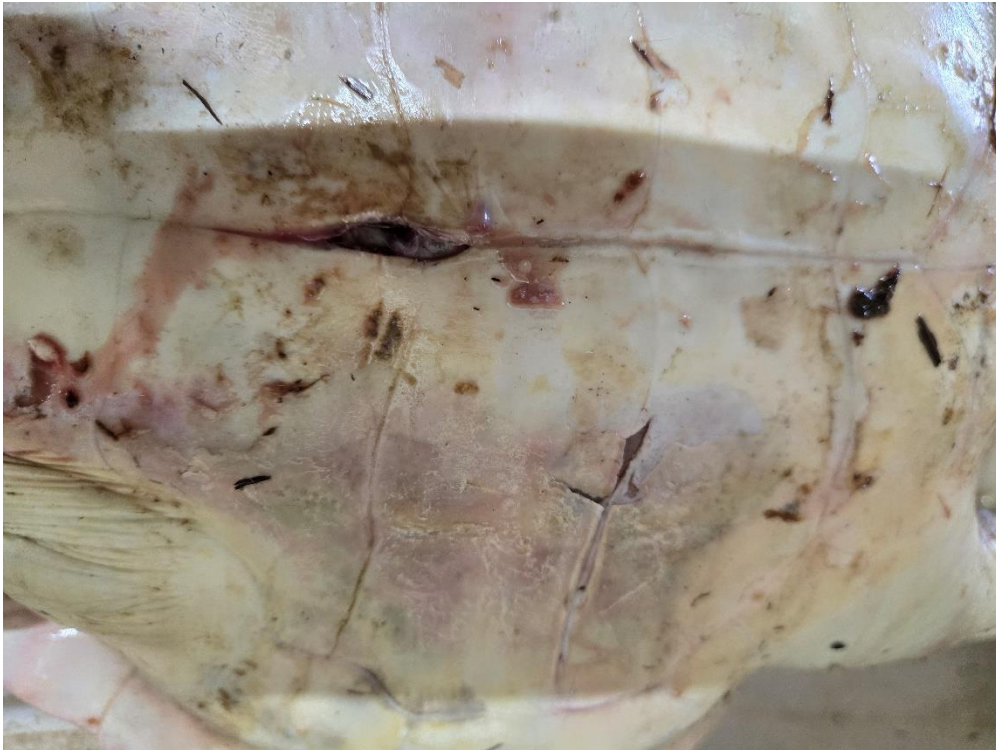
A close-up view of the plastron, showing the small puncture wound, located between the central scutes (06/12/2025)
