ANNUAL SITE ENVIRONMENTAL REPORT PANTEX PLANT

Calendar Year 2023

Prepared for
U.S. Department of Energy/National Nuclear Security Administration Pantex Field Office

Consolidated Nuclear Security, LLC (Pantex)
Amarillo, Texas 79120-0020

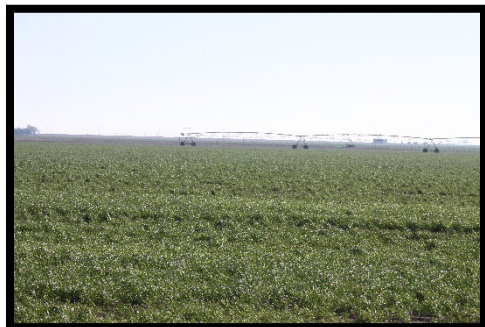
Fig. 3.19. Center pivot irrigation sprinkler system at Pantex.

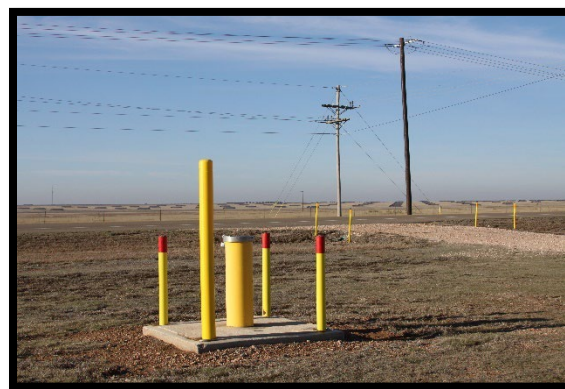
Fig. 3.20. In-situ bioremediation system well near Zone 11.

To treat contaminants, amendment is injected into the treatment zone to provide a food source for naturally

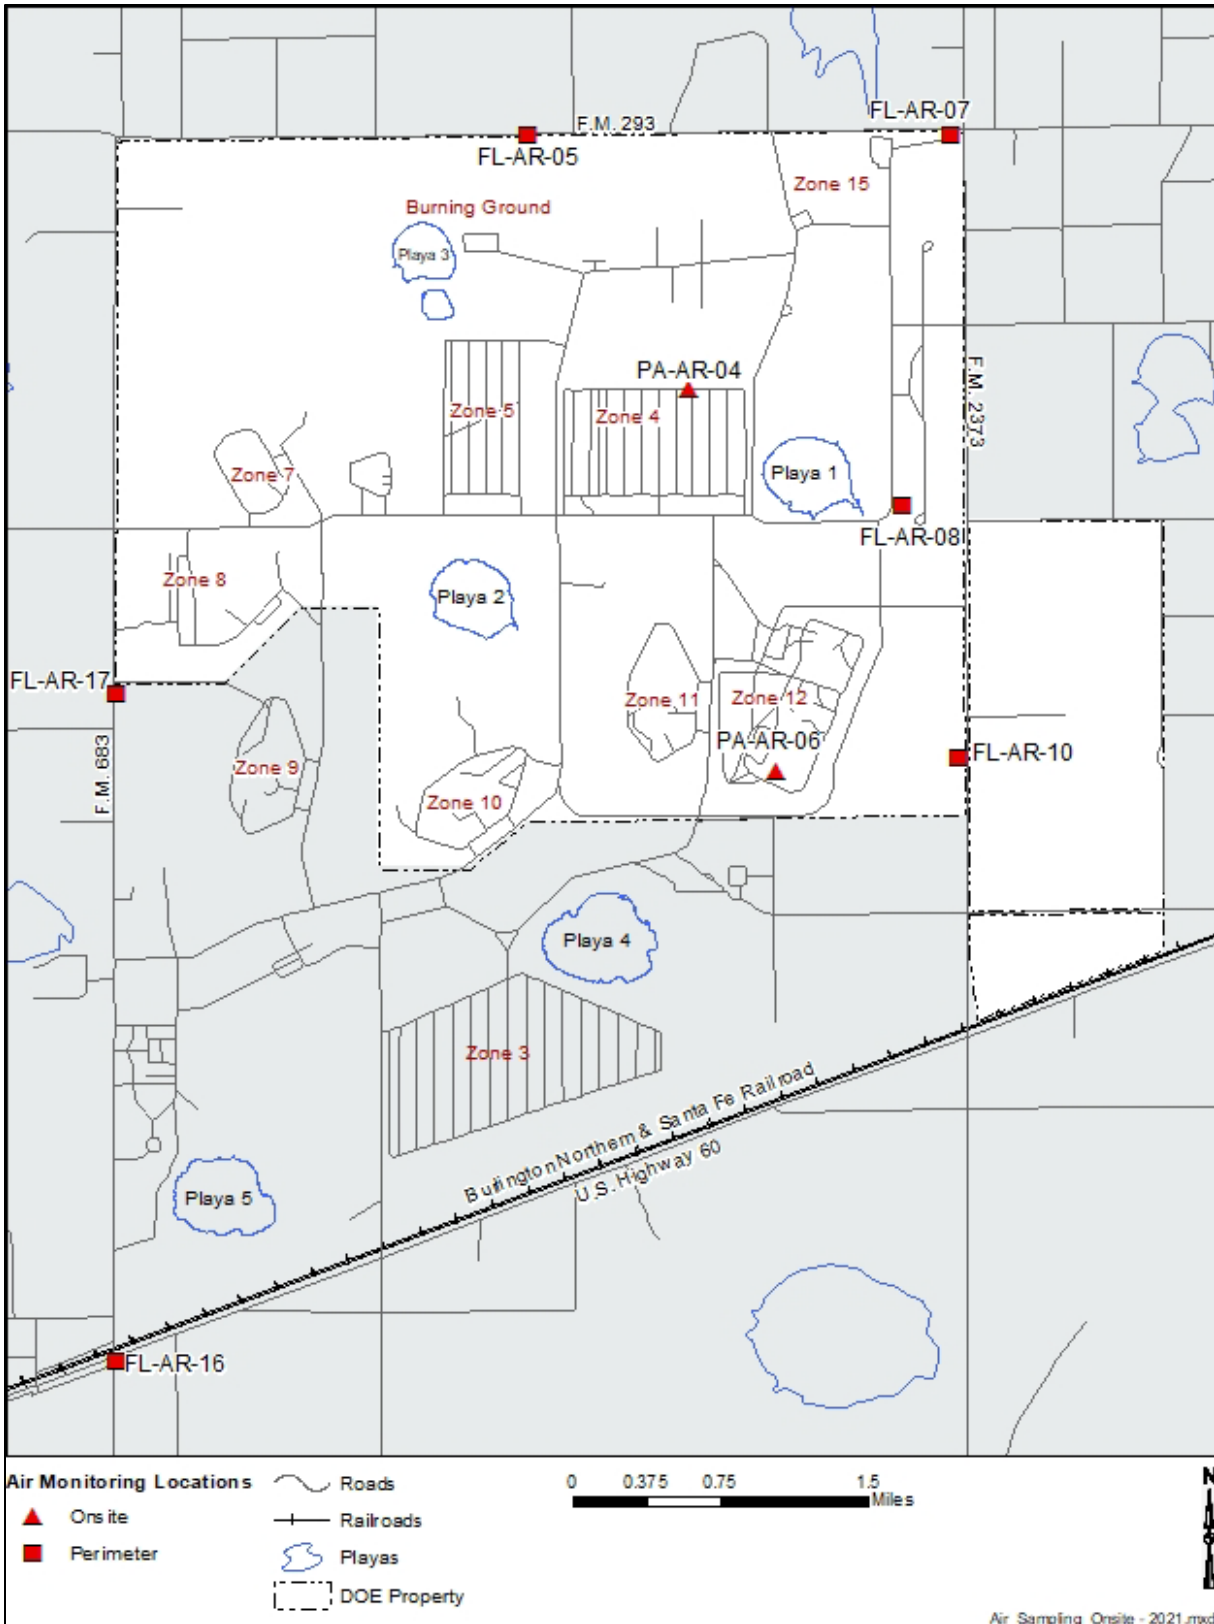
Fig. 5.1. Locations of on-site and fence line air-monitoring stations.

Fence line monitoring stations are located along the perimeter of Pantex (Fig. 5.1.). The perimeter is defined as the perimeter that existed prior to the purchase of the property east of FM 2373 in the latter part of 2008. Two stations are located along the northern fence line, two stations are located along the eastern fence line, and two stations are located along the western fence line. Stakeholders were considered in establishing the locations of the stations.

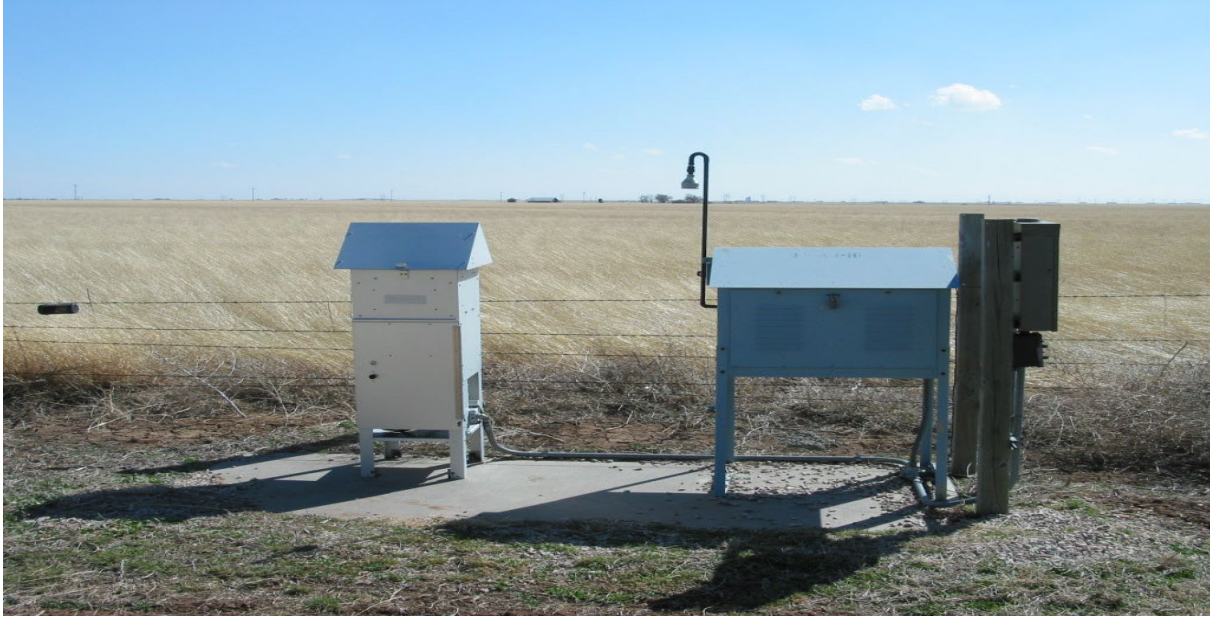
Fig. 5.3. Typical air-monitoring site.

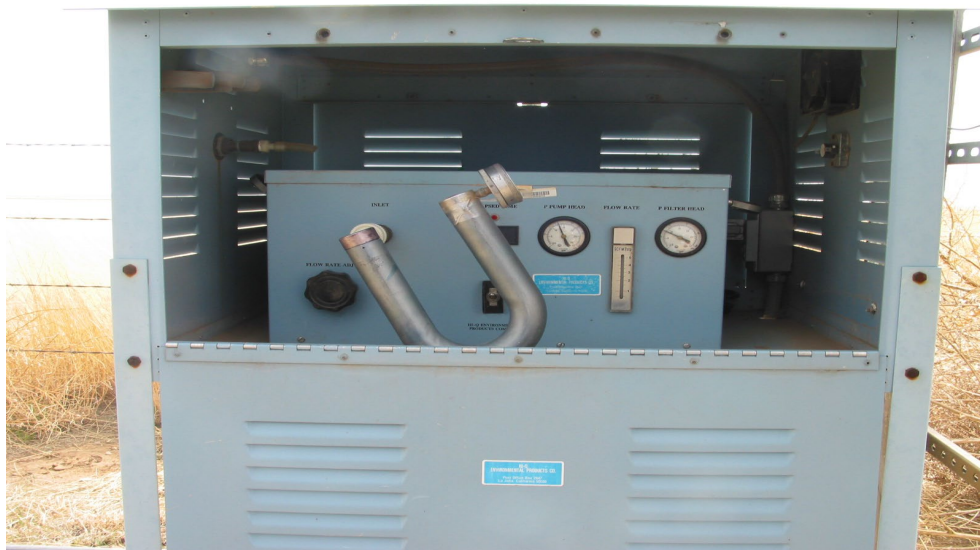
Fig. 5.4. Low-volume sampling apparatus.

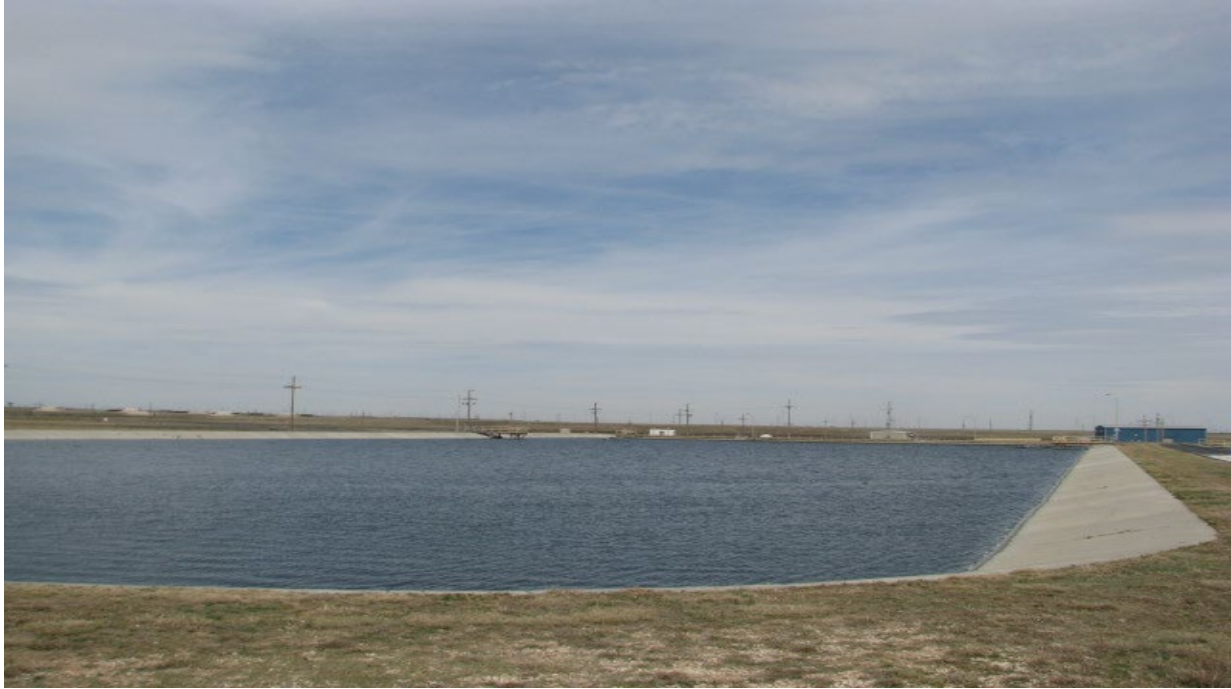
Fig. 8.2. Wastewater Treatment Facility, facultative lagoon.
