**ADP CR3, LLC**  
**DOCKET NUMBER 50-302 / DOCKET NUMBER 72-1035**  
**LICENSE NUMBER DPR – 72**

**Historical Site Assessment for Crystal River 3**

*Technical Support Document No. 16-015 Rev 00.*

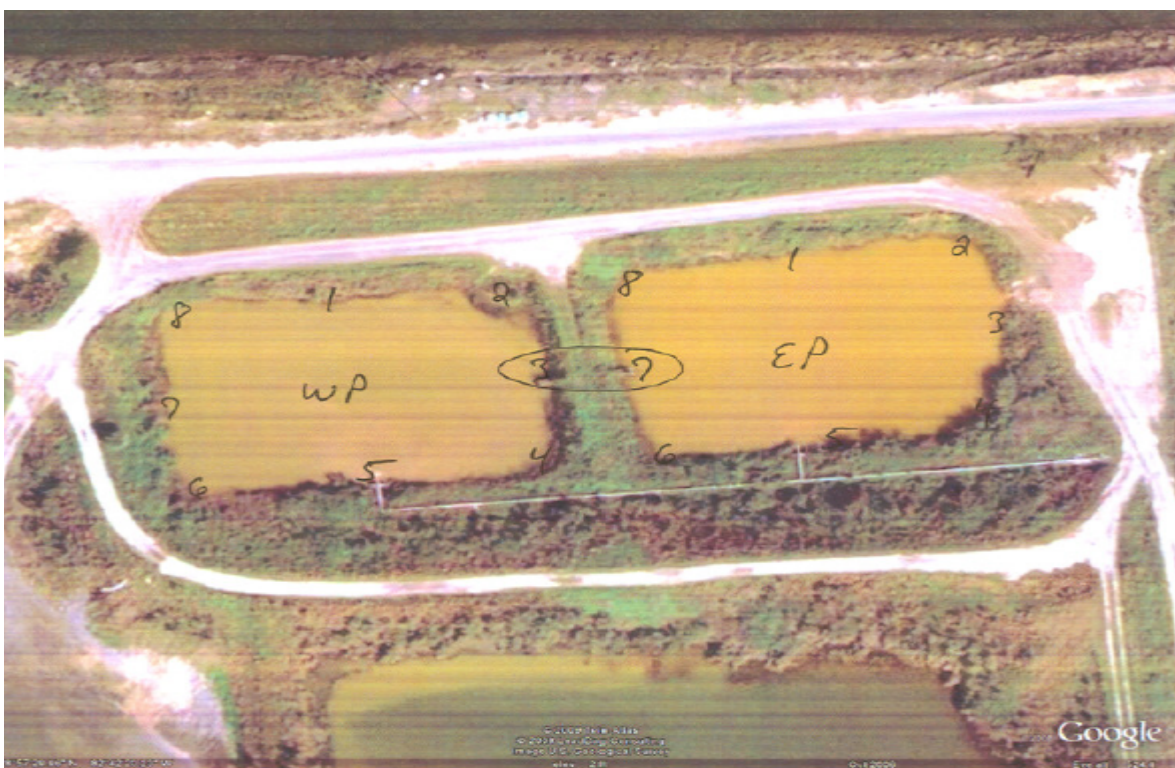
Figure 2, State of Florida Sampling Locations

In summary, one of the eight sediment samples collected from the pond in 2009 identified very-low-levels of plant-related radionuclides (Co-60 and Cs-137). All other samples had no detectable Co-60; the Cs-137 levels were considered in the background range based on REMP results. Sampling and analysis of the pond conducted in 2010 thru 2014 have not identified any plant-related radioactivity.

Soil  
 EPS 1-8  
 WPS 1-8

Veg  
 EPV 1-8  
 WPV 1-8

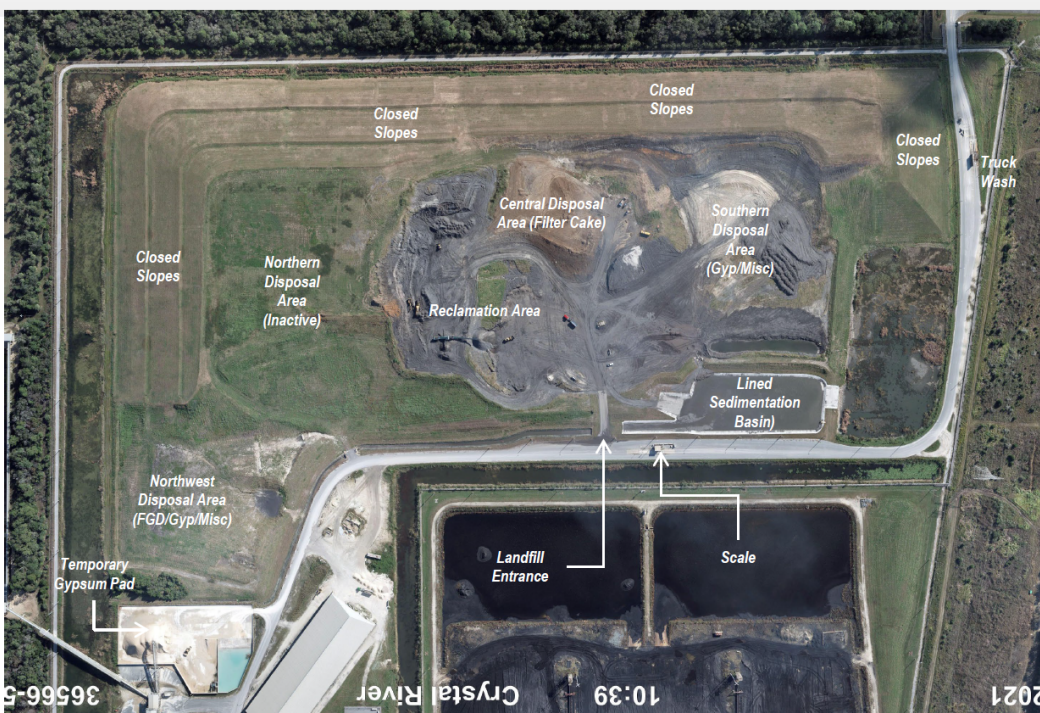
### Ash Storage/Disposal Area (AS/DA) – CRN Ash Landfill

In March of 2022, communication between the Duke Coal Ash Storage Area Environmental and their EHS SME. The Duke manager asked the EHS SME for waste and groundwater to also have a look at your characterization plan. It generally looks fine to me, but I do have some input. The attached is a recent air photo of the landfill that I've labeled with some relevant info. I didn't add a north arrow, so please note that the image is rotated so north is to the left.
