Subject: Rio Piedras Sono-Nuclear Center NRC License No. 52-24937-01,  
30 Day Written Report Regarding Loss of Licensed materials

### **30 Day Written Report to NRC Region I Regarding Loss of Licensed Material**

Licensee: Rio Piedras Sono-Nuclear Center

NRC License Number: 52-24937-01

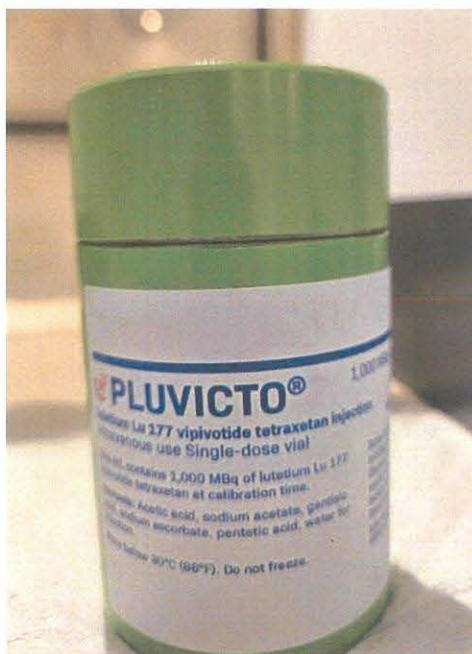
**A-1. Lead Container of Lu-177 dose**

A photo of a similar box and a Lu-117 dose lead container is included as **Exhibit A**.

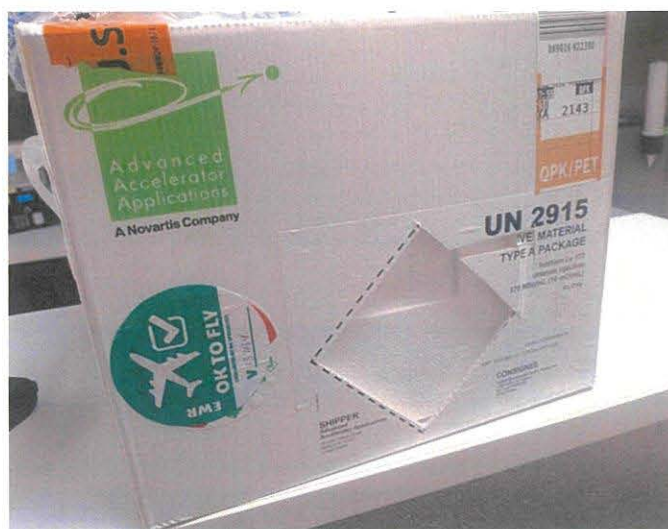
**A-2. Empty/De-labeled Shipping Box**

The white shipping box containing the Lu-177 injection was accidentally presumed to be empty of the actual Lu-177 injection vial, while still containing the Styrofoam packing materials (top and bottom) and the box discarded in the normal trash after obliteration of the labels and radioactive markings. The janitorial crew typically picks up trash between 3pm to 5 pm, and the box was placed in the compactor of normal trash on May 28, 2025, which would have been picked up by the waste disposal company at approximately 7:00 am on Friday, May 30, 2025 and transported to a landfill.

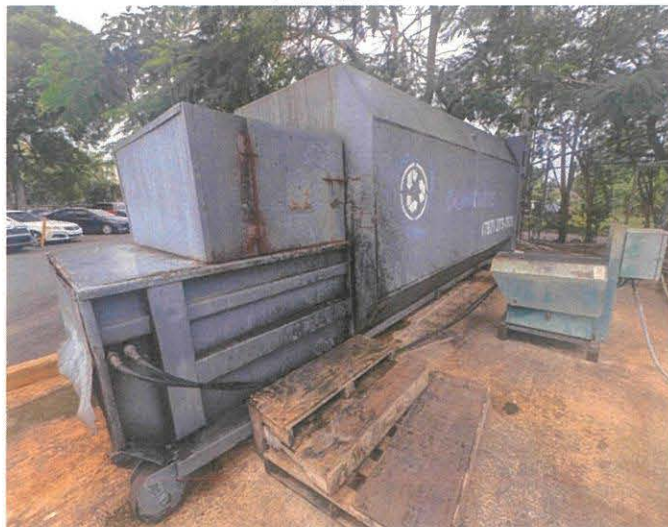
**B-1. Waste Compactor**

Afterwards, the janitor picked up the trash between 3:00 p.m. and 5:00 p.m., and the box was put into a compactor container localized at the end of the parking lot of the San Francisco Hospital. This compactor serves for our facility and the nearby hospital to dispose of regular trash.

A photo of the compactor is included as **Exhibit B**.

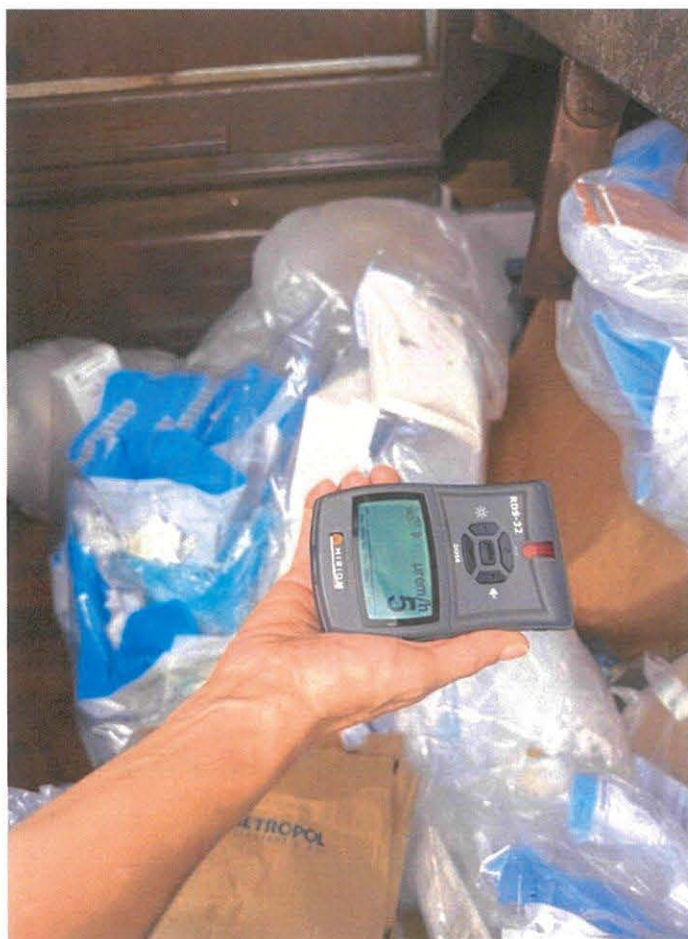
**B-2. Measurements taken inside the compactor, May 29 2025 around 9:00A.M.**

**At 9:00 a.m.:** A second visit was made by the administrator in order to reach both the RSO and the hospital administrator, but it was also unsuccessful. By the other hand, the technologist, along with the quality control manager, went to survey around and inside the compactor; the readings were background ( 5 urem/h inside, 6 urem/h outside)

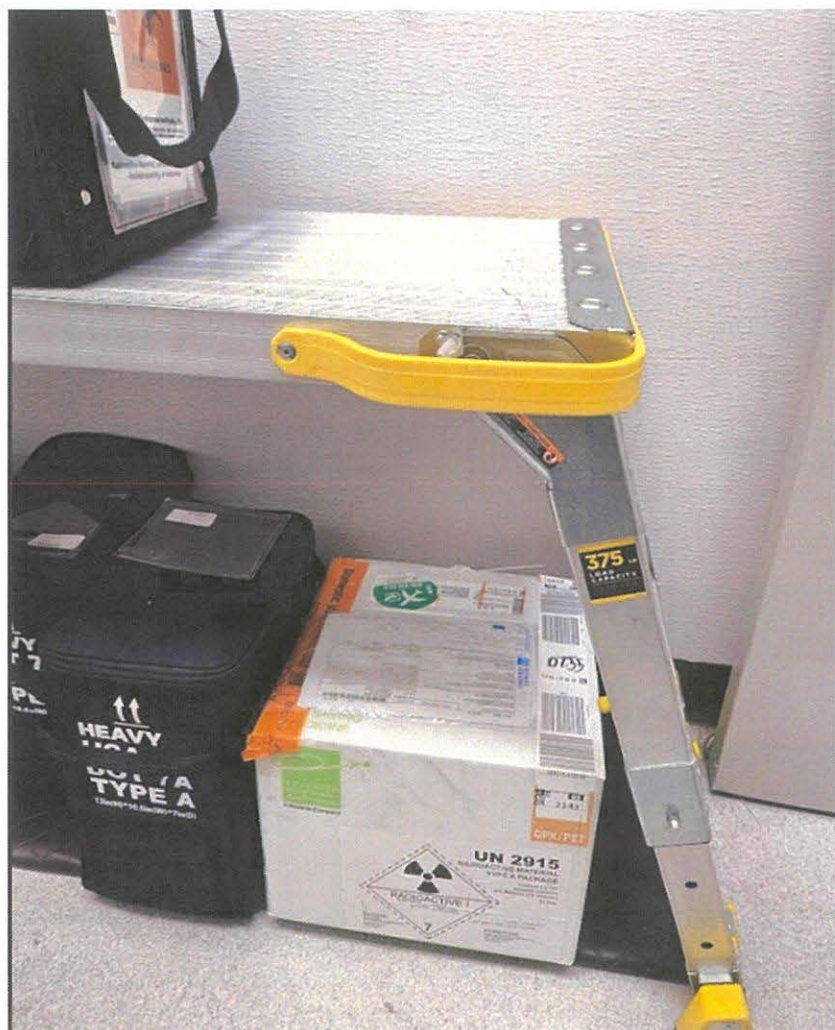
C-1. Hot Lab Bench

**7:00 a.m.-** The technologist arrived at Sononuclear lab and performed routinary procedures of daily dose calibrations and when surveyed, wipe tested and logged the receiving dose packages into the logbook. While doing so, she remembered that the PLUVICTO dose shipping box that was left to be decayed since the day before, under the nuclear medicine hot lab bench for doses, was no longer there. The technologist could not locate the white box that contained the second vial.

A photo of hot lab bench is included as **Exhibit C**.

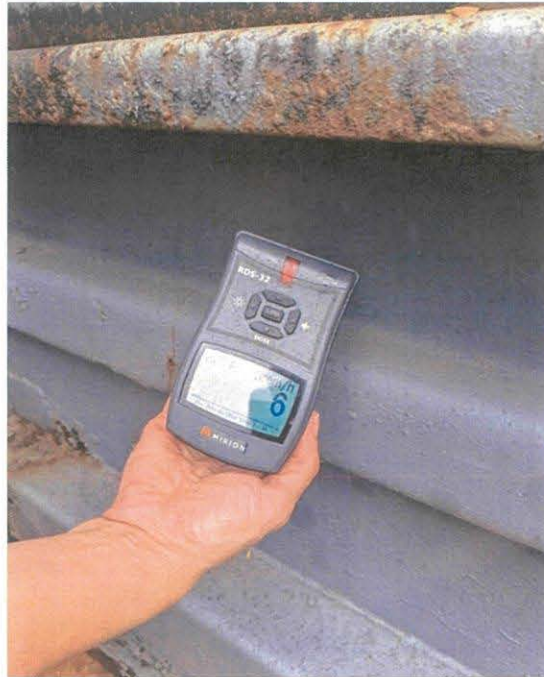
D-1. Measurement at container side May 29, 2025 around 9:00A.M

Photos of survey readings is included as **Exhibit D**.

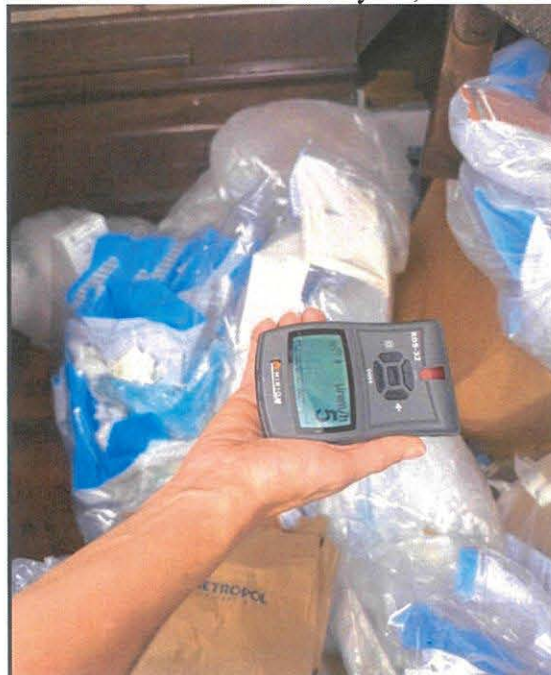
D-2. Measurement inside the container May 29, 2025 around 9:00A.M

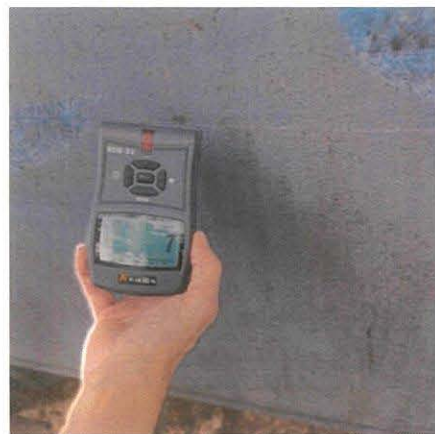
D-4. Measurement at container side May 30, 2025 around 1:42P.M.

**1:42 p.m.** – The quality control supervisor and the technologist surveyed the container again. readings were indistinguishable from background (7 urem/h).
