**10CFR Part 21 Interim Notification: P21-10112025-INT Rev 0**

**Subject: Potential Deviation Related to Stryten (formally GNB) N&M Series Flooded Batteries Installed in 24VDC, 48VDC, 125VDC and 250VDC Station Battery Strings Need for Additional Analysis**

## Visual Inspection Conditions Requiring Further Evaluation

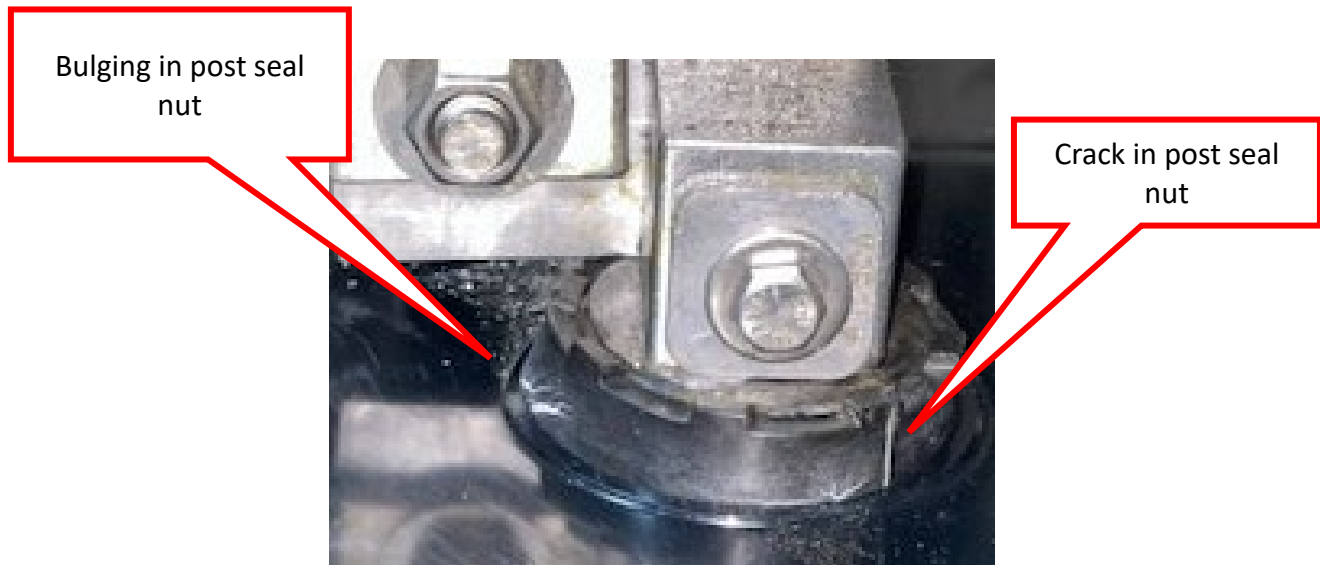
**Figure 1**

**Positive Post Corrosion Indications** – Figures 1 thru 4 below provide visual indicators of corrosion in the post seal area.

1. For In-service Batteries: (See attached pictures for examples of the conditions below)
  - a. Indication of nodular corrosion is often visible in advanced stages, and Paragon is recommending impacted licensees perform an inspection of their batteries for nodular corrosion.

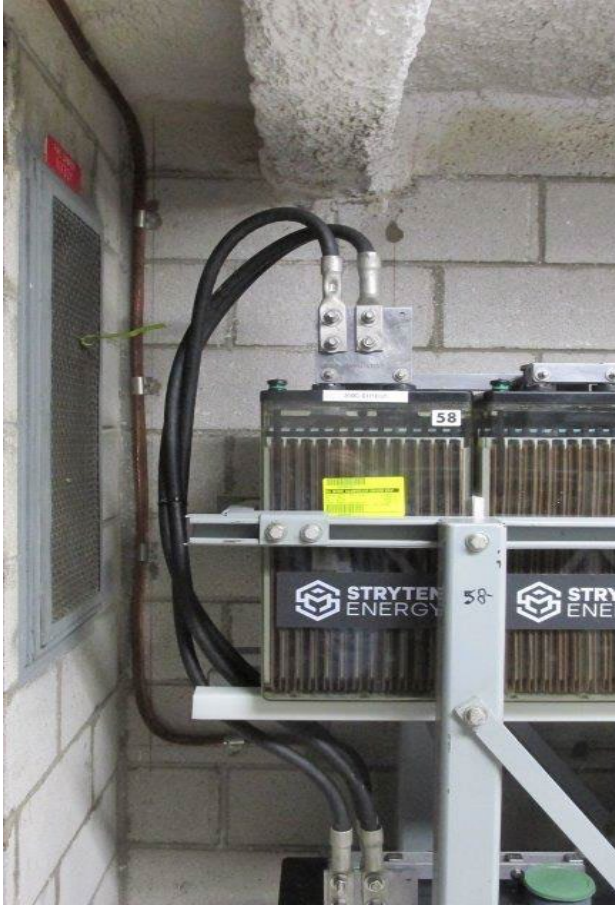
**Battery Cabling Support** – intercell/tier battery cabling should be well supported with sufficient bend radius to minimize post stress.

**Figure 5.** Unsupported Inter-Tier Cabling

- Verify intercell cabling is properly supported such that the weight of the cables is not supported by the post alone.
    - Verify proper alignment of intercell connector plates and cells.
