PWR Owners Group

Josh Morton – Industry Core Barrel Focus Group Update

Industry / NRC Materials Technical Exchange Meeting – June 17, 2026

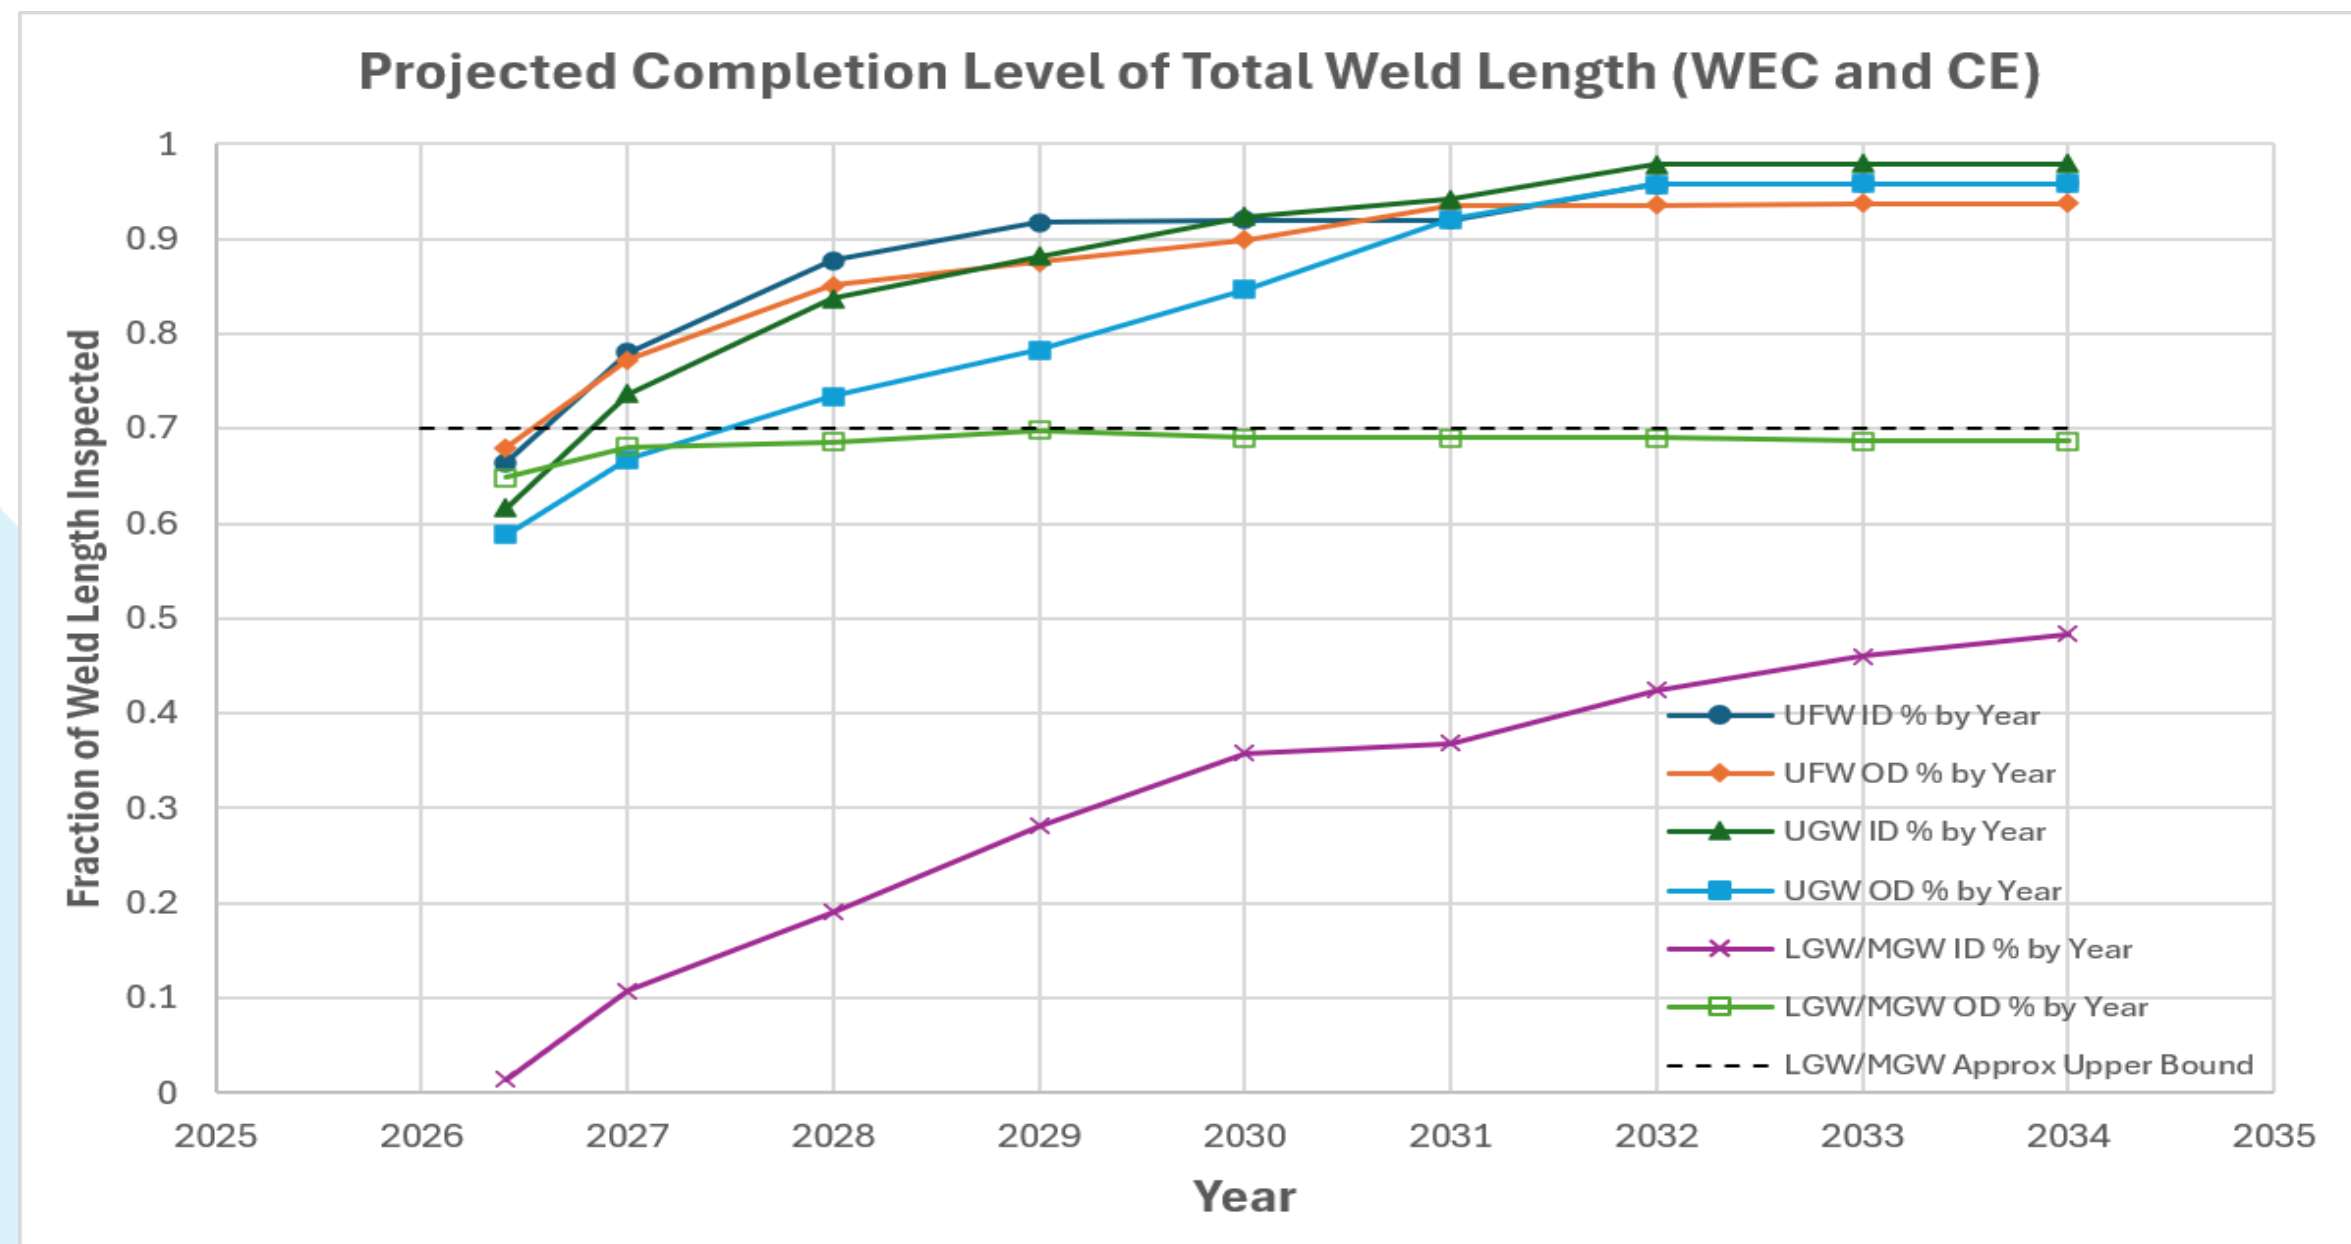
- Summary of inspection coverage to date per weld with projection over the next 8 years (following guidance provided in MRP-227 and interim guidance)
