Galvanic Corrosion Dealloying Corrosion Velocity Phenomena

Galvanic, Dealloying and Fluid Velocity Corrosion Learning Objectives

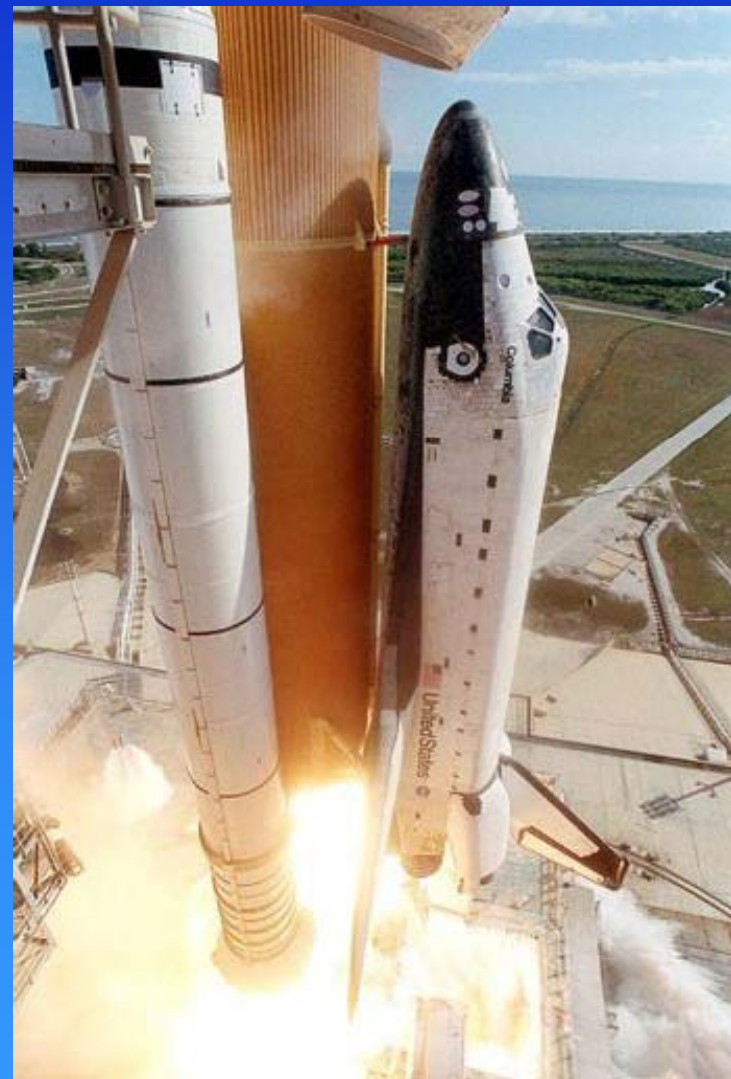
Galvanic couple: Alloy 718 and A286 bolts coupled to 2024 Al honeycomb

Al preferentially corrodes when salt spray from the nearby ocean was dissolved in rainwater and seeped into the structure while Columbia was on the launch pad

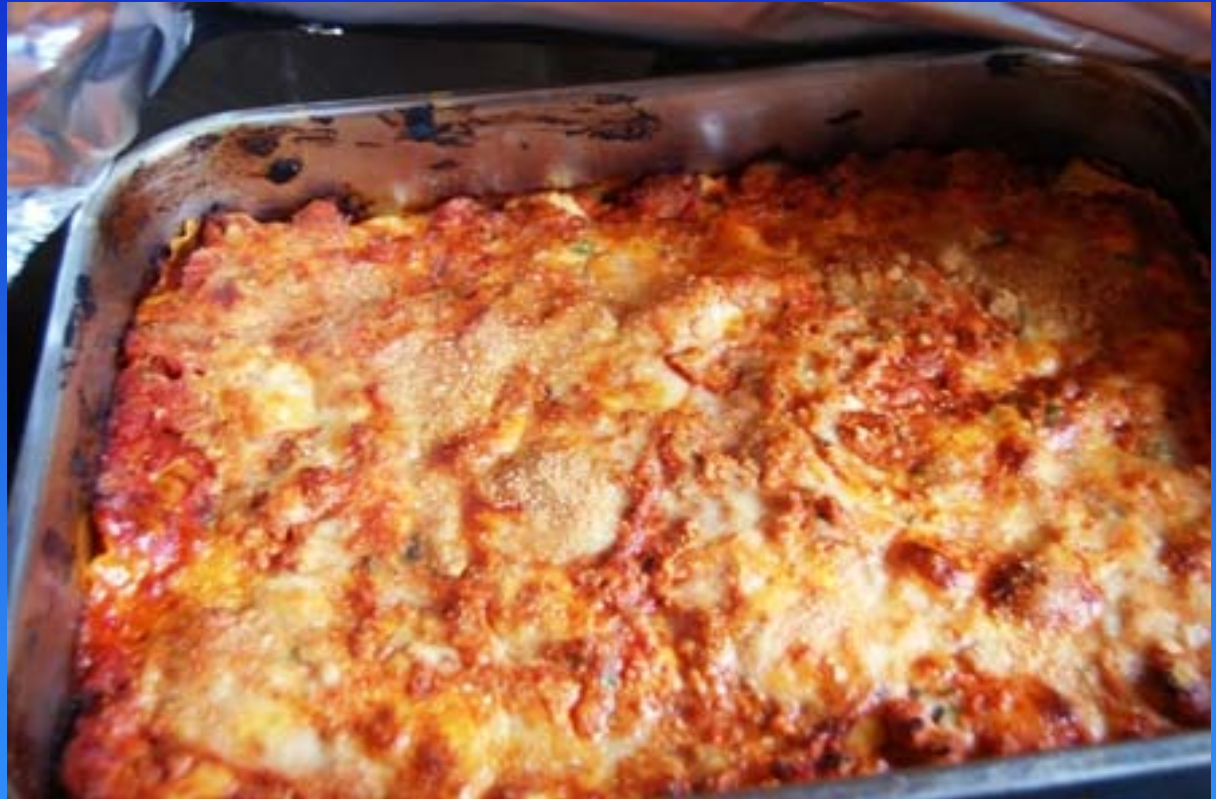
Lasagna Cell Corrosion

After a few hours foil develops small holes where it touches the lasagna and the food surface becomes covered with small spots of Al_2O_3

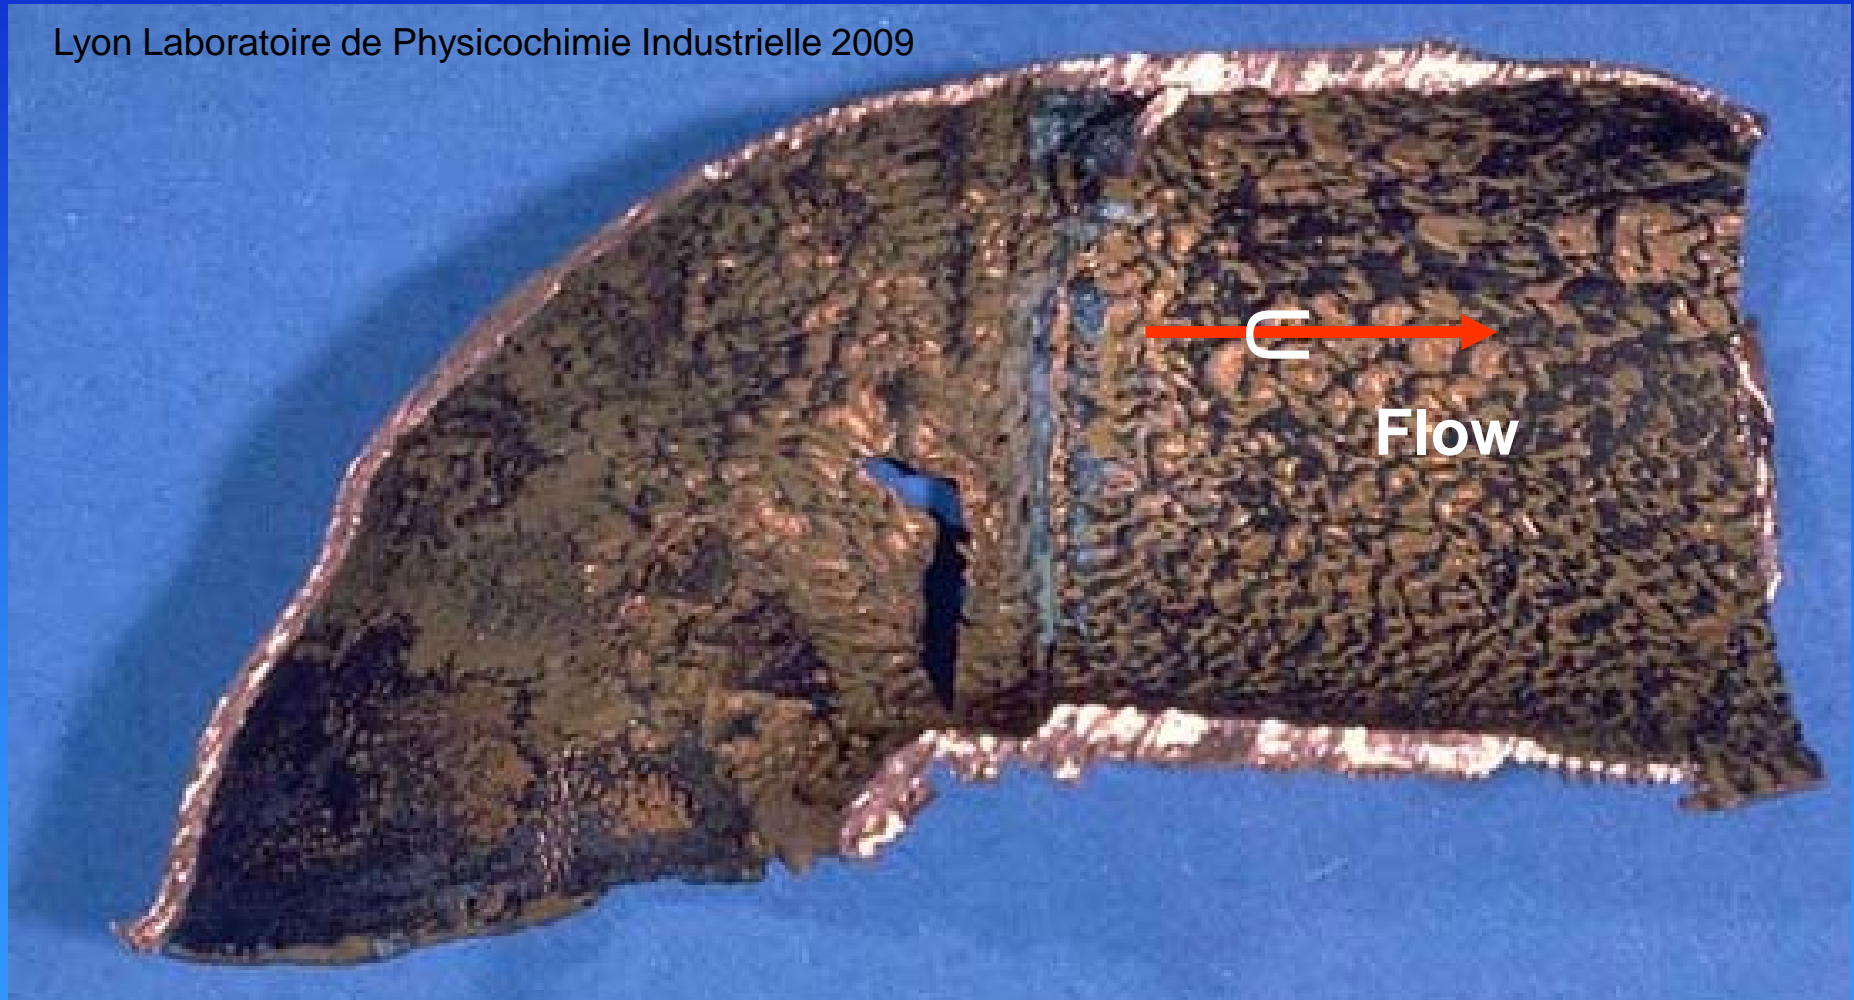
Copper Erosion-Corrosion

“Horseshoes” are characteristic of E/C that are oriented with the closed end of the features pointing in the direction of source of flow. “Horses walk upstream.”

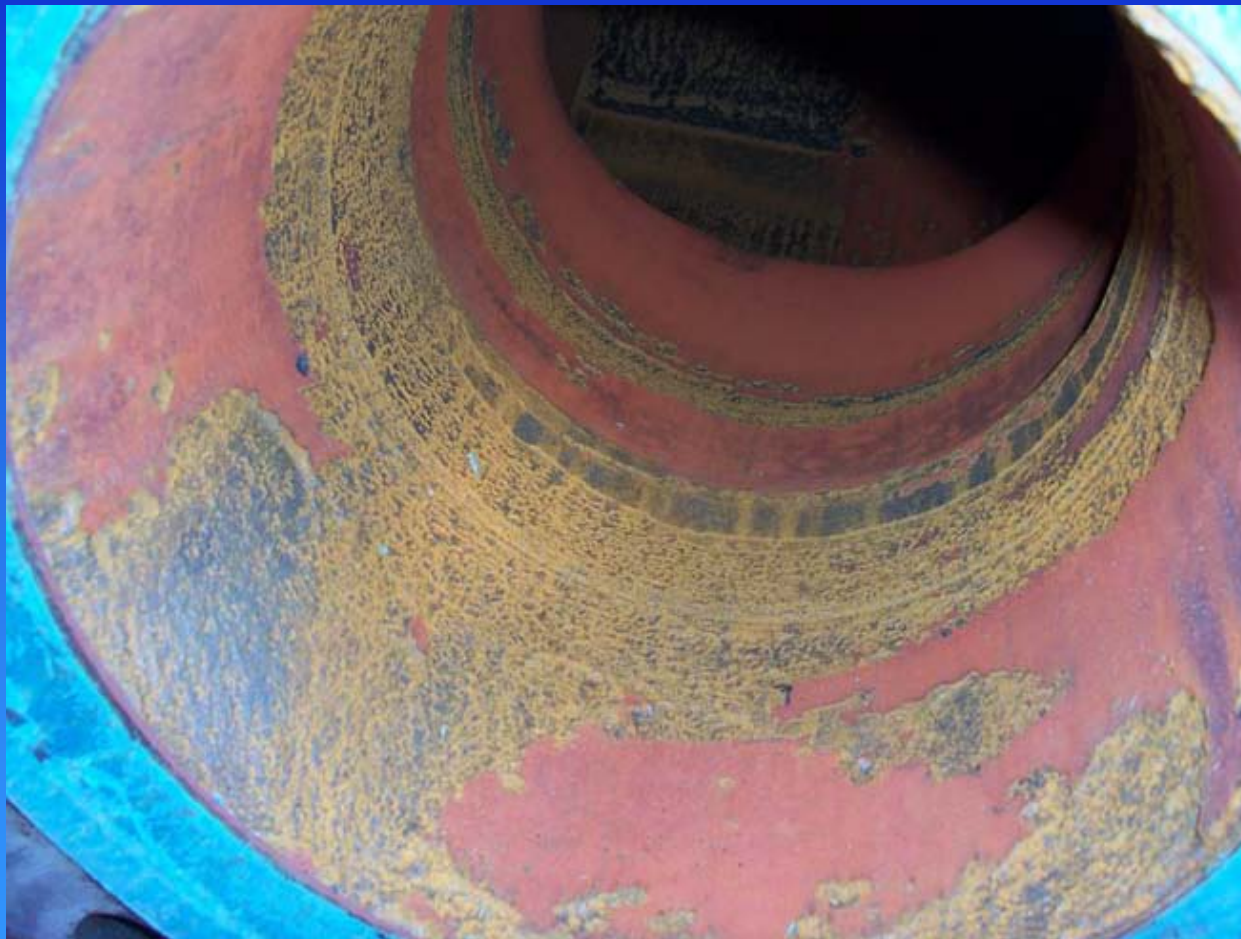
South Texas Project Low Temperature FAC

32 – 54°C (90 – 130°F)
2.7 m/s (8.9 f/s)
pH 7
5 ppb DO

2004 - Piping downstream of the
condensate polisher

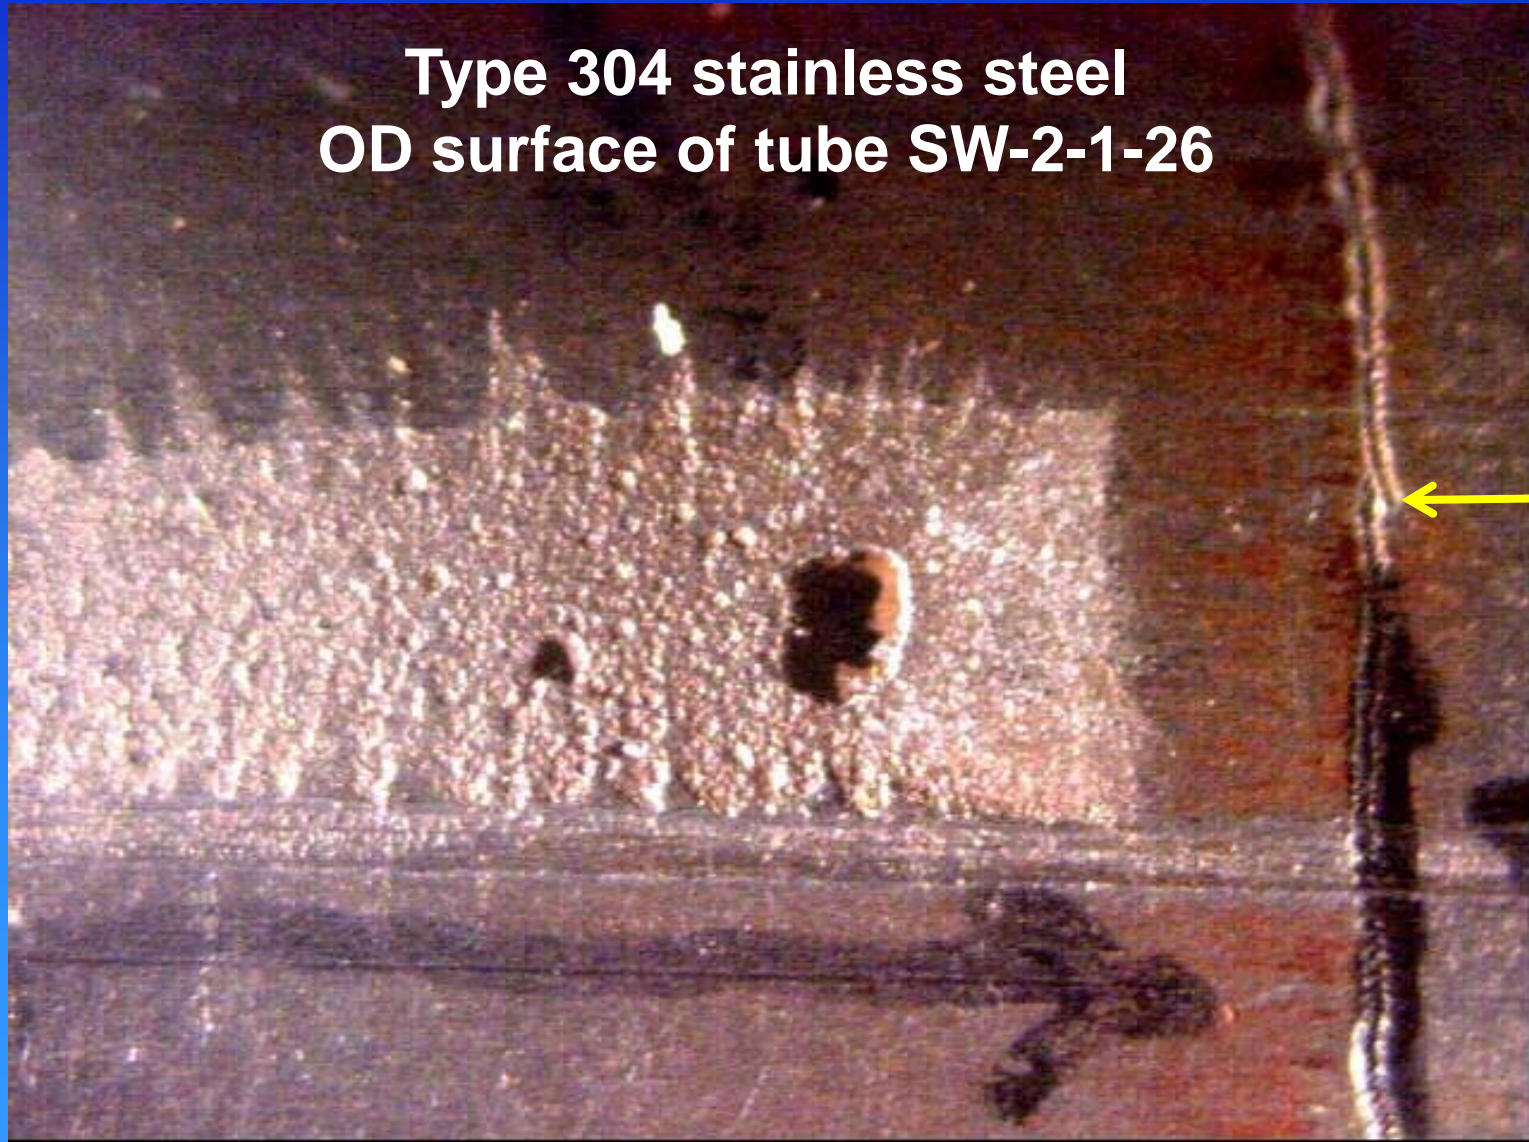
Impingement Corrosion of Quad Cities 1 Main Condenser

Type 304 stainless steel
OD surface of tube SW-2-1-26

Engraved
Tube
support
edge

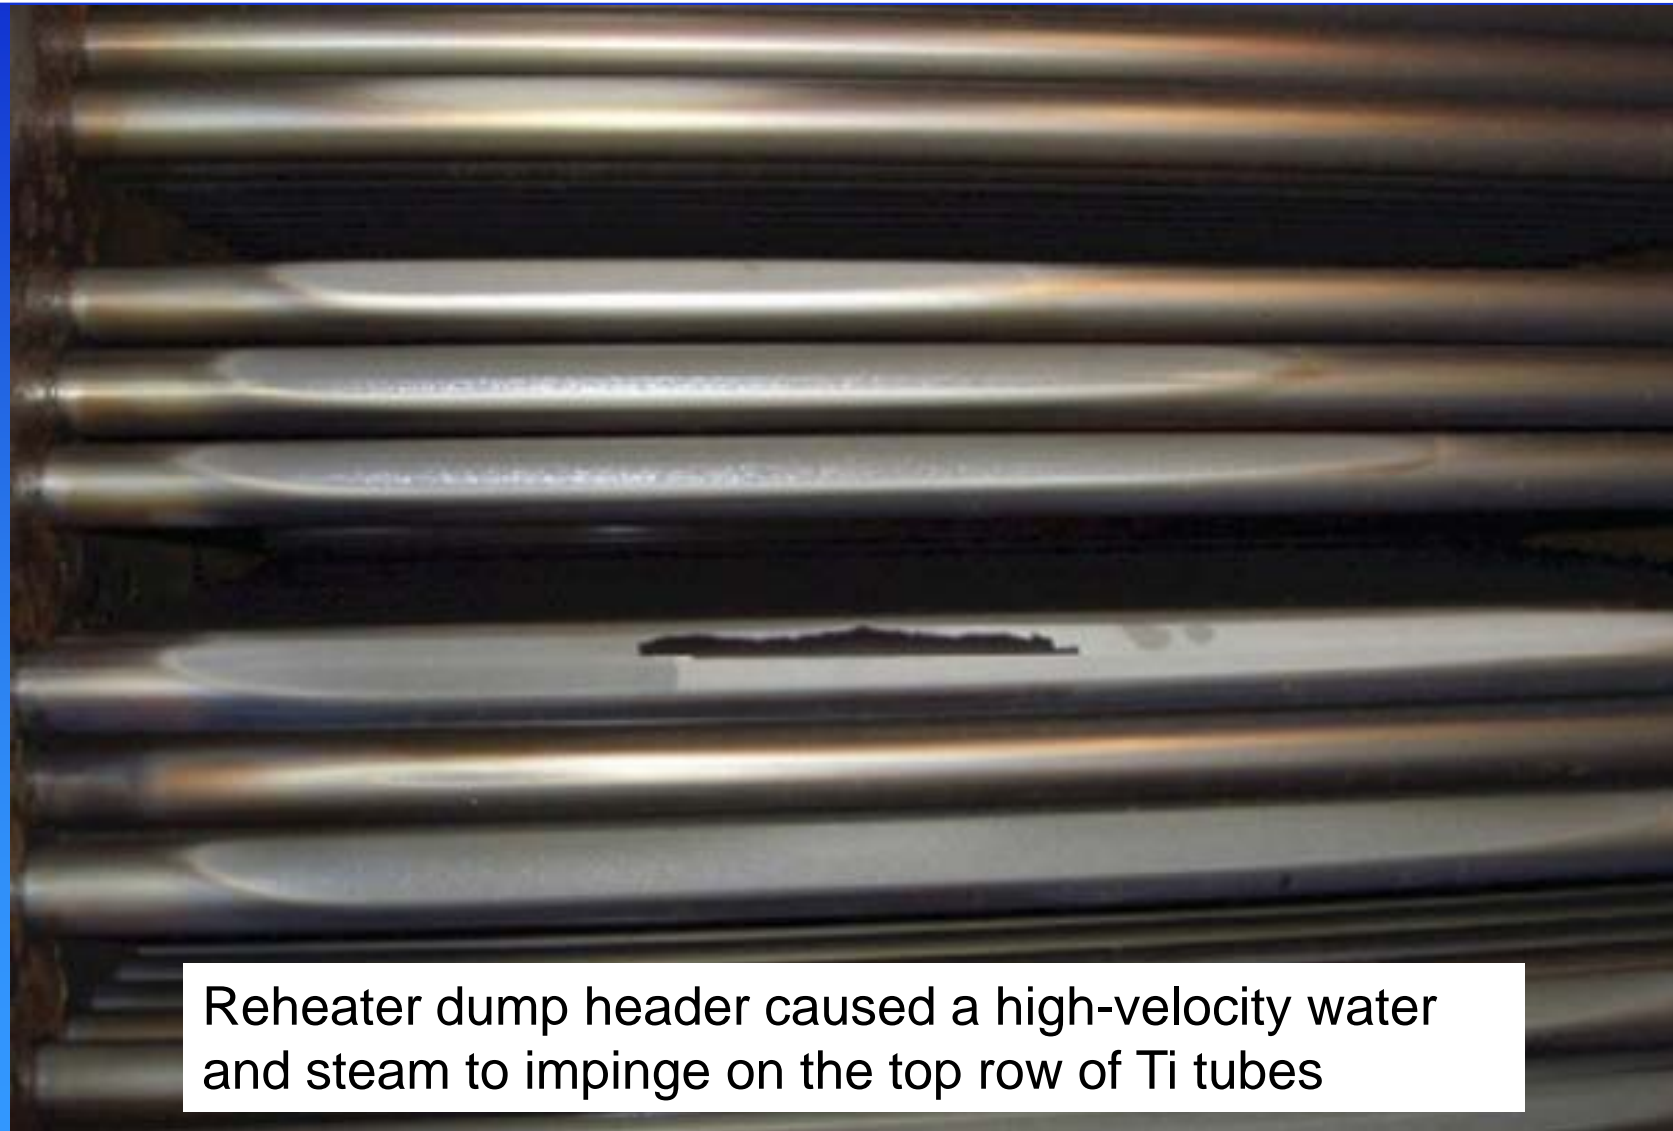
Impingement Corrosion of Ti Condenser Tubes

Reheater dump header caused a high-velocity water and steam to impinge on the top row of Ti tubes

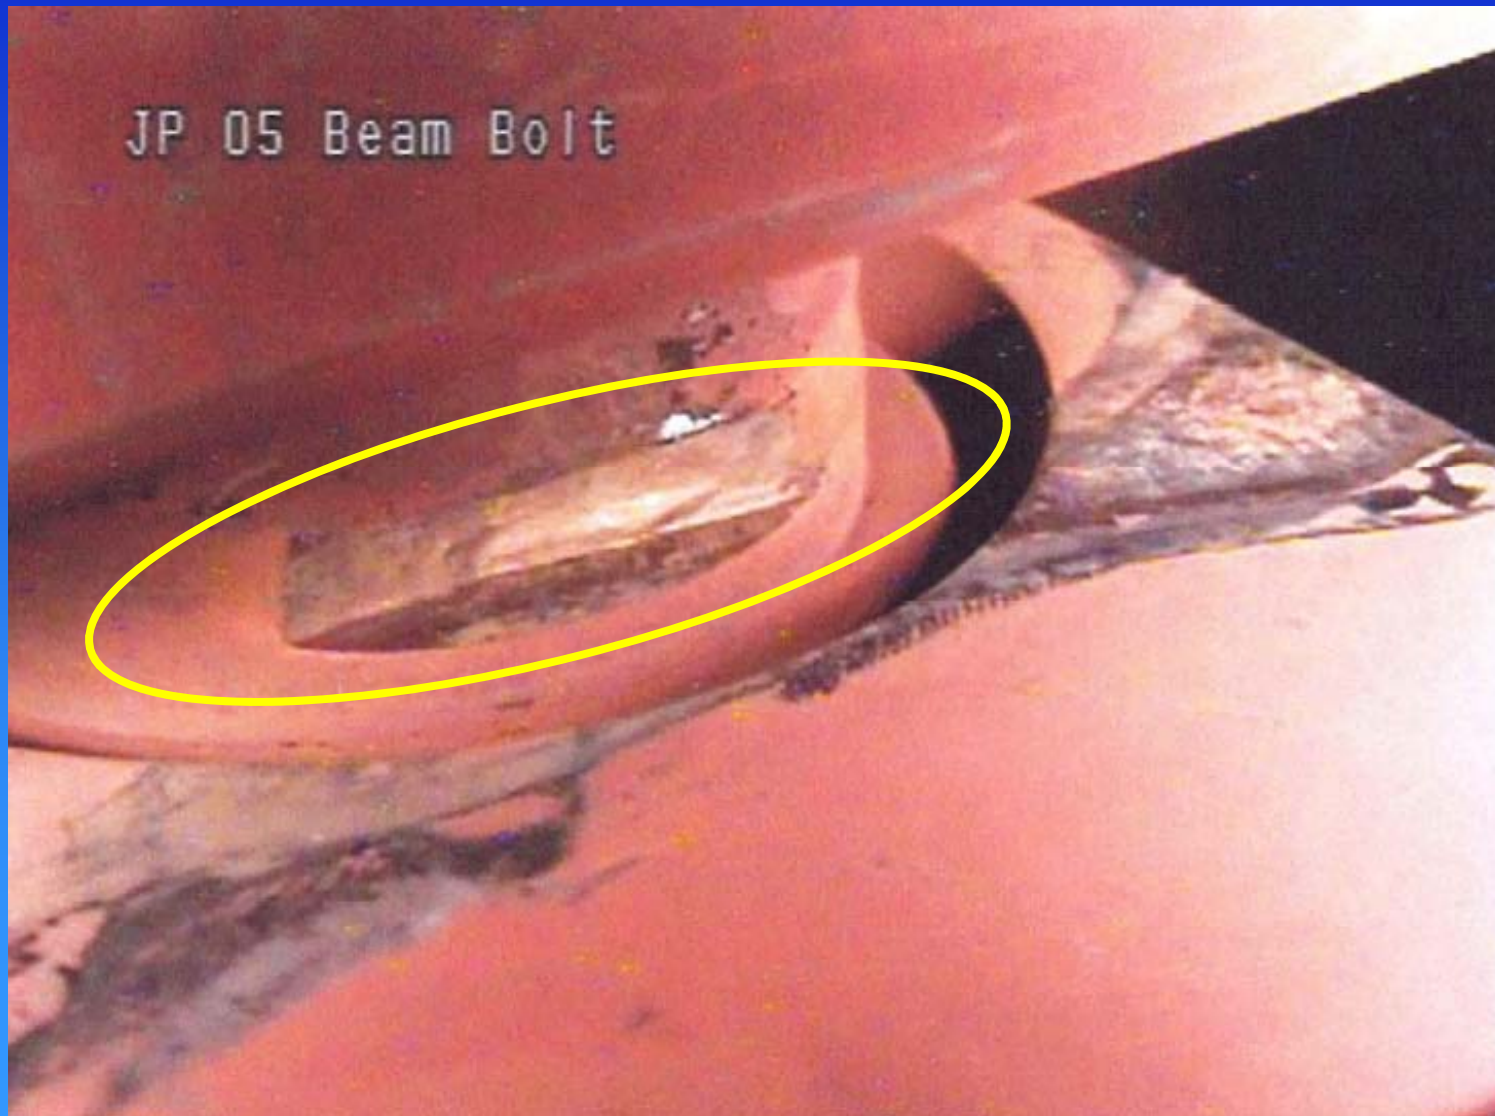
Jet Pump Beam Type 316L SS Bolt Fretting Corrosion

- Spring 2011 - JP retainer plate loose under one jet pump beam
- Plate used for beam alignment during installation, otherwise provides no other function
- Retainer bolt pulled out during beam replacement in 1994 and then worked its way out
- Retainer and retainer bolt were removed and upon inspection noted notching on the hold down beam bolt due to fretting corrosion

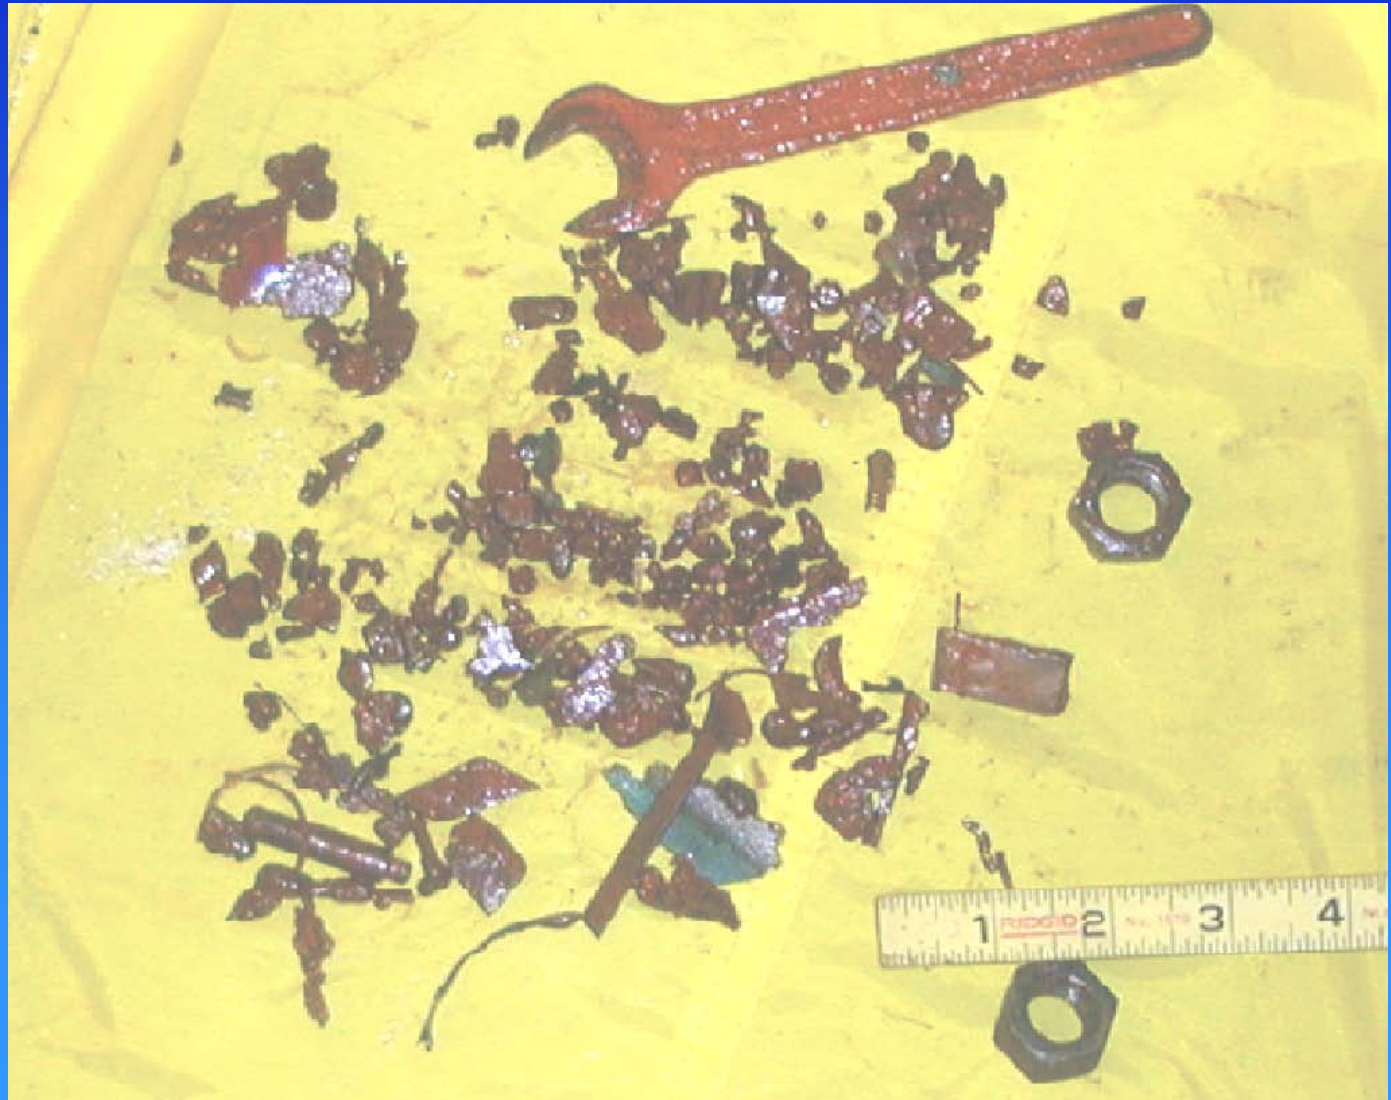
Feedwater Heater Debris

Debris found
in a feedwater
heater where
a fretting fuel
failure
occurred
