Crystal River Unit #3 Containment Delamination Investigation & Repair

March 9, 2010
Garry Miller

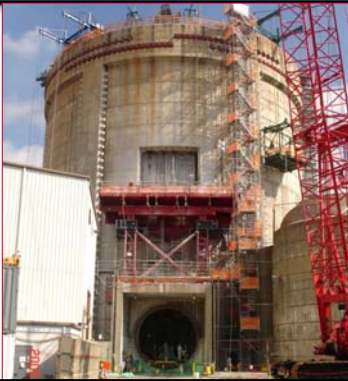
Steam Generator Replacement (SGR) Opening
(between Buttresses 3 and 4)

SGR Opening Dimensions
@ Liner
23' 6" x 24' 9"
@ Concrete Opening
25' 0" x 27' 0"

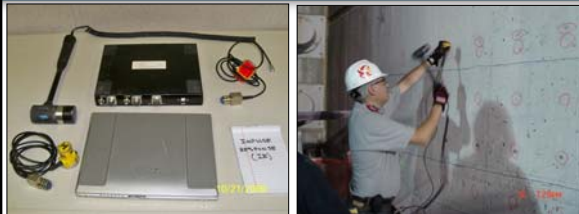
Condition Assessment Techniques Impulse Response (IR)

IR Equipment

- Primary test method used in this evaluation

IR Performed in the Field

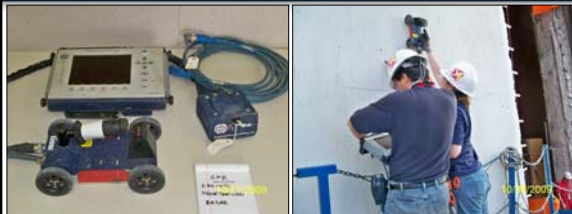
Condition Assessment Techniques Ground Penetrating Radar (GPR)

Ground Penetrating Radar (GPR) Equipment

- Locates internal features (rebar, tendon conduits, etc.)

GPR Performed in the Field
