Three Mile Island, Unit 1 Summary of Tube-to-Tube Wear

RIC 2013
Steam Generator Operating
Experience

Rick Libra, Site Vice President,
Three Mile Island Unit 1, Exelon
Corporation

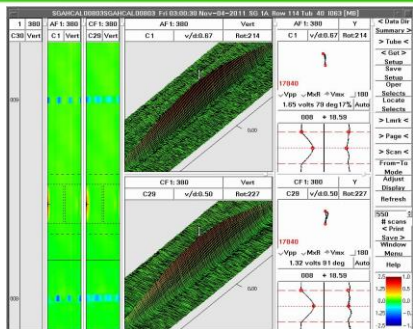
Example TMI-1 T-T Wear X-Probe Data

- ✓ Performed X-Probe and +Point on ADI signals
 - Verified indications in adjacent tubes face each other
 - Symmetrically tapered to maximum depth in center
 - In adjacent tubes the indications are at same elevation and are same length/depth
 - Length and depth have a correlation that is consistent with wear
 - Good correlation of phase angles and voltages between channels

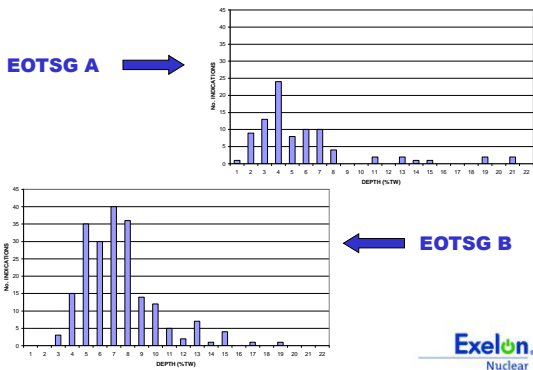
T-T Wear Depth Distribution

- ✓ A total of 257 tubes were identified with T-T wear
 - EOTSG A: 89 indications in 74 tubes
 - EOTSG B: 206 indications in 183 tubes
- ✓ Wear depths range from 1% to 21% through wall (TW)
- ✓ Wear axial lengths range from 2" to 8"
- ✓ No proximity or tube contact detected
 - Tubes are in tension at cold conditions and in compression at hot conditions
- ✓ All tubes met condition monitoring limits and in-situ pressure testing was not required
