*Root Cause Analysis of the
Reactor Pressure Vessel Head Degradation at
the Davis-Besse Nuclear Power Station*

May 7, 2002

Root Cause Summary

Inadequate inspection of the RPV closure head prevented early detection of nozzle leakage, resulting in prolonged boric acid corrosion and significant degradation.

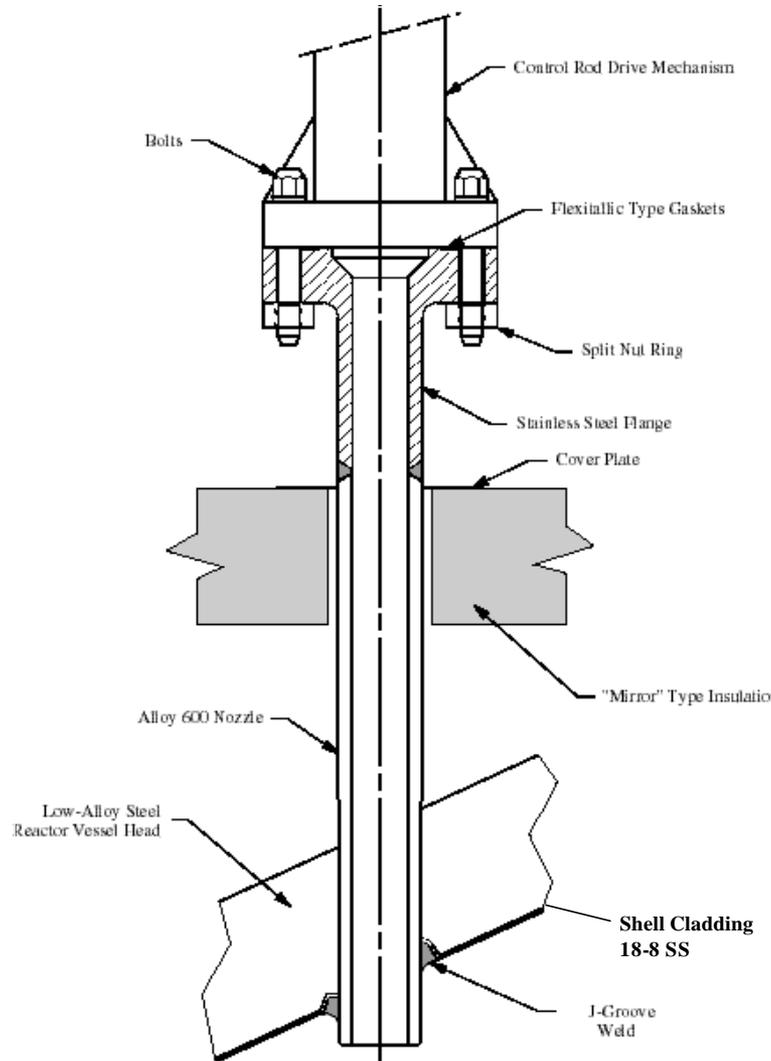
Typical Control Rod Drive Nozzle (Babcock & Wilcox)

- Cracked CRD nozzles are Alloy 600 material with Alloy 82/182 J-groove welds
- Heat treatment of nozzles met code requirements (1600-1700 °F vs >1850 °F)
- Nozzles 1 through 5 are from heat M3935
- Heat M3935 has experienced more leaks in B&W plants than other heats
- High residual tensile stress present adjacent to J-groove weld
- Higher operating temperature (605°F vs 601°F)
- No counterbore on nozzle penetrations
- Interference fit between nozzle and vessel by design

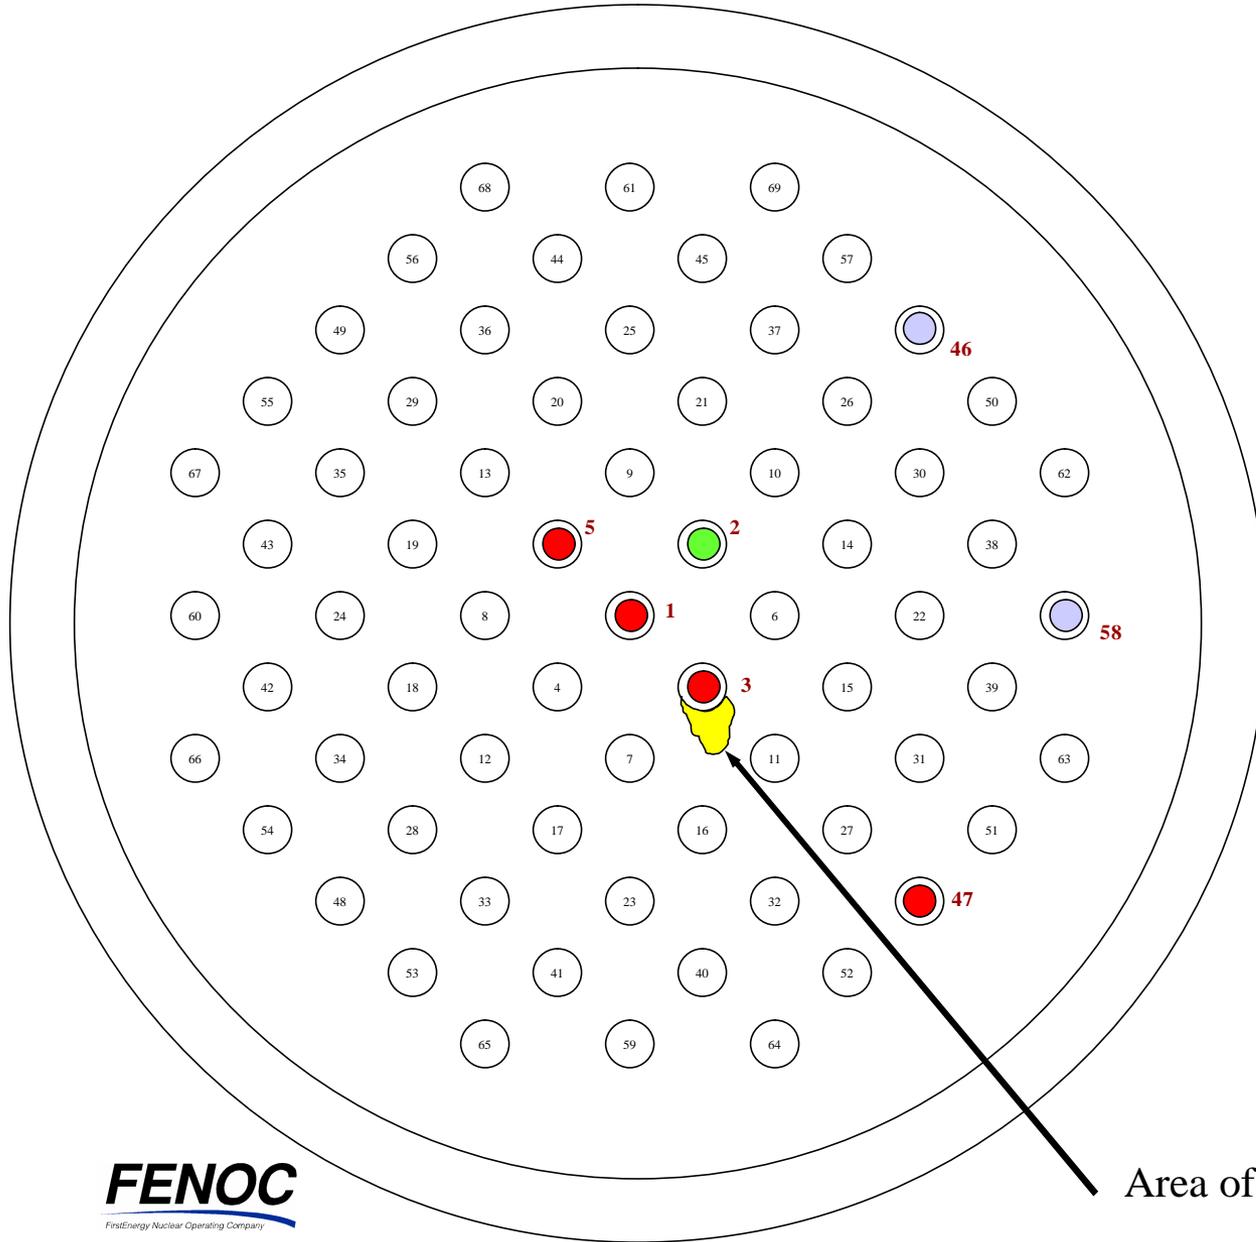
Facts of Discovery

Nozzle with Axial Indication - ●

Nozzle with Axial and Circumferential Indication - ●

No flaw indication - ●

<u>Nozzle #</u>	<u>Summary of Results</u>
1*	9 Axial Flaws, 2 through-wall (TW)
2*	8 Axial Flaws, 1 Circumferential Flaw, 6 TW
3*	4 Axial Flaws, 2 TW
5*	1 Axial Flaw
46	No Flaw Indication
47	1 Axial Flaw
58	No Recordable Indications

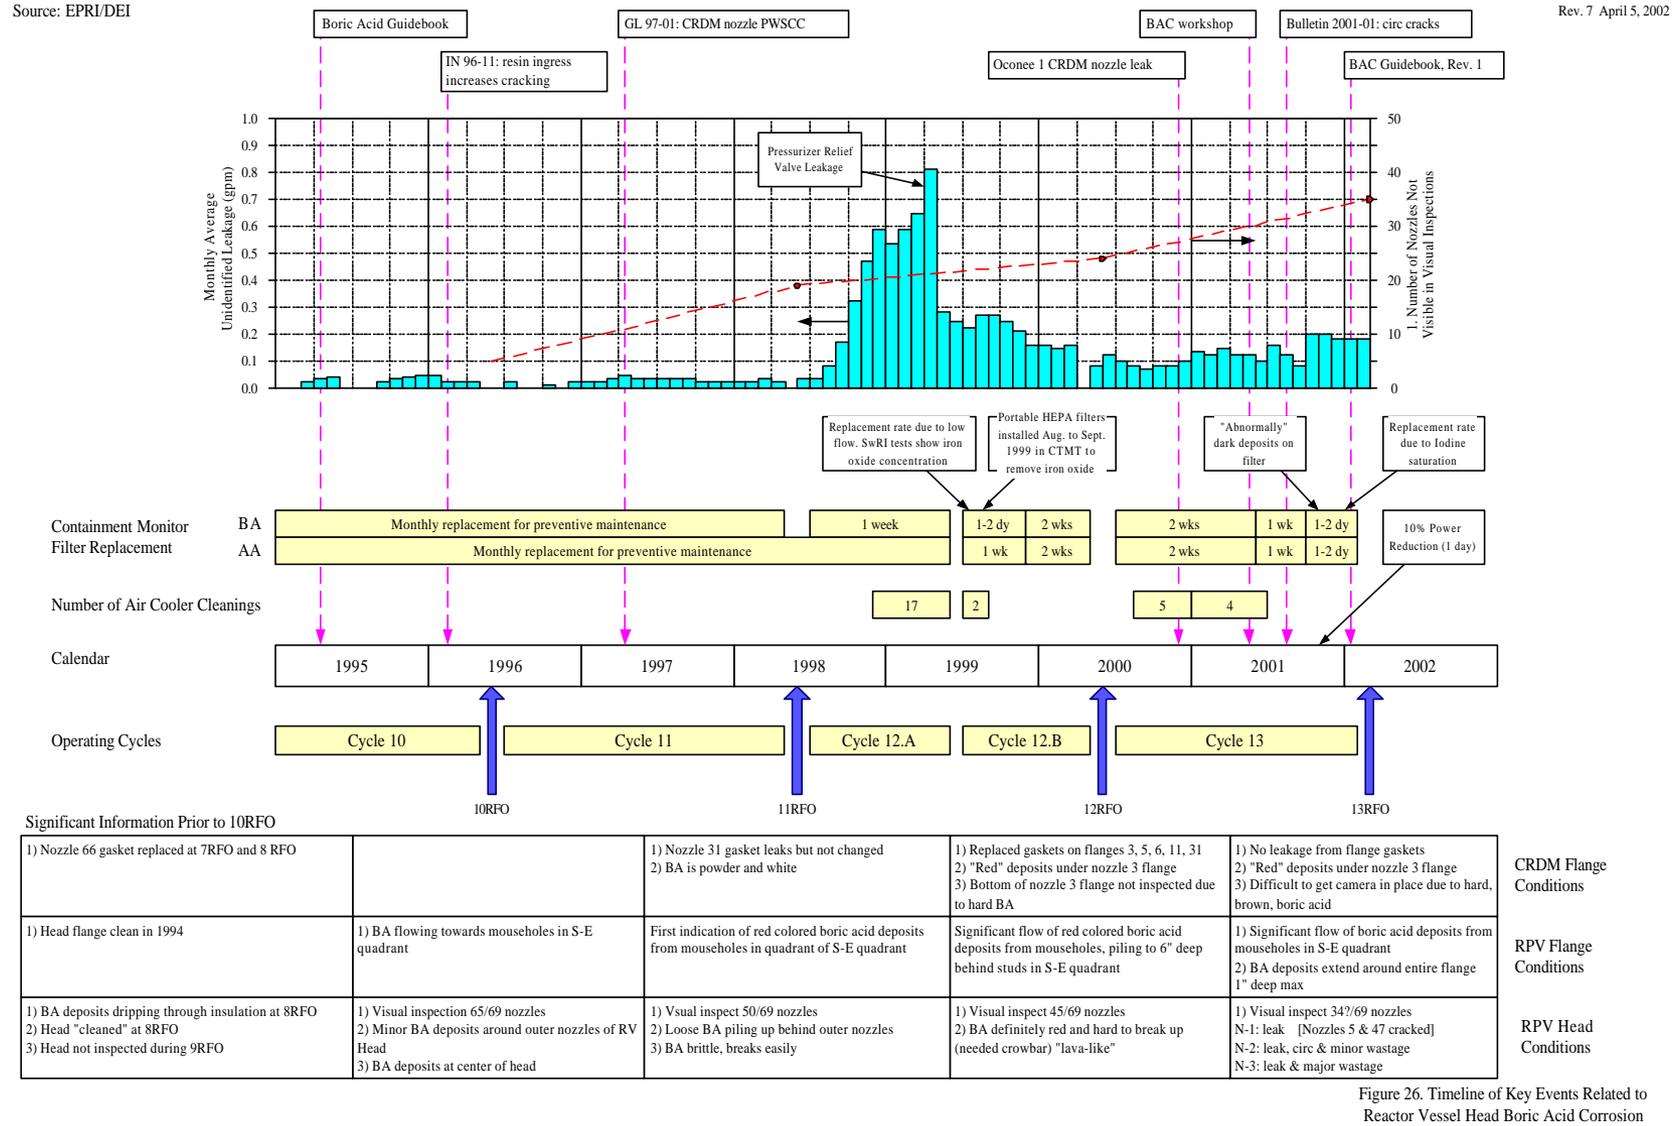
Figure 26. Timeline of Key Events Related to Reactor Vessel Head Boric Acid Corrosion

Timeline of Key Events

- 1990 (+/- 3yrs) Nozzle 3 cracking initiated
- 1994-1996 Nozzle 3 cracking propagates through-wall
- 1998 and 2000 Nozzle leak not identified
- 2002 Corrosion discovered at nozzle 3, minor degradation at nozzle 2

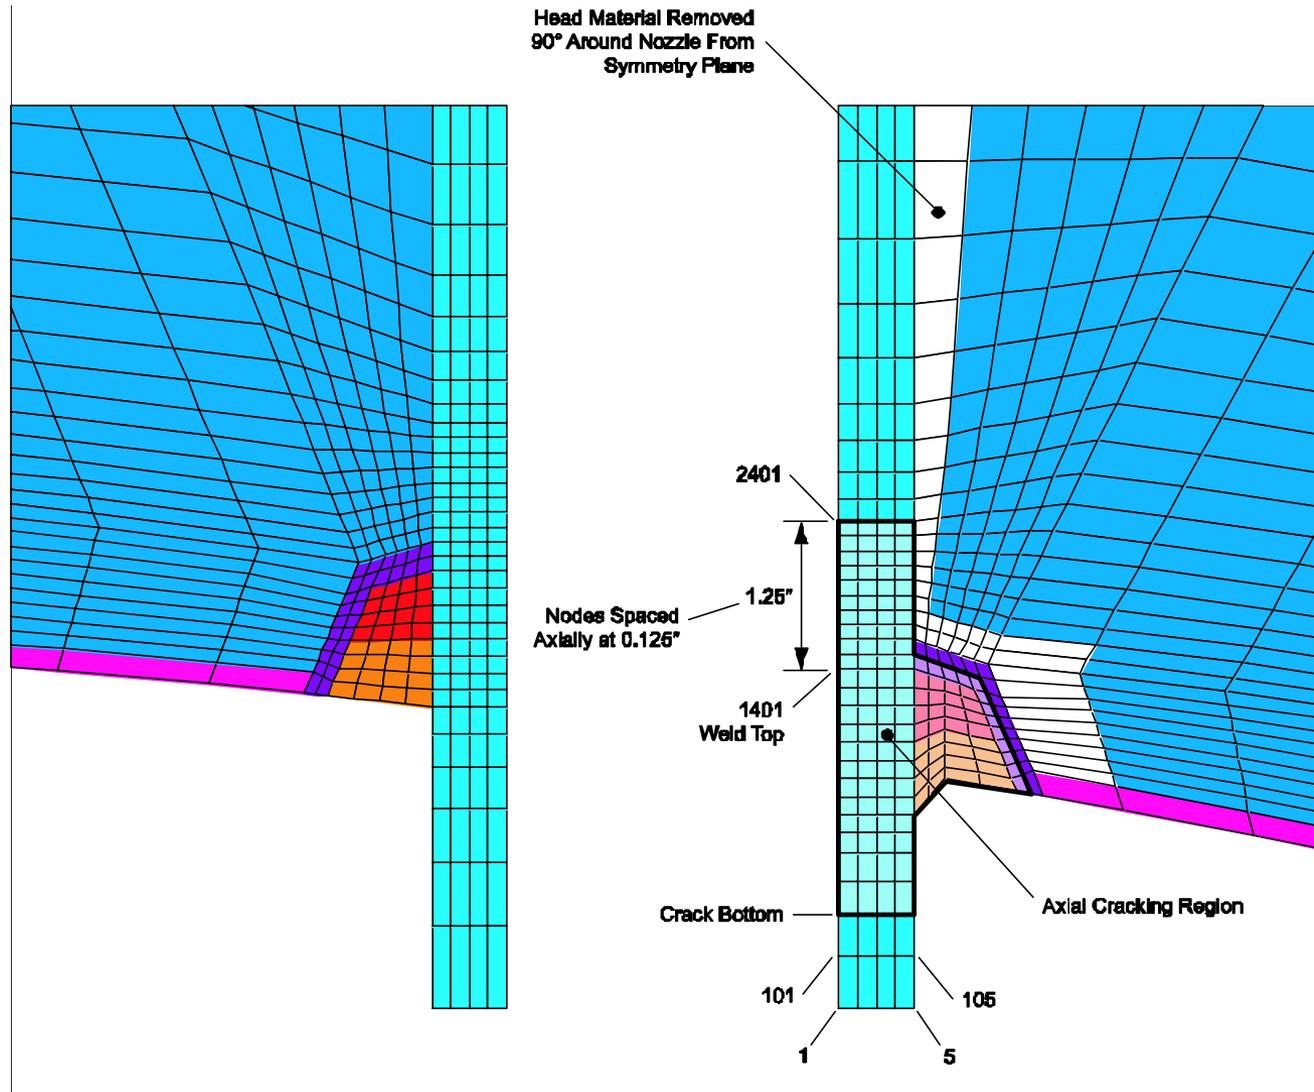
Nozzle 3 Crack Finite Element Model

- Davis-Besse axial cracks above weld were longer than reported from other plants (1.1 inches for nozzle 2 and 1.2 inches for nozzle 3)
- Analytical leakage predictions yield wide range of results (.025 to >1 gpm) depending on method and assumed geometry used
- Estimated leak rate based on boric acid deposits and unidentified leakage are in the range of 0.04 to 0.2 gpm

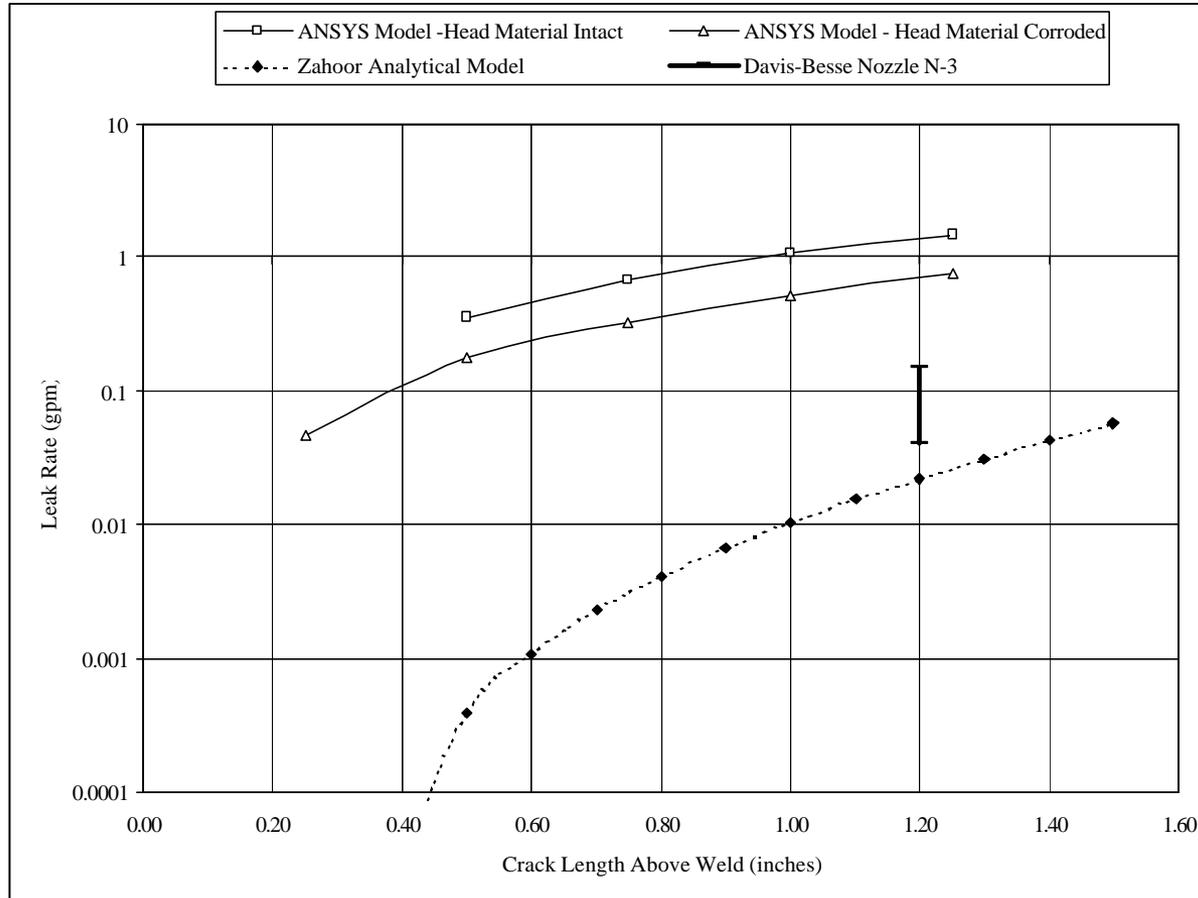
Analytically Predicted Leak Rates

Leak Rate versus Crack Length

Estimated leakage rate from nozzle 3 crack is consistent with analytical predictions
