7.0 REVISED LOCAL PENETRATION POSTTEST MODEL ANALYSES

7.1 Overview of Pretest Local Models

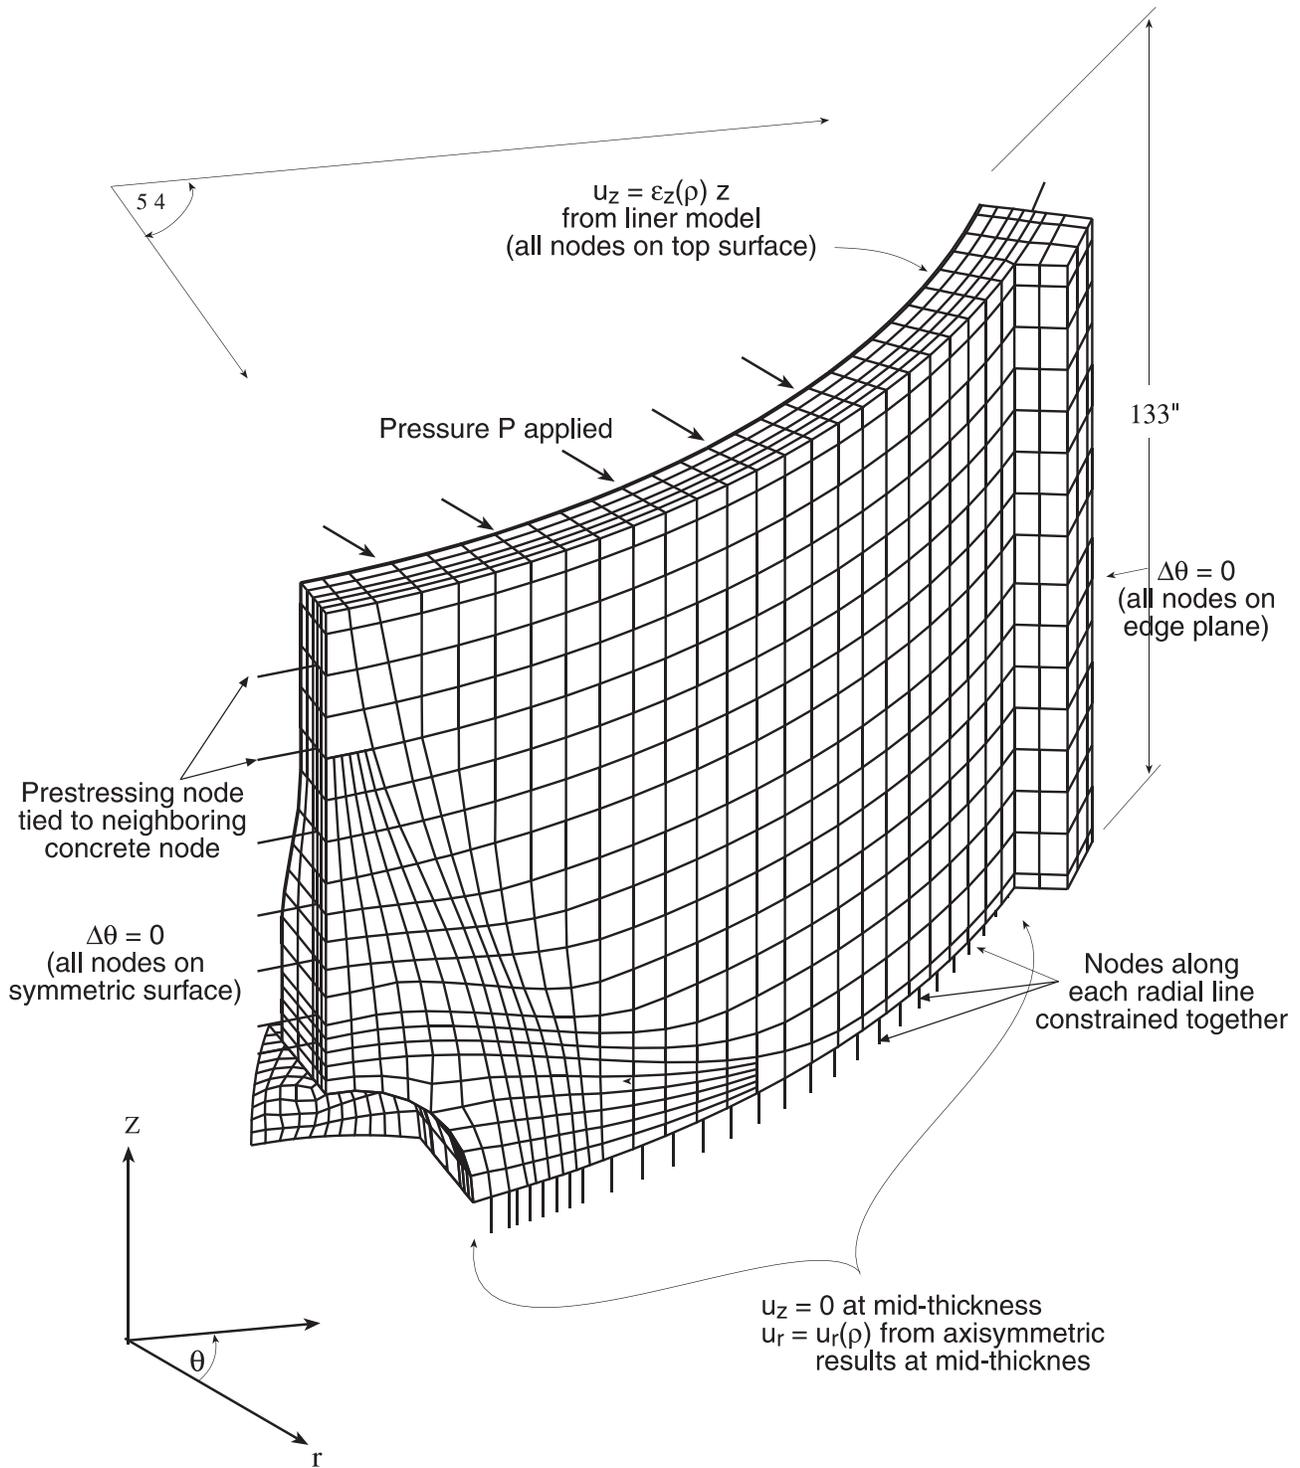
Figure 7-1. Boundary Conditions and Geometry for 3D E/H Model Used in Pretest Analysis [1]

The concrete and liner model for the pretest analysis E/H study is illustrated in Figure 7-1. The grid was developed by generating a concrete mesh based on the tendon layout and then joining the embedded edges of the T-anchor webs to the concrete mesh with the ABAQUS *SURFACE attachment command. The upper quadrant around the hatch was selected for modeling in order to have a local model completely encompassed by the 3DCM model. Five layers of concrete elements through the wall thickness were used, and the liner was modeled with shell elements so that liner bending and membrane behavior could be studied. The method of connecting the liner to the concrete (shown in Figure 7-2) was an important assumption, one that has been studied in the posttest analyses. In the pretest analysis, the liner had no bond or friction with the concrete, other than tying the T-anchor webs to the concrete. Rebar in the concrete wall was modeled with rebar subelements, and tendons were modeled explicitly with truss elements and friction truss-tie elements, as previously described.

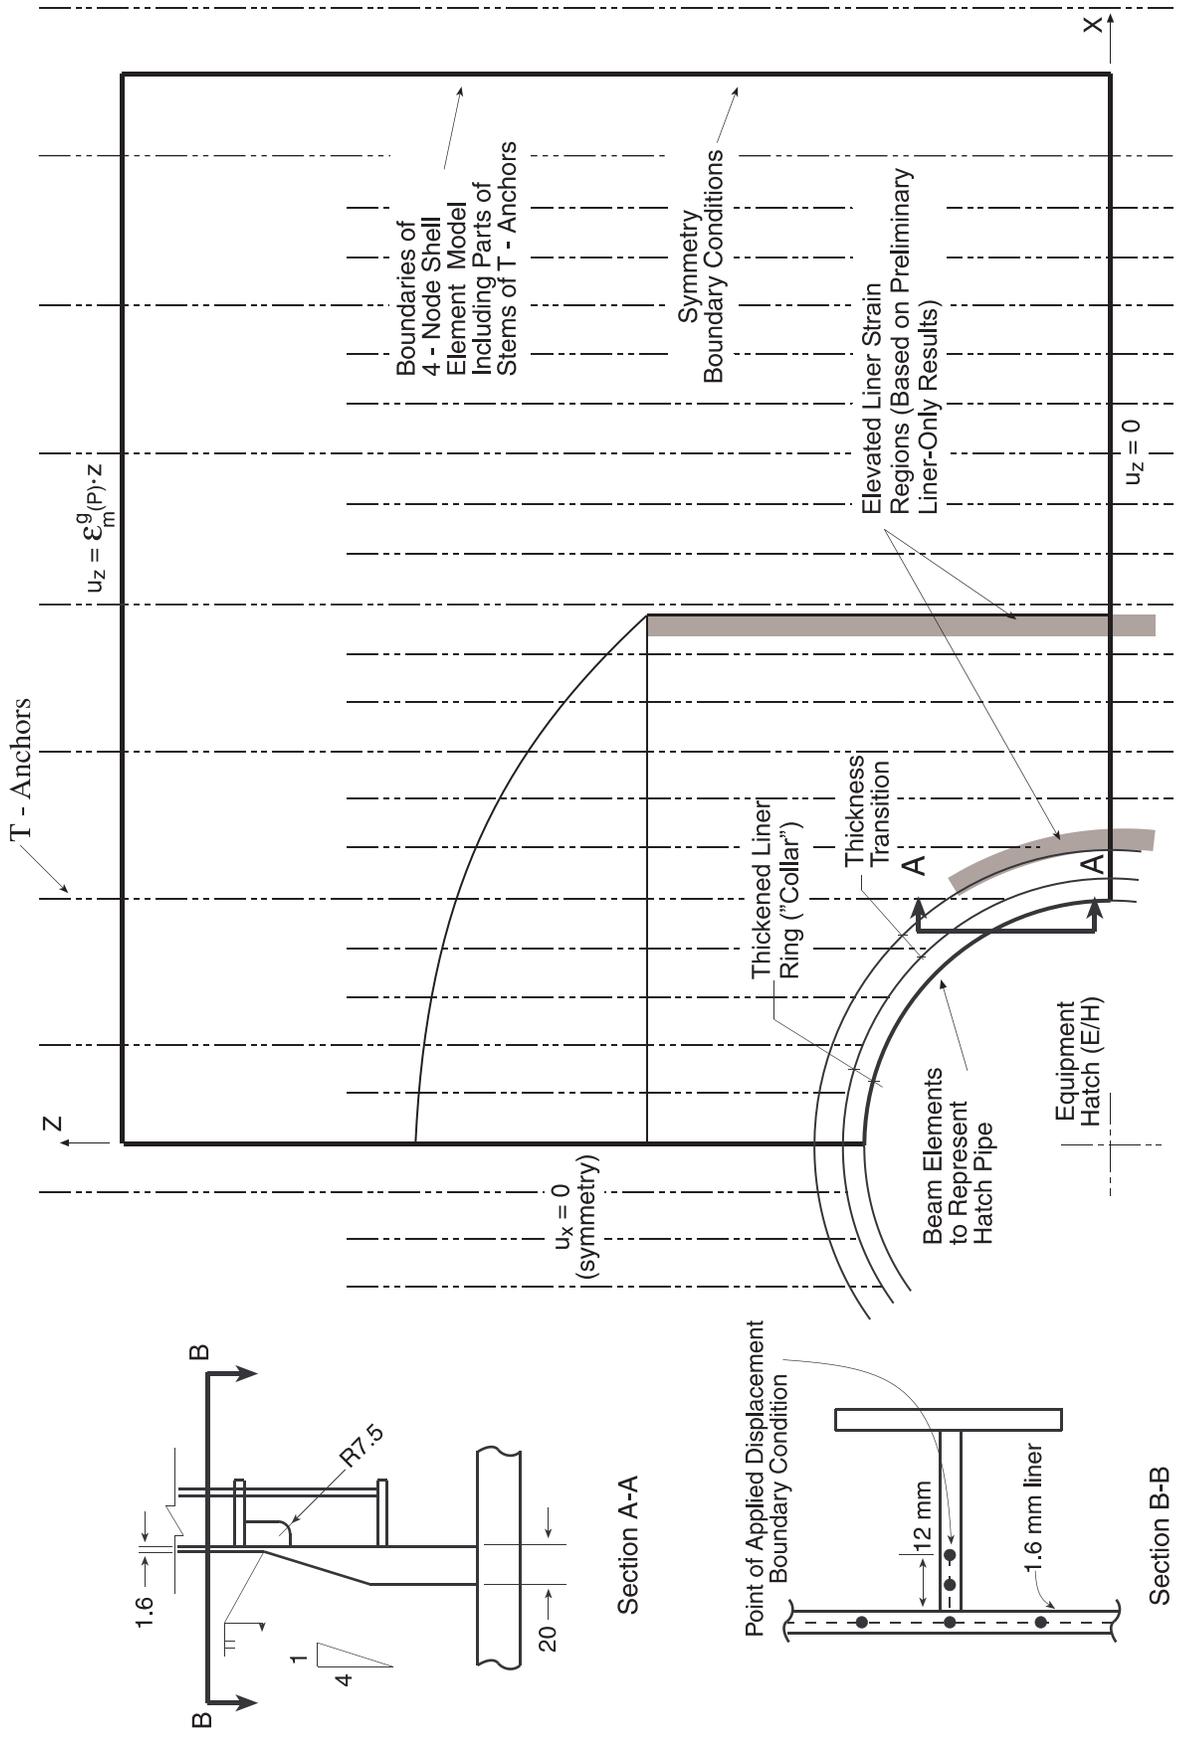
View Looking Radially Out from Center of Cylinder
 Figure 7-2. Additional Details of Prestress E/H Model (View from Inside PCCV Looking Out Radially)

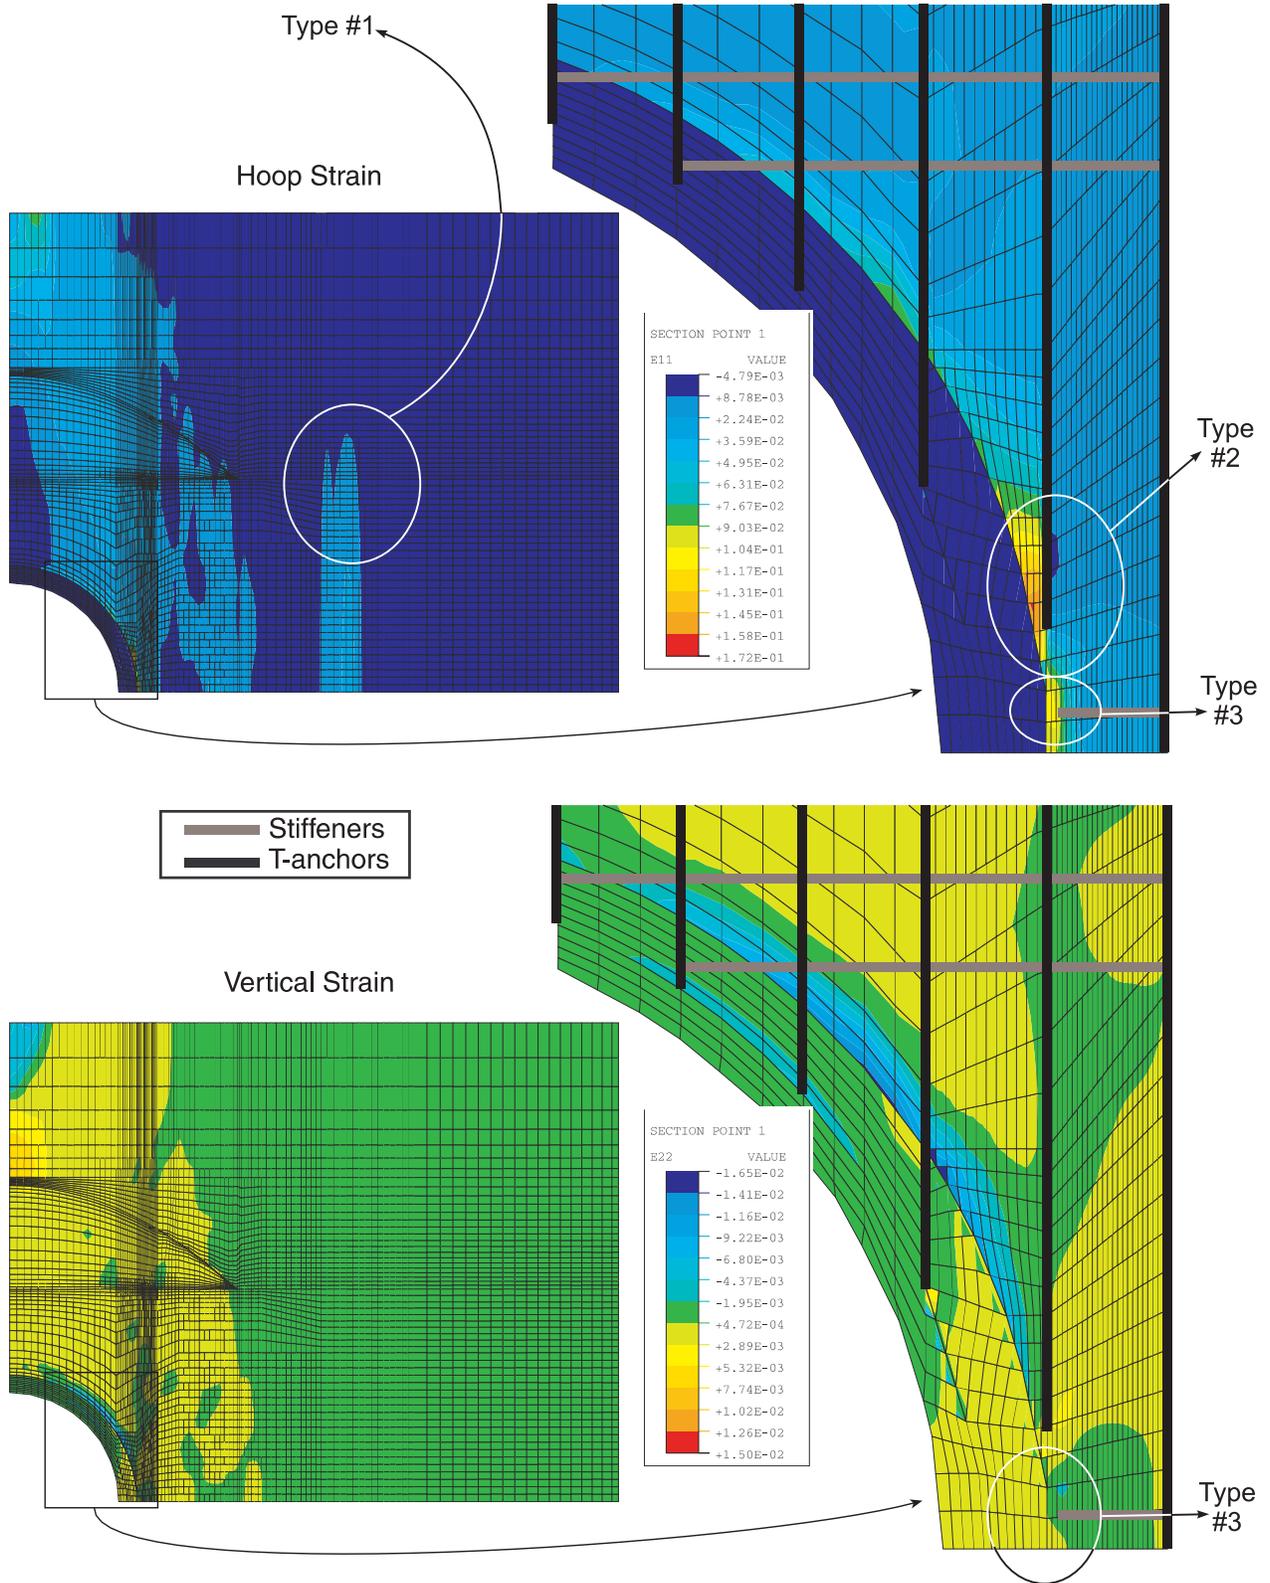
Figure 7-3. Liner Contour Strain Plots at P = 3.2 Pd for E/H from Pretest Analysis [1]

The local E/H analyses results were reported as a function of pressure, and adjusted so the average hoop strains at the boundary matched the average hoop strains in the 3DCM model at the same location and pressure. Pretest E/H analysis revealed elevated liner strains 1) near hoop stiffeners that terminate near the 3:00 position of the edge of the insert plate, as indicated in Figure 7-3; 2) locally near the termination of vertical stiffeners; and 3) at the juncture to the wall embossment. Strains near the vertical stiffener exceed 16% at 3.2 Pd, which became the most probable failure pressure and failure location predicted for the PCCV model.

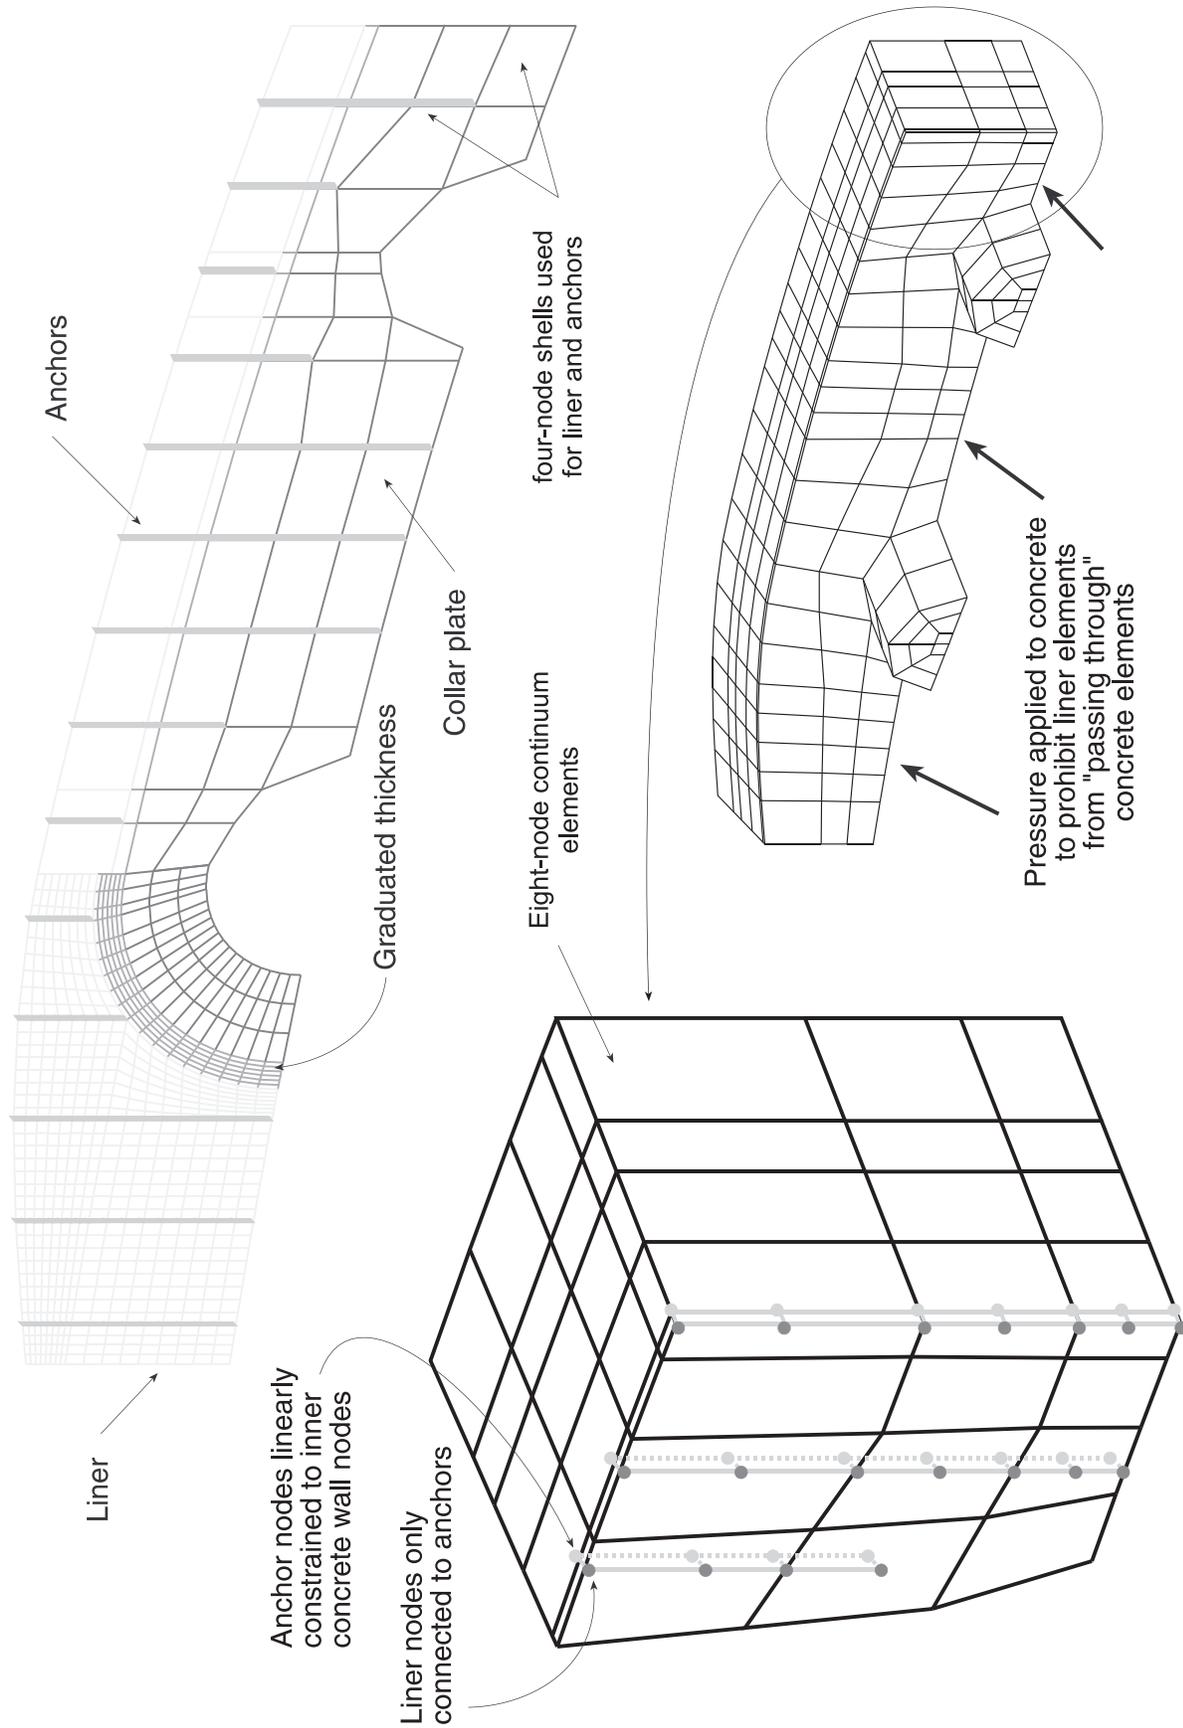
Figure 7-4. M/S Local Model Liner Details from Pretest Analysis

The M/S is the third-largest penetration group, consisting of a group of four penetrations located at the 180 degree azimuth. (The F/W penetration group is similar to M/S penetration in geometry. However, since it is at a lower elevation at the same azimuth as the M/S, and was therefore assumed to see lower near-field strains, it was not explicitly modeled. The results of the M/S analysis should be applicable to the F/W penetration as well, however.) As with the E/H, there are liner connection and anchorage details near the M/S that cause strain concentrations, making the region near the M/S another candidate for liner tearing failure. The local M/S 3D model is illustrated in Figure 7-4. The modeling details for the local M/S model are similar to those developed for the E/H model. The liner-anchor interaction (shear force deflection behavior of the anchors) is modeled identically to the E/H, as is the method of attaching the liner/anchor mesh to the concrete mesh.

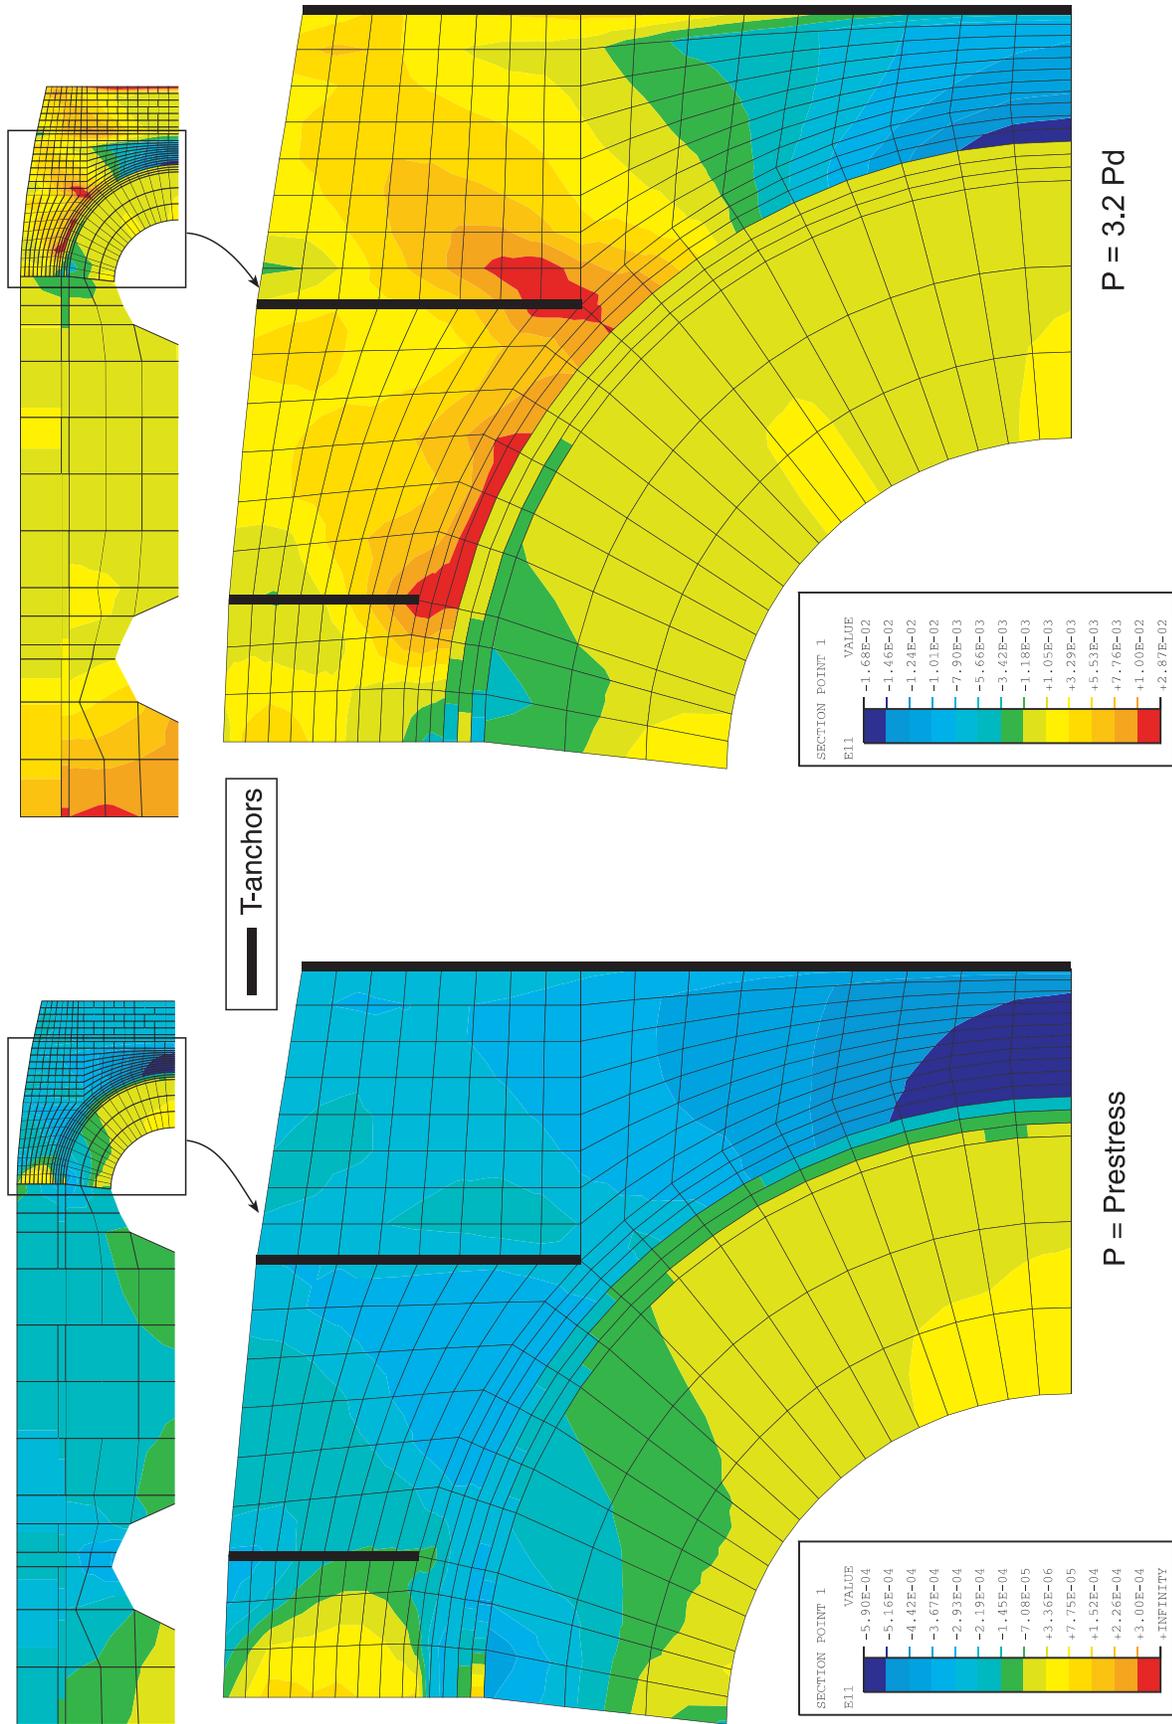
Figure 7-5. Liner Contour Hoop Strain Plots from Prestress M/S Model Analysis

Unlike the E/H and A/L models, which were given symmetry boundary conditions on both vertical boundary planes, the M/S model was directly loaded with displacement versus pressure histories at every node along the boundaries of the model. These pressure histories (different at every node and in all three degrees of freedom) were obtained directly from the 3DCM model. The end result of the average hoop strain correlation approach used for the E/H and A/L is believed to be nearly the same as the direct application of displacements to nodes used in the M/S model. Some liner strain results for the pretest analysis of the M/S are shown in Figure 7-5. The "hot spots" for this region are near the vertical T-anchor terminations and the thickened insert plate surrounding the penetration group. Peak strains at 3.2 Pd are only about 3%, and these were generally lower than those predicted for the E/H.

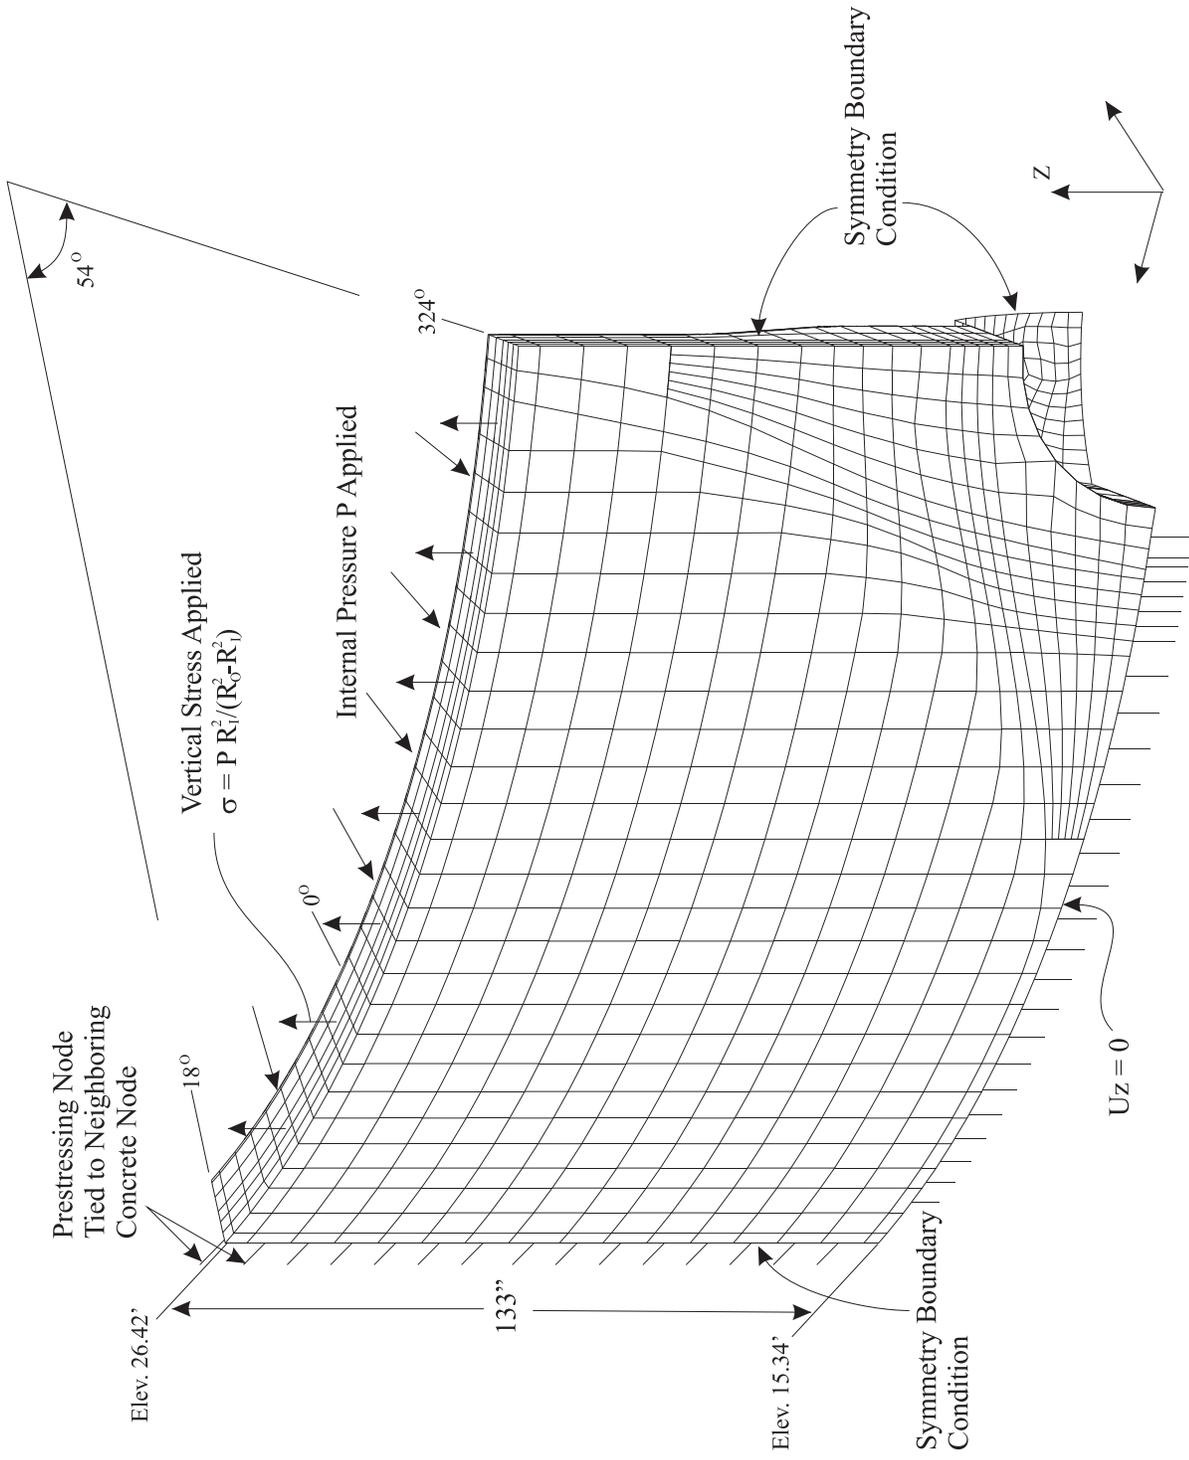
Figure 7-6. Finite Element Mesh and Boundary Conditions for 3D E/H Model

Since the highest measured strains in the E/H region were observed on the side away from the buttress, the E/H model was converted to a 3D concrete and liner model for the upper quadrant around the E/H opening between azimuth 18 degrees and 324 degrees for posttest evaluation. This model was developed and modified from a similar E/H local model with buttress that was used in the pretest analysis. Figure 7-6 illustrates the finite element model and boundary conditions used in the posttest analyses. Unlike the pretest analysis, the radial displacement at the bottom boundary of the model (elev. 15.34 feet) was not specified according to results from axisymmetric analysis and only vertical displacement was applied (fixed) at the boundary. Figures 7-7 and 7-8 plot the rebar, tendon and liner details around the E/H opening.

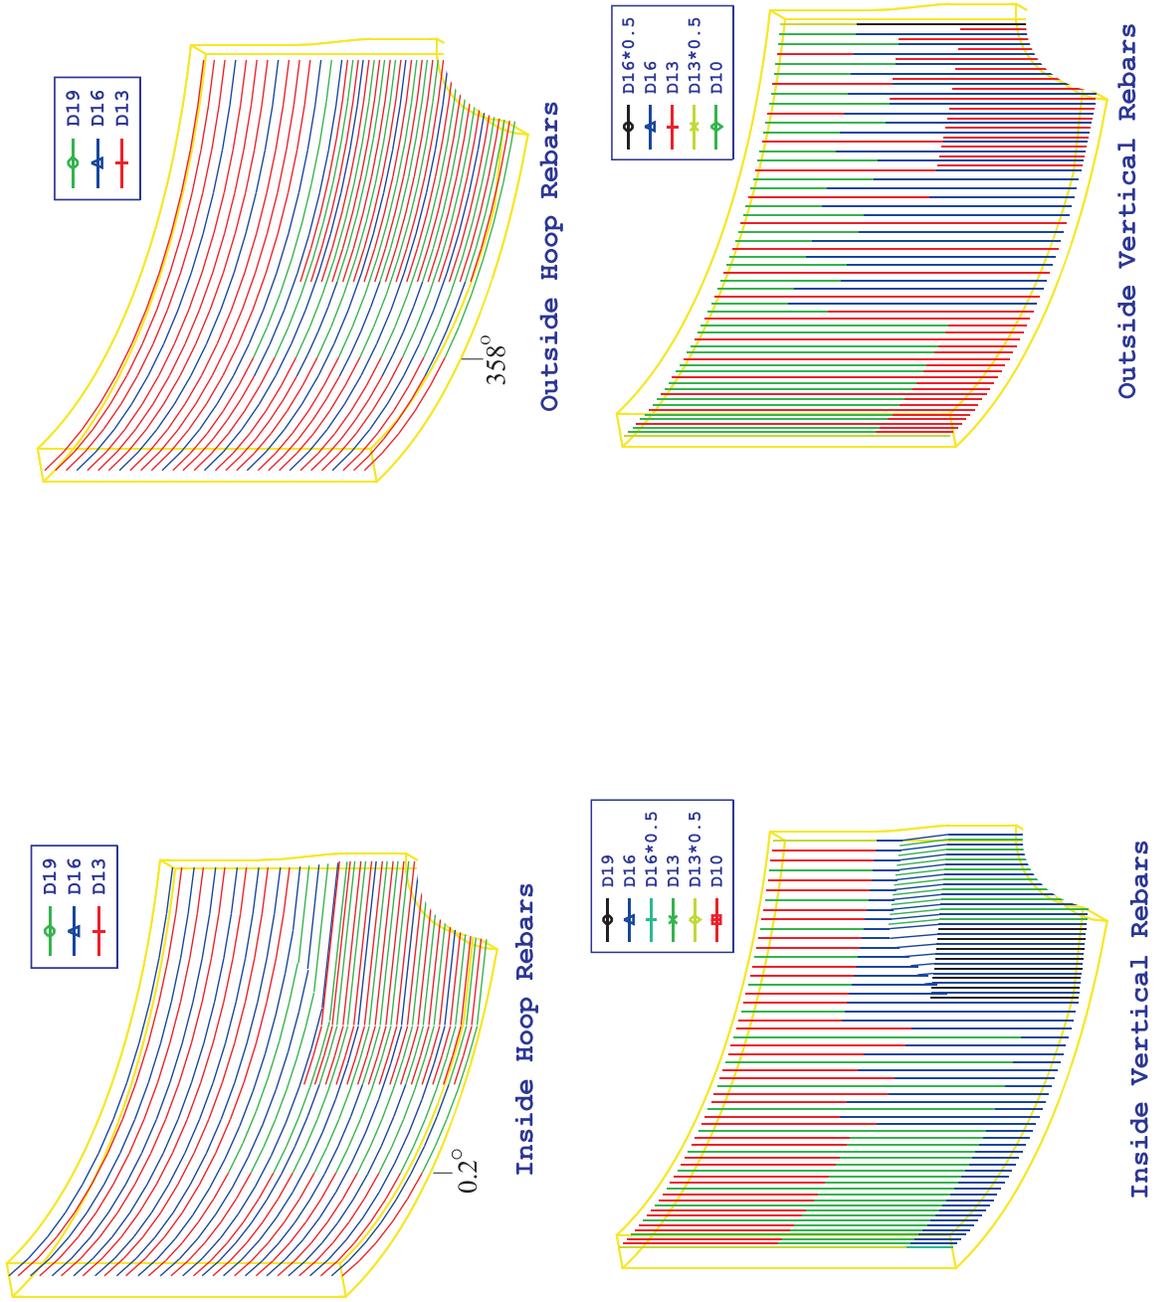
Figure 7-7. Schematic of Hoop and Vertical Rebars in E/H Region

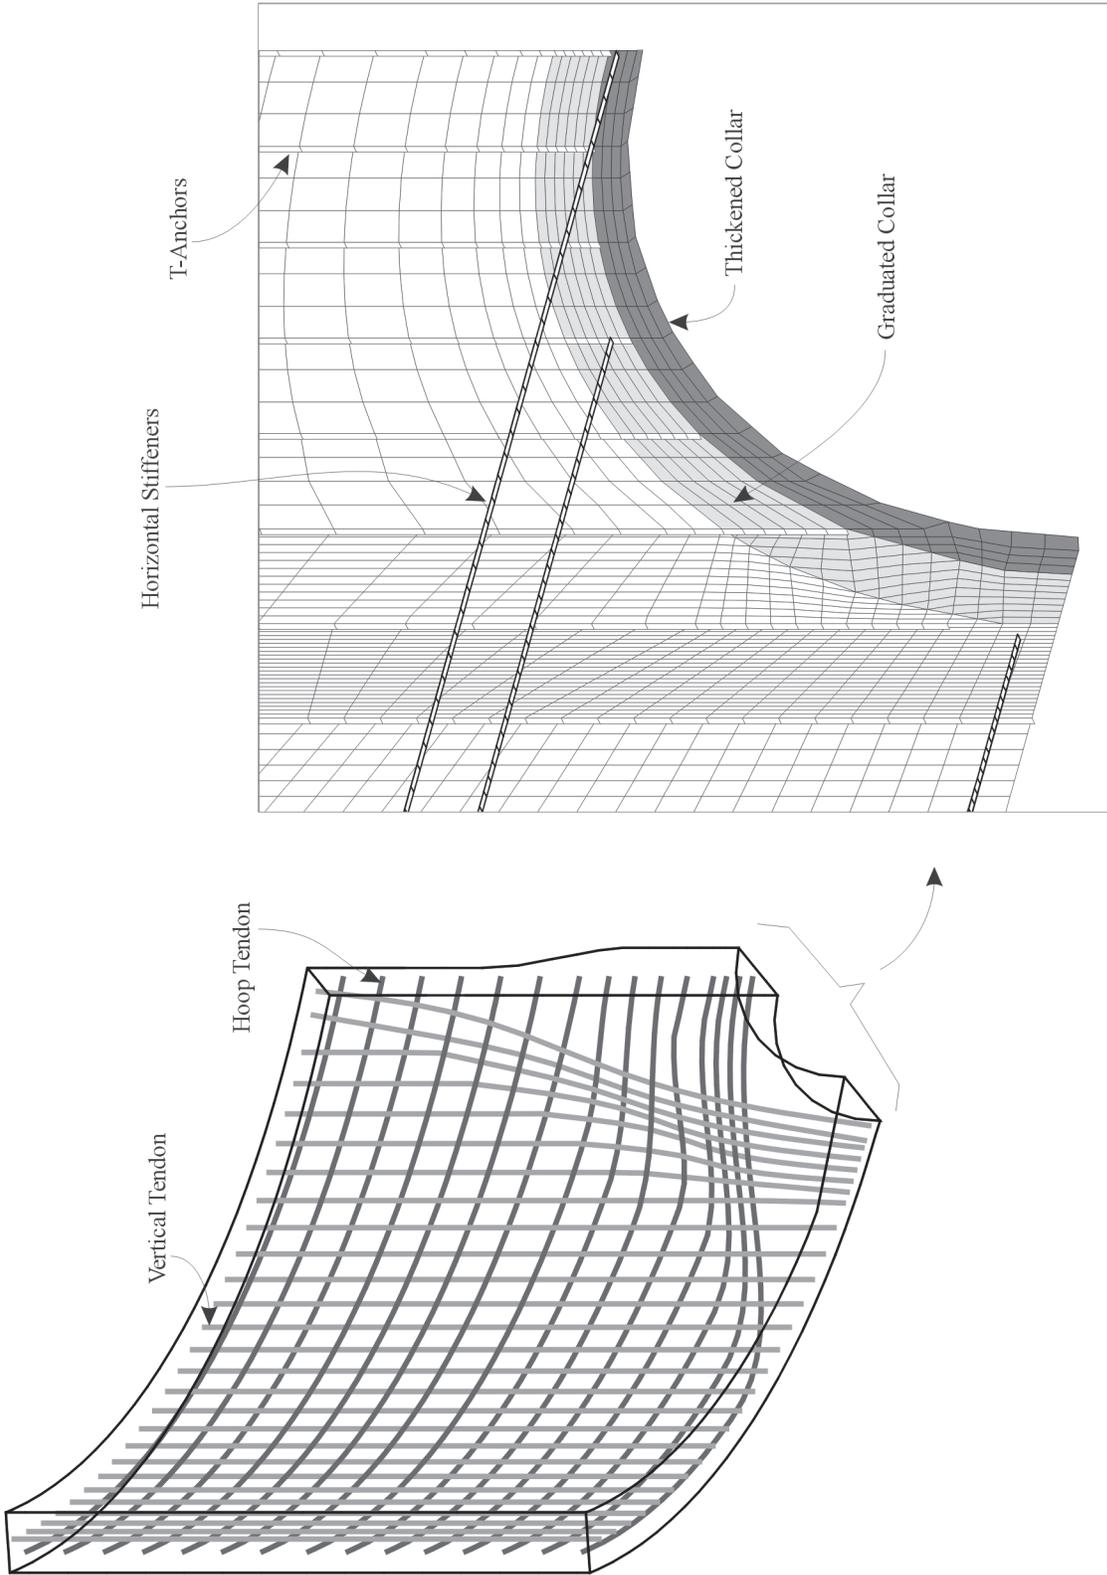
Figure 7-8. E/H Finite Element Model Including Tendons, Liner, Anchors, and Stiffeners

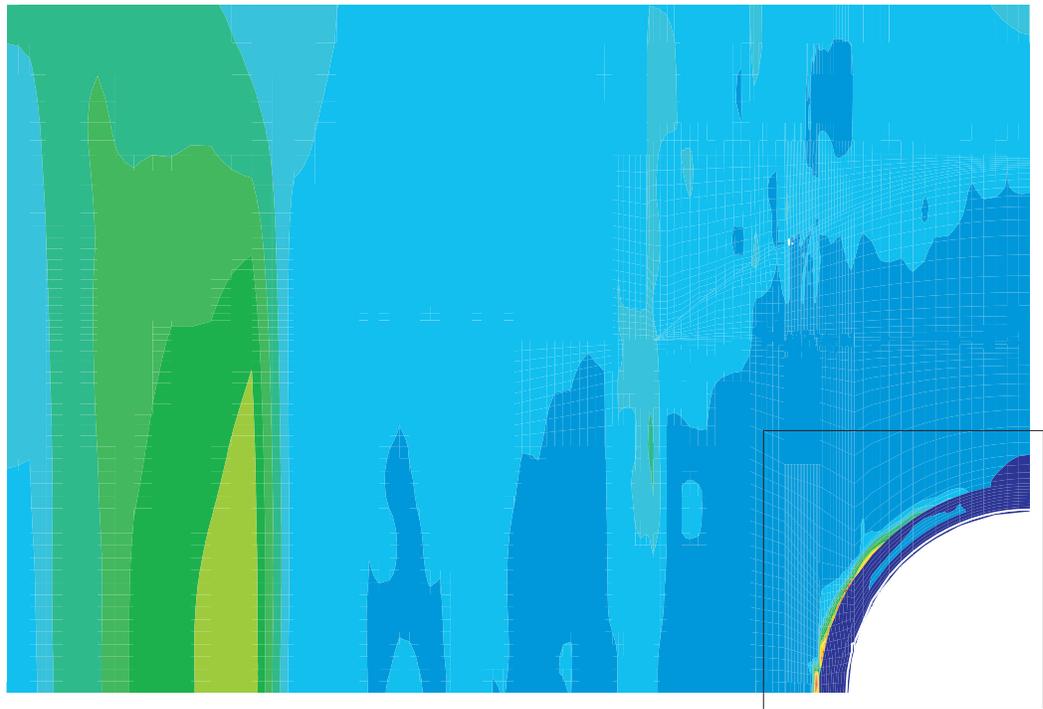
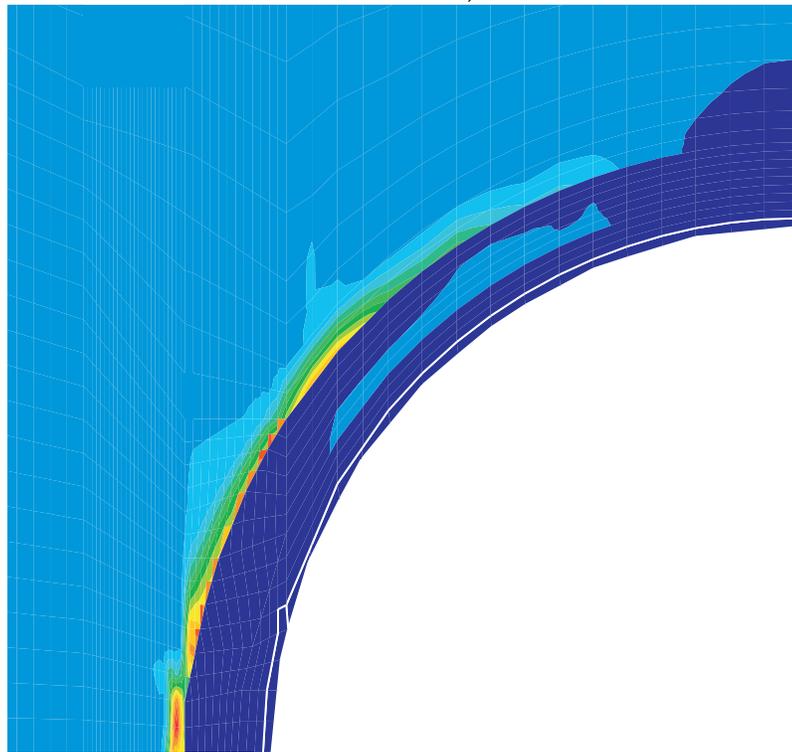
Figure 7-14. Liner Hoop Strains, Posttest Analysis Case A, at 3.0 Pd

Results of the basic E/H posttest model (Model A) are plotted in Figures 7-9 through 7-16. Comparing these plots to those of the pretest analysis report [1] shows a uniform displaced shape and deformation pattern that agrees better with the test. In other words, adjustments to the pressure scale for matching hoop displacements were no longer needed. At pressure beyond 3.5 Pd, liner and tendon strains grew larger and tendons reached strains approaching rupture in the zone between 0 degrees and 6 degrees azimuth. This was caused by a discontinuity in wall reinforcement. (The percentage of hoop reinforcement decreases in this region between the free-field percentage and the extra added around the E/H.) A high strain zone also exists just above the E/H. The liner strains near the E/H collar, though significantly lower than in the pretest analysis, were still elevated and show similarities to the pretest analysis, which, based on the LST strain measurements, is a generally incorrect prediction. The strains near the edge of the embossment are also generally lower than what was measured in the test. The authors have proposed a hypothesis for each of these observations, which were tested by the following variations of posttest analysis shown in Table 7-1.

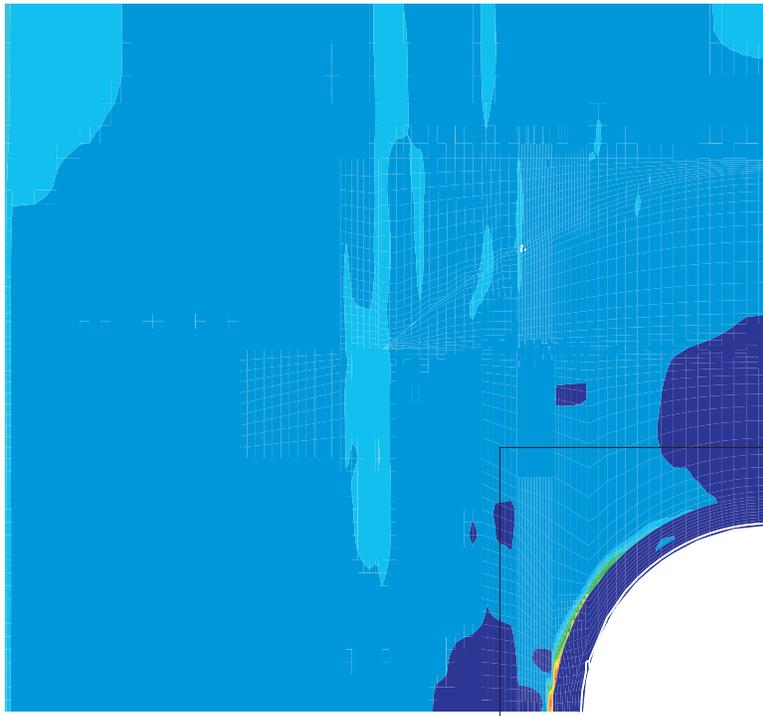
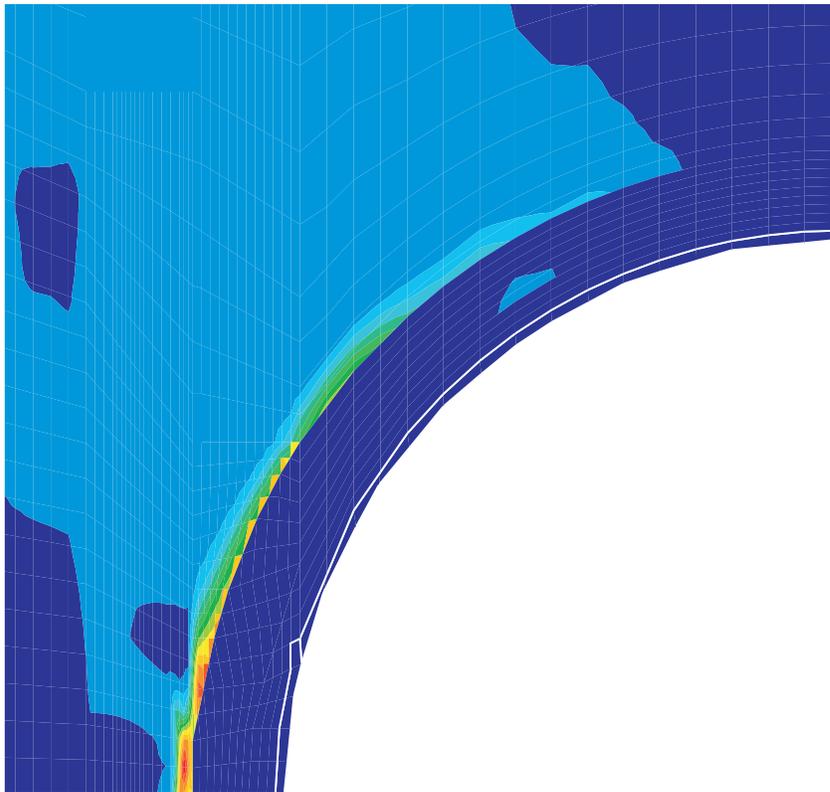
Figure 7-15. Liner Hoop Strains, Posttest Analysis Case A, at 3.2 Pd

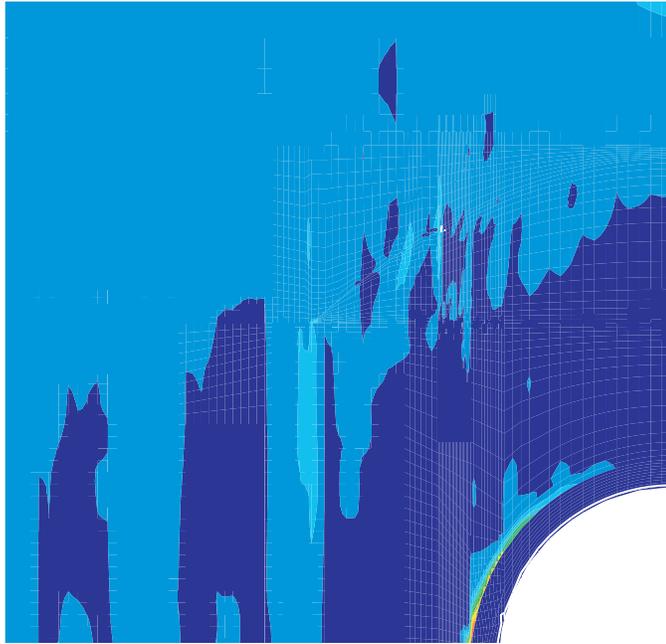
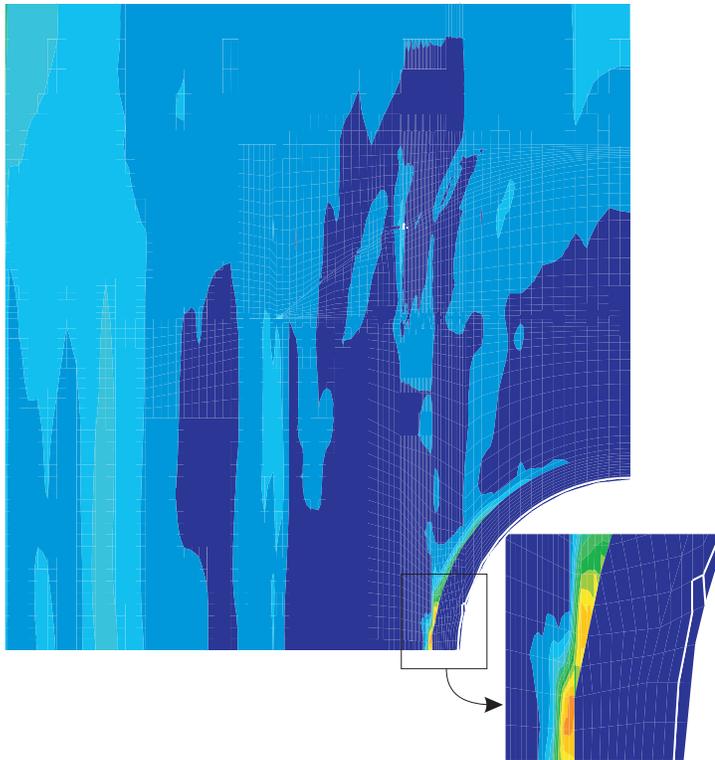
Figure 7-16. Liner Hoop Strains, Posttest Analysis Case A, at 3.5 Pd and 3.6 Pd

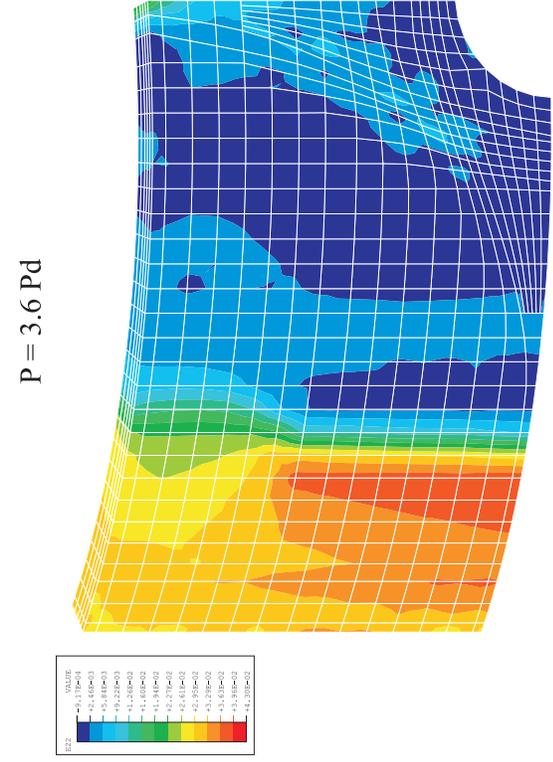
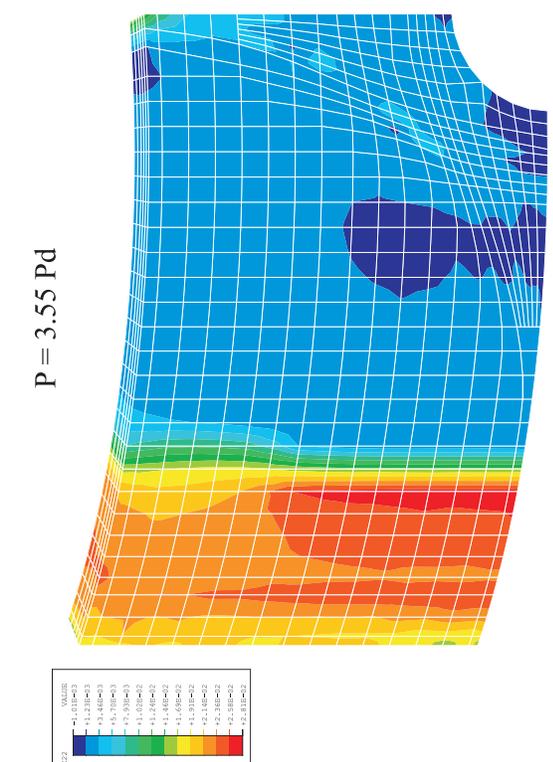
Figure 7-17. Concrete Hoop Strain Contours, Posttest Analysis Case B

The hypotheses are examined in Cases B and C. Case B uses the contact surface sticking/friction capability in ABAQUS. Contact with friction bonding properties were assigned to the liner-concrete interaction surface for Case B. The results of Case B are plotted in Figures 7-17 through 7-22. They show that by preventing relative slip between liner and concrete, the overall behavior of the system (concrete strains, tendon strains, liner strains away from the hatch) remains the same, but the elevated strains close to the collar are completely eliminated.

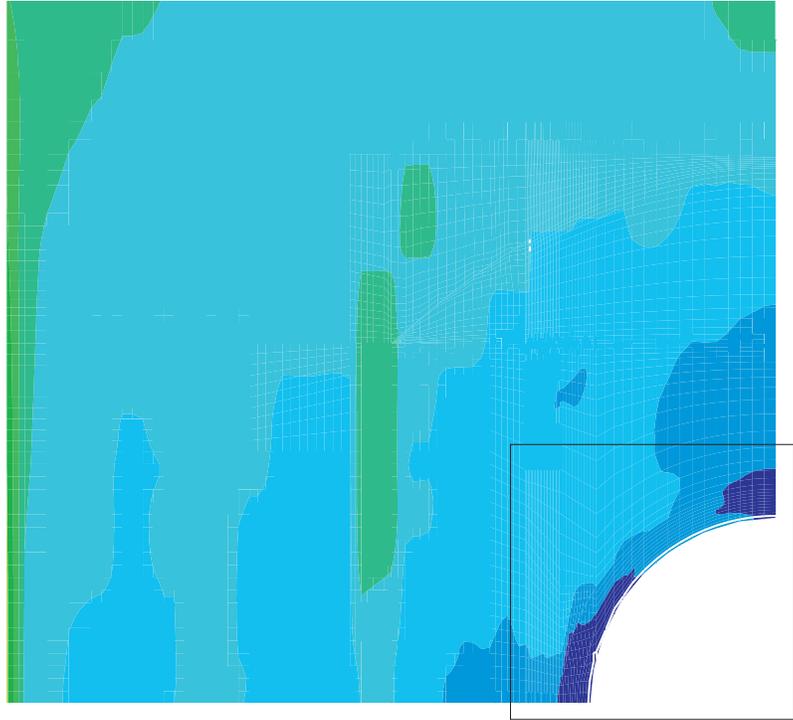
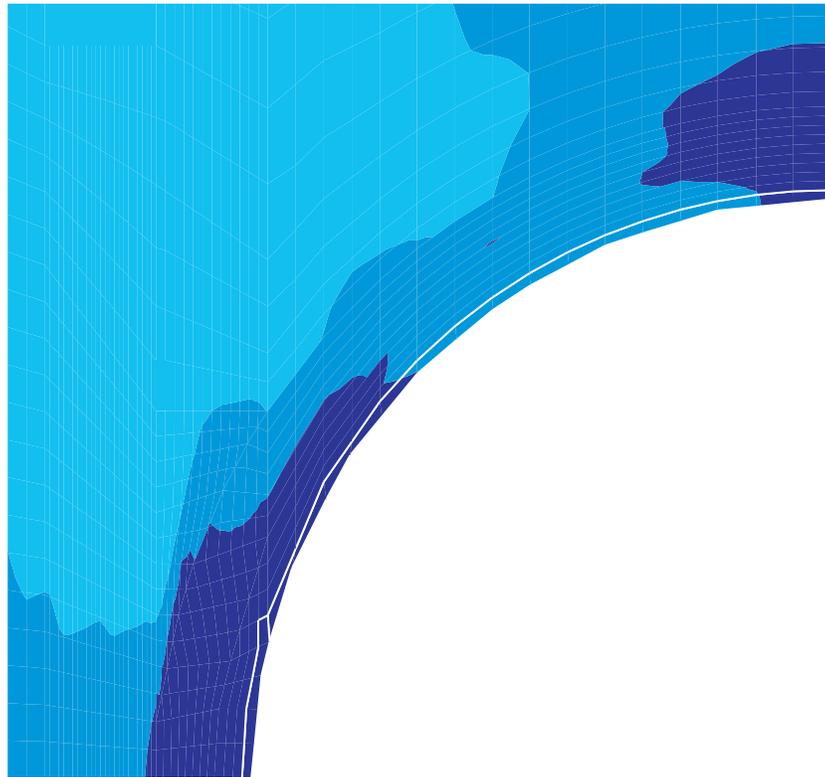
Figure 7-20. Liner Hoop Strains, Posttest Analysis Case B, at 3.0 Pd
