7.0 REVISED LOCAL PENETRATION POSTTEST MODEL ANALYSES

7.1 Overview of Pretest Local Models

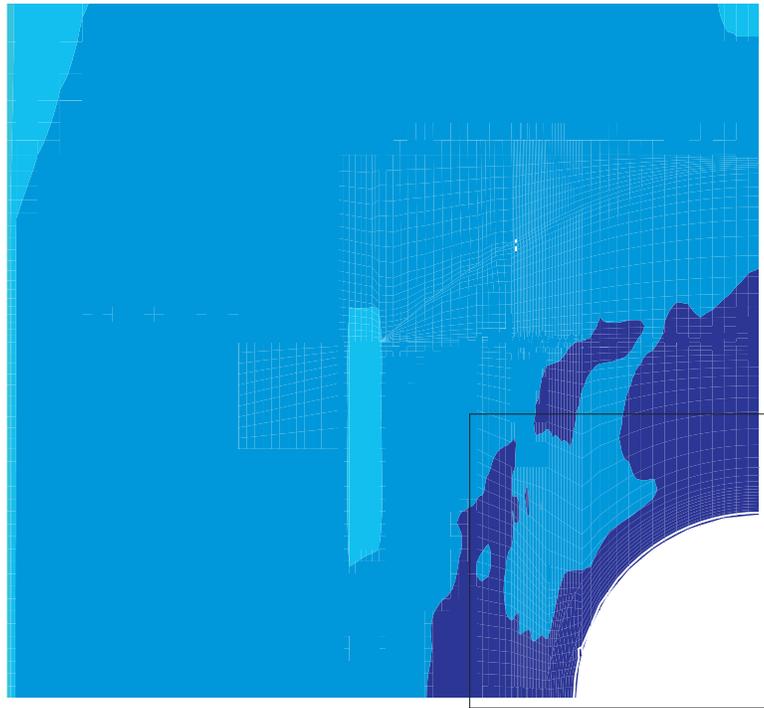
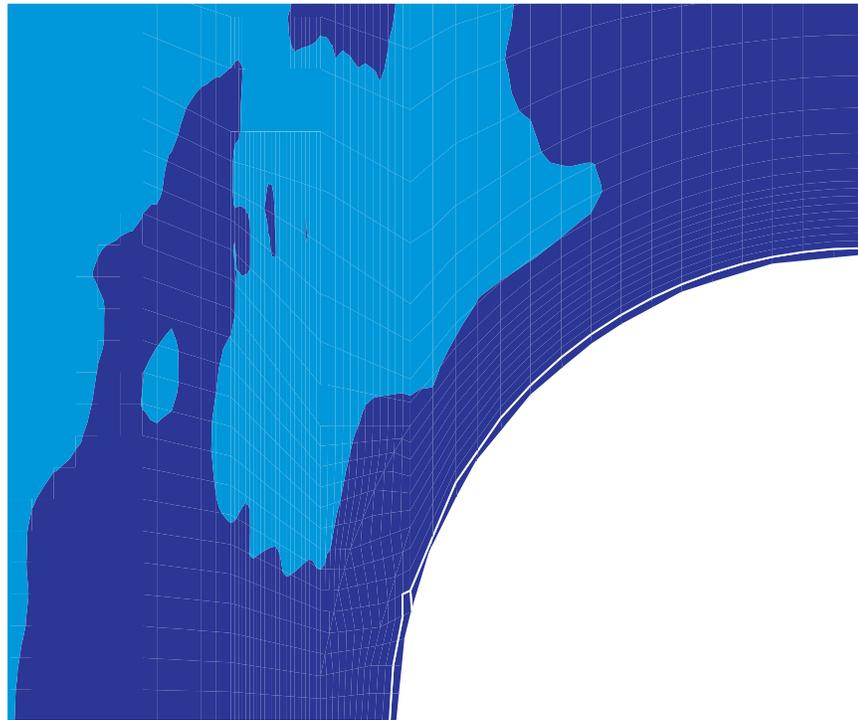
Figure 7-21. Liner Hoop Strains, Posttest Analysis Case B, at 3.2 Pd

The hypotheses are examined in Cases B and C. Case B uses the contact surface sticking/friction capability in ABAQUS. Contact with friction bonding properties were assigned to the liner-concrete interaction surface for Case B. The results of Case B are plotted in Figures 7-17 through 7-22. They show that by preventing relative slip between liner and concrete, the overall behavior of the system (concrete strains, tendon strains, liner strains away from the hatch) remains the same, but the elevated strains close to the collar are completely eliminated.

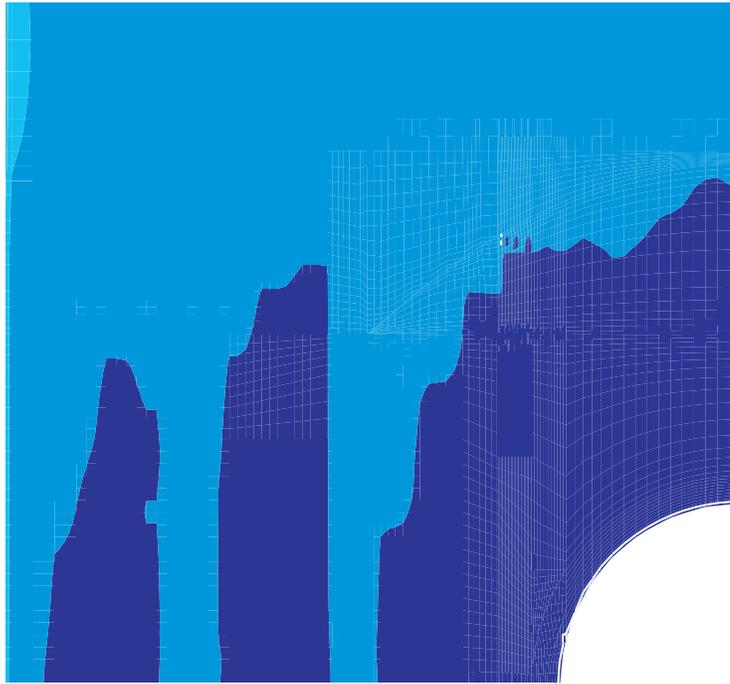
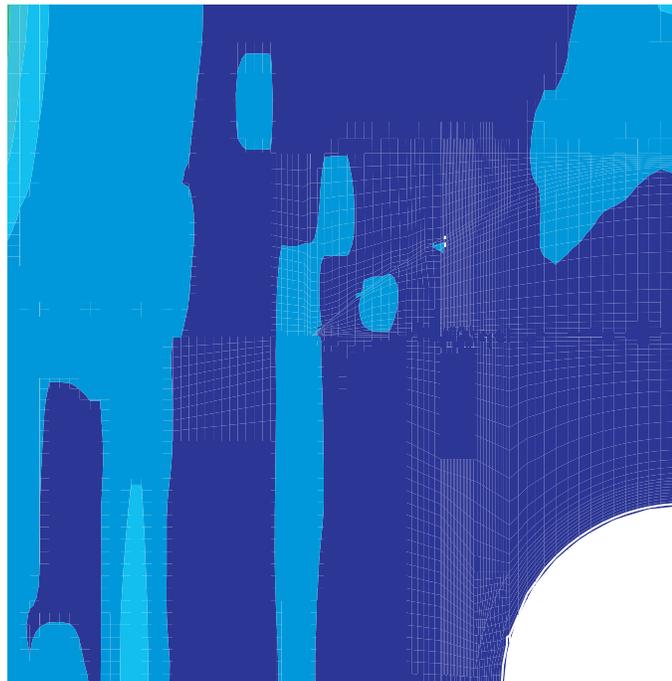
Figure 7-22. Liner Hoop Strains, Posttest Analysis Case B, at 3.5 Pd and 3.6 Pd

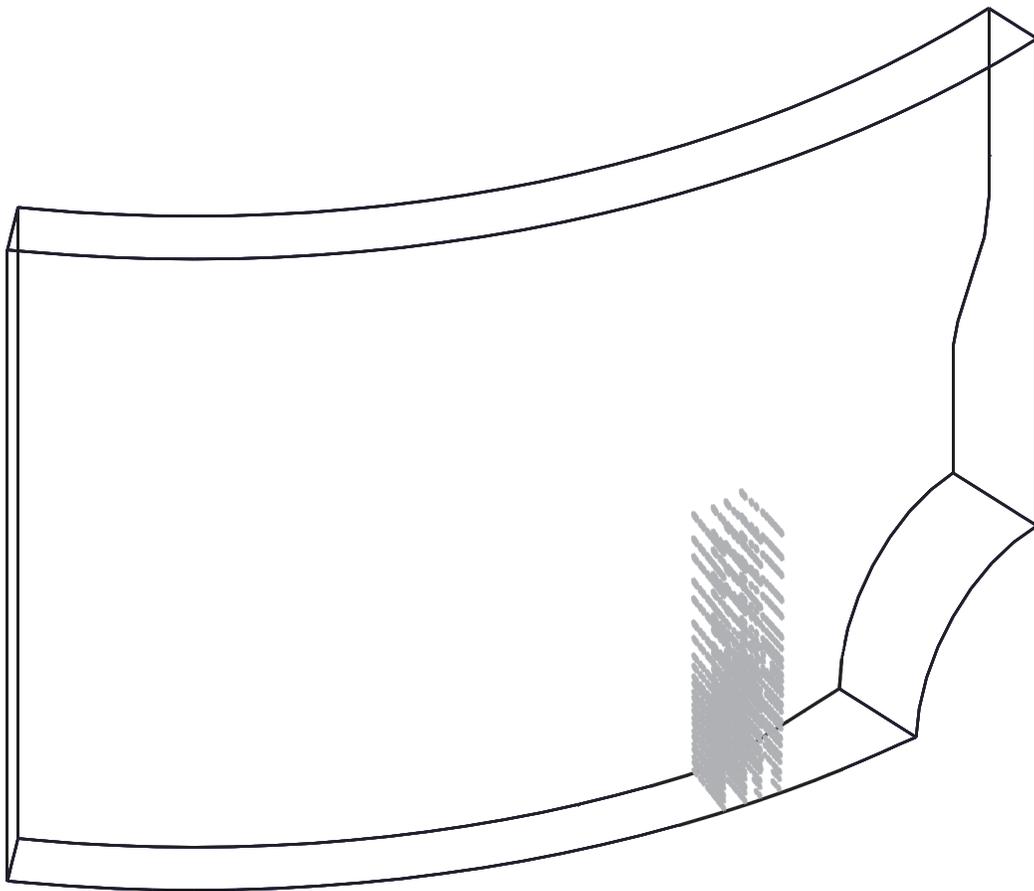
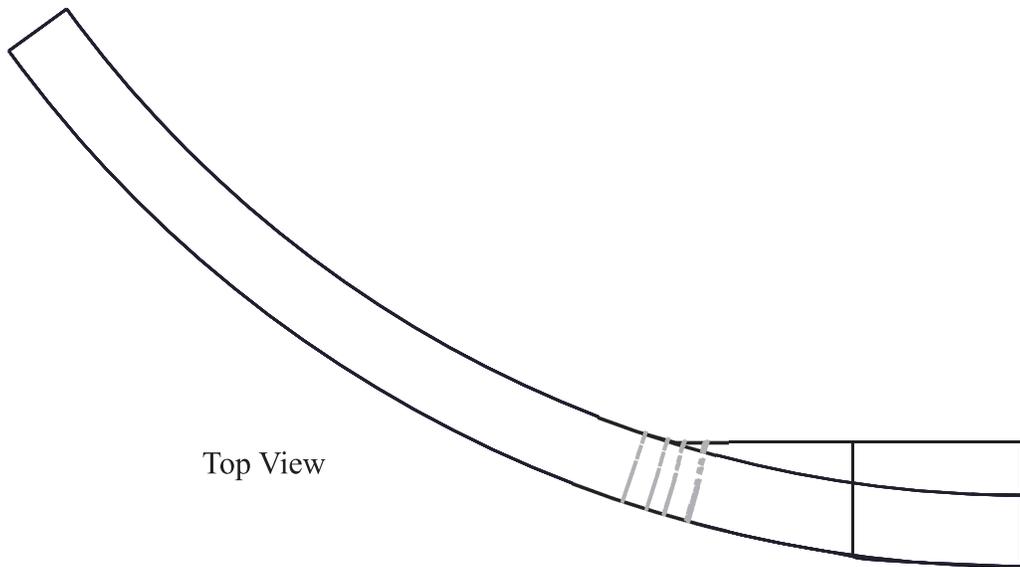
Figure 7-23. Pre-Cracking along Edge of E/H Embossment

The results of Case C are plotted in Figures 7-23 through 7-29. The ANACAP-U pre-cracking algorithm was used to introduce pre-cracking along the edge of the embossment. According to the liner strain results, however, the pre-cracking has only a minor effect on liner strain localization. Based on this result, investigating this phenomena may require a discrete crack approach, where a double row of concrete nodes along the embossment are introduced and allowed to open.

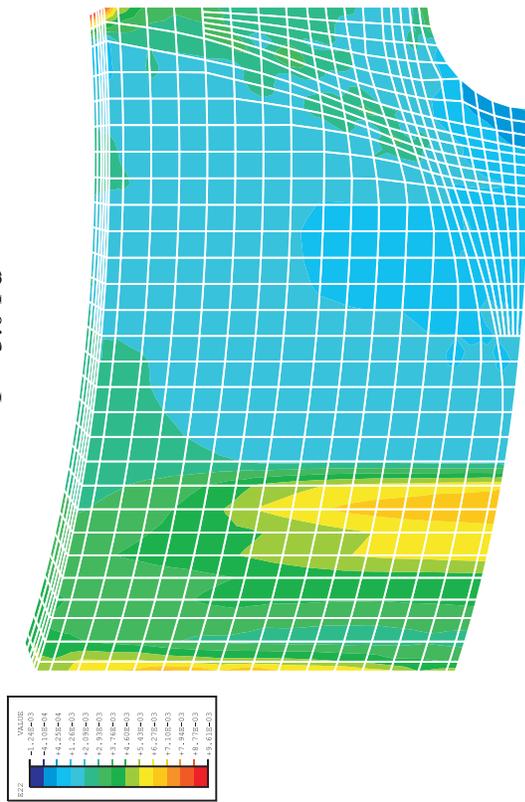
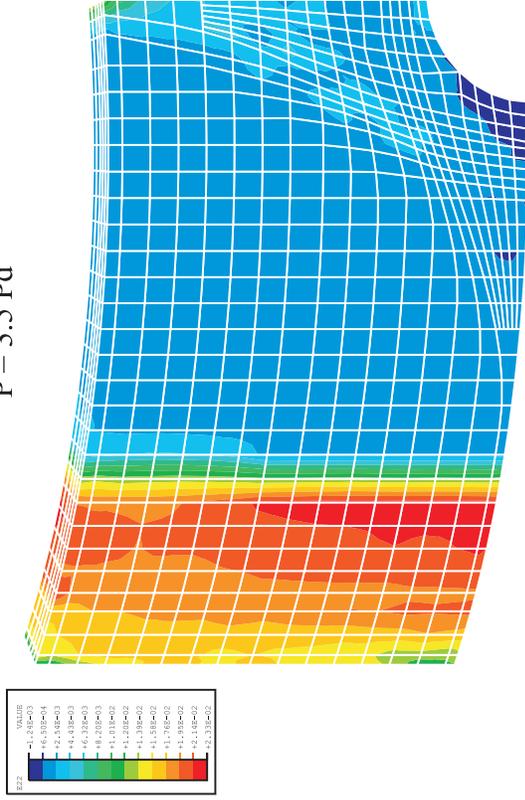
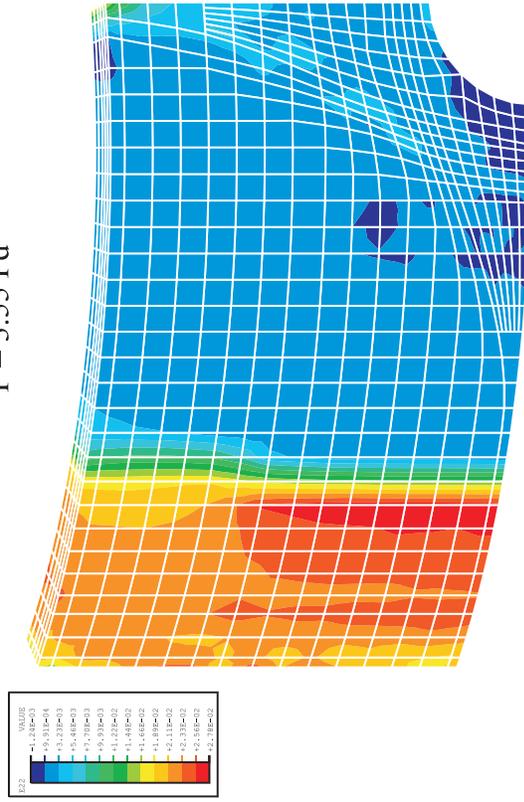
Figure 7-24. Concrete Hoop Strain Contours, Posttest Analysis Case C

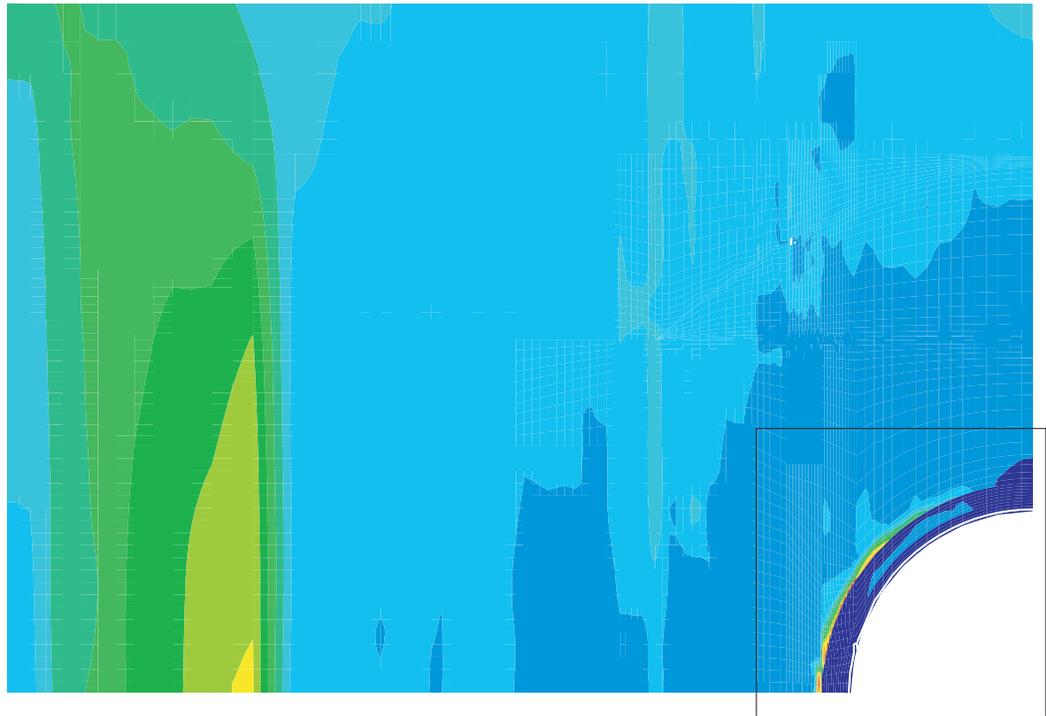
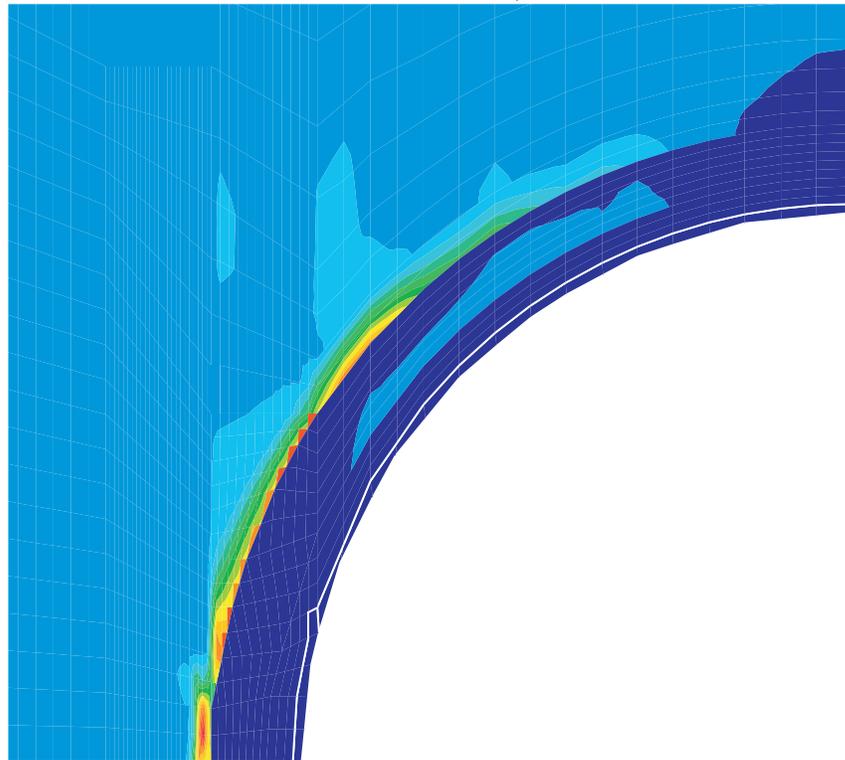
Figure 7-27. Liner Hoop Strains, Posttest Analysis Case C, at 3.0 Pd

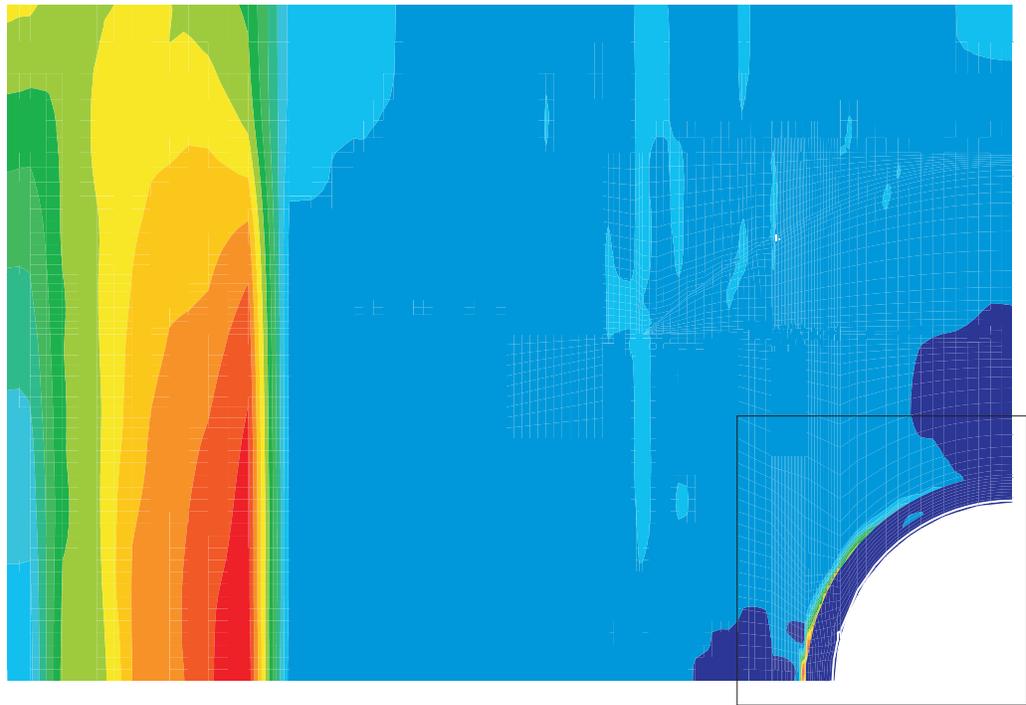
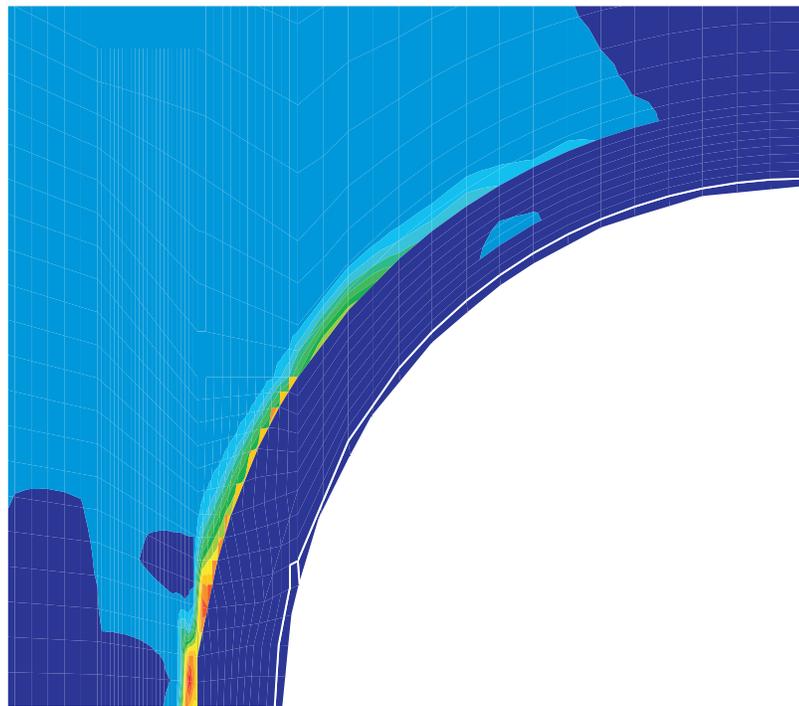
Figure 7-28. Liner Hoop Strains, Posttest Analysis Case C, at 3.2 Pd

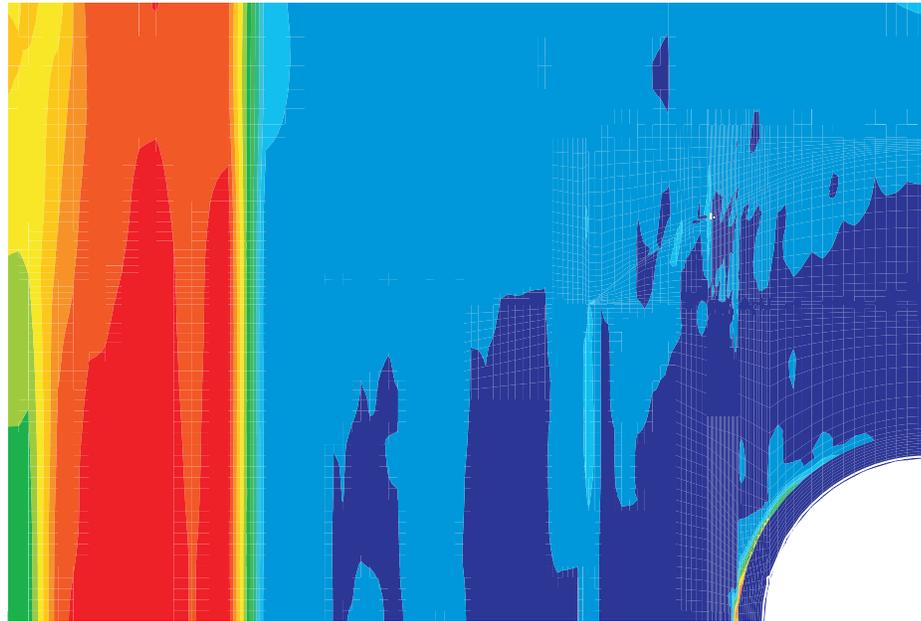
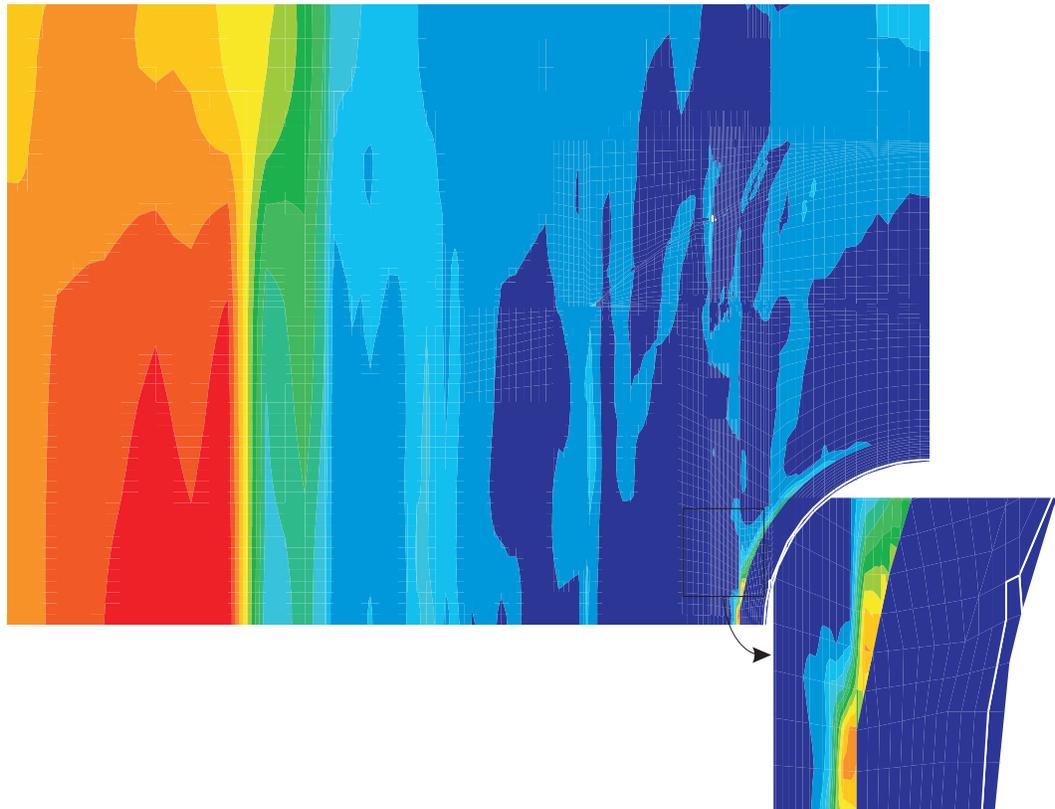
Figure 7-29. Liner Hoop Strains, Posttest Analysis Case C, at 3.5 Pd and 3.6 Pd

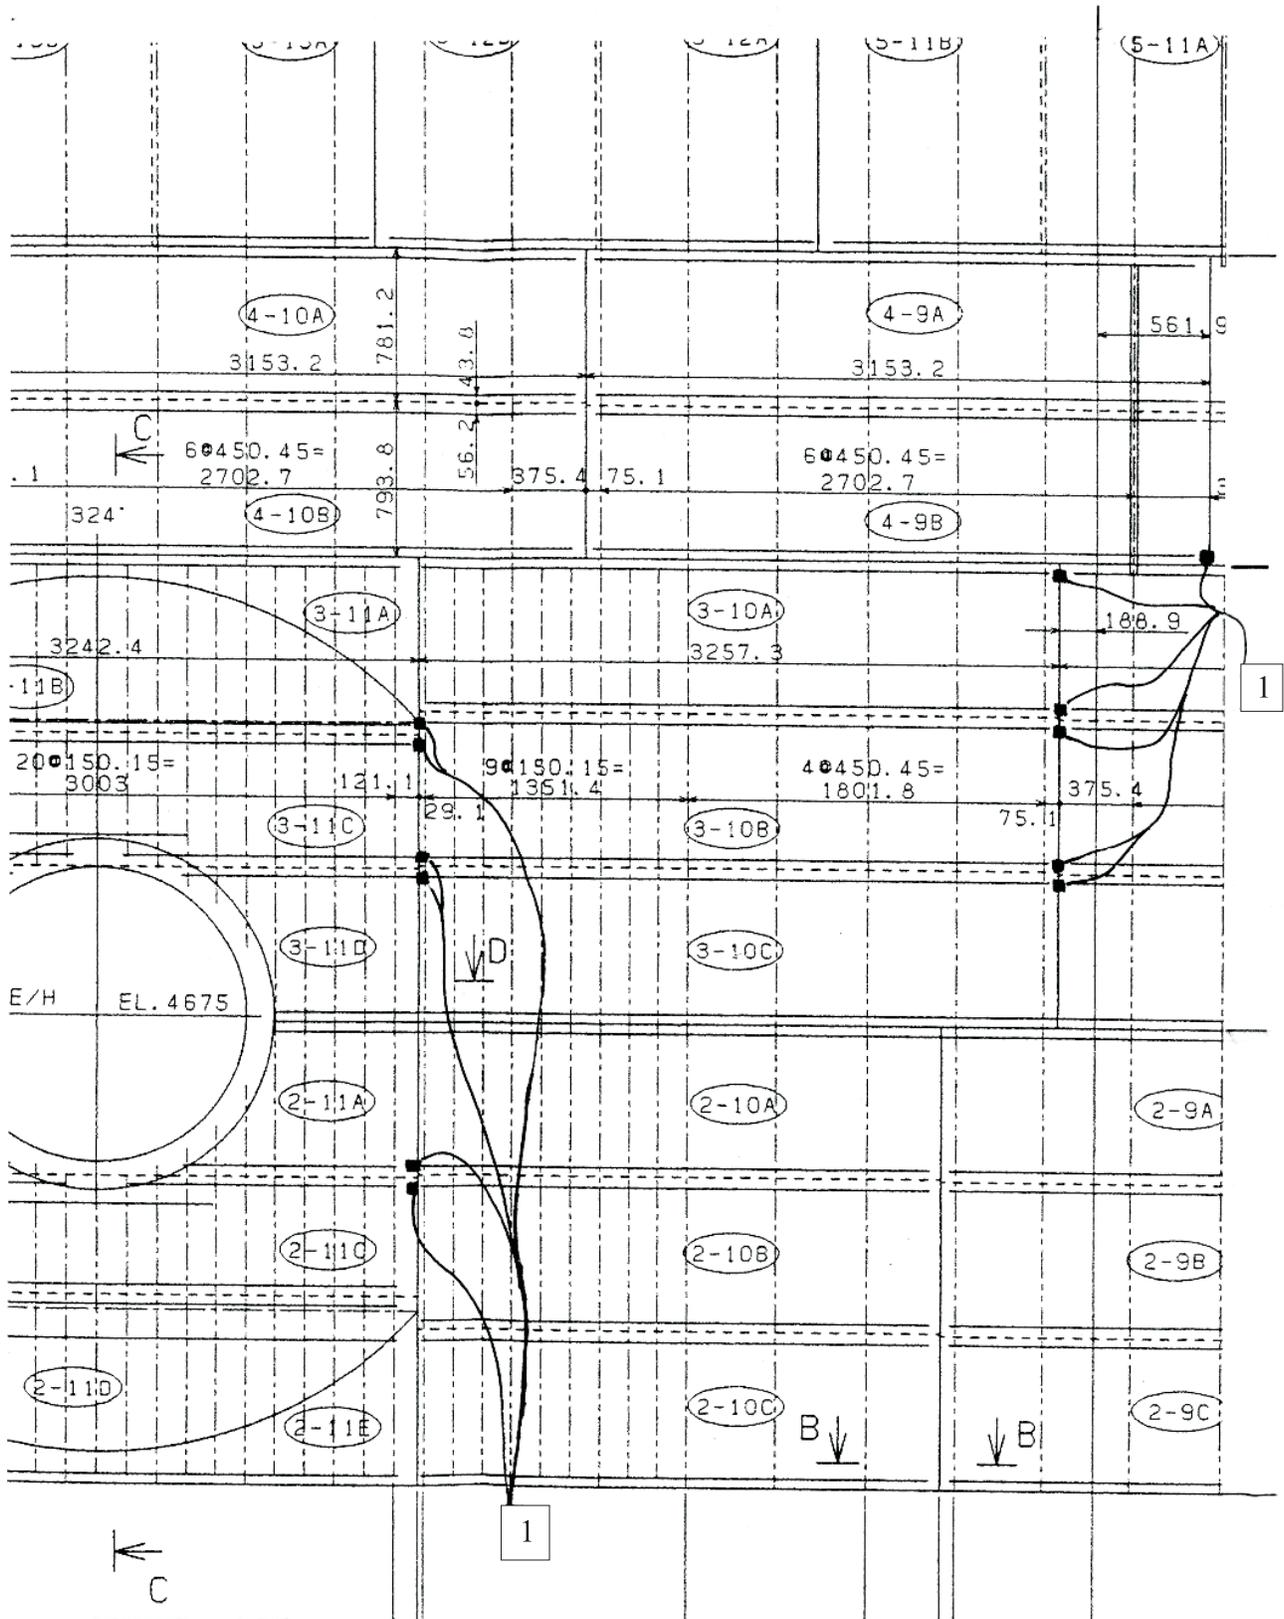
Figure 7-30. Strain Concentration Type 1 Near 270 Degrees Buttress and Near E/H

The liner areas near the E/H that have hoop stiffener splices (rat-holes), some of which exhibited tears, are shown in Figures 7-30 and 7-31. To further investigate Hypothesis 2, and to develop a model that even more closely simulates what occurred in the test, two more analyses were performed, as shown in Table 7-2.

Note from Figures 7-30 and 7-31 that the mild strain concentration simulated in E/H Model Case E coincides with rat-hole weld seam details. Numerous tears occurred at these details (see Figure 1-5). Based on the results of the detailed liner rat-hole (weld-seam) analysis (Chapter 8), the additional strain concentration associated with these local details is approximately 45 for a pristine rat-hole detail and about 59 for locations with severe (~40% reduction in thickness) local liner thinning by grinding from the weld repairs. (These strain concentrations would be applied to free-field liner strains away from all discontinuities). As reported in [8], there was extensive liner thinning at most of these tear locations. The tears at the edge of the embossment can be explained by magnifying the strains calculated in the E/H analysis by the strain concentration factors from Chapter 8. This calculation is shown in Table 7-3. It shows that with discrete crack modeling and local rat-hole modeling, a liner tear would be predicted to occur as early as 2.8 Pd. Based on the evidence provided by liner strain gages and acoustic monitoring, one of the tears along this embossment edge may have even occurred as early as 2.5 Pd.

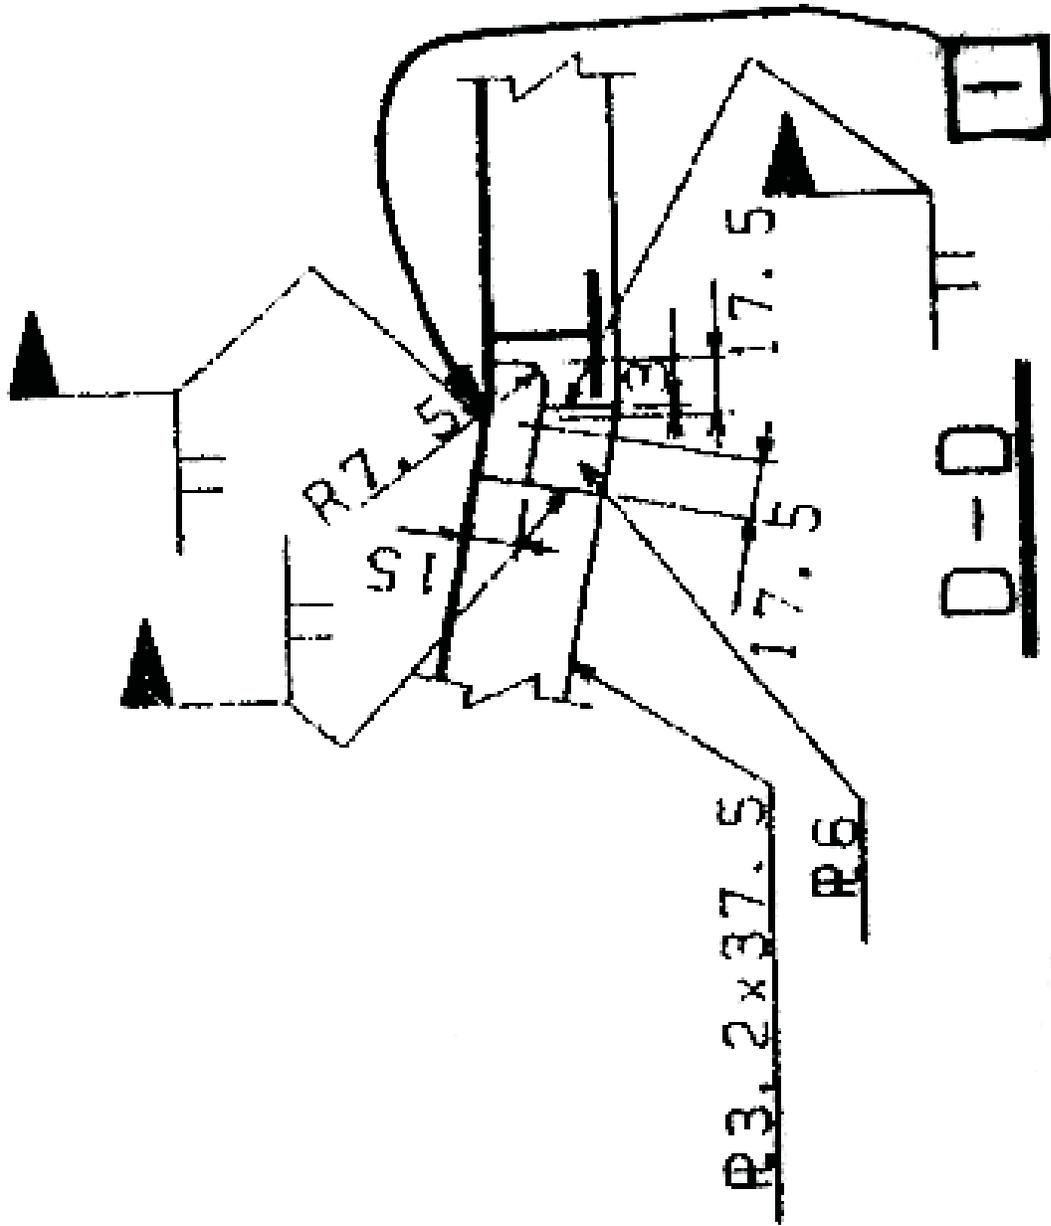
Figure 7-31. Liner Strain Concentration Rat-Hole Detail

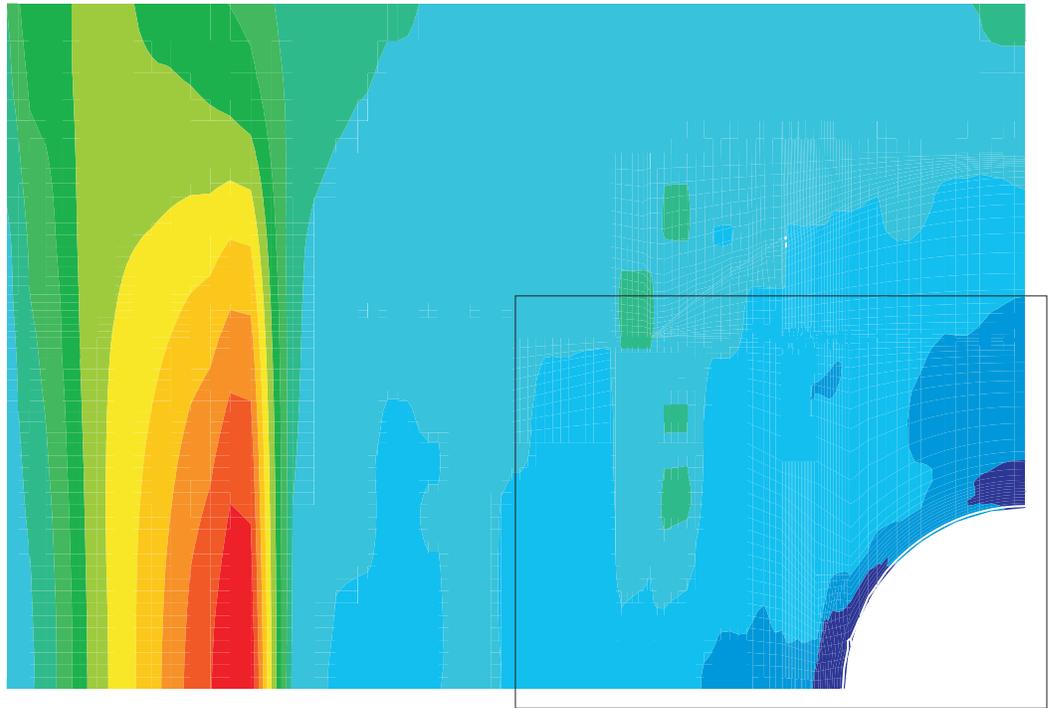
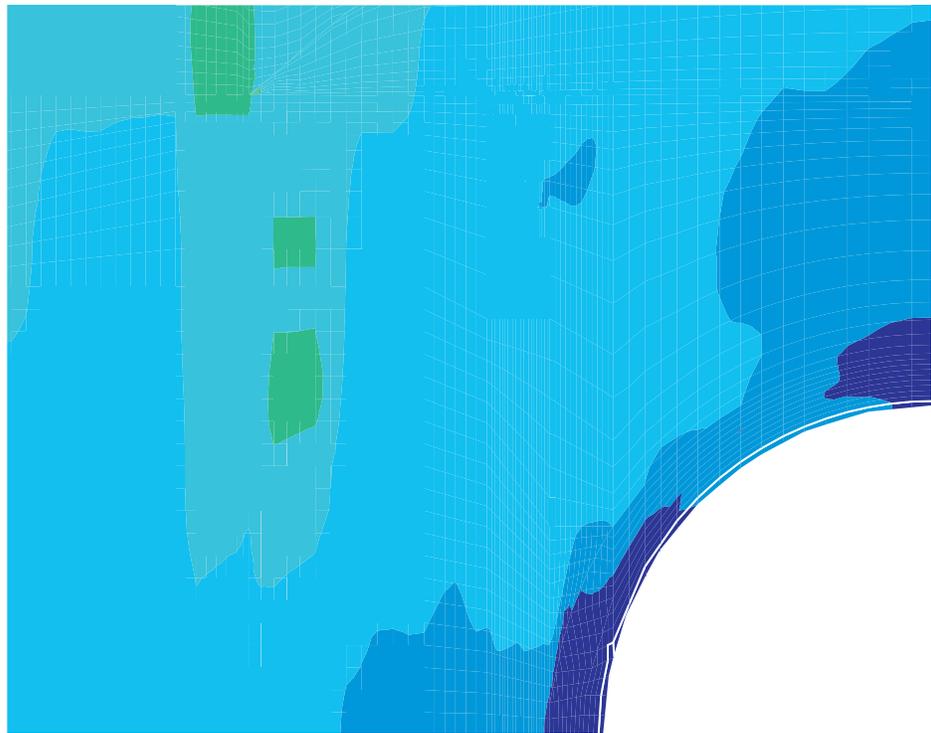
Figure 7-32. Liner Hoop Strains, Posttest Analysis Case D, at 3.0 Pd

The first (Case D) is an extension of the previous analysis series; namely, the liner/concrete friction bond was applied to the pre-cracked case (directed crack at element integration points). The liner strain results of this case are summarized in Figure 7-32, 7-33, and 7-34. The results are similar to Case C, except that now the liner strain concentrations near the Hatch collar insert plate are (for the most part) eliminated, as they were in Case B.

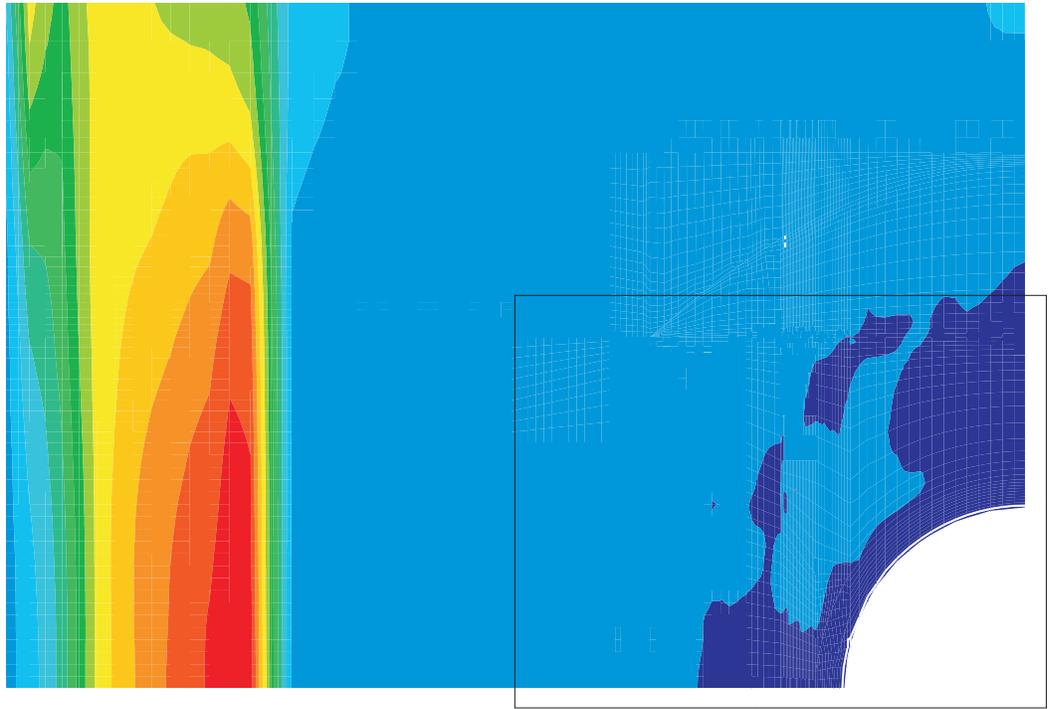
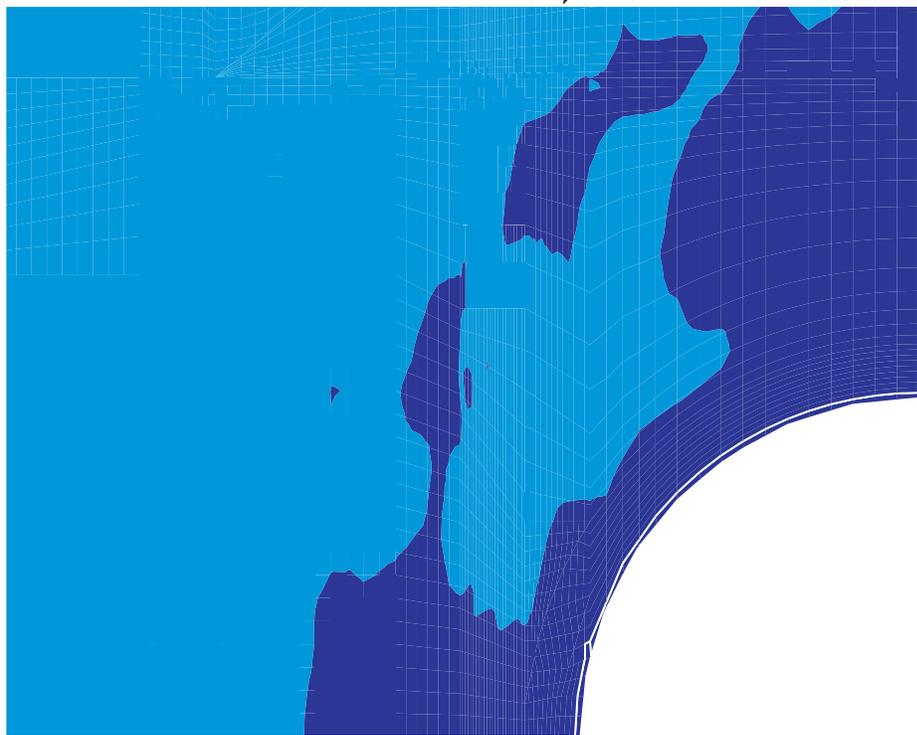
Figure 7-33. Liner Hoop Strains, Posttest Analysis Case D, at 3.2 Pd

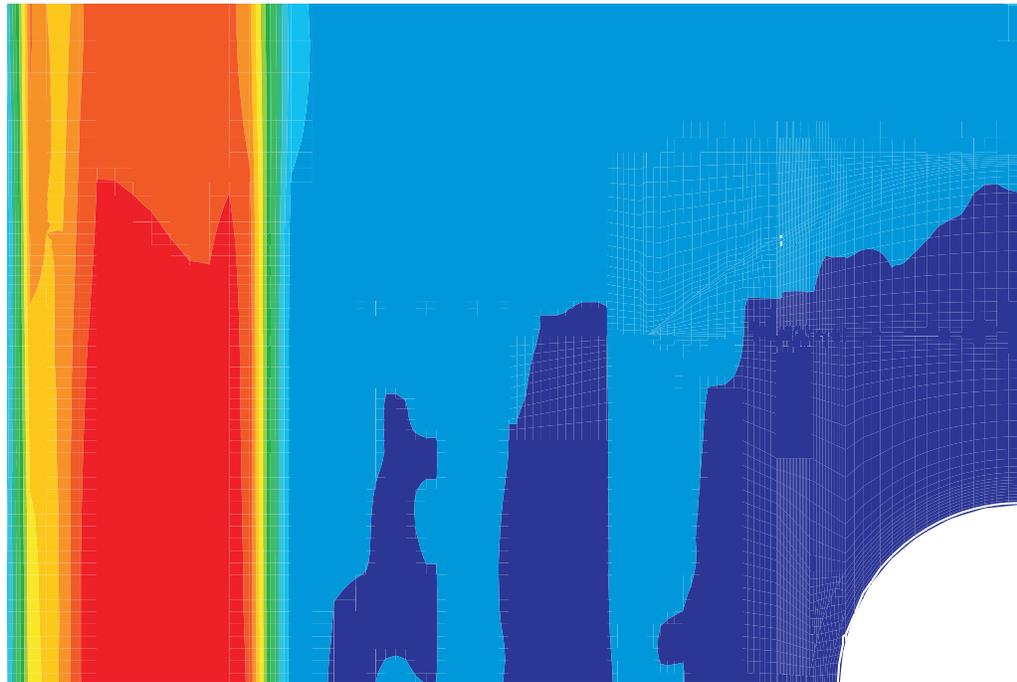
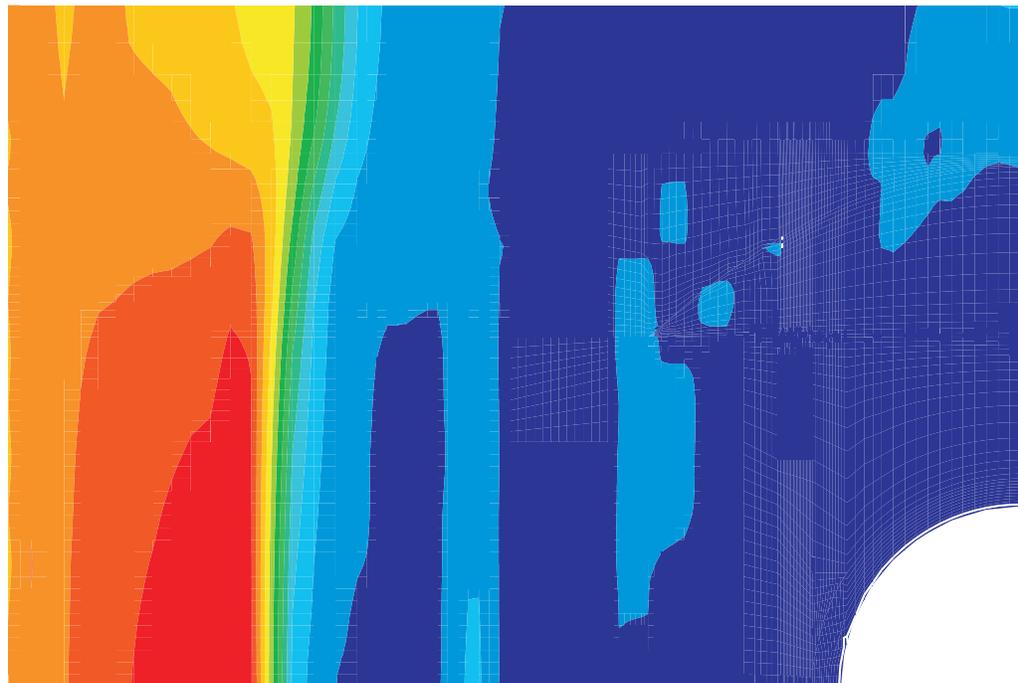
Figure 7-34. Liner Hoop Strains, Posttest Analysis Case D, at 3.5 Pd and 3.6 Pd

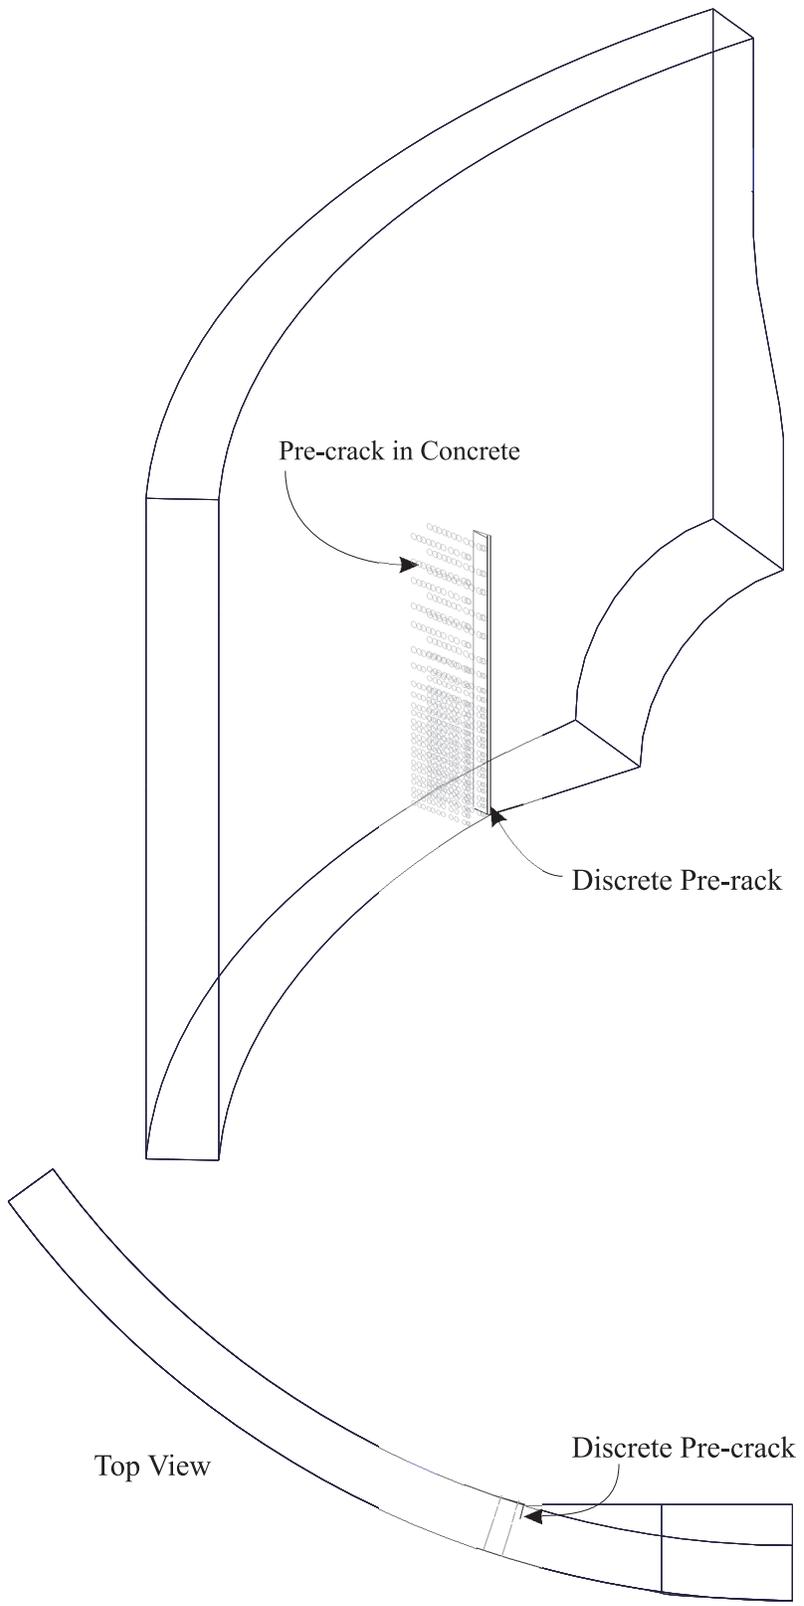
Figure 7-35. Illustration of Case E, Discrete Pre-Crack

In the final case (Case E), the integration point directed crack is reduced to one row of elements and a discrete crack is formed by adding double rows of nodes along an assumed crack line, as shown in Figure 7-35. The double row of nodes could not be extended all the way through the wall section because it would interrupt the modeling of the reinforcement (modeled with subelements within the concrete elements). However, just "unzipping" the first element layer (which has no reinforcement) to simulate a discrete crack partway through the wall thickness was found to create a liner elevated strain phenomenon.

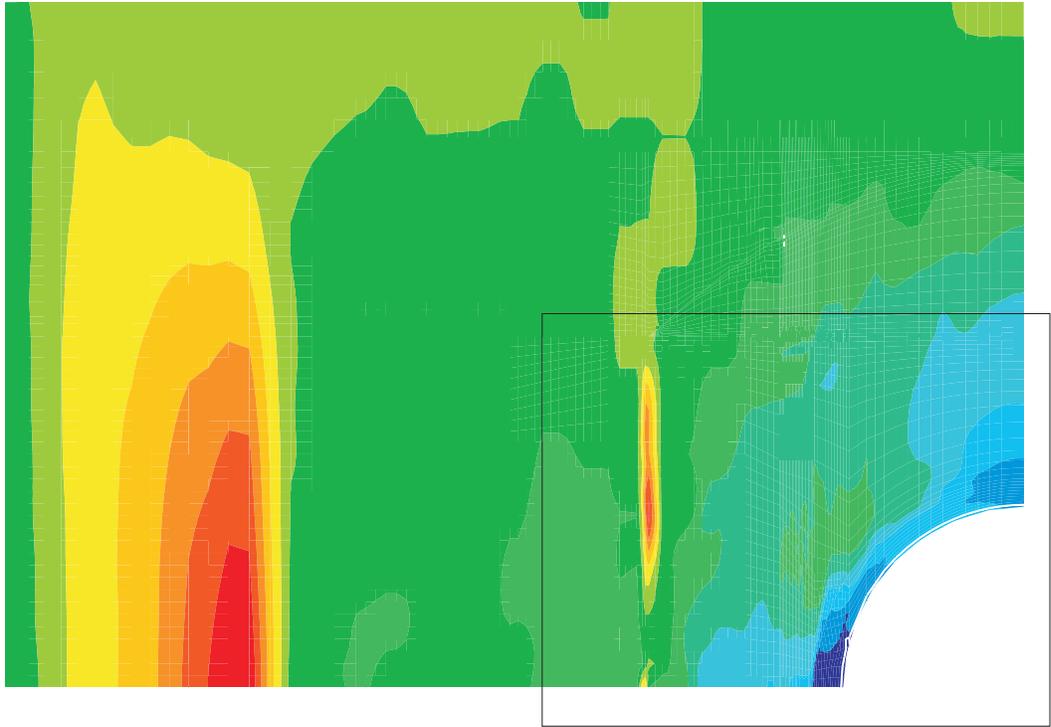
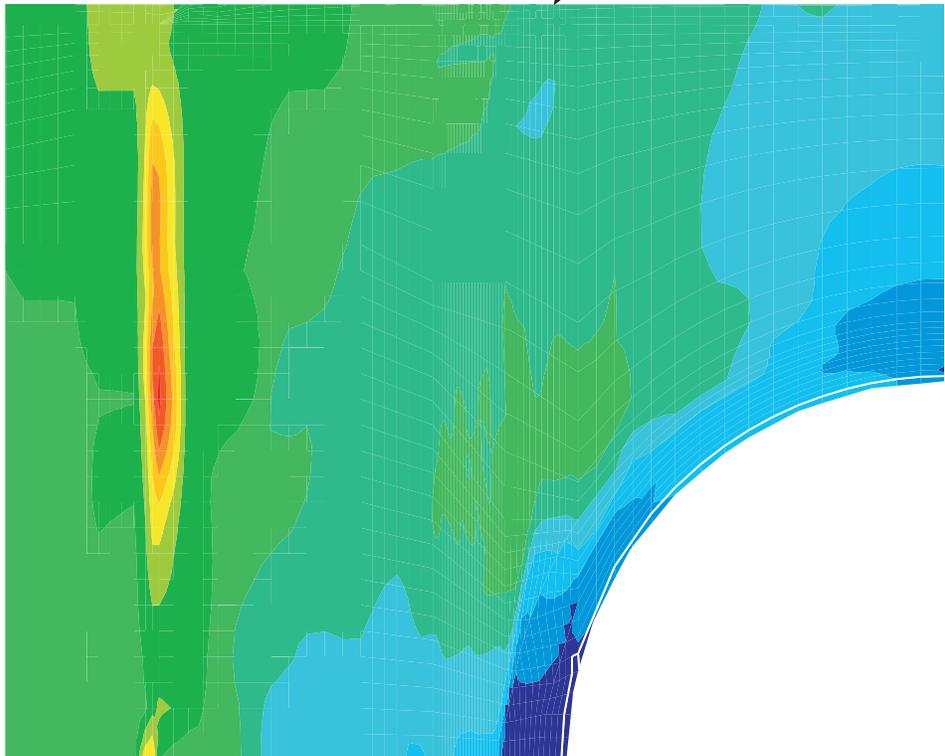
Figure 7-36. Liner Hoop Strains, Posttest Analysis Case E, at 2.8 Pd

The results of Case E are illustrated in Figures 7-36 through 7-39, at pressures of 2.8, 3.0, 3.2, 3.5, and 3.6 Pd. At this point, a mild strain concentration emerged at the edge of the wall embossment. The peak strain predictions of this wall embossment edge are listed in Table 7-3.

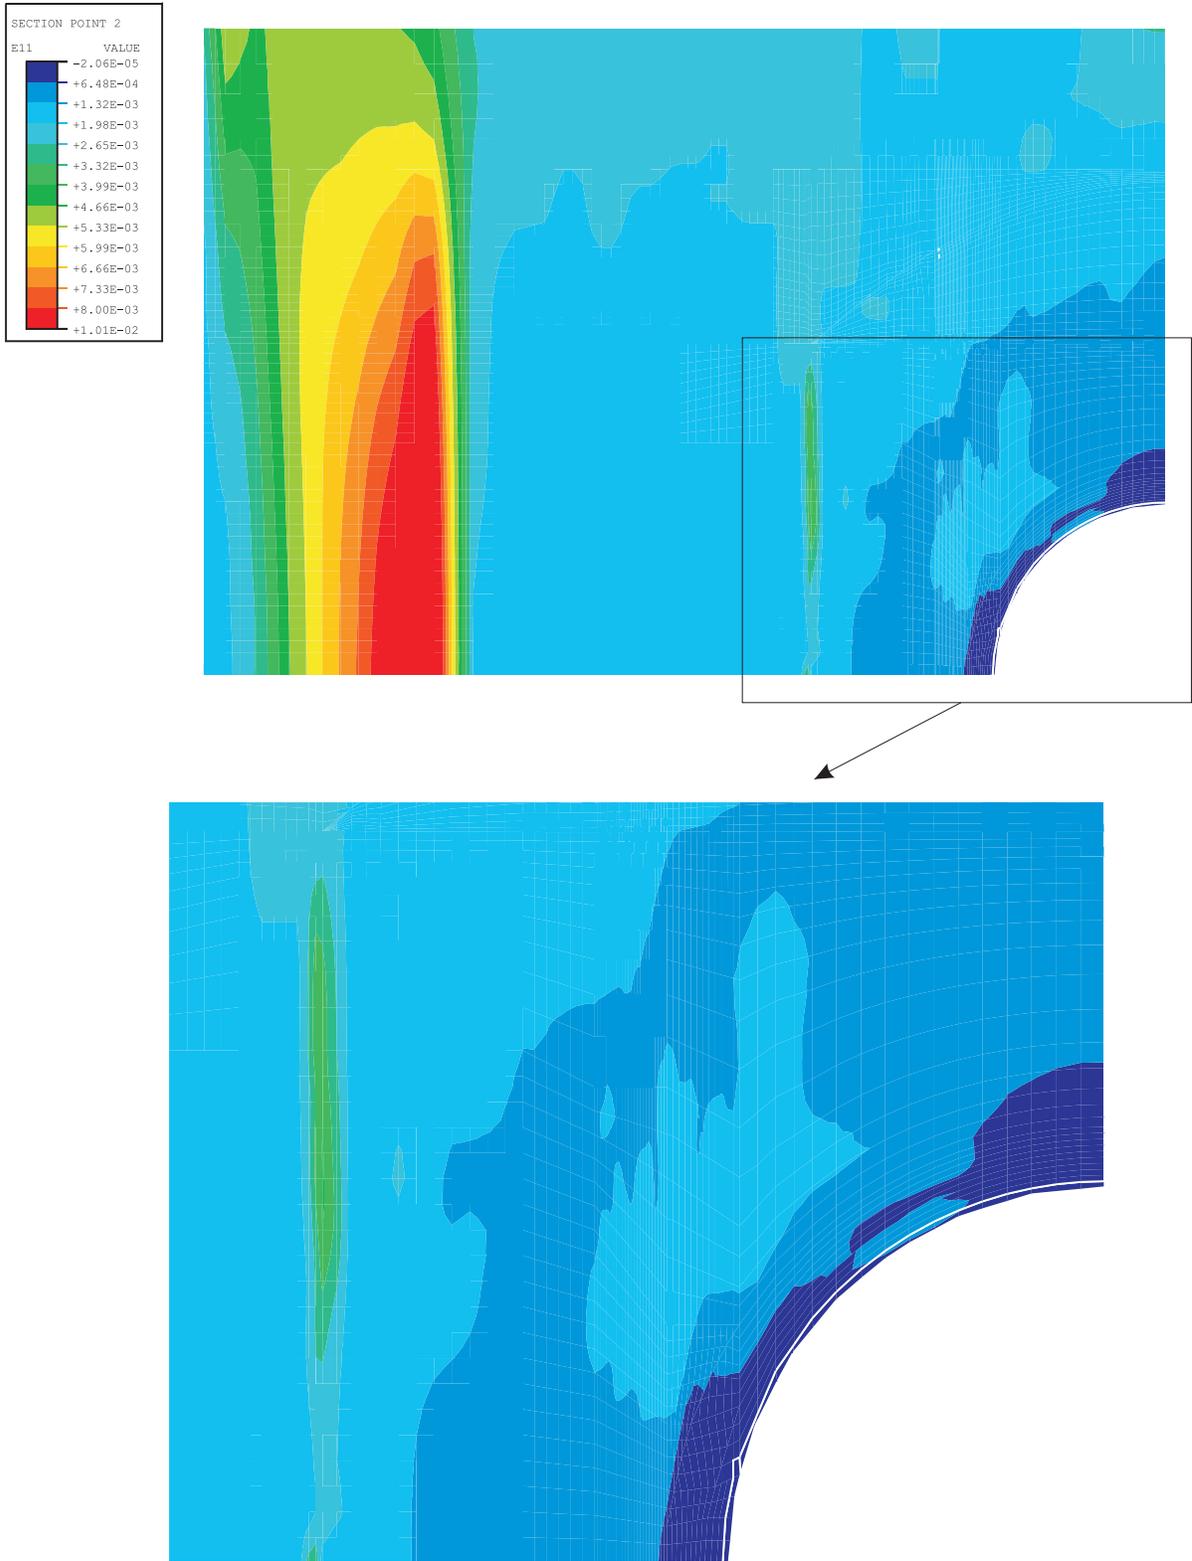
Figure 7-37. Liner Hoop Strains, Posttest Analysis Case E, at 3.0 Pd
