7.0 REVISED LOCAL PENETRATION POSTTEST MODEL ANALYSES

7.1 Overview of Pretest Local Models

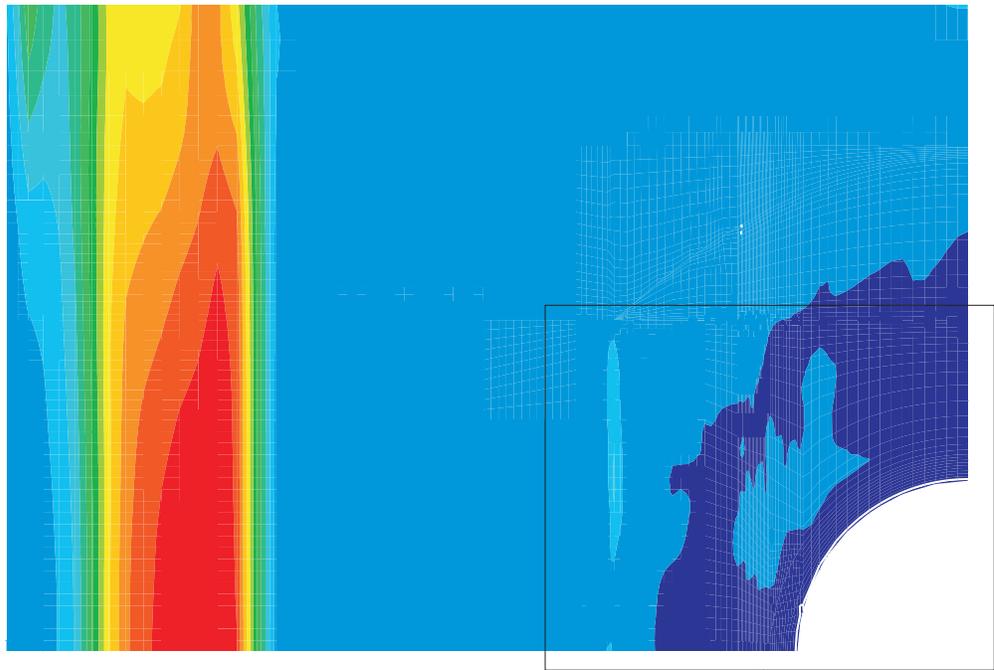
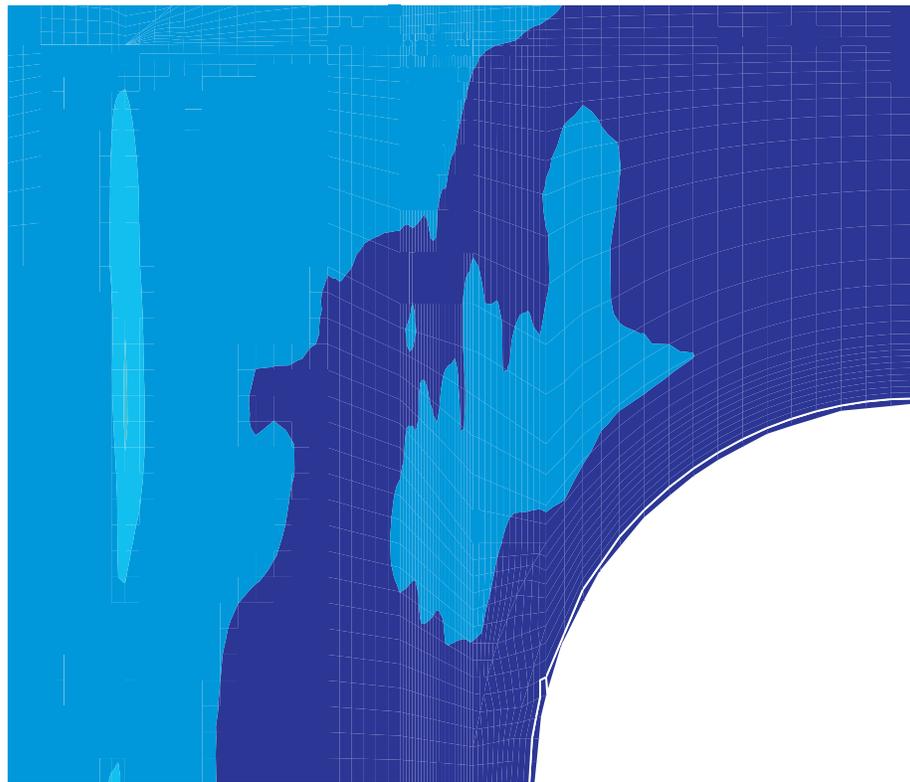
Figure 7-38. Liner Hoop Strains, Posttest Analysis Case E, at 3.2 Pd

The results of Case E are illustrated in Figures 7-36 through 7-39, at pressures of 2.8, 3.0, 3.2, 3.5, and 3.6 Pd. At this point, a mild strain concentration emerged at the edge of the wall embossment. The peak strain predictions of this wall embossment edge are listed in Table 7-3.

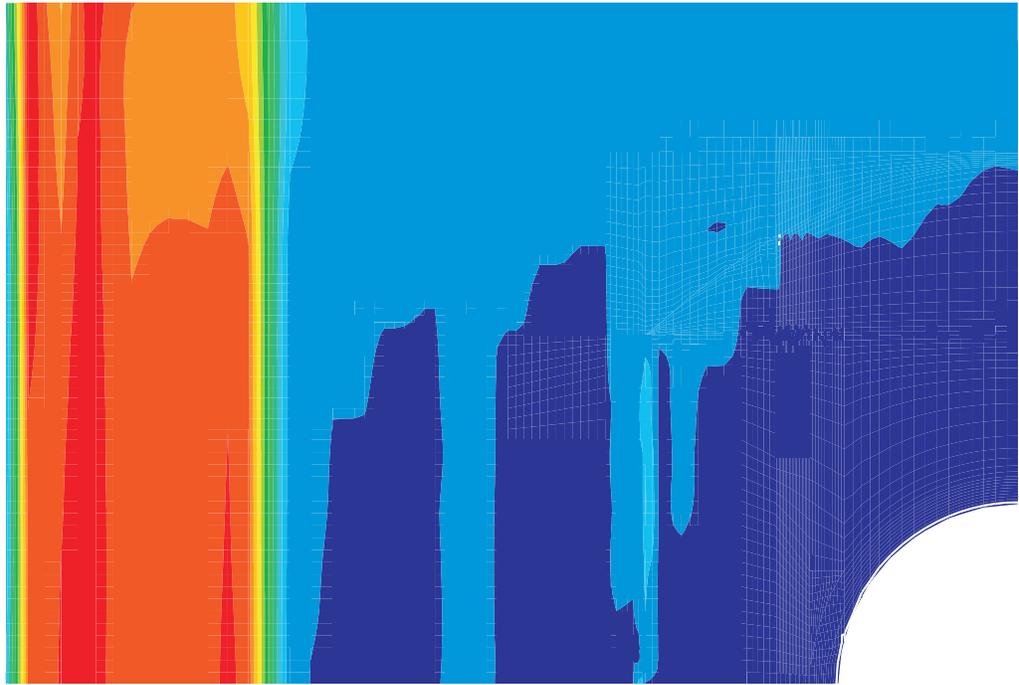
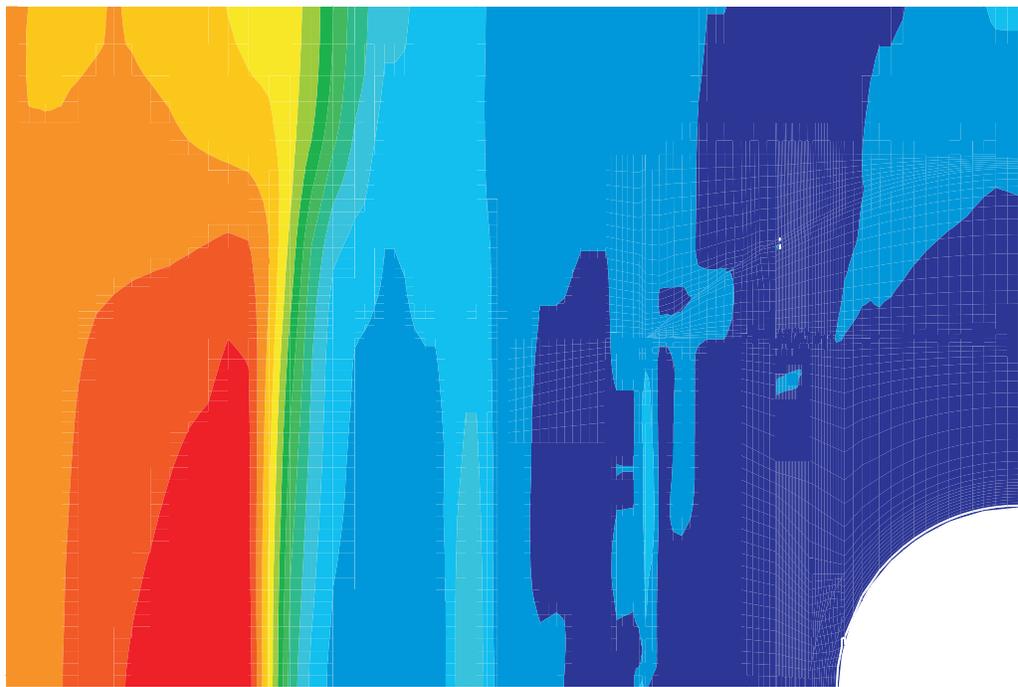
Figure 7-39. Liner Hoop Strains, Posttest Analysis Case E, at 3.5 Pd and 3.6 Pd

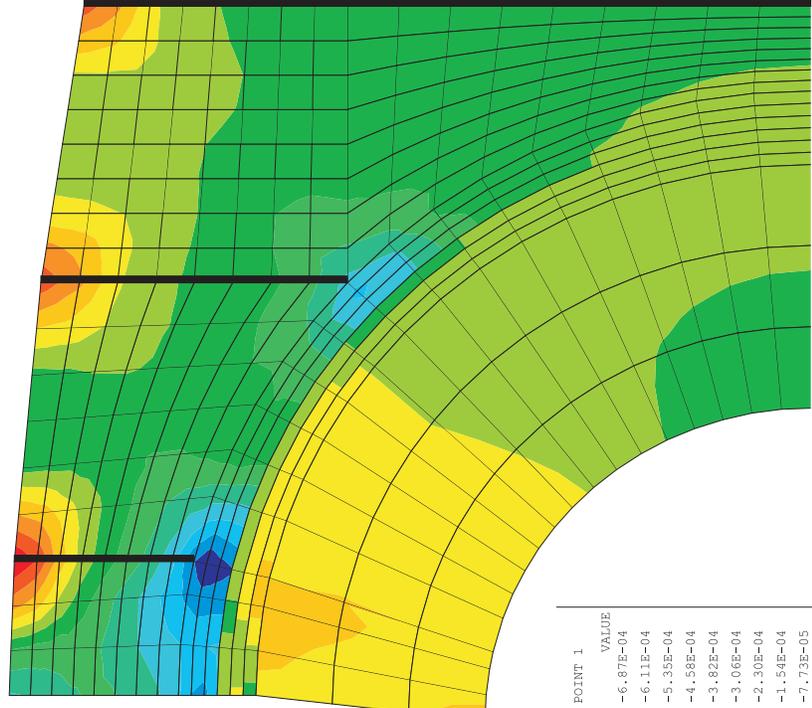
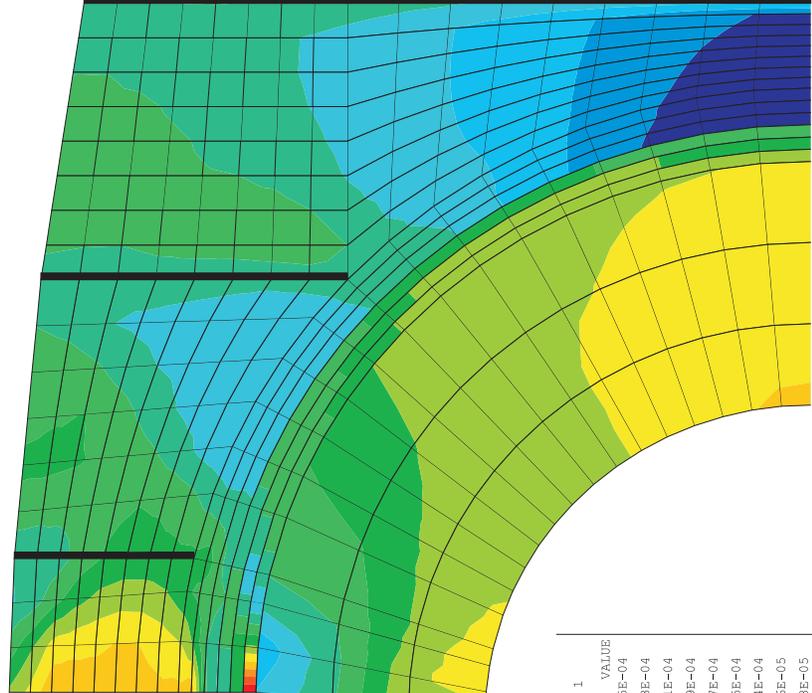
Figure 7-40. Hoop (Left) and Meridional (Right) Strains for Posttest M/S Analysis at Prestress

Posttest analysis strain contour results are shown in Figures 7-40 through 7-44. The figures show a little larger strains than in the pretest analysis but still not large enough for a liner tearing prediction. At 3.3 Pd (the end of the LST), the strains around the edge of the liner insert collar are between 2% and 3%. As shown in Section 7.5, this agrees fairly well with liner strain measurements taken during the LST.

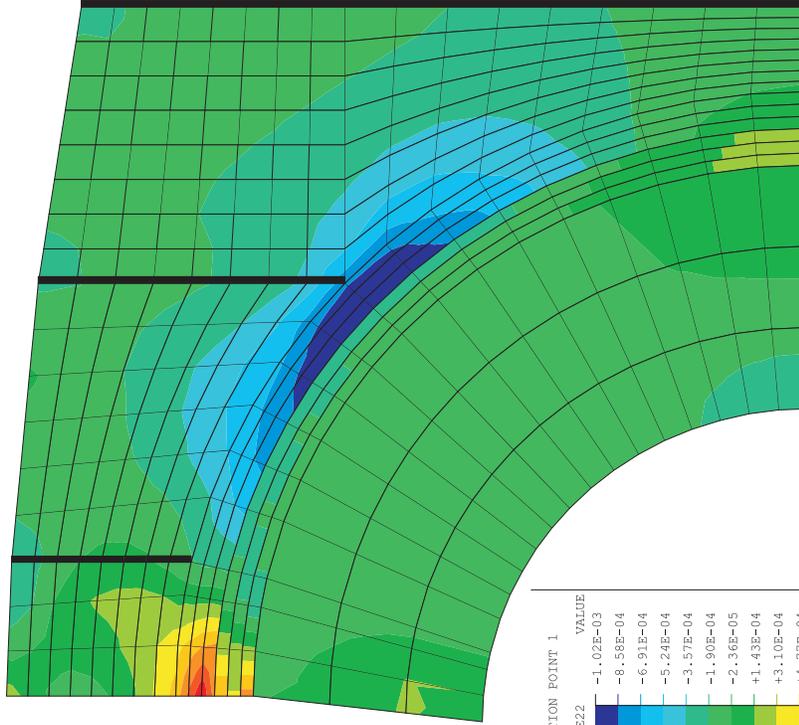
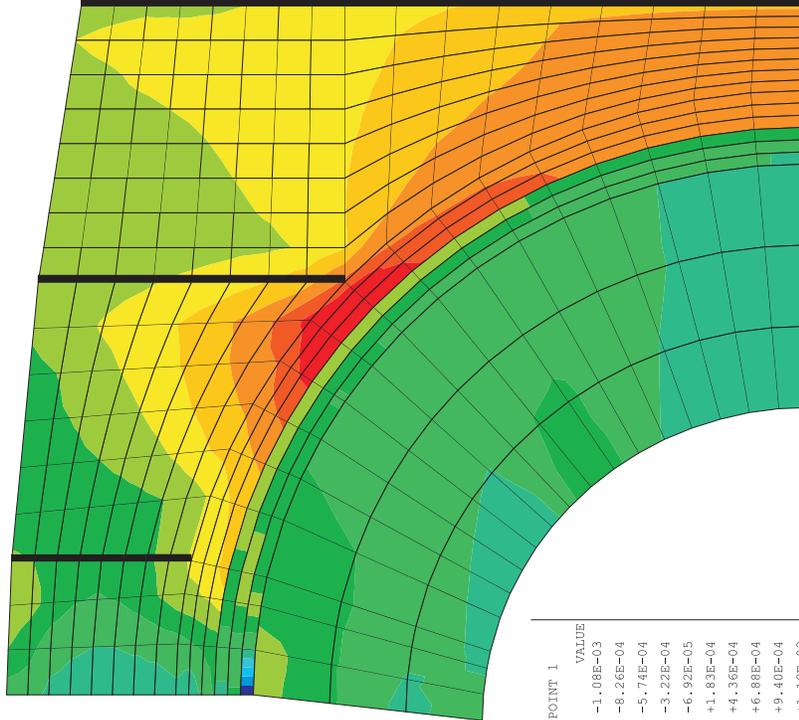
Figure 7-41. Hoop (Left) and Meridional (Right) Strains for Posttest M/S Analysis at P = 2.0 Pd

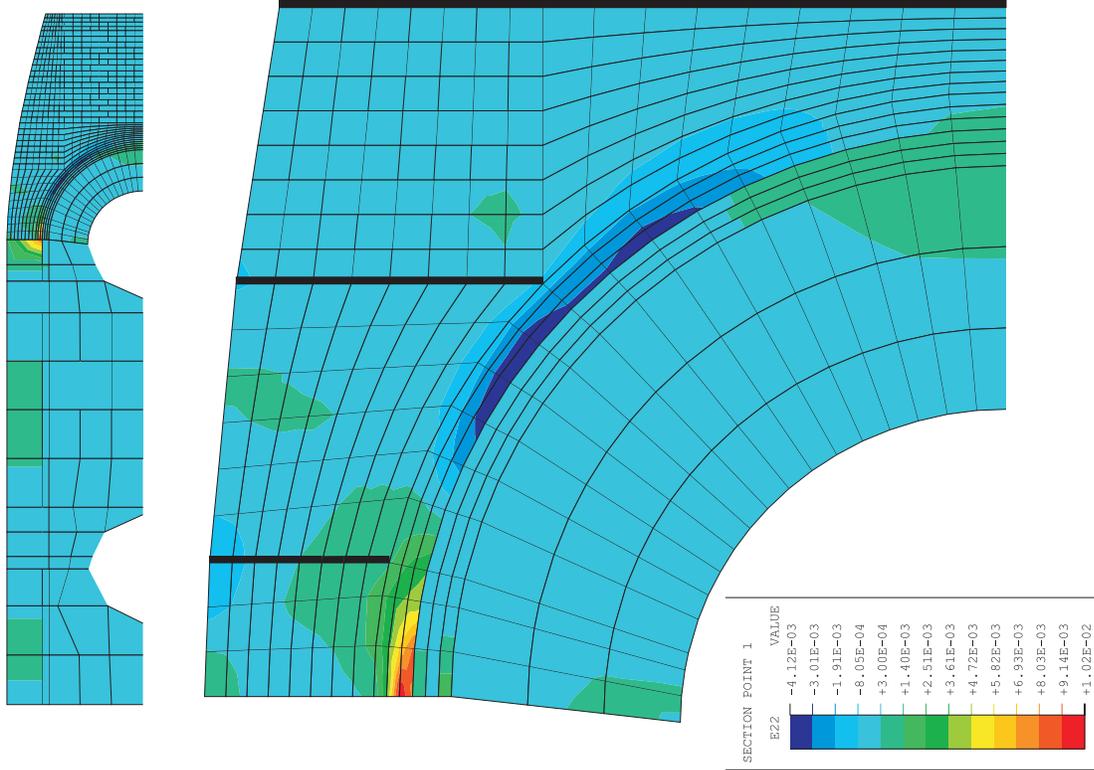
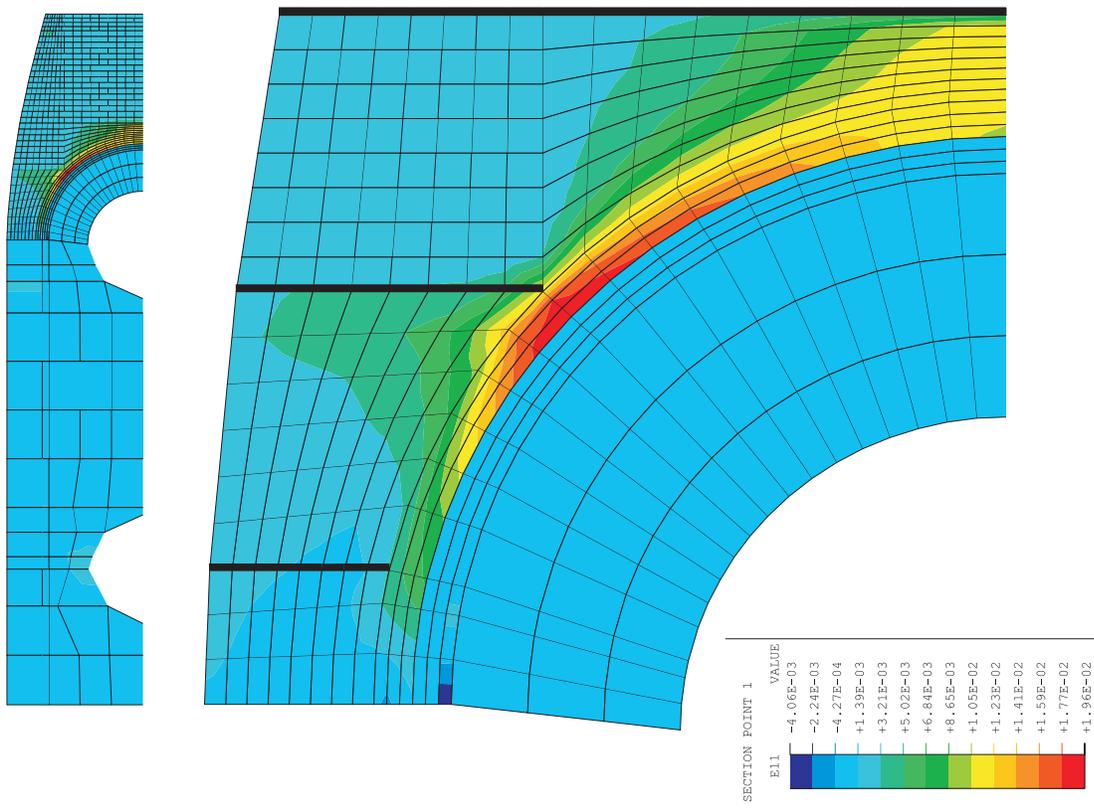
Figure 7-42. Hoop (Left) and Meridional (Right) Strains for Posttest M/S Analysis at P = 3.0 Pd

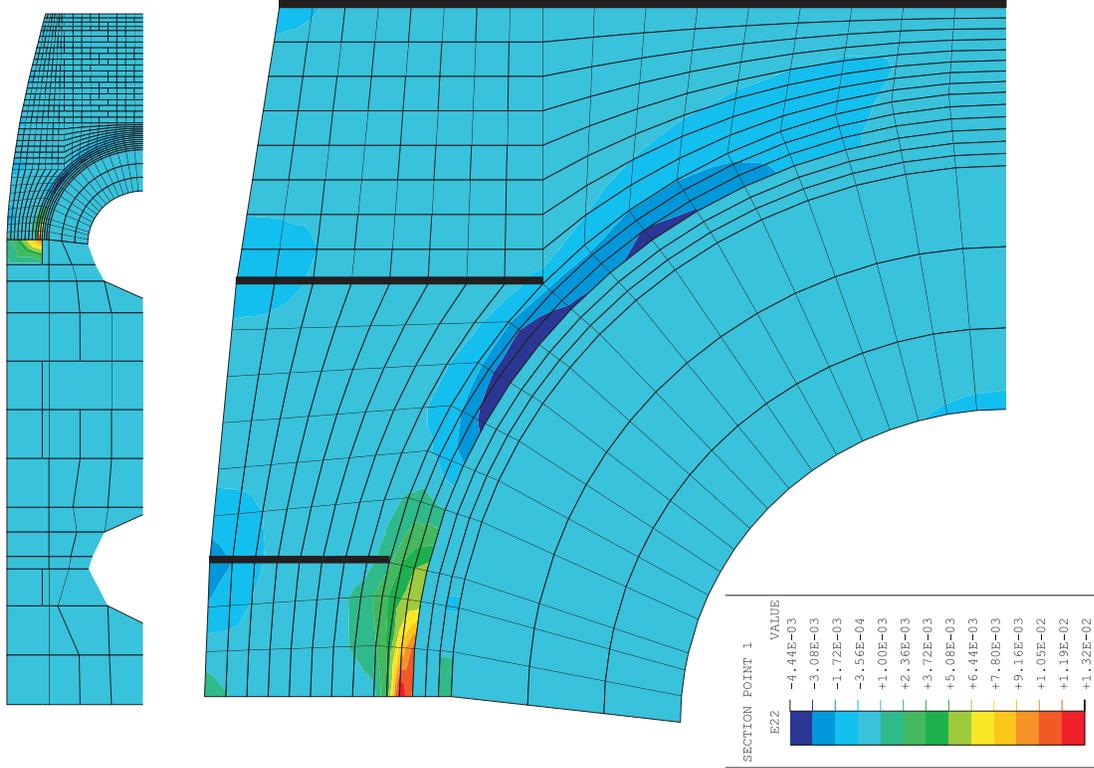
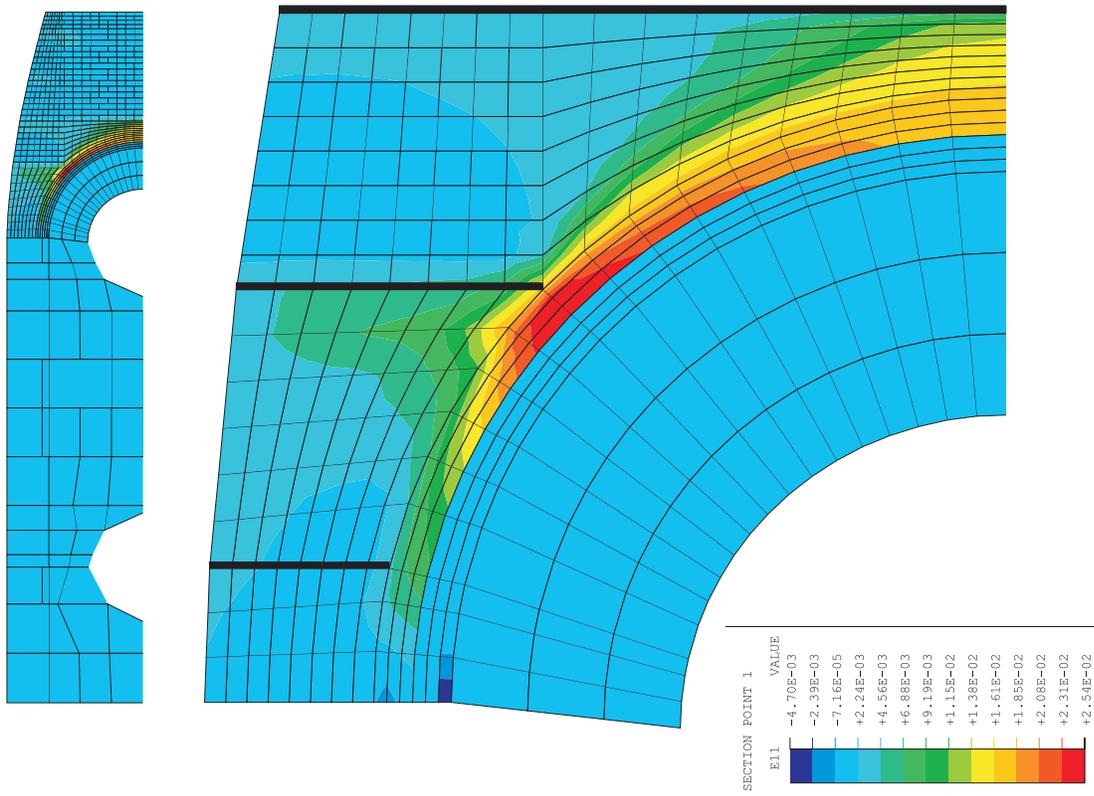
Figure 7-43. Hoop (Left) and Meridional (Right) Strains for Posttest M/S Analysis at P = 3.3 Pd

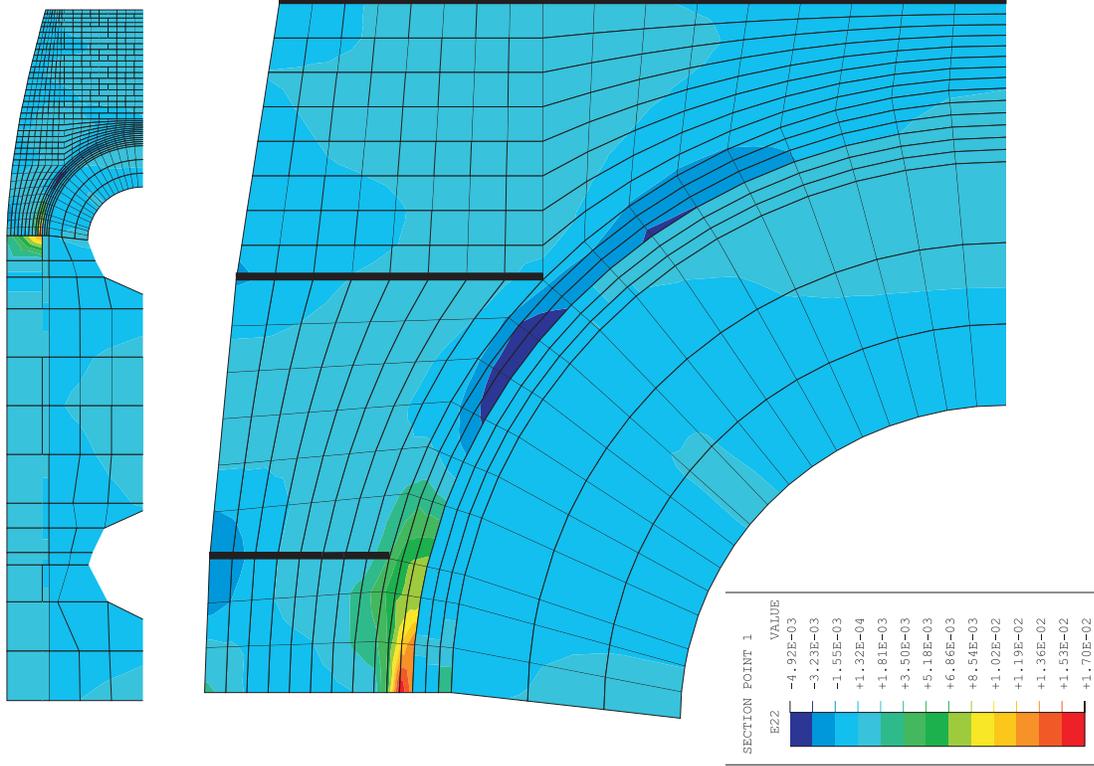
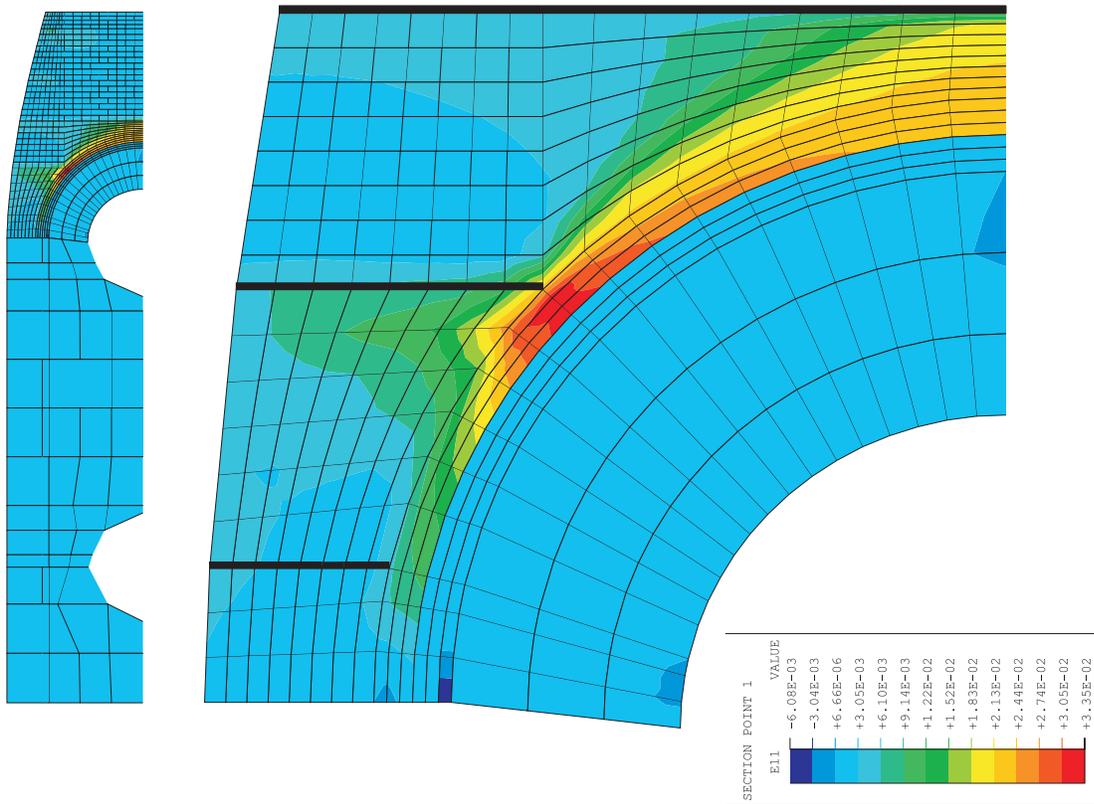
Figure 7-44. Hoop (Left) and Meridional (Right) Strains for Posttest M/S Analysis at P = 3.5 Pd

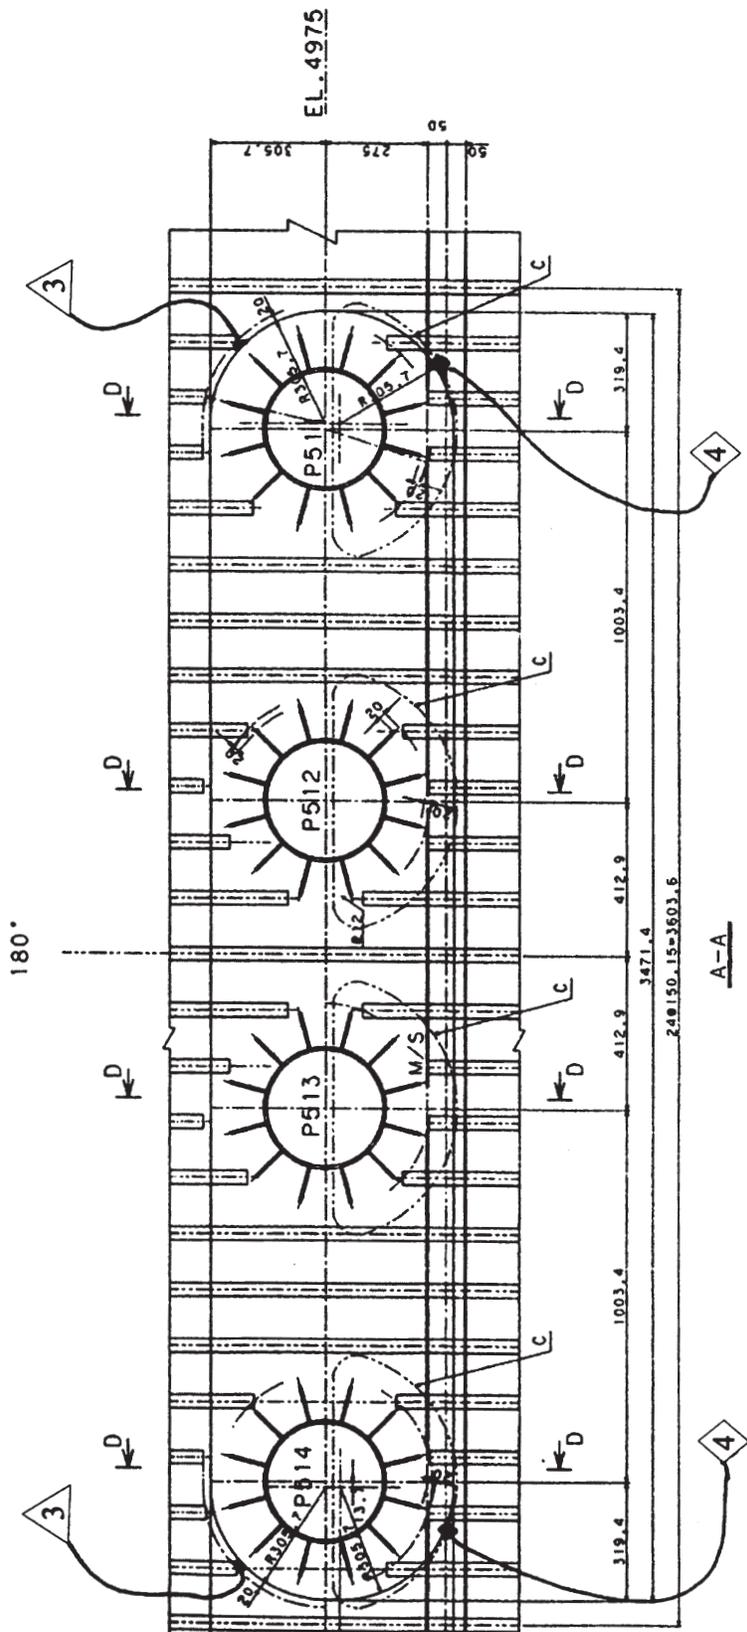
Figure 7-45. Strain Concentration Type 3 and 4 Near M/S Penetrations

Figure 7-45 shows the M/S penetration geometry and the strain concentration locations predicted in the pretest work. Similar conditions exist at the F/W penetrations, as shown in Figure 7-46. An additional concentration location not specifically called out in Figure 7-45 is the liner-to-collar transition at the 3:00 and 9:00 positions of the penetration group (using a clock-face analogy). All of these strain concentration locations were well-instrumented for the LST, as shown in Figure 7-47. The figure also shows where tears were observed, and highlights gages at strain concentration locations that are compared to analysis. Strain versus pressure histories for all of the M/S and F/W liner strain gages are plotted in Figures 7-48 and 7-49. It is interesting to note the wide variation in peak strain measurements, even at locations that are theoretically identical; for example, locations 4 and 14 at the 9:00 and 3:00 positions of the M/S. Gage 14 measures twice as much as 4, even though nominal geometric conditions are the same. Of course, there are many contributing factors to these differences, most significantly, variations in as-built conditions—slight variations in liner thickness (due to manufacturing and weld repair grinding) from one side to the other, gage placement relative to the collar/weld, material properties (including welding heat effects), etc. Also note that many of the highest liner strains recorded anywhere on the model during the LST are near the M/S (e.g., 4.6% for gage 19) and the F/W (e.g., 6.4% for Gage 33).

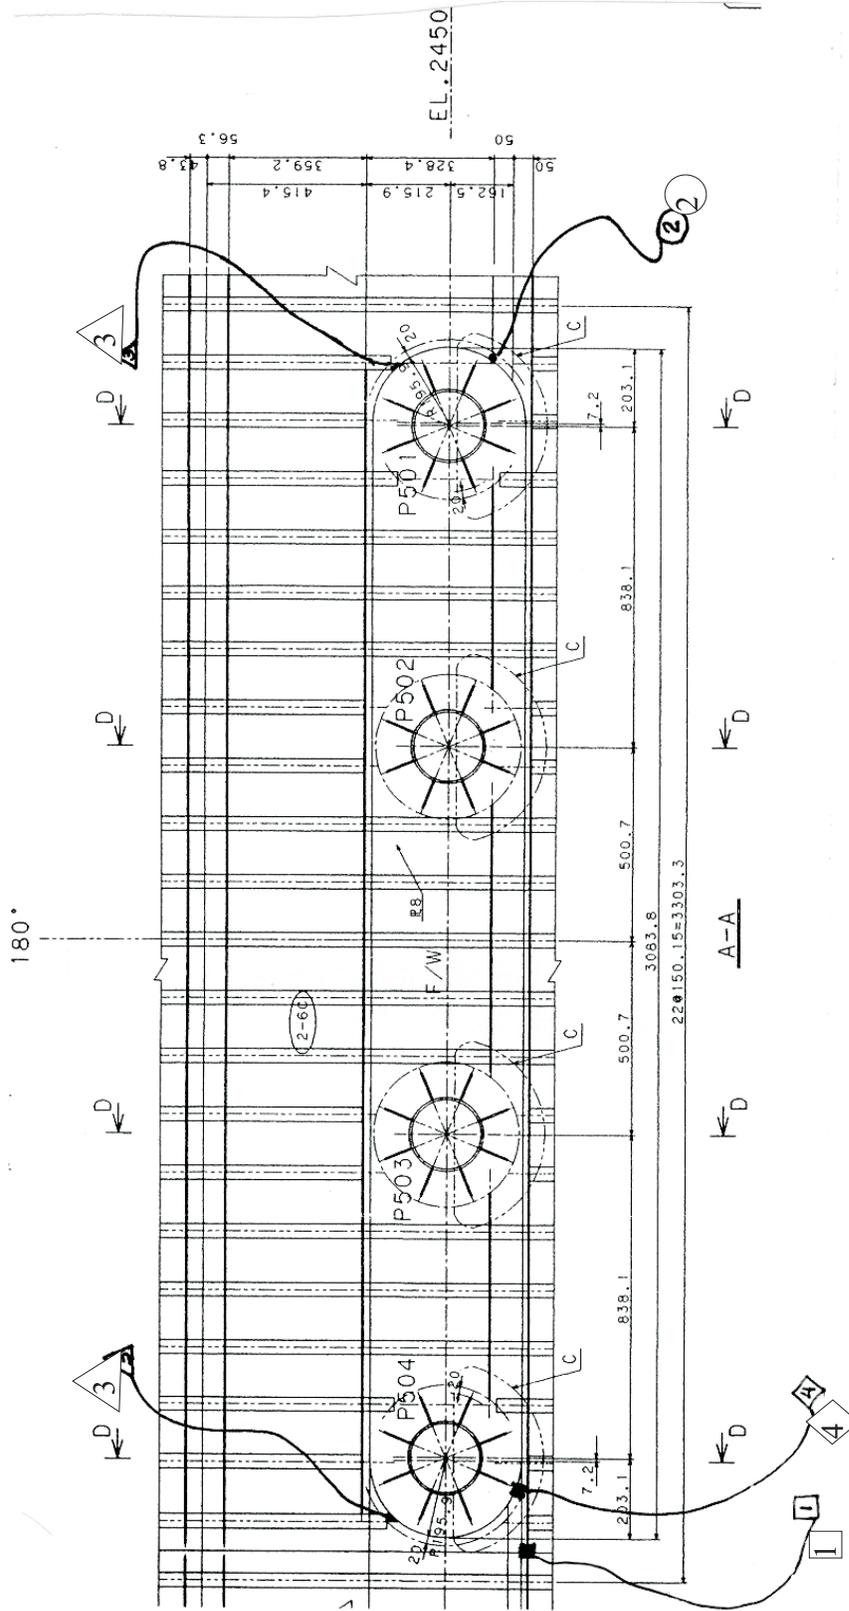
Figure 7-46. Strain Concentration Type 1, 2, 3, and 4 Near F/W Penetrations (from [1])

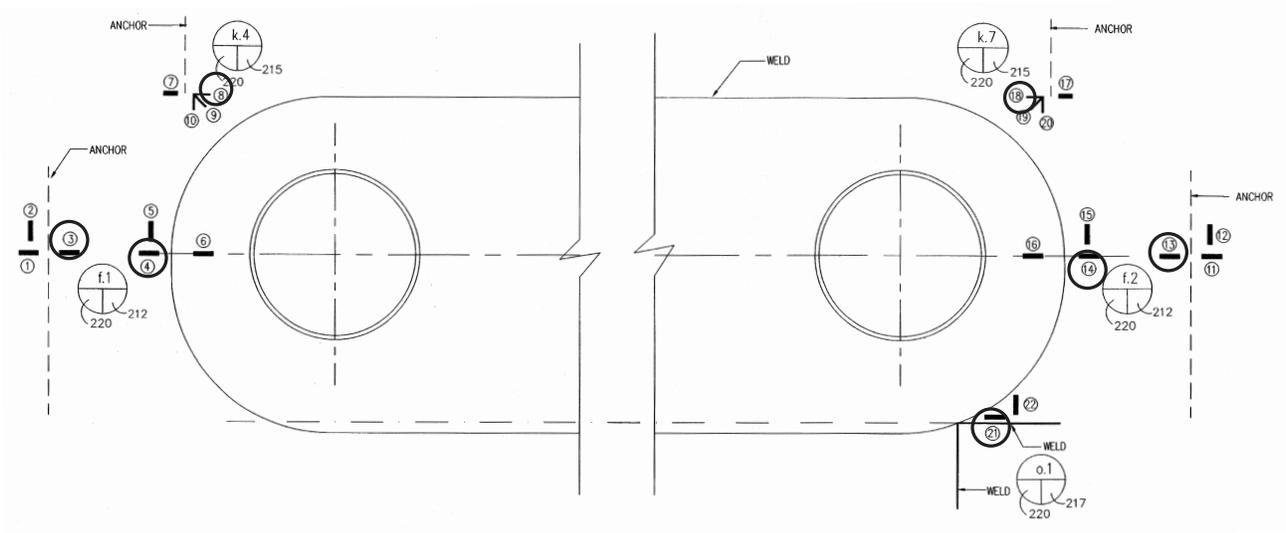
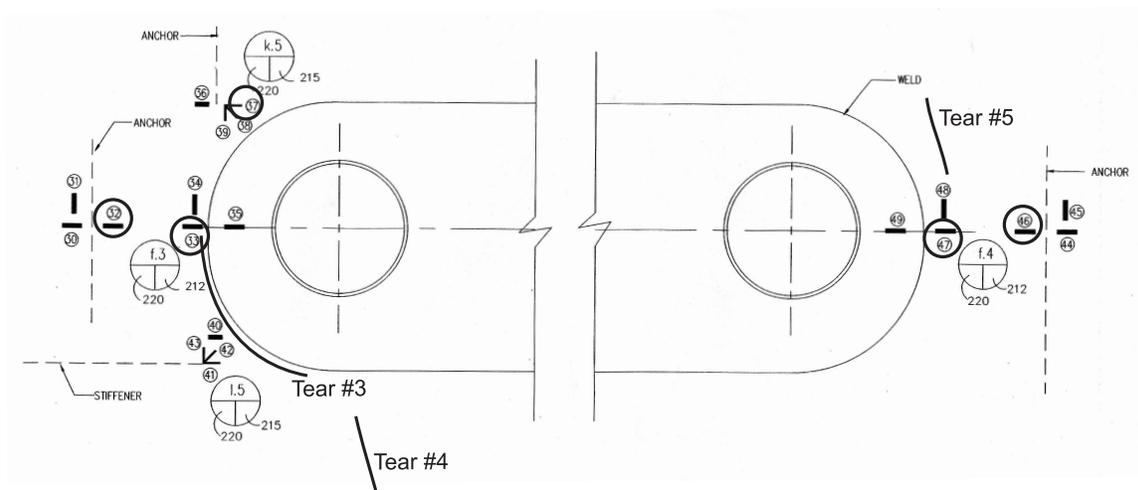
M/S - Inside View

F/W - Inside View

Figure 7-47. Strain Gage Locations Near the M/S and F/W Penetrations

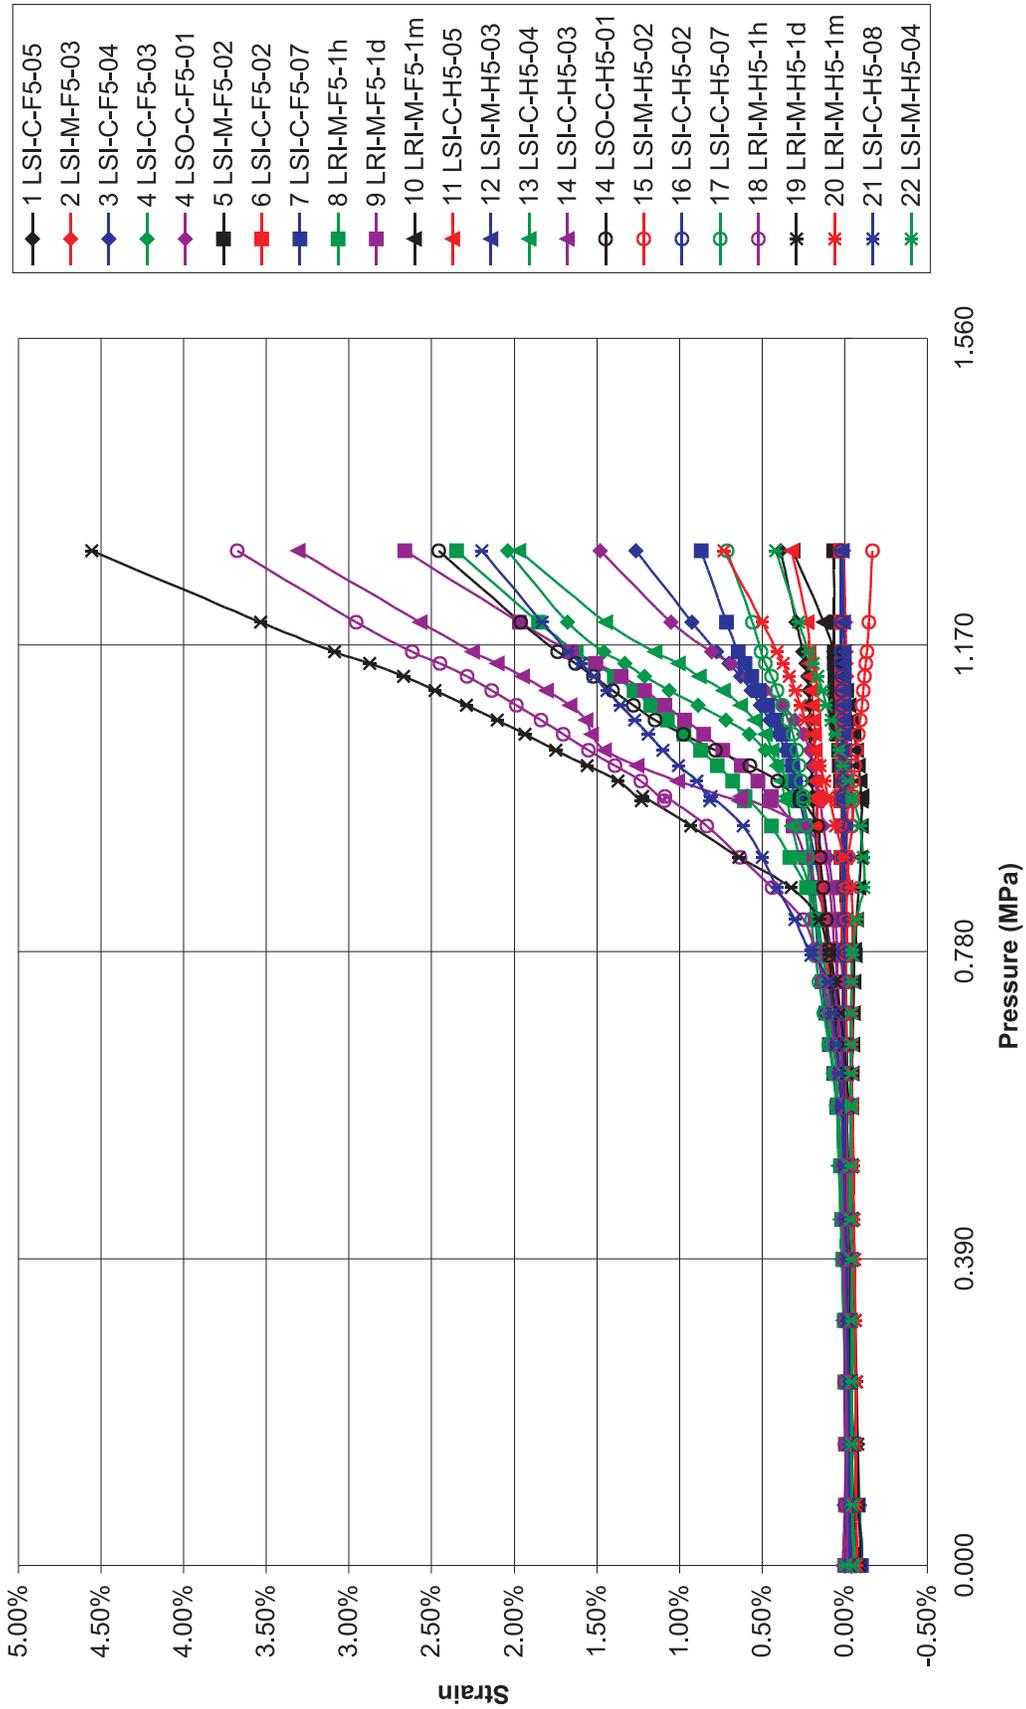
Figure 7-48. Linear Strain Histories Measured by the Gages Near the M/S Penetrations

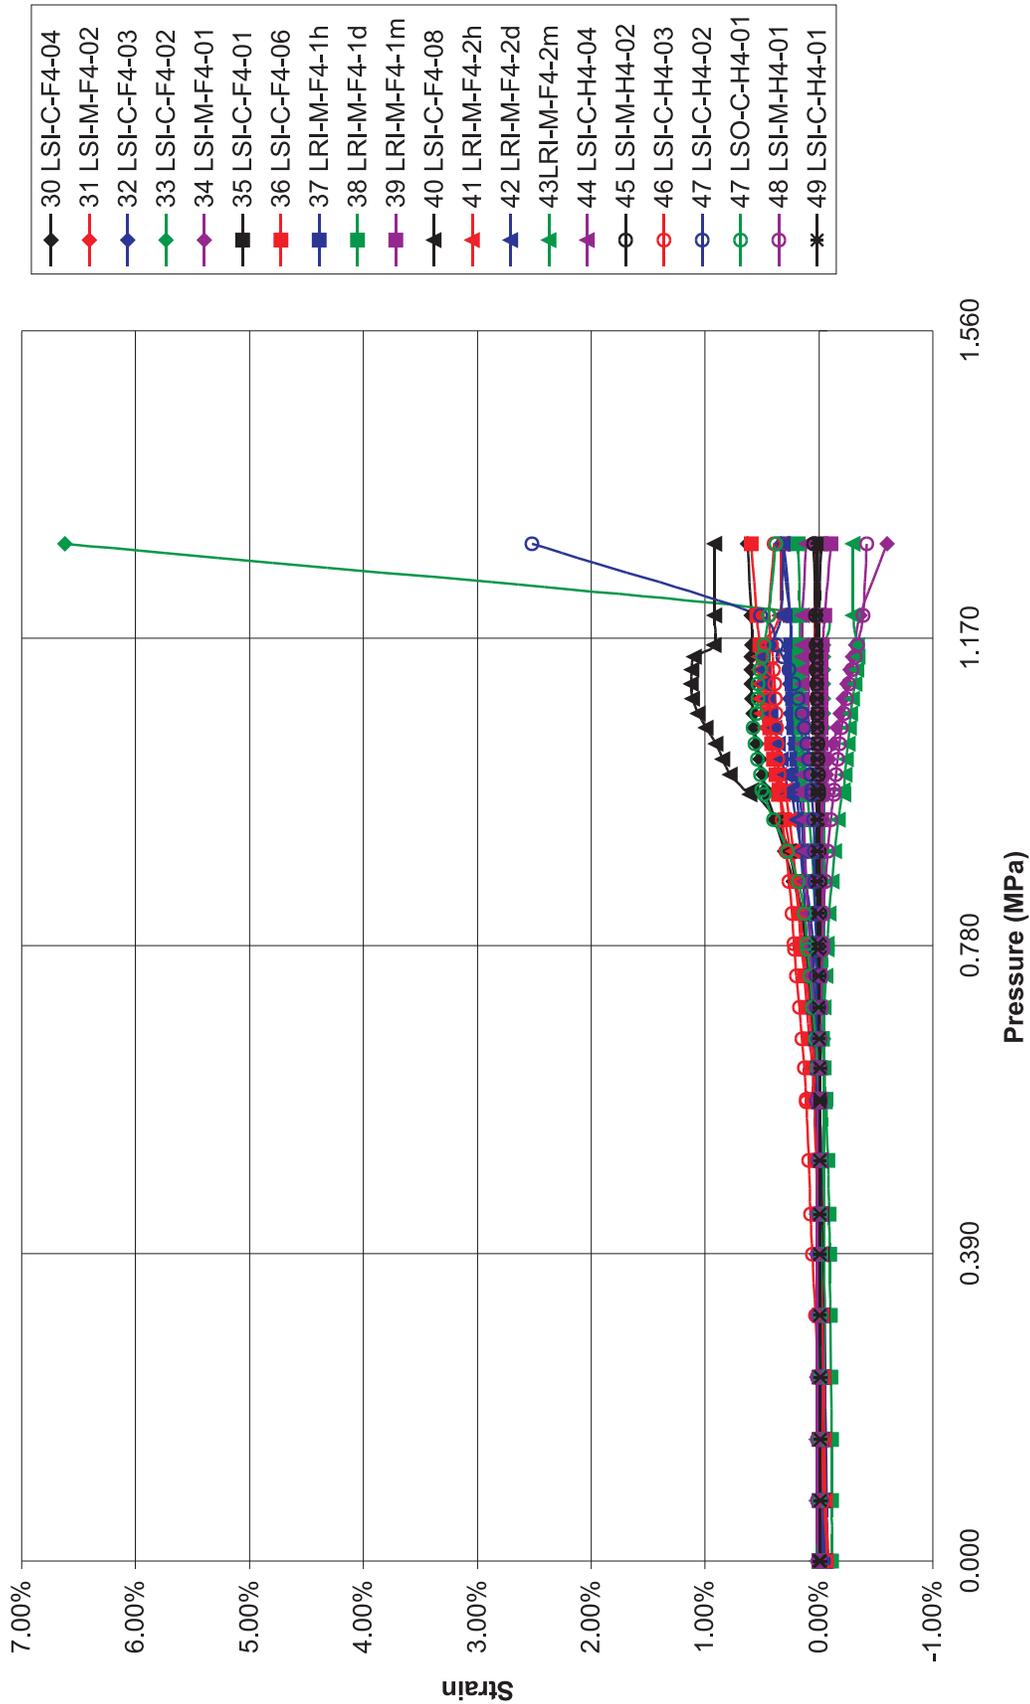
Figure 7-49. Linear Strain Histories Measured by the Gages Near the F/W Penetrations

Gages 40 and 41, which are close to the long tear (tear 3) at the F/W, have relatively low strains. Gage 40, in particular, shows evidence of rising strain prior to tear occurrence; then, starting at about 2.9 Pd, declining strain from stress relief caused by the tear.

Gage 33, on the other hand, may have been located near the tip of the crack of tear 3. Gage 33 shows quite low strain up to 3.1 Pd and then a sudden jump. This supports a hypothesis that tear 3 initiated at a pressure of 2.9 Pd at the 7:30 o'clock position (midpoint of the tear) and then between 2.9 Pd and 3.1 Pd, the tear ran along a band of equally high strain (as evidenced by analysis) around the perimeter of the thickened collar and up to nearly the 9 o'clock position. When it reached that position, Gage 33 shot up due to localized crack tip effects.

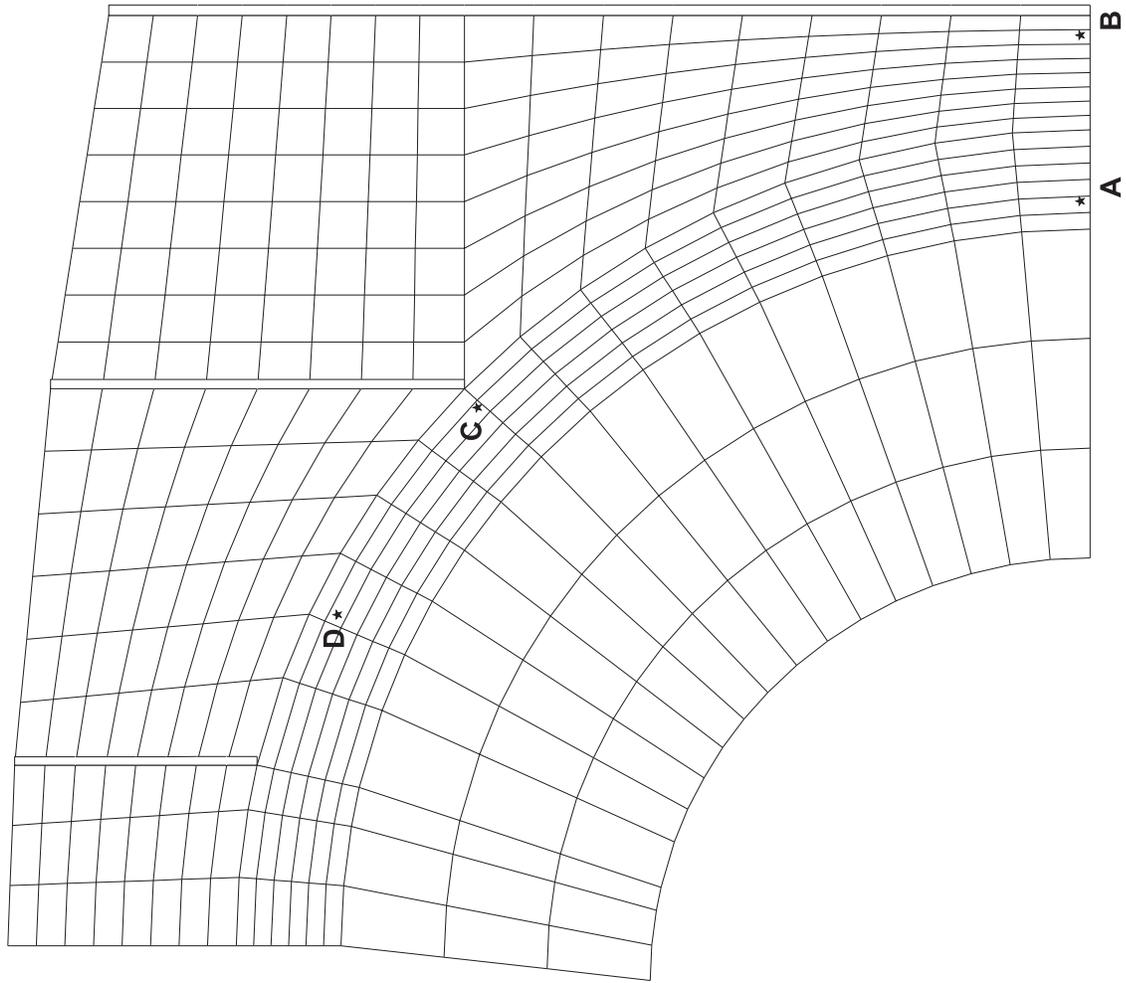
Figure 7-50. Liner Strain Locations for Comparing Analysis to M/S and F/W Gage Measurements

Figure 7-50 shows the locations extracted from the local penetration analysis to compare liner strains with the M/S and F/W measurements. The locations are labeled A, B, C, and D. Figures 7-51 through 7-54 compare the M/S and F/W liner strain gages that correspond to these locations. These figures show that the posttest analysis of the M/S penetrations captures the strains measured in the LST quite well for both the M/S and F/W penetrations. Note that the free-field hoop strains near the F/W are 10% - 15% lower than at the M/S (based on measured radial displacement), explaining why measured strains near the M/S were initially larger than near the F/W. It is likely, however, that the occurrence of tears at the F/W versus non-tears at the M/S is due to the more extensive weld repair in the F/W area.

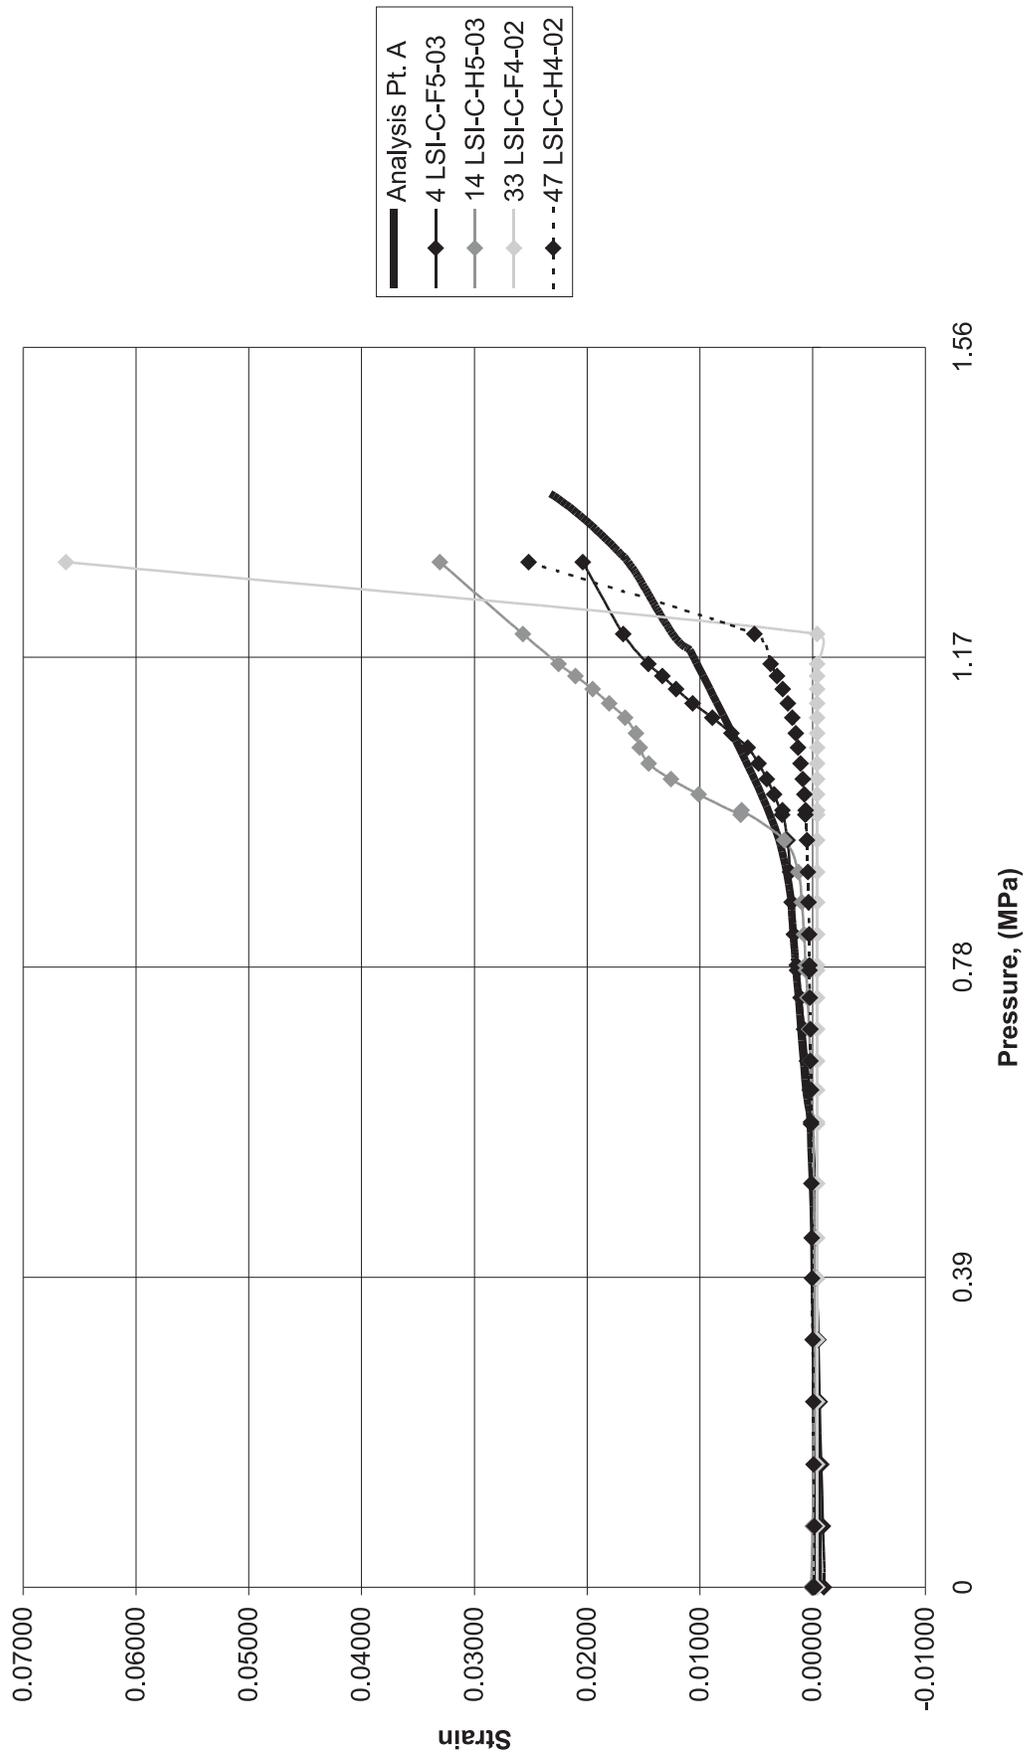
Figure 7-51. M/S and F/W Test vs. Analysis Linear Strain Comparisons at Location "A,"
Near Collar Insert, 3:00, 9:00 Position
