7.0 REVISED LOCAL PENETRATION POSTTEST MODEL ANALYSES

7.1 Overview of Pretest Local Models

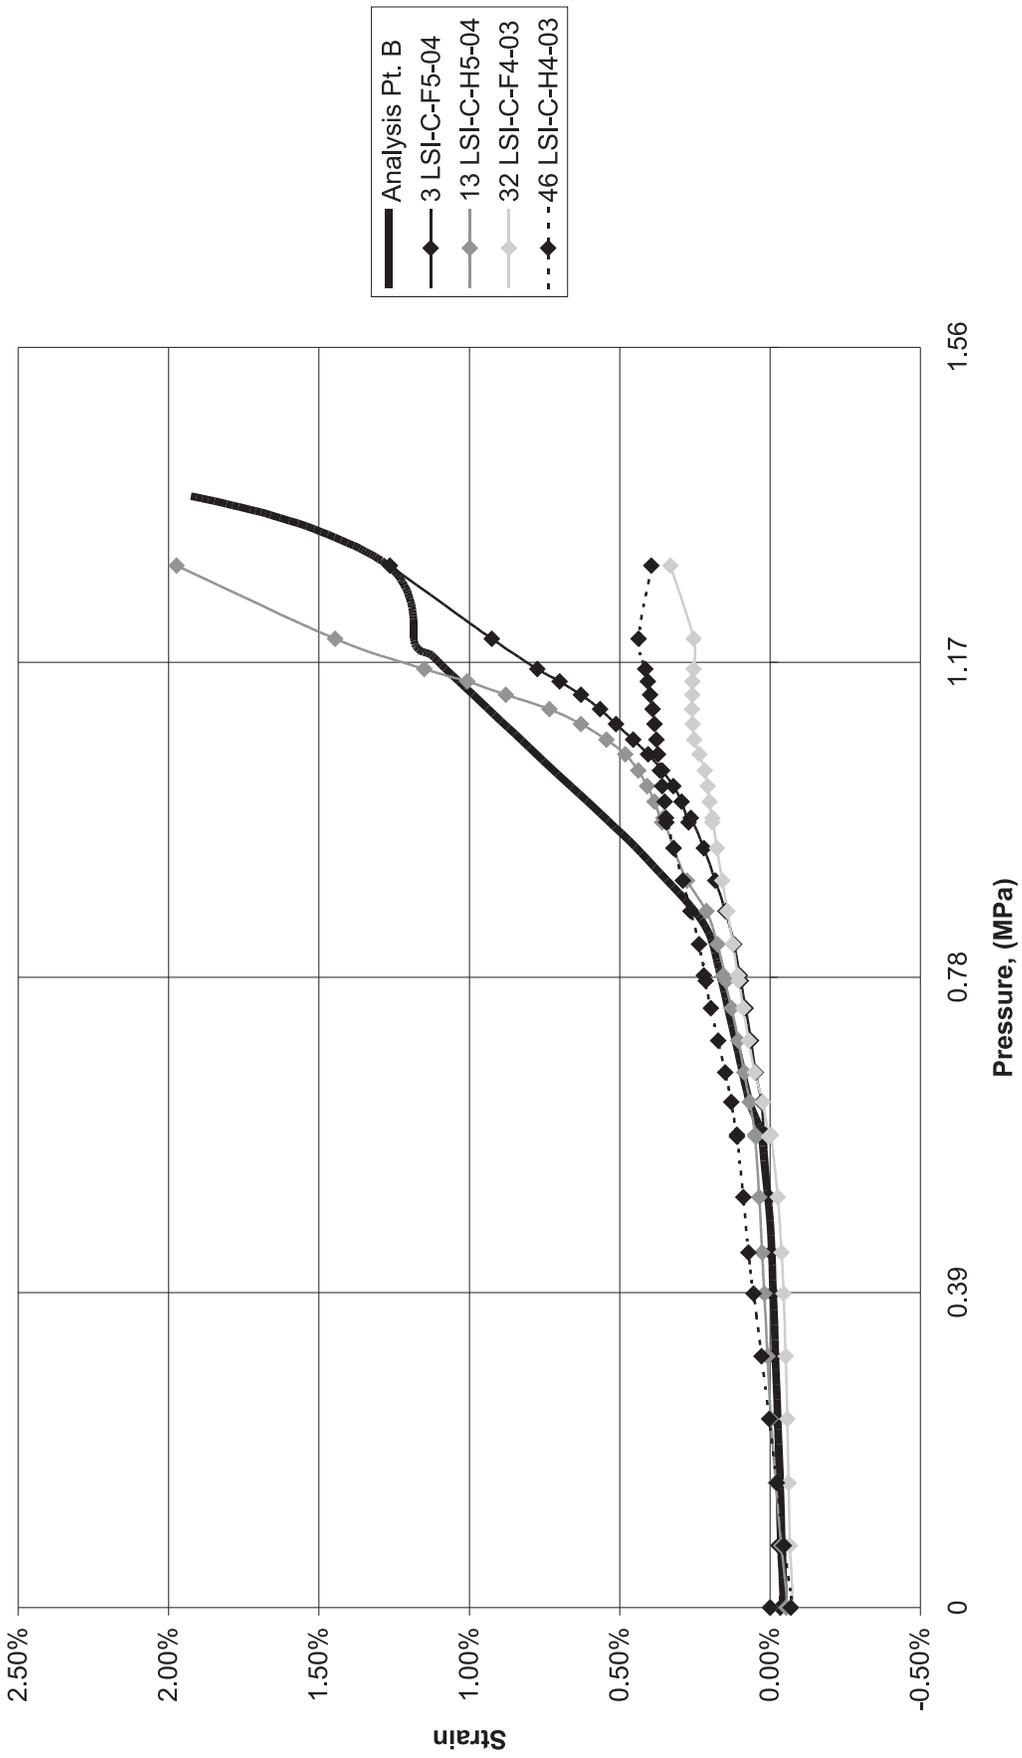
Figure 7-52. M/S and F/W Test vs. Analysis Linear Strain Comparisons at Location "B,"
Near T-Anchor, 3:00, 9:00 Position

Figure 7-50 shows the locations extracted from the local penetration analysis to compare liner strains with the M/S and F/W measurements. The locations are labeled A, B, C, and D. Figures 7-51 through 7-54 compare the M/S and F/W liner strain gages that correspond to these locations. These figures show that the posttest analysis of the M/S penetrations captures the strains measured in the LST quite well for both the M/S and F/W penetrations. Note that the free-field hoop strains near the F/W are 10% - 15% lower than at the M/S (based on measured radial displacement), explaining why measured strains near the M/S were initially larger than near the F/W. It is likely, however, that the occurrence of tears at the F/W versus non-tears at the M/S is due to the more extensive weld repair in the F/W area.

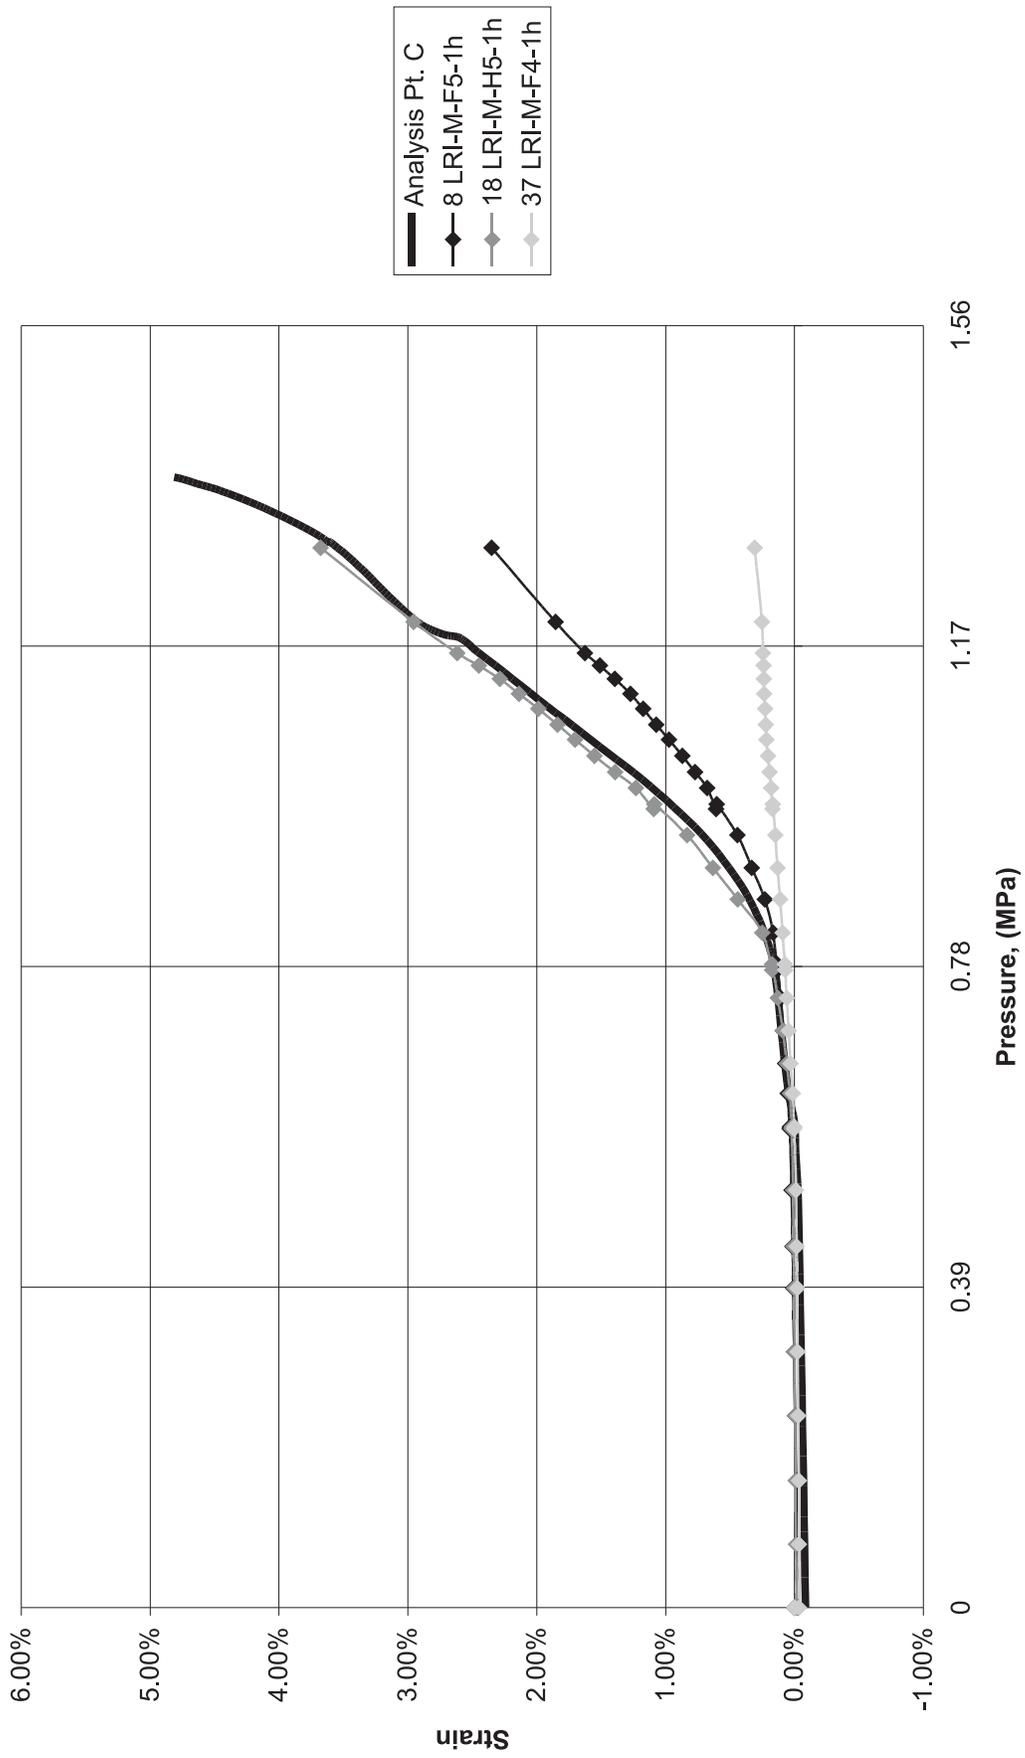
Figure 7-53. M/S and F/W Test vs. Analysis Linear Strain Comparisons at Location "C,"
Near T-Anchor, 3:00, 9:00 Position

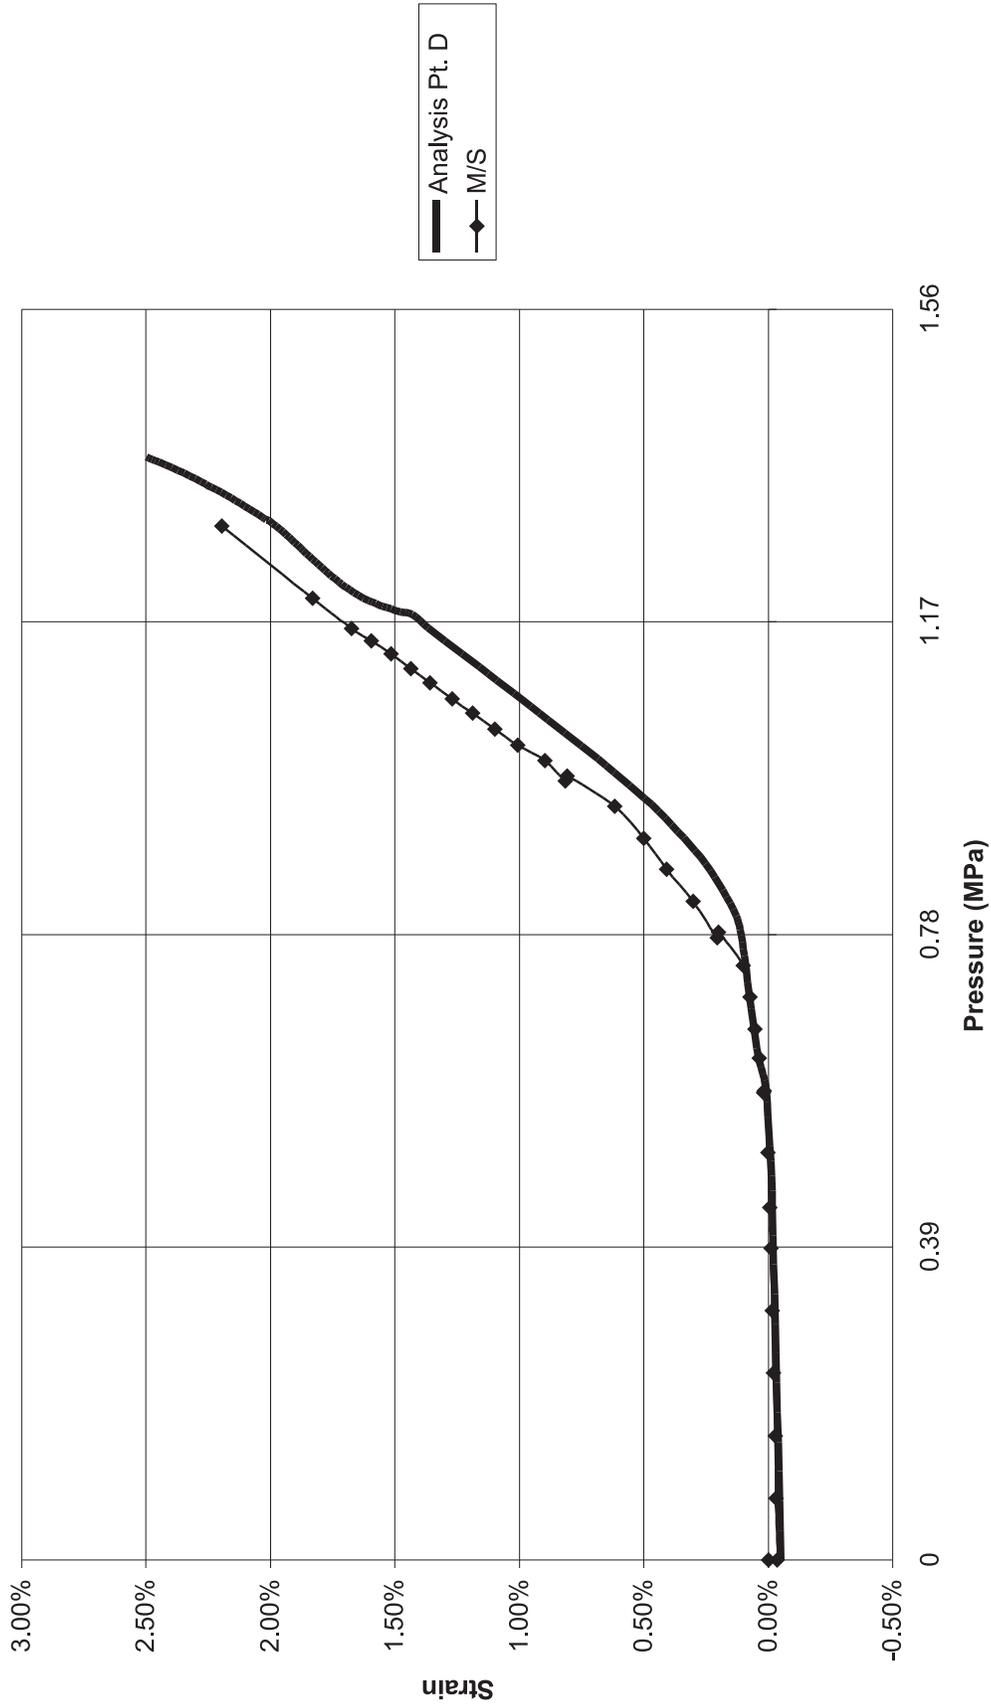
Figure 7-54. M/S Test vs. Analysis Linear Strain Comparisons at Location "D,"
Near Weld-Corner, 3:00, 9:00 Position.
