Generic Issue 87: Flexible Wedge Gate Valve Test Program

Phase II Results and Analysis

Prepared by
R. Steele, Jr., K. G. DeWall, J. C. Watkins

Idaho National Engineering Laboratory
EG&G Idaho, Inc.

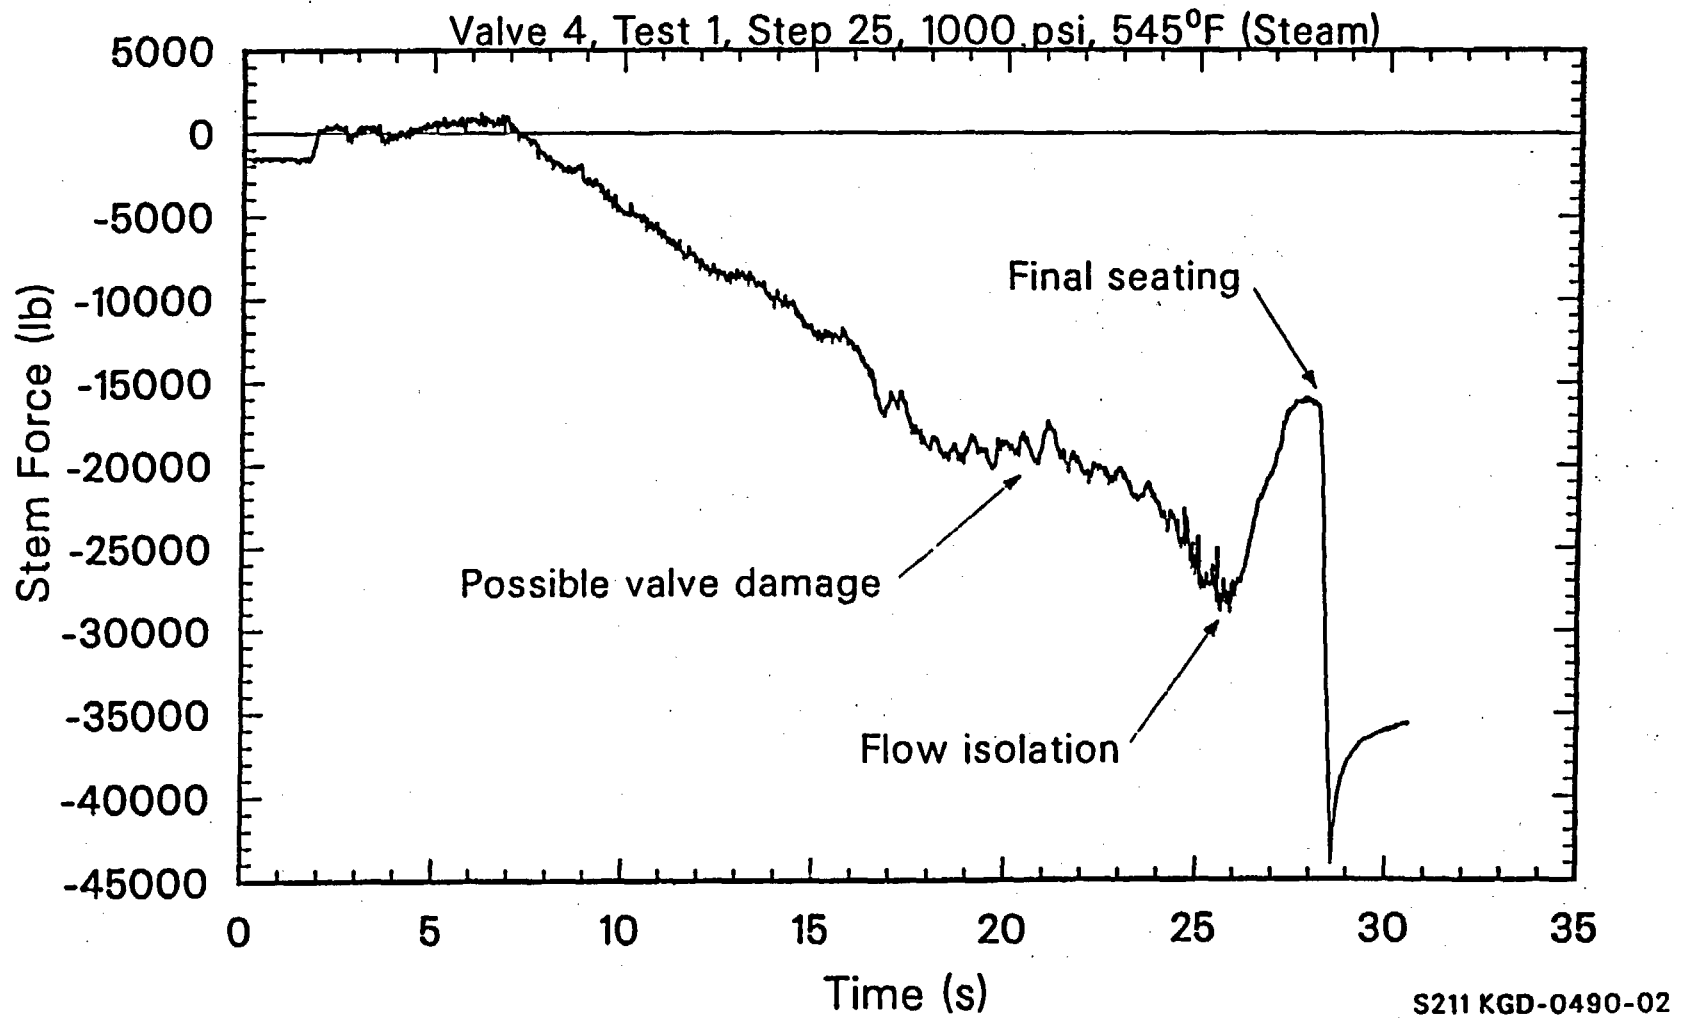
- To determine if the valve had been damaged during the test. Valve stem force plots are very good indicators of valves sustaining damage during the high flow tests (see Figure 6).

Figure 6. Valve stem force history from Phase II testing shows nonlinear performance of the valve, indicating valve damage.

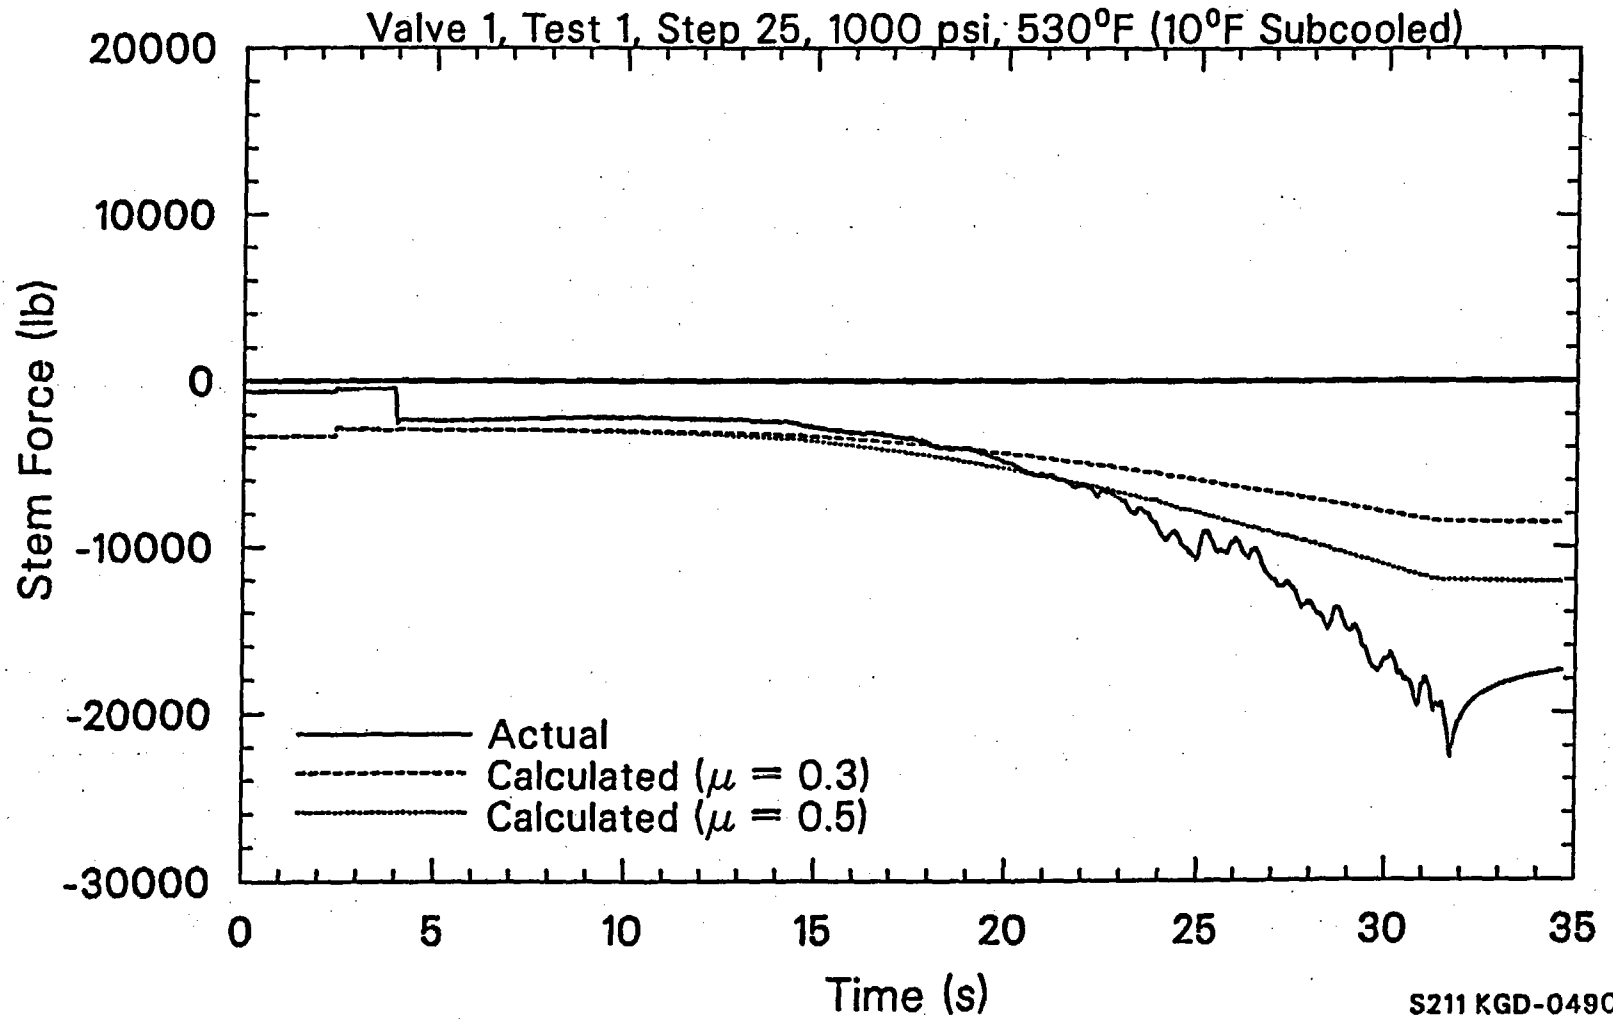
Figure 7. Valve 1 in Phase II, 6-in. RWCU system valve, same as Valve A in Phase I, nonhardfaced guides, refurbished, and tested with the opposite end as the inlet at line break flow, comparing actual versus predicted stem force.

The nonpredictable valve response is exhibited in Figures 7, 10, 11, and to some degree, in Figure 12. The stem force history in Figure 7 departs radically from the calculations, and the stem force load recovers at seating in Figures 10 and 11. There is no recovery in Figure 7 because the valve did not fully seat. We will be discussing this anomaly later in the report; however, in the Phase I test series we did seat the valve and it exhibited the same characteristics as seen in Figures 10 and 11. You will also note commonality (the sawtooth characteristic) in the three stem force histories. Posttest inspection of these valves showed this jagged response to be representative of internal damage occurring to the valve guide and seating surface. The damage took three forms: plastic deformation of the guides, ripping and gouging of the guide surfaces, and the disc machining off part of the body seat surface during the closing stroke. The INEL believes all three of the damage mechanisms were allowed by the clearance between the disc and valve body guide surfaces. The clearances were great enough to allow the flow forces to tip the disc downstream, as demonstrated in Figure 14. Damage was observed when the clearances were great enough to allow the nose of the disc to contact the seat sealing surface. The tipping disc also reduced the contact area on the guide surface, concentrating the disc load on a smaller surface area. The yield strength of the material was exceeded, resulting in one of the above damage mechanisms depending on the relative roughness of the disc body guide surfaces. The rougher surfaces ripped and gouged the smoother surfaces. Some valves exhibited combinations of both guide and sealing surface damage. Those valves without antirotation features on the stem also showed that stem torque reacting on the disc influenced the damage. One side of the disc was damaged more than the other. Figures 15 through 19 are photographs of representative damage.

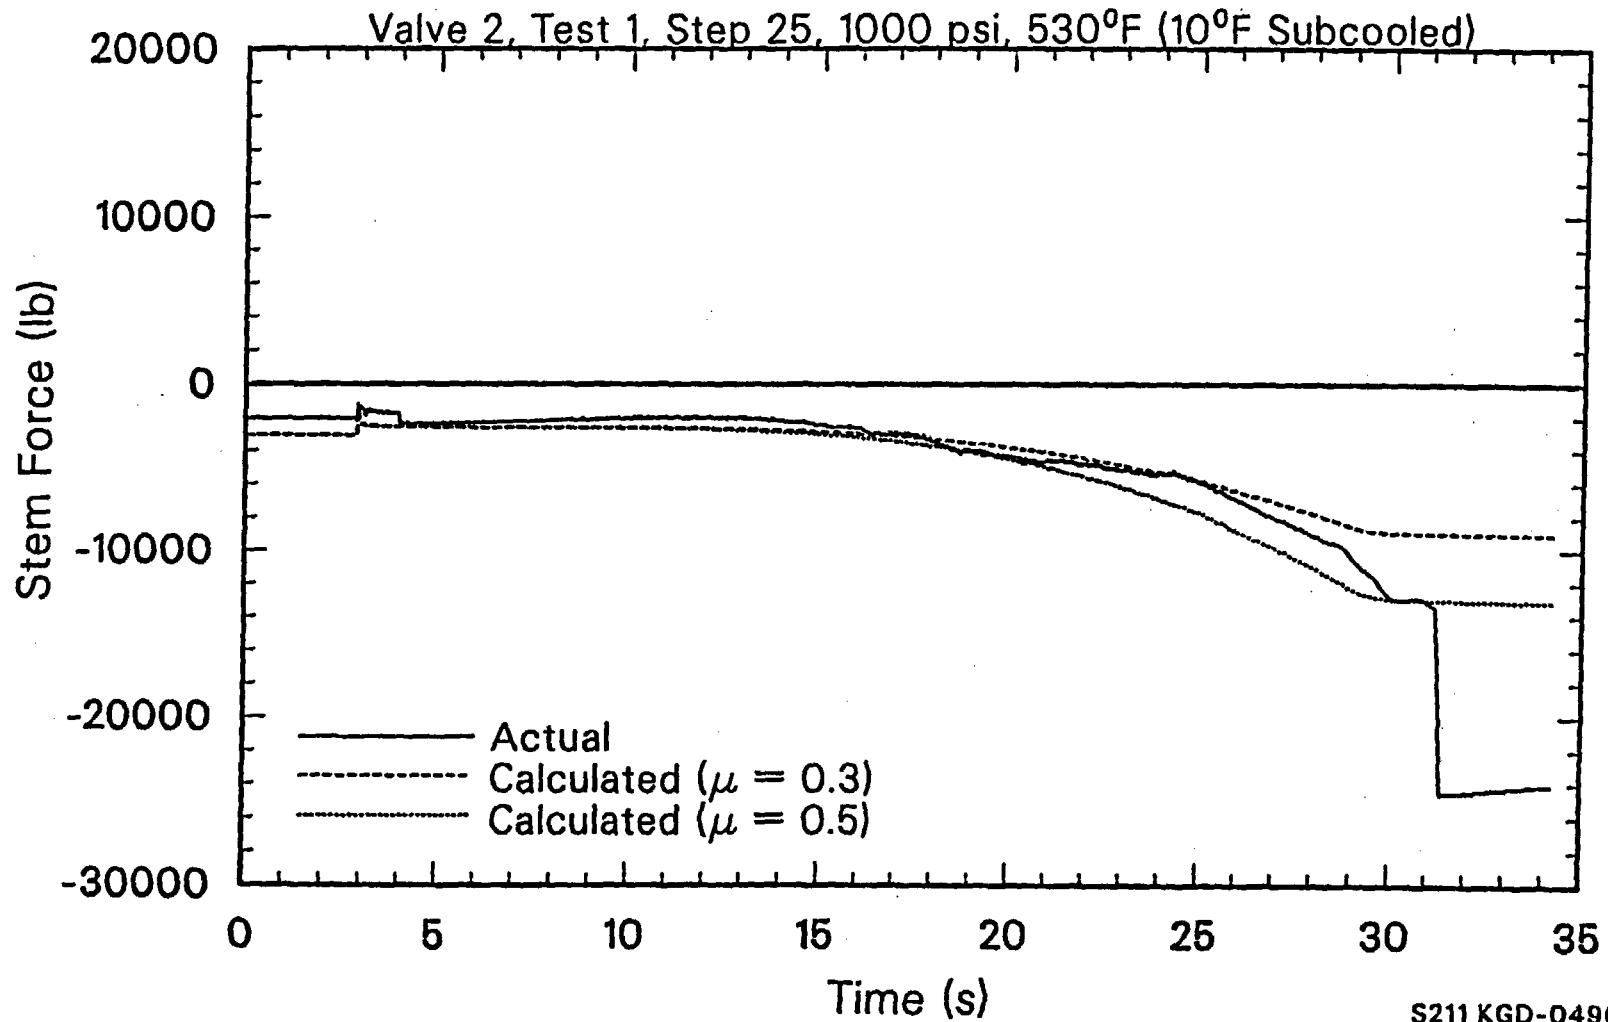
Figure 8. Valve 2 in Phase II, 6-in. RWCU system valve, same as Valve B in Phase I except nonhardfaced disc guides, line break flow, comparing actual versus predicted stem force.

force histories exhibit linear behavior; however, Valve 2 (Figures 8 and 13, tested with hot water and steam, respectively) follows the general trend of the calculations with a slowly increasing load. Thus, the actual valve response is not modeled by Equation (1) calculated stem force histories, but it can be bounded with a conservative disc factor. This response we have called predictable.

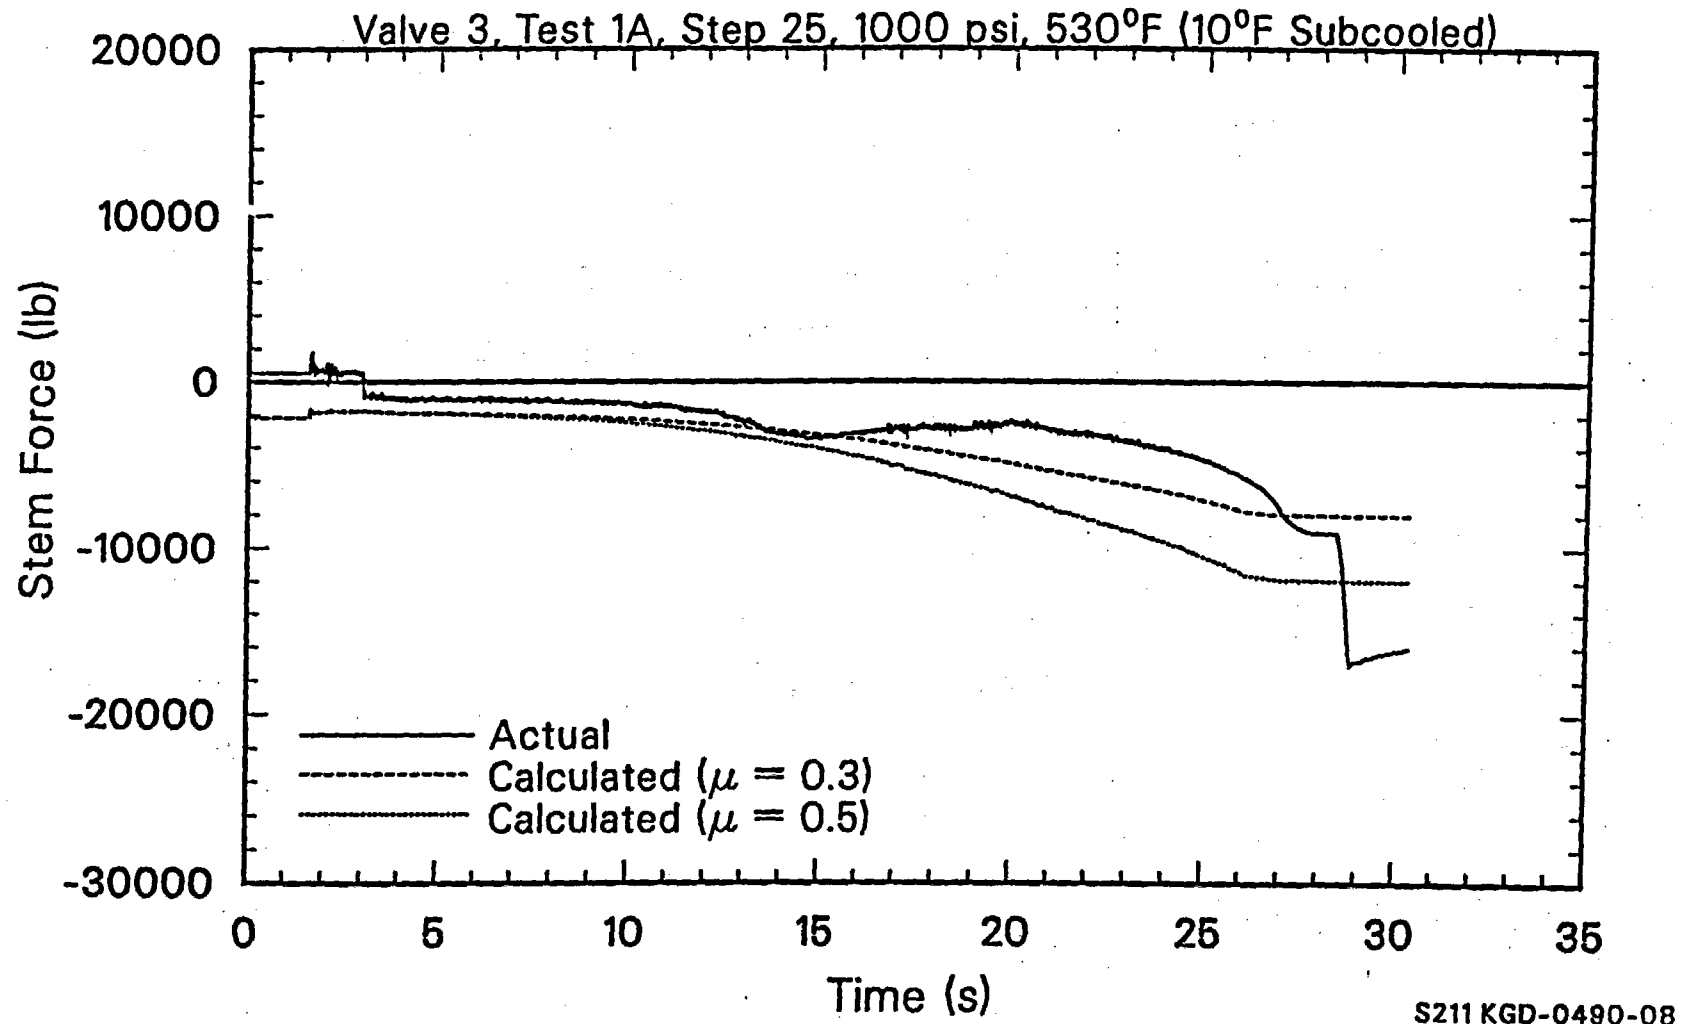
Figure 9. Valve 3 in Phase II, 6-in. RWCU system valve, nonhardfaced guide surfaces, line break flow, comparing actual versus predicted stem force.

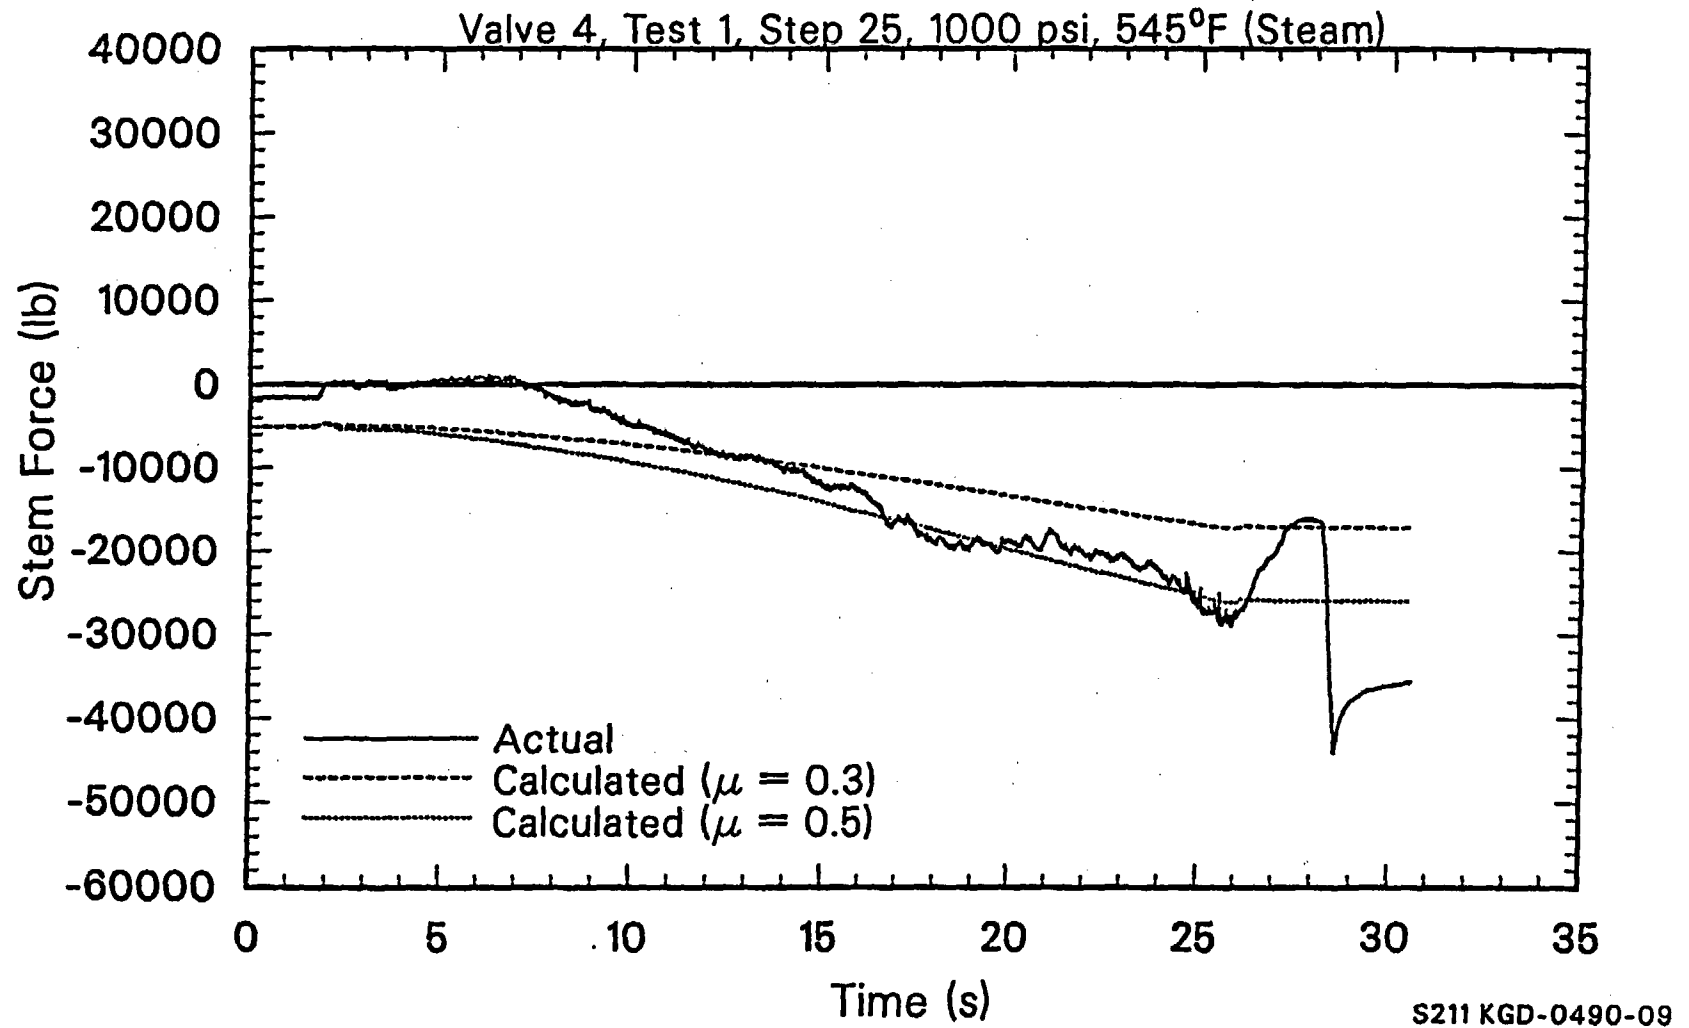
Figure 10. Valve 4 in Phase II, 10-in. HPCI system valve, nonhardfaced guide surfaces, line break flow, comparing actual versus predicted stem force.

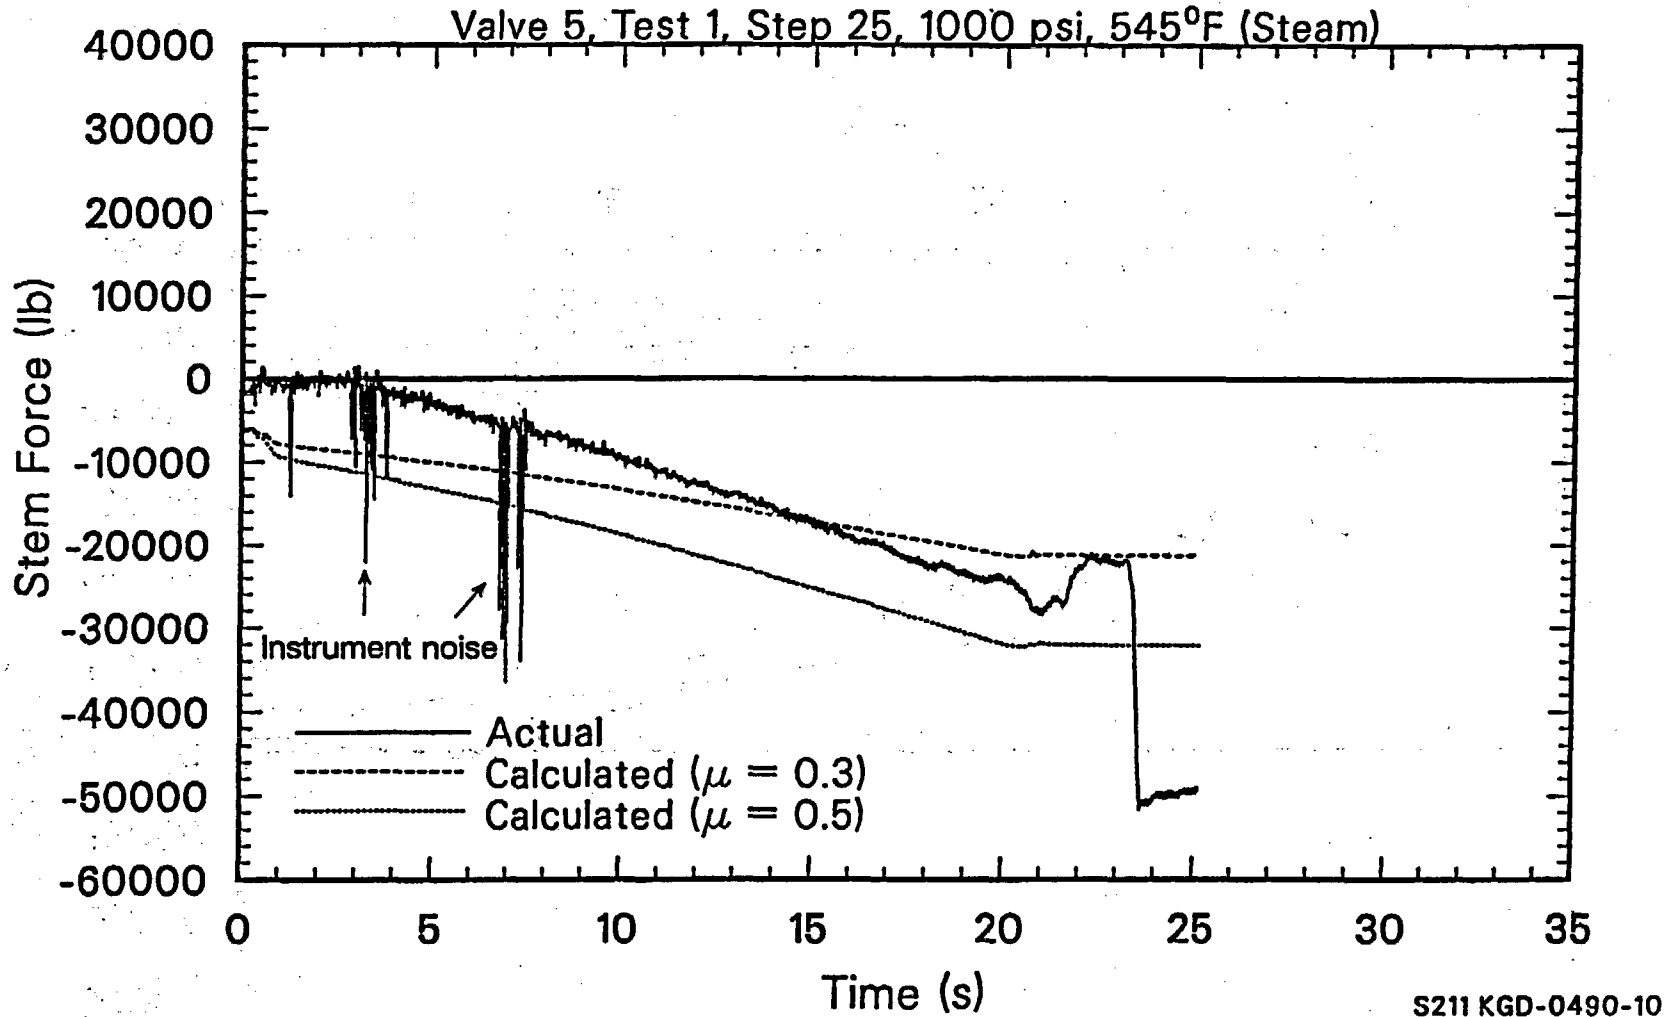
Figure 11. Valve 5 in Phase II, 10-in. HPCI system valve, nonhardfaced guide surfaces, line break flow, comparing actual versus predicted stem force.

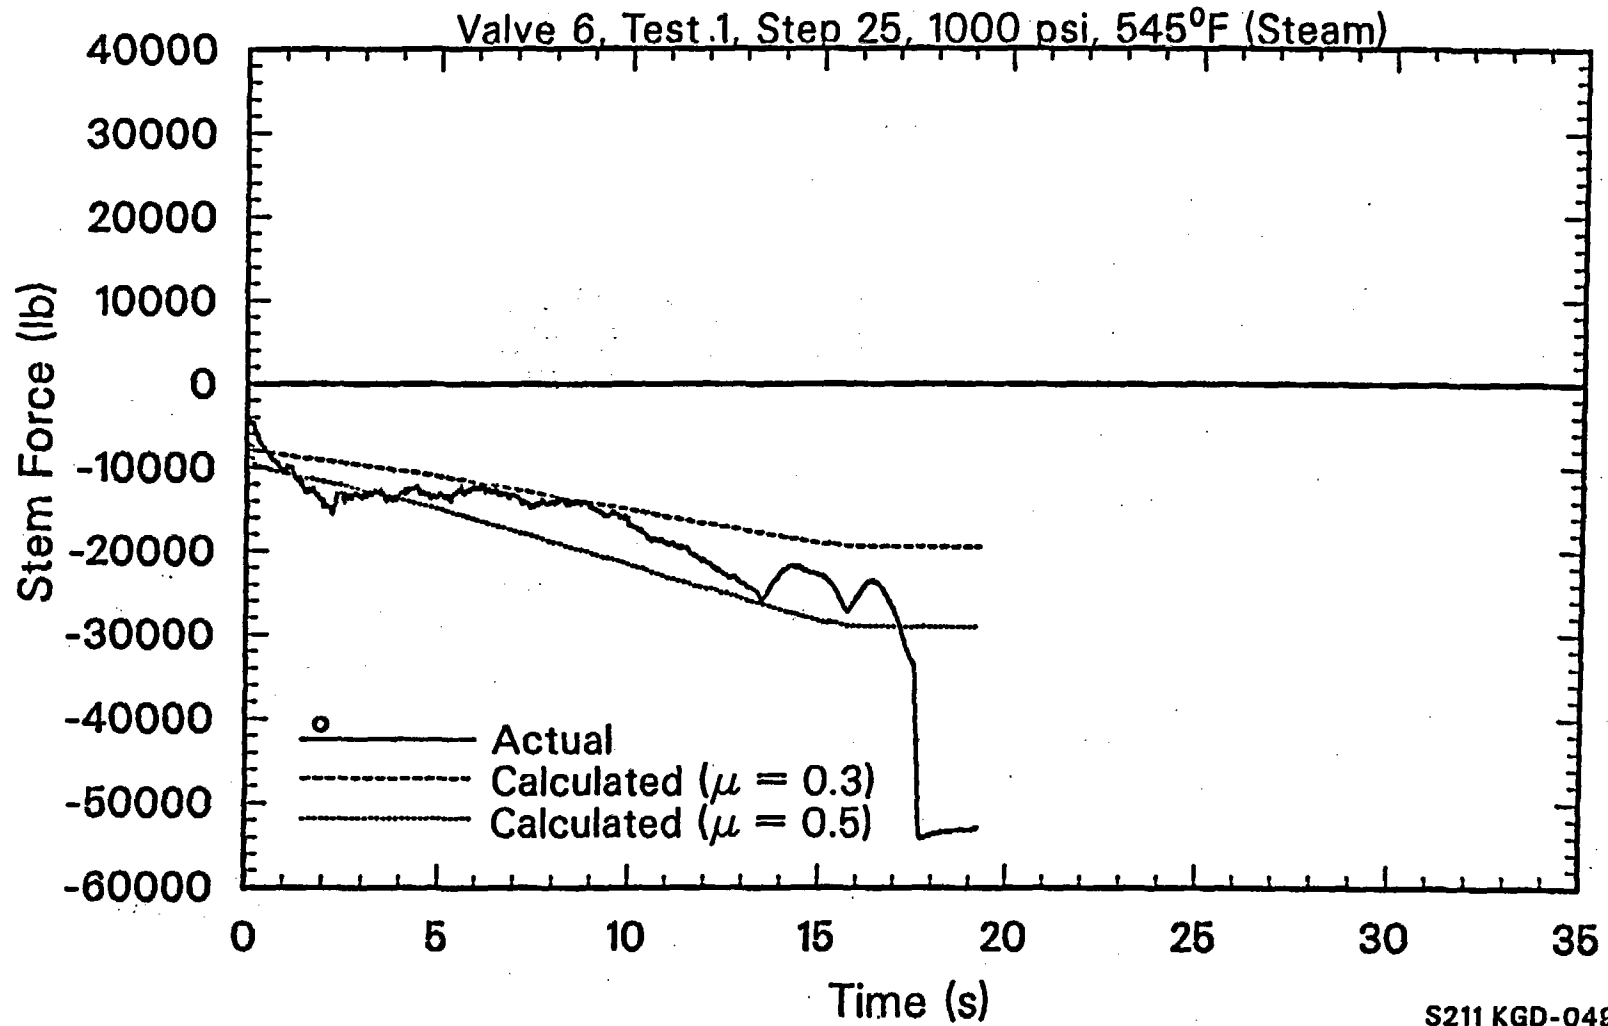
Figure 12. Valve 6 in Phase II, 10-in. HPCI system valve, nonhardfaced guide surfaces, line break flow, comparing actual versus predicted stem force.

From the stem force history and posttest inspection, it appeared that Valve 6 (Figure 12) suffered a combination of both disc guide surface damage and seat damage. These did not occur simultaneously, however. During the period of 0-5 seconds, it appeared that damage was occurring to the guide. Then, as more of the disc entered the flow stream and more seat contact was made, the disc straightened out.

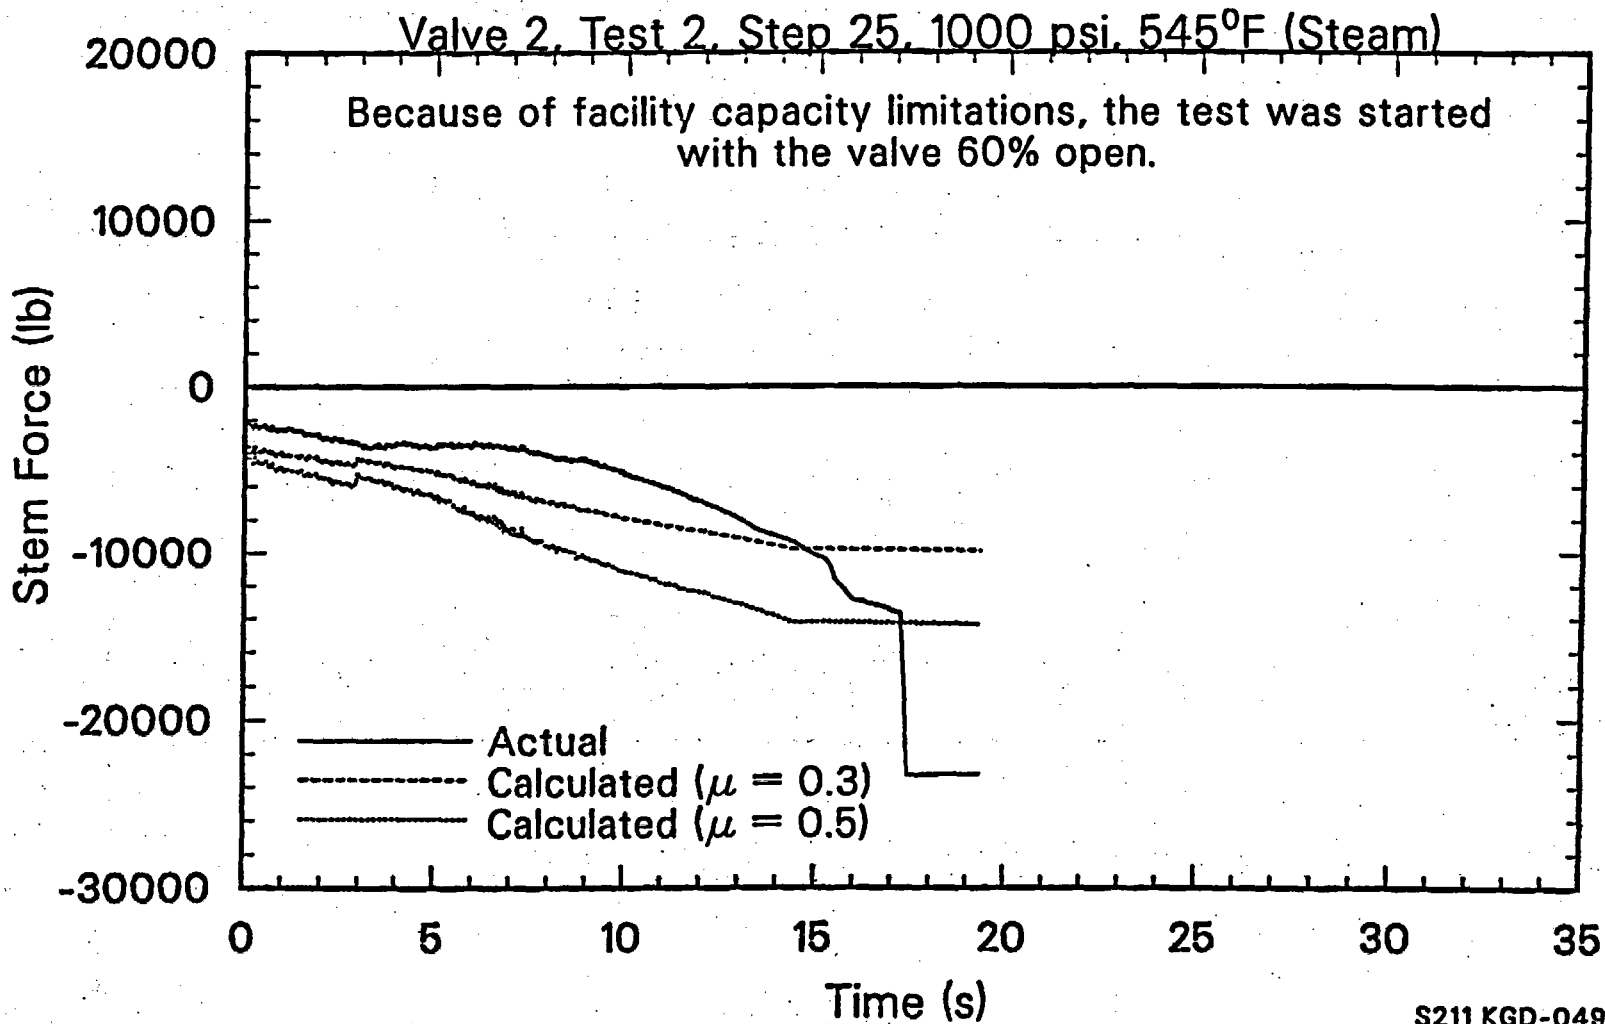
Figure 13. Valve 2 in Phase II, 6-in. RCIC system valve test, closing on line break steam flow, comparing actual versus predicted stem force.

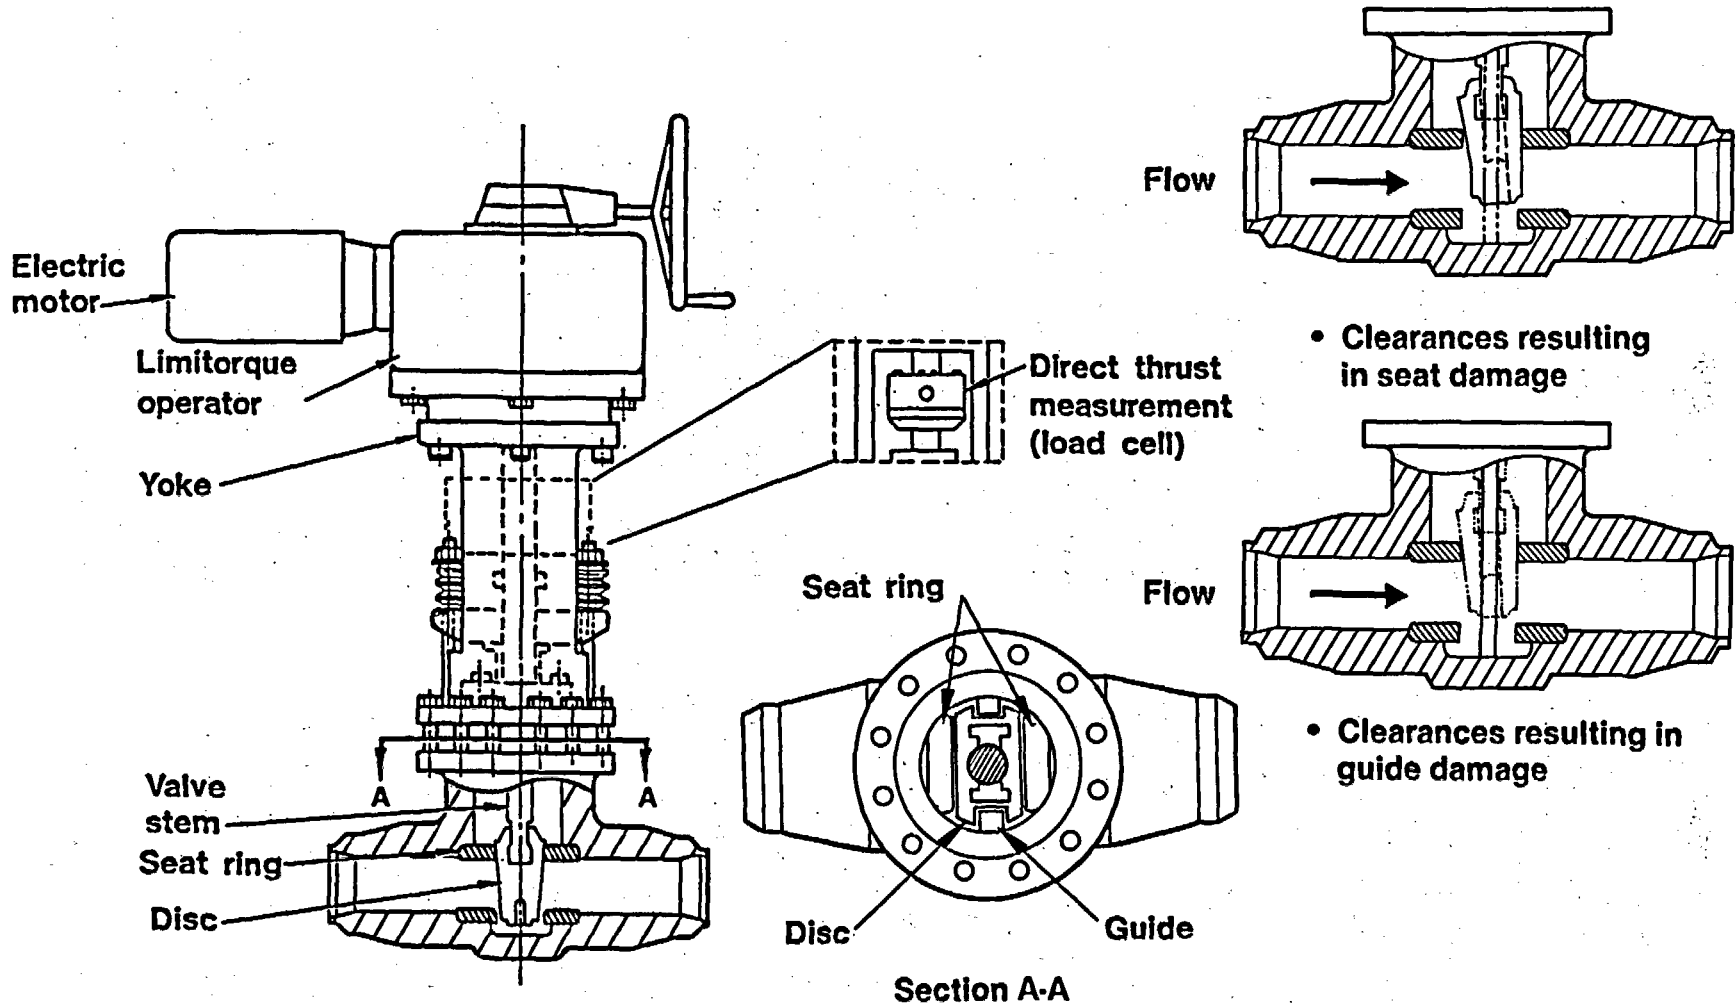
• Clearances resulting in seat damage

• Clearances resulting in guide damage

Figure 14. Gate valve cross section showing possible valve tippage during flow.

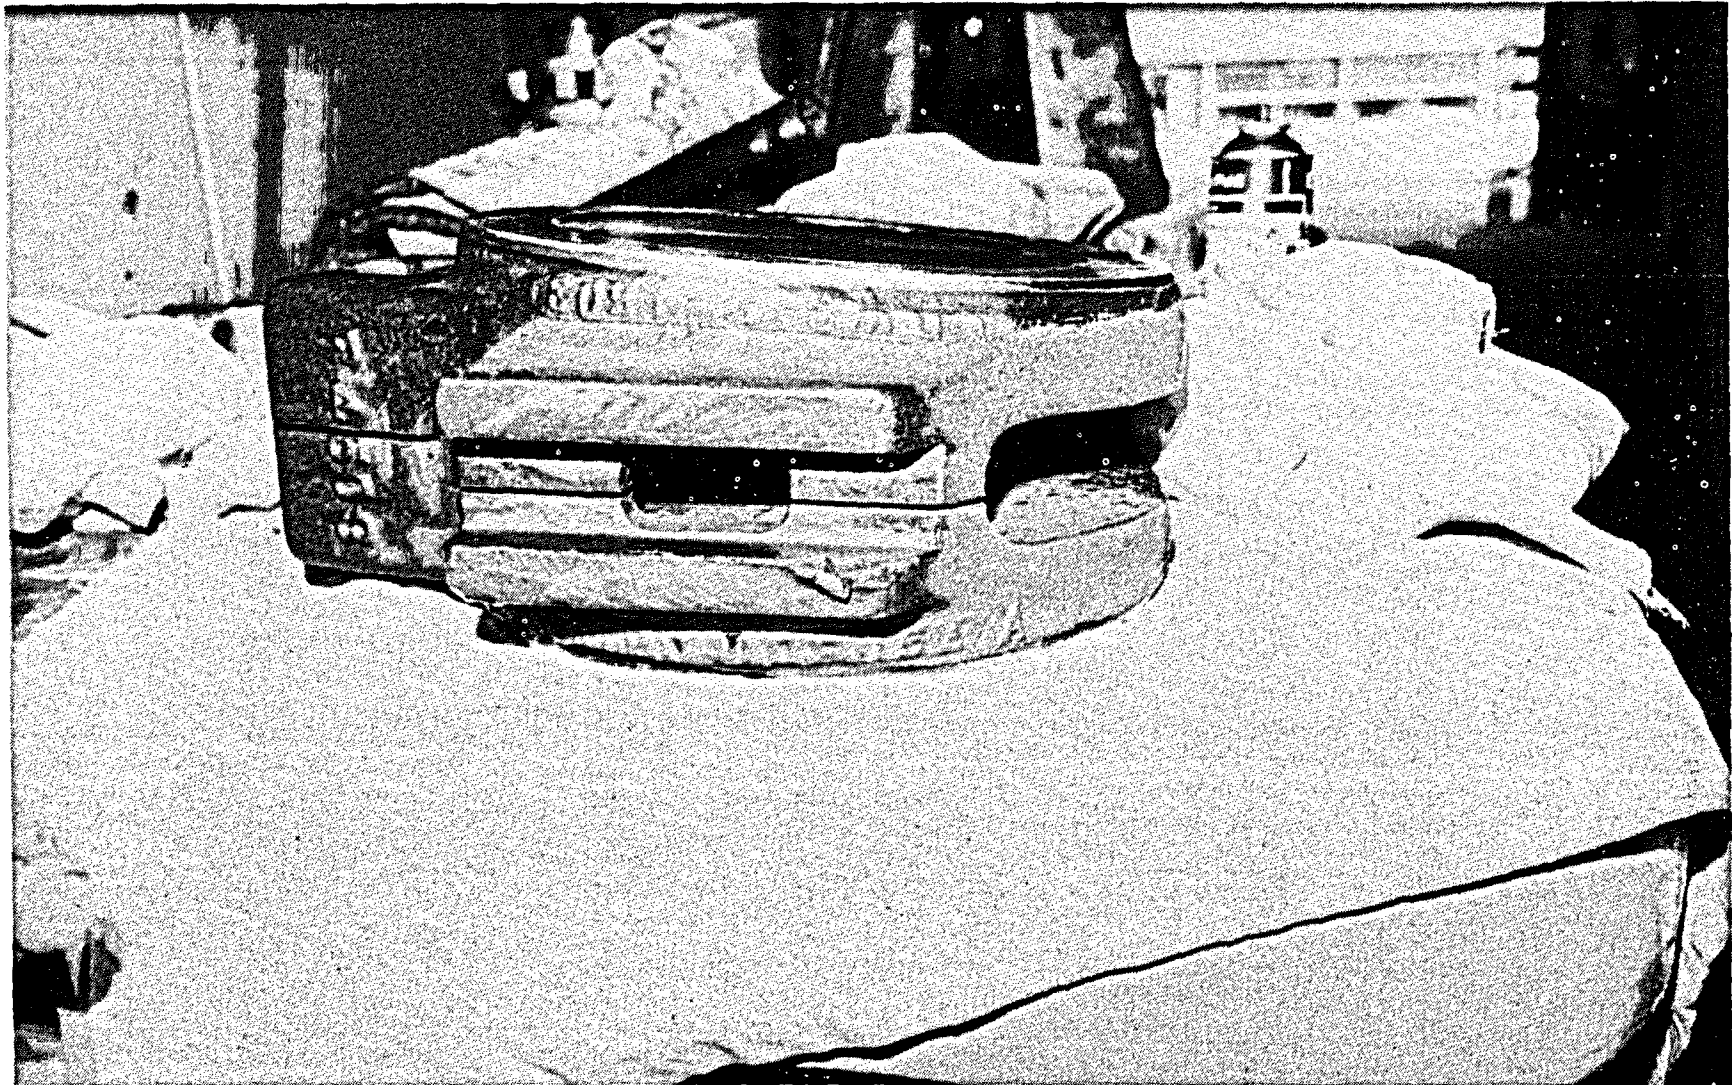
Figure 15. Typical valve damage observed.

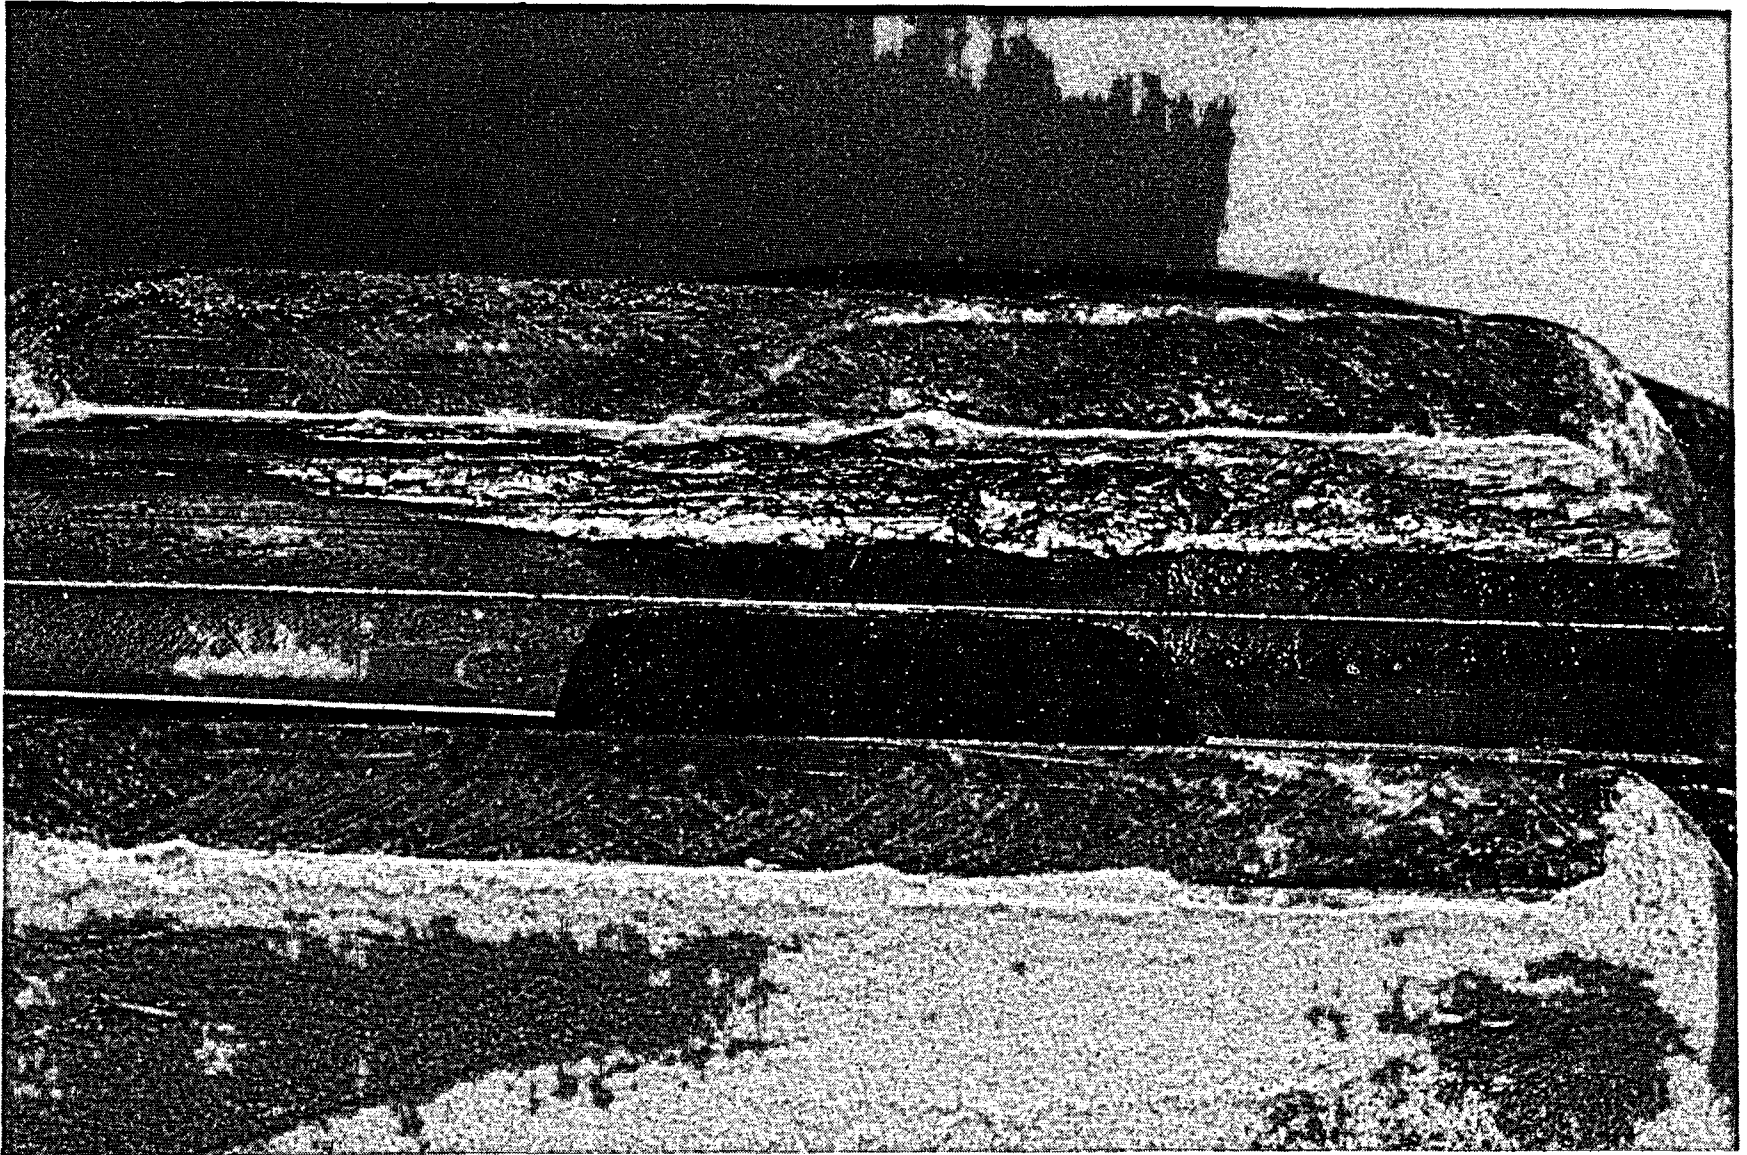
Figure 17. Typical valve damage observed.

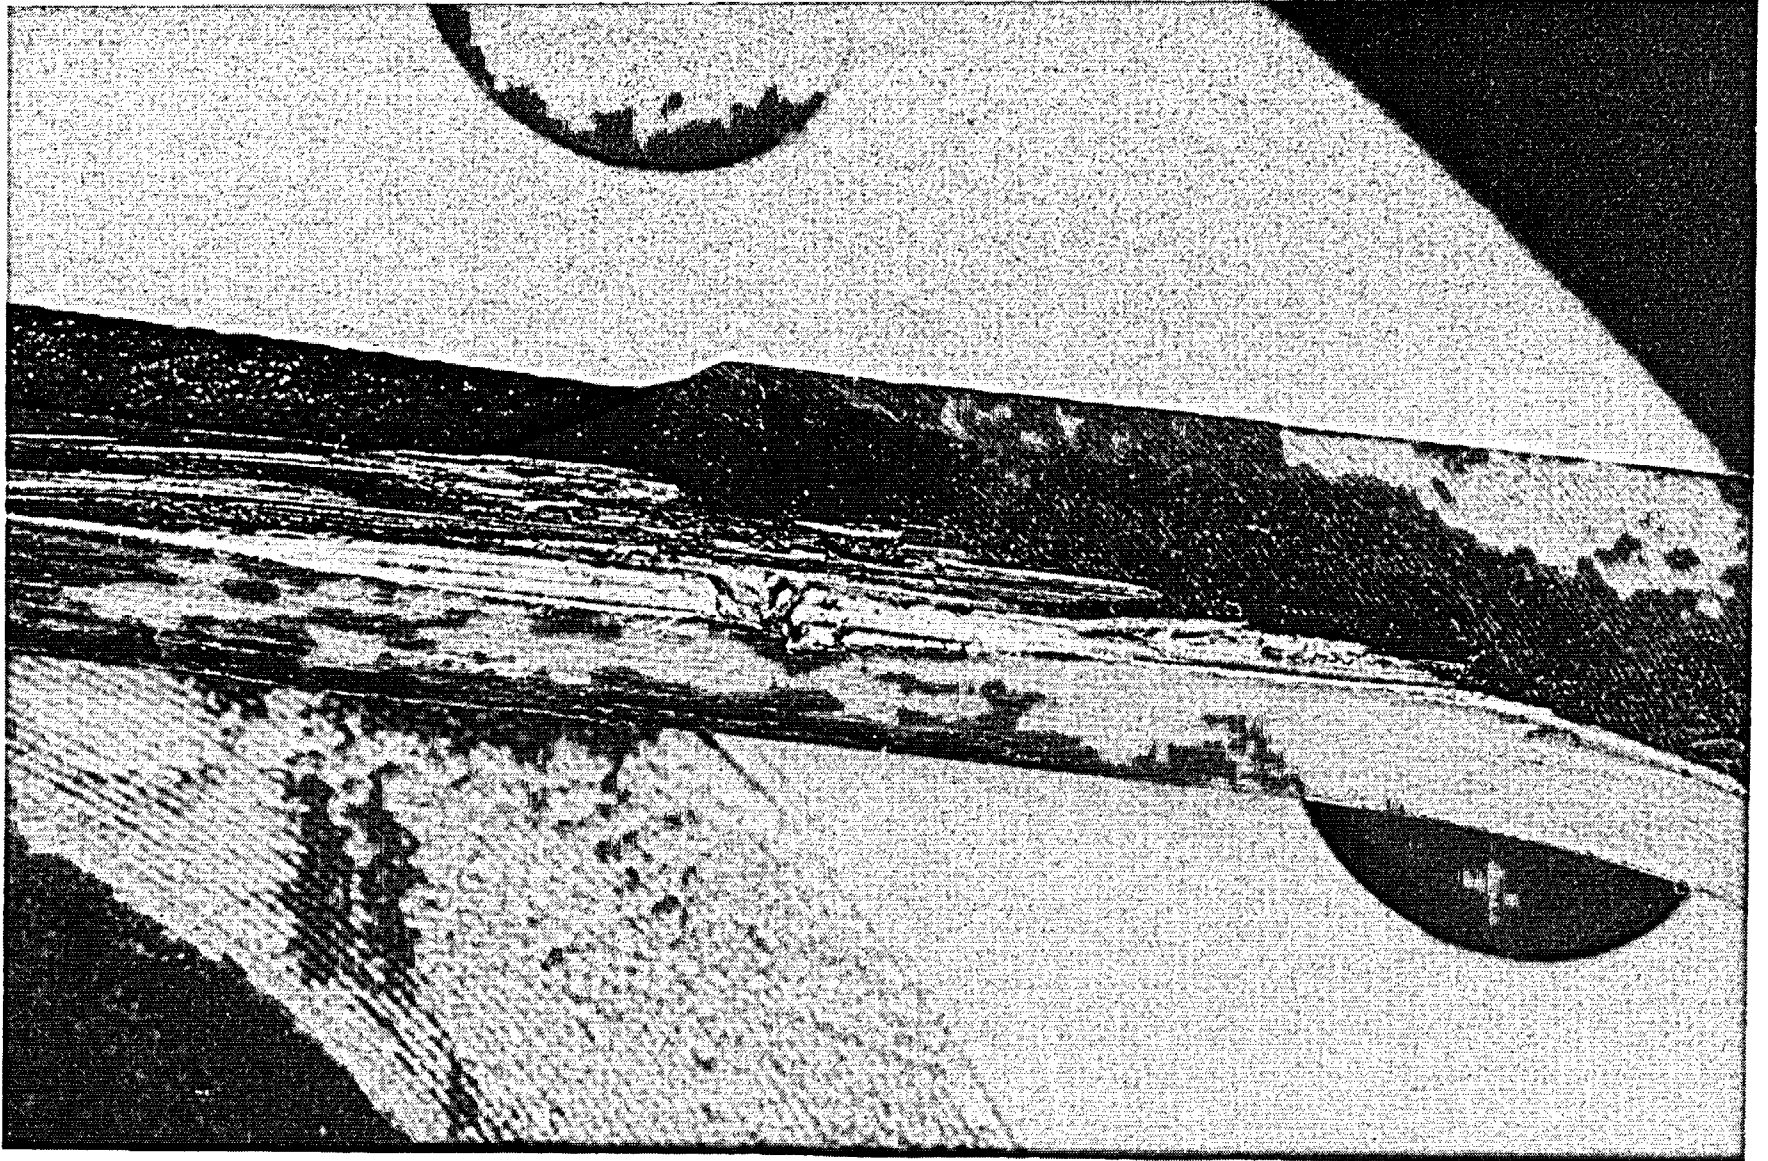
Figure 18. Typical valve damage observed.
