Generic Issue 87: Flexible Wedge Gate Valve Test Program

Phase II Results and Analysis

Prepared by
R. Steele, Jr., K. G. DeWall, J. C. Watkins

Idaho National Engineering Laboratory
EG&G Idaho, Inc.

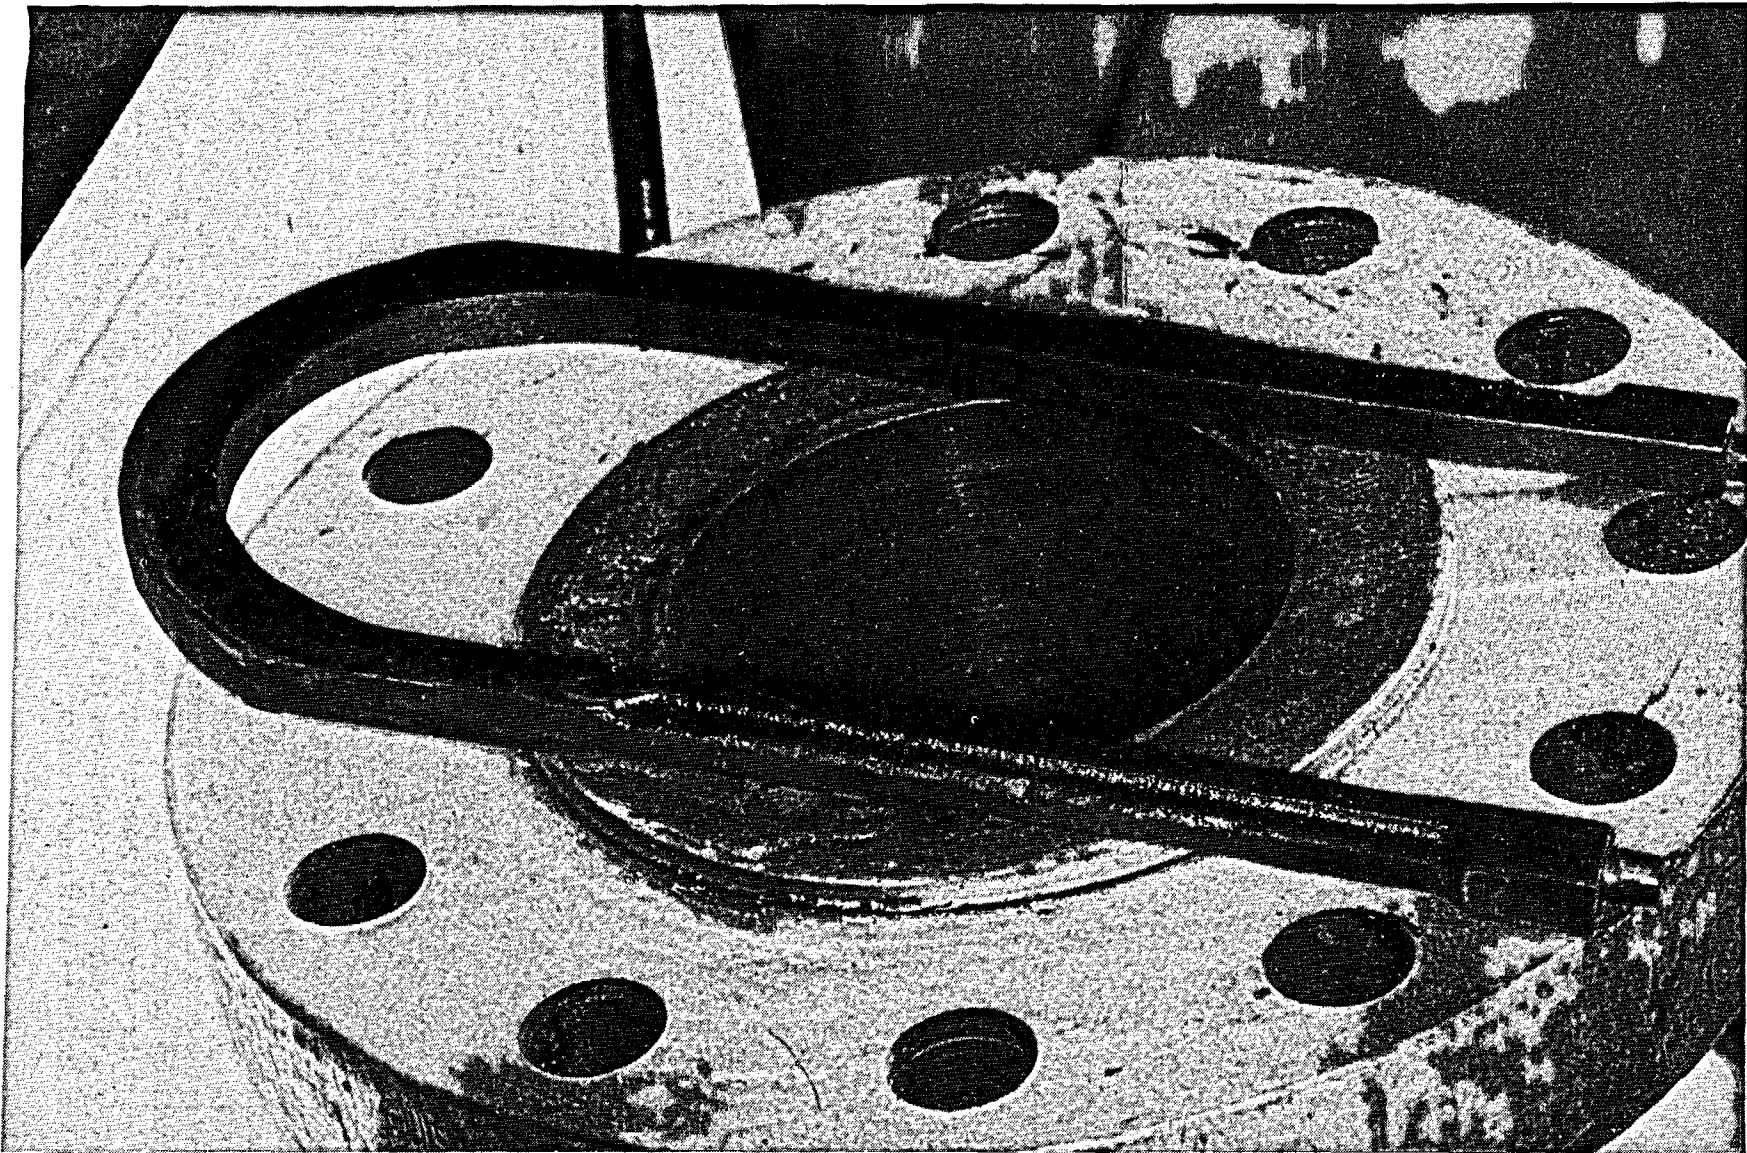
Figure 19. Typical valve damage observed.

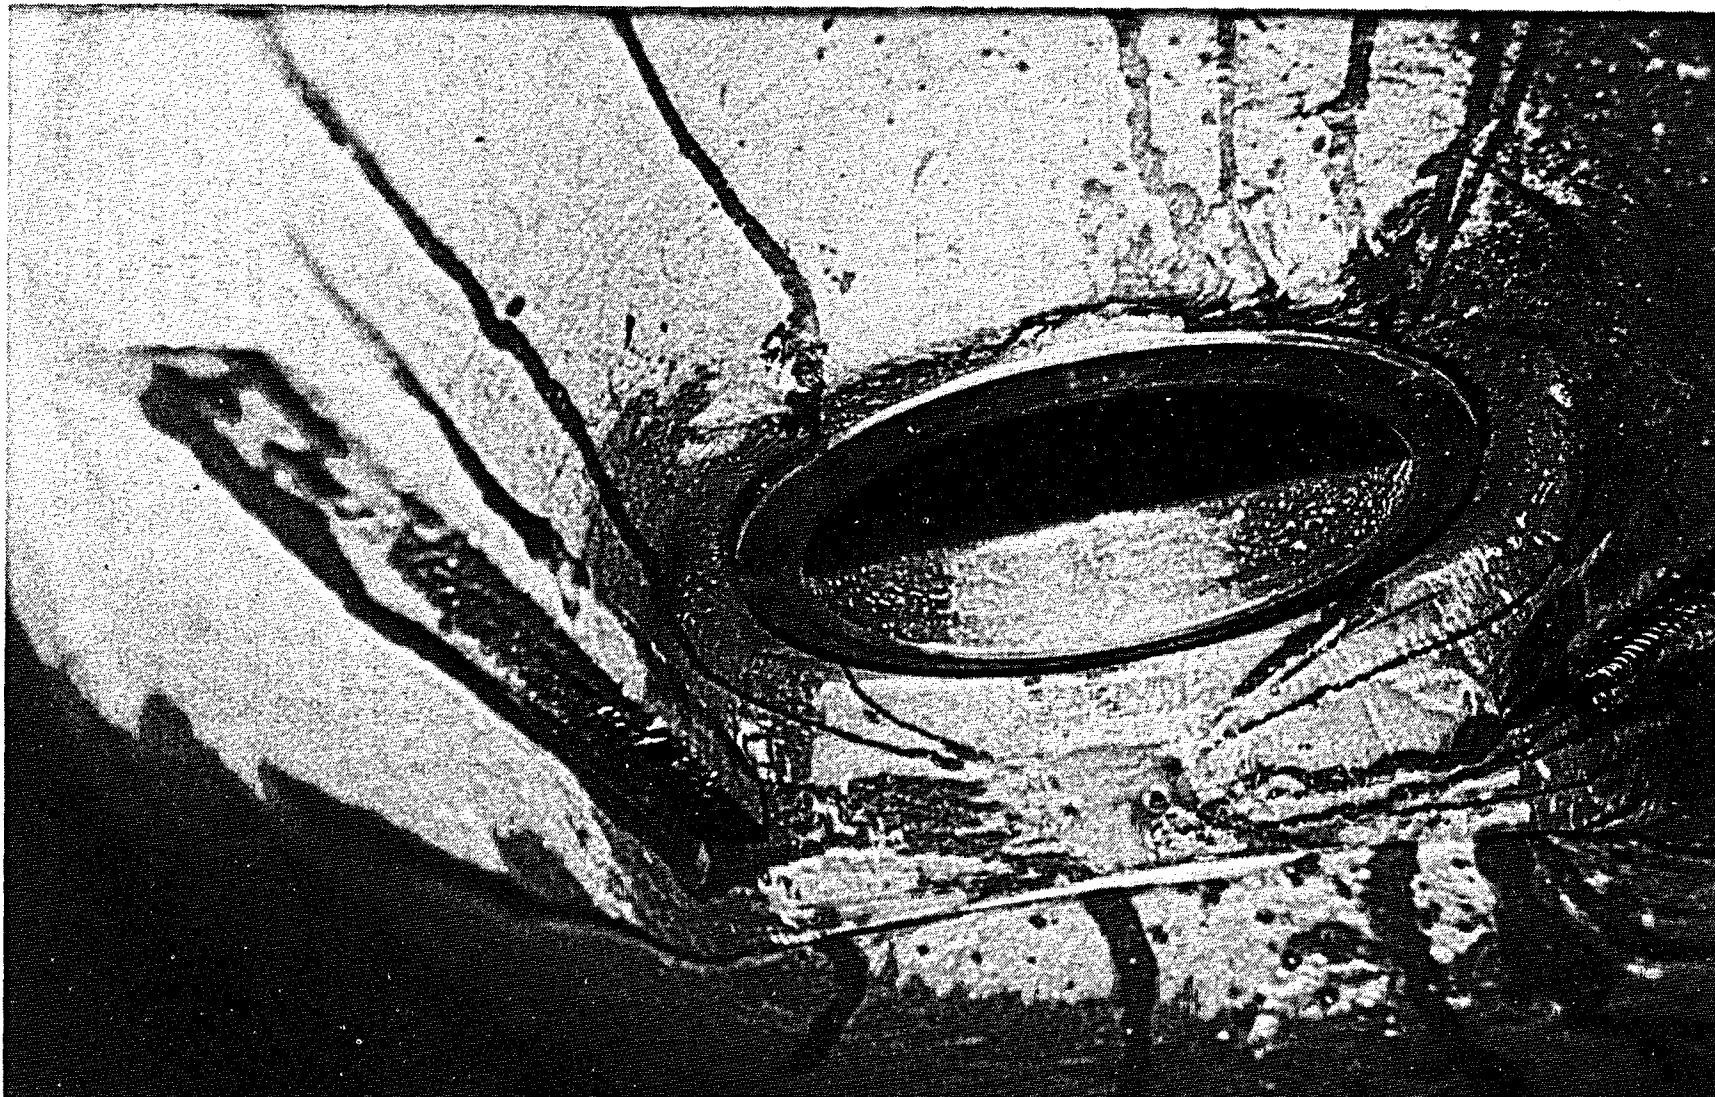
Valves 1 and 4 were also from the same manufacturer. Both were in the unpredictable category, but the damage mechanisms were different. For Valve 1, the primary damage was to the seat. For Valve 4, the guide surfaces showed more damaged. The type of damage experienced by Valve 1 (Valve A in Phase I tests, where the flow through the valve was reversed from the Phase II direction), was dependent on flow direction. In Phase I, the damage was heavier on the guide surfaces.

Figure 42. Damage to the seat and guide rail of Valve 4 because of closure loads.

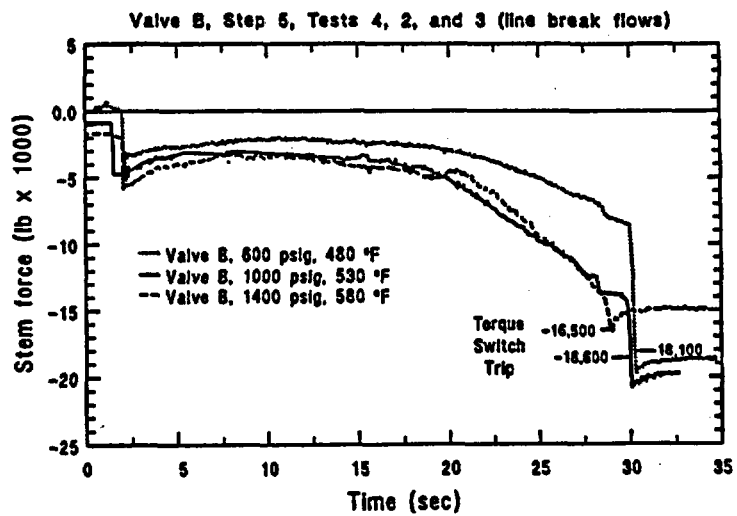
Figure 43. Valve B stem force measured at pipe break flow.

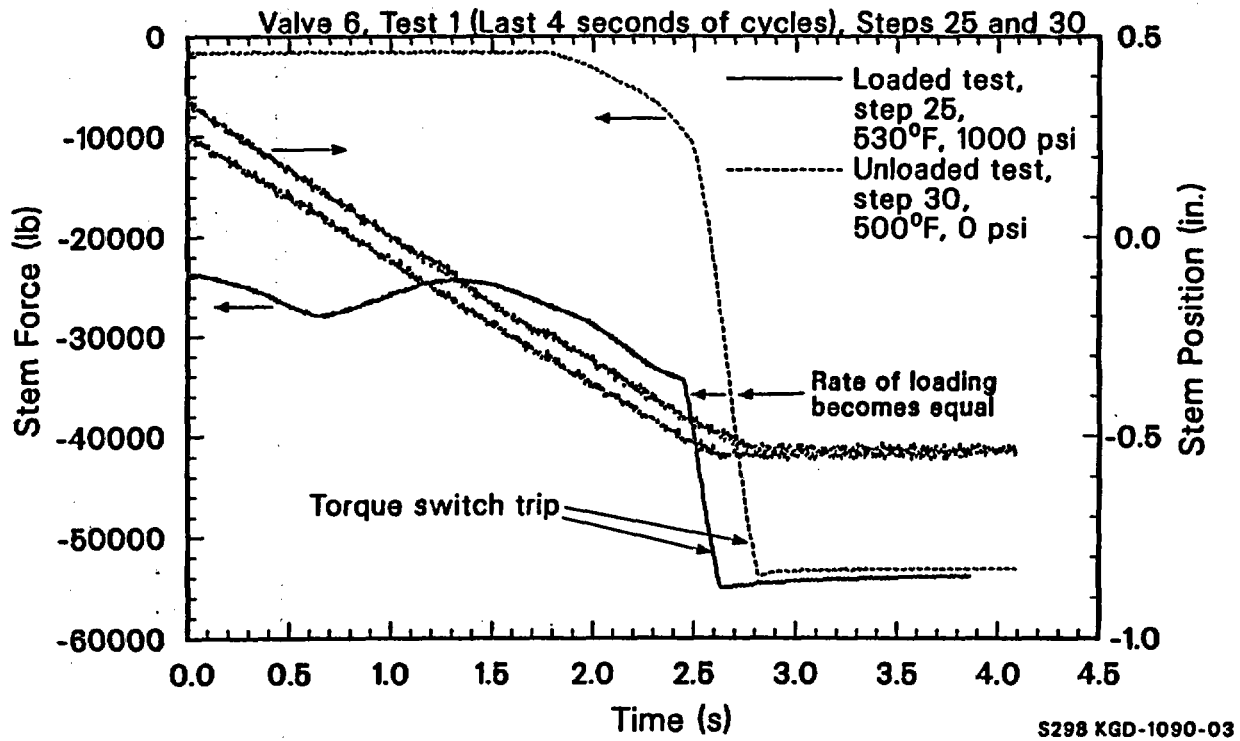
When a valve is tested under high differential pressure conditions, which results in a high stem load, the spring pack is being compressed simultaneously with the rotation of the stem nut. Thus, the motor output energy is split between the two motion paths and their frictional losses. The additional inefficiencies can result in lower stem forces compared to the low load condition if the torque switch is tripped prior to achieving the same seating stiffness as in the unloaded case. Therefore, the relationship of motor-operator torque-to-valve stem force with both motion paths active can only be ensured under design basis loading.

If the loads during design basis closure can be overcome to reach the same structural stiffness prior to torque switch trip, there will only be one motion path active when the torque switch trips, and the resulting stem force will be primarily the same as in the unloaded case. Once determined, the no-load relationships can be baselined and monitored for degradation. Valves that experience the rate of loading phenomenon at torque switch trip are not as fully seated as those that do not.

Figure 45. Phase II, 10-in. HPCI system valve, stem position and stem force at torque switch trip, comparison for a loaded and unloaded valve test.

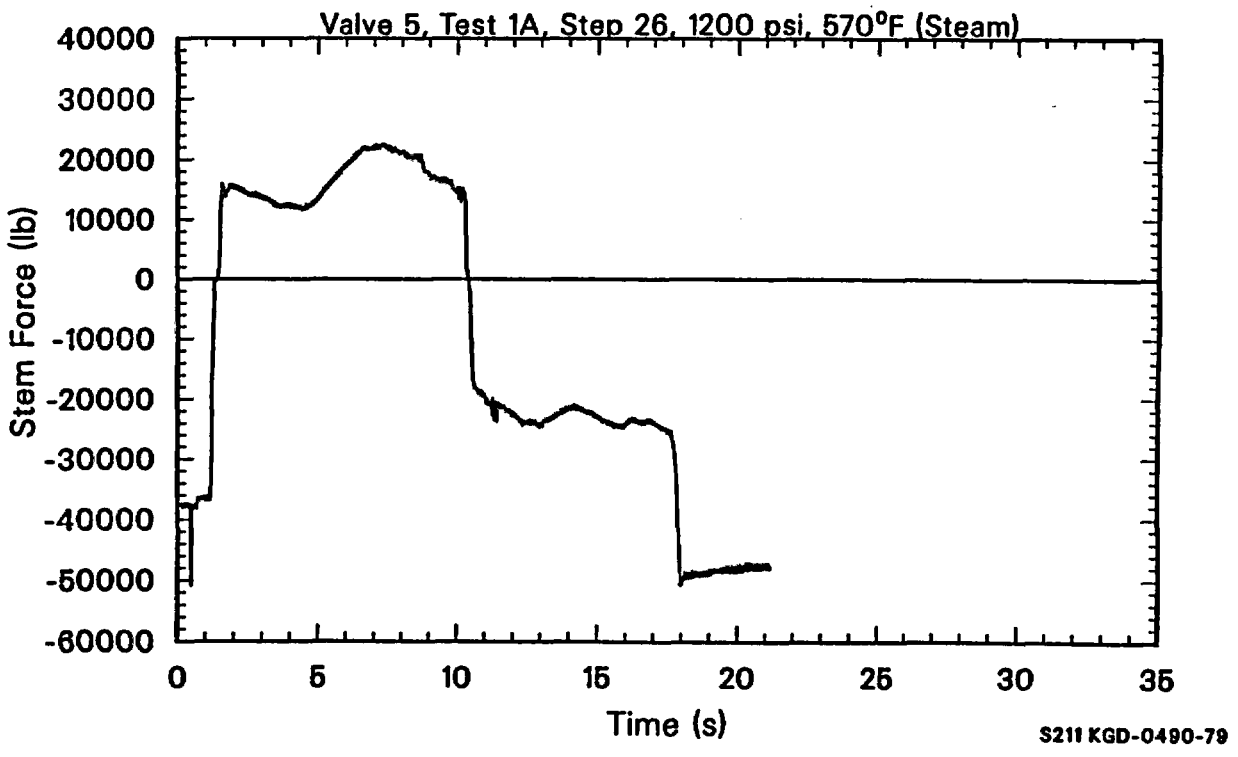
An example of the motor capacity problem is shown in Figures 50 and 51. These plots show two consecutive stem force traces for Valve 5, closing to isolate full pipe break flow at normal BWR HPCI operating pressure and temperature, then opening to 30% open, and reclosing to isolate full flow again. The time axis indicates that the two steps amount to about 38 s of highly loaded operation for this 15-min duty cycle motor. A look at the current traces (Figure 52) shows that during the first closure, the current is exceeding or has exceeded the 20-A maximum range of the transducer at torque switch trip. A "normal" trip was experienced, however. In the reopening and reclosing step (Figure 53), the current again exceeds the maximum range of the transducer at the end of the valve stroke, but the motor is never able to generate enough torque to reach torque switch trip, resulting in a stall as evidenced by the current transducer remaining saturated for about 4 s before we manually stopped the motor.

**Figure 50.** Stem force for Valve 5 closing at normal BWR HPCI operating pressure and temperature.

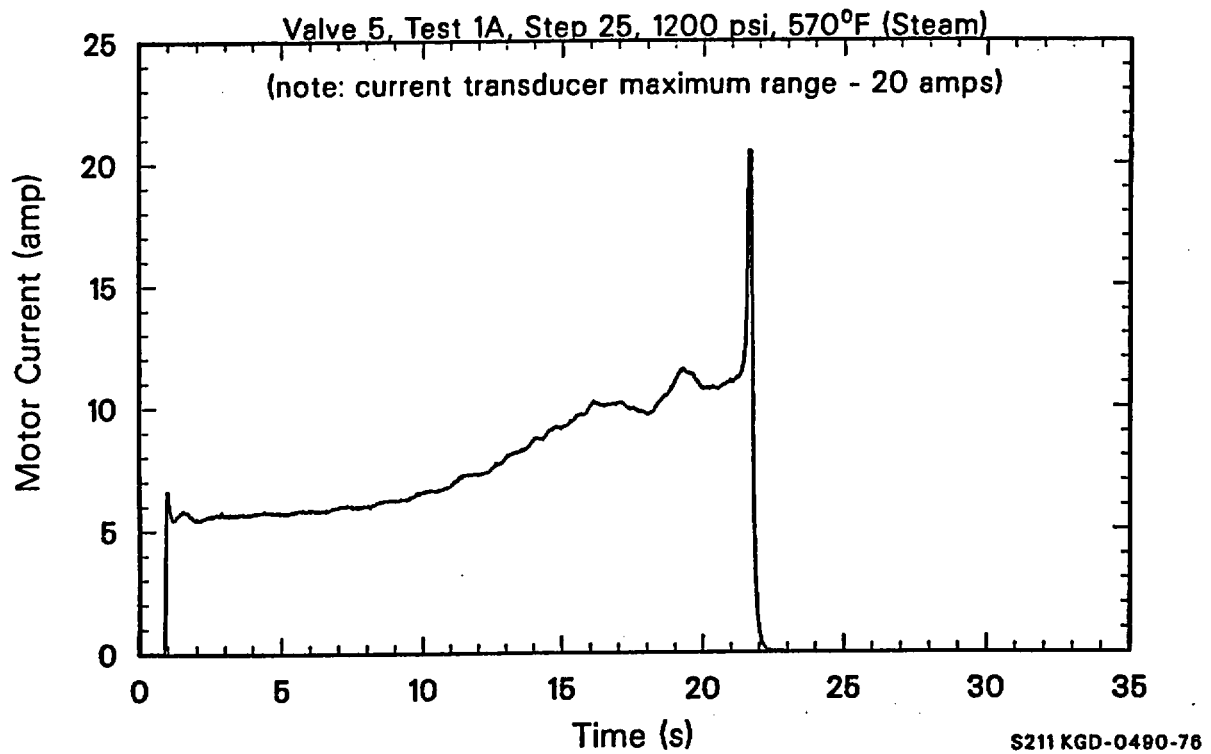
**Figure 52.** Motor current for Valve 5, closing at normal BWR HPCI operating pressure and temperature.

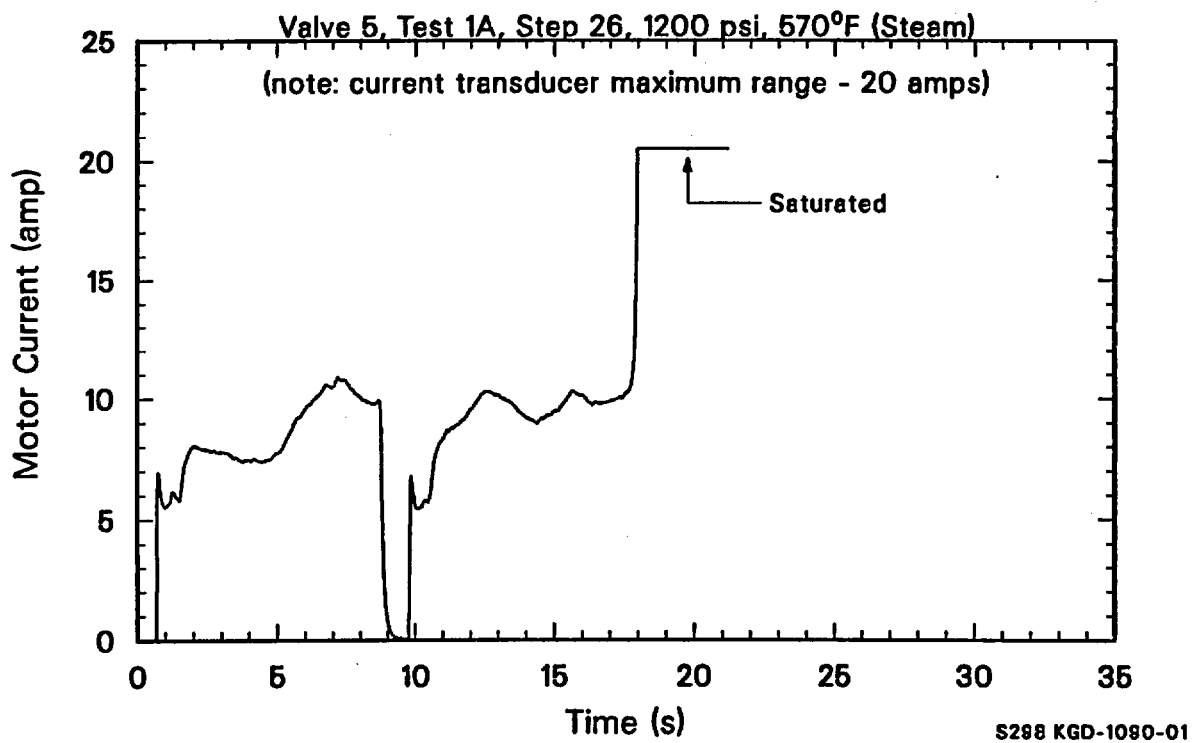
**Figure 53.** Motor current for Valve 5, opening to 30% open and reclosing.

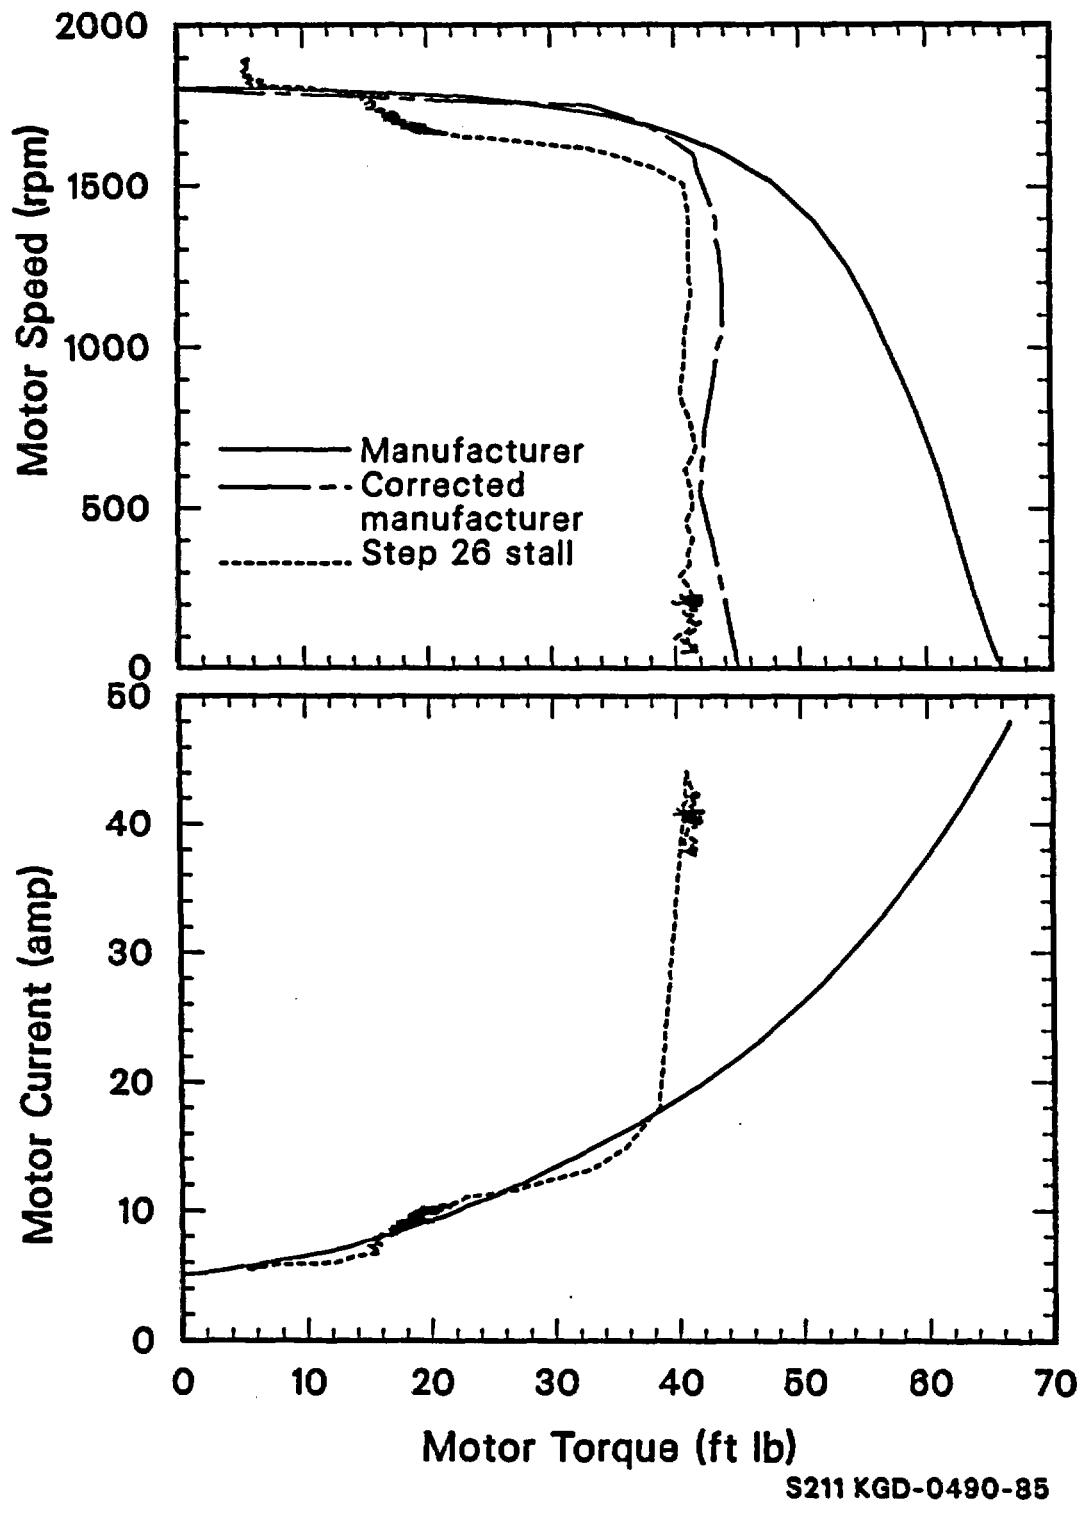
Figure 54, which shows the manufacturer's motor performance curves, gives some information about this behavior. The solid line indicates the expected performance of the motor, both motor speed and current-versus-motor torque. During the test, we observed that the voltage at the motor dropped from 460 V ac to as low as 380 V because of the response of the power supply, the resistance in the motor cables, and the stall or near stall currents. The dashed line in the motor speed plot shows the expected motor performance, corrected for the actual measured voltage. Actual motor performance observed during this test is shown by the dotted line, indicating that the motor was actually performing as anticipated at the measured voltage.

Unfortunately, we designed our current measuring system based on a Limitorque recommended 40-ft-lb motor. Limitorque later notified us that a 60-ft-lb motor would be necessary for Valve 5. If our measurement system could have handled the unexpected higher current reading from the larger motor, we could have checked the current demand after the design basis test. We then could have determined whether we were operating the motor so far out on the knee of the motor torque speed curve that there was little safety margin left in the motor, or that a voltage drop was driving the motor's poor performance.

Figure 54. Comparison of Limitorque's motor performance curves and observed performance during motor trip.
