> Byron Station, Unit 2
> Facility Operating License No. NPF-66
> <u>NRC Docket No. STN 50-455</u>

Subject: Submittal of Analytical Evaluation of Pressurizer Seismic Restraint Lug Indications

Byron Unit 2 Flaw Evaluation at the Pressurizer Seismic Lug (PSL-1) Region

LTR-PAFM-05-78

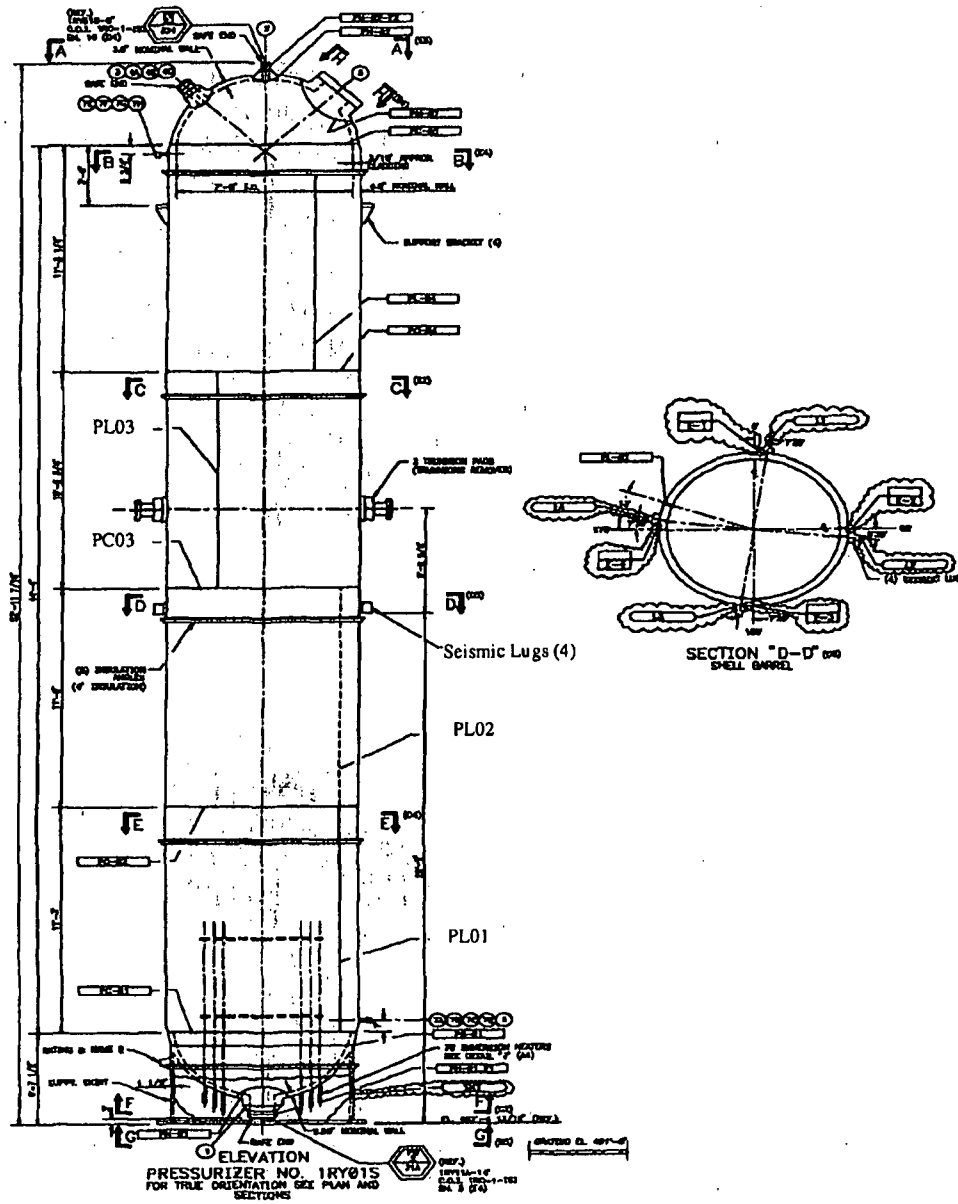
Figure 1-1

During the B2R12 refueling outage, the Byron Unit 2 ISI program scheduled the inspection of the Pressurizer Integrally welded attachment seismic lugs PSL-1 through PSL-4. The geometry of the pressurizer and the seismic lugs are shown in Figures 1-1 and 1-2 respectively.

Geometry of the Byron Unit 2 Pressurizer

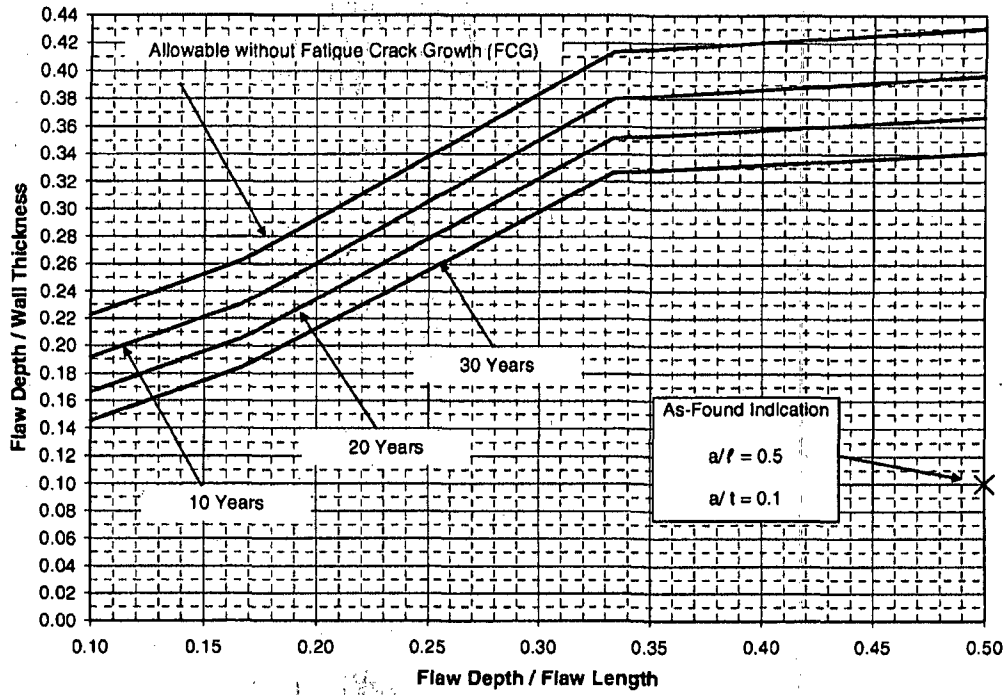
These flaw parameters are plotted in Figures 6-1 and 6-2. It is evident that ample margin exists and that the as-found indications are acceptable without repair for at least 30 years of service life.

Assuming a circumferential flaw depth of 0.4 inch, that is a/t = 0.1, the maximum allowable aspect ratio as shown in Figure 6-1 is at least 10:1 (length:depth) . Therefore for a circumferential flaw with a flaw depth of 0.4 inch, the maximum allowable length of the flaw can be at least 4 inches for an operational period of at least 30 years.

Circumferential Flaw Evaluation Chart – Pressurizer Welded Attachment Seismic Lug (PSL-1) Region

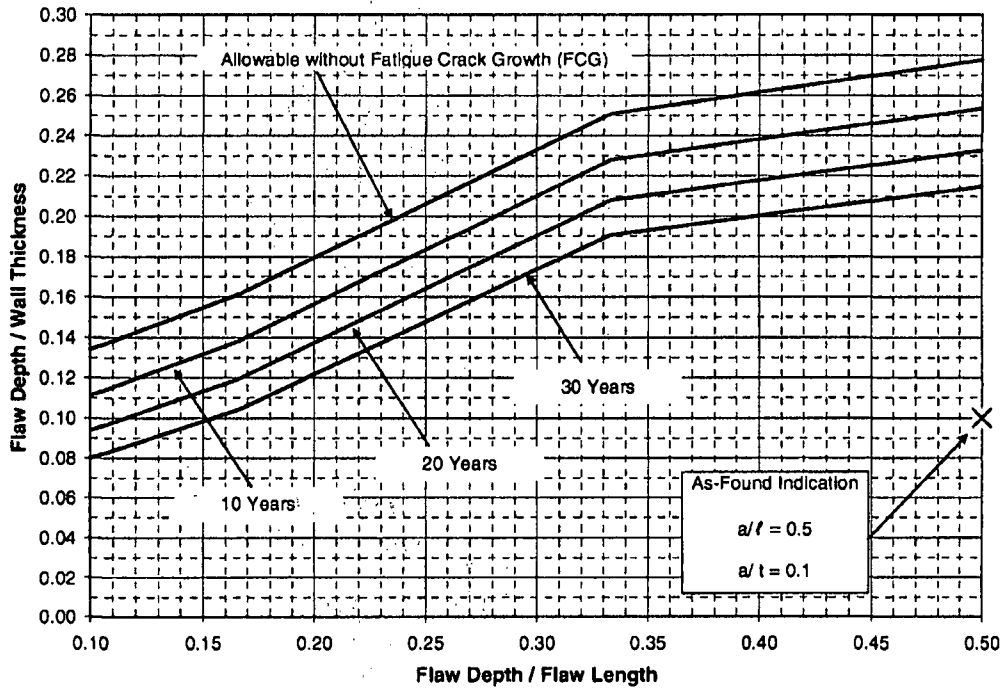
For an axial flaw with a flaw depth parameter a/t = 0.1, the maximum allowable aspect ratio as shown in Figure 6-2 for an operational period of 30 years is about 6.5:1. Therefore for an axial flaw with a flaw depth of 0.4 inch, the maximum allowable length of an axial flaw is 2.6 inches for an operational period of 30 years. Using the same approach, the maximum allowable length is at least 4 inches for an operational period of 10 years.

Axial Flaw Evaluation Chart – Pressurizer Welded Attachment Seismic Lug (PSL-1) Region

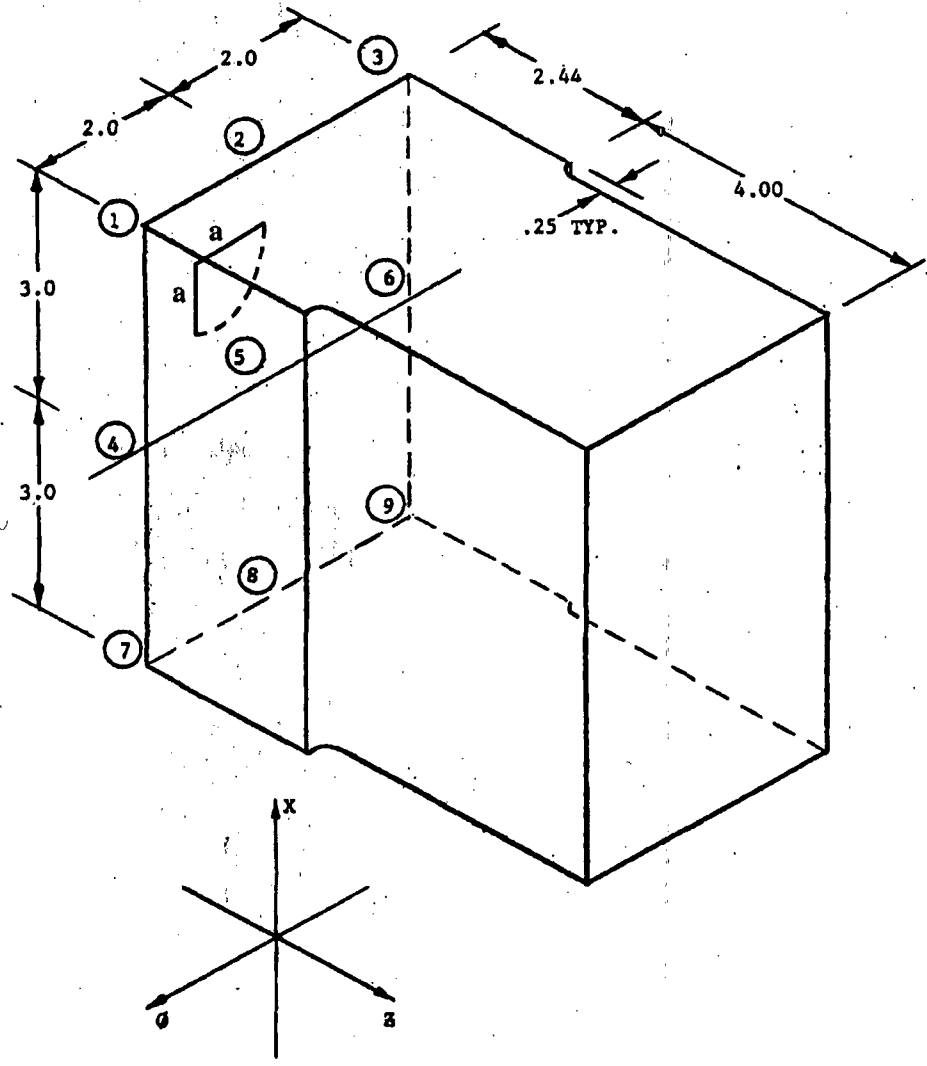
Figure 7-1

A linear quarter-circular flaw is postulated along the top of the seismic lug (PSL-1) as shown in Figure 7-1. The stress intensity factor expression for a plane quarter-circular flaw at the edge of a square bar was used as discussed in Section 4.2. The use of this stress intensity factor expression is conservative with respect to the detected flaw configuration because the indication is assumed to be an edge crack and that the depth of the flaw is assumed to be the same as the length of the detected indication. This quarter-circular edge flaw model is also a conservative model for a semi-circular flaw near the top center of the seismic lug weld. Therefore the flaw evaluation results obtained can be conservatively applied to the actual indication detected.

Based on the results tabulated in Table 7-1, a quarter-circular flaw (a = ℓ = 1.23 inch) postulated along the top of the seismic lug is acceptable for 30 years without repair. As

can be seen in Table 7-1, the fatigue crack growth due to seismic loading experienced by the lug is negligible.   Since the flaw shape of the as-found indication is being encompassed by the maximum allowable flaw shape, it can be concluded that the as-found indication along the top of the seismic lug is acceptable for 30 years without repair.

Postulated Crack Along the Top of Pressurizer Seismic Lug

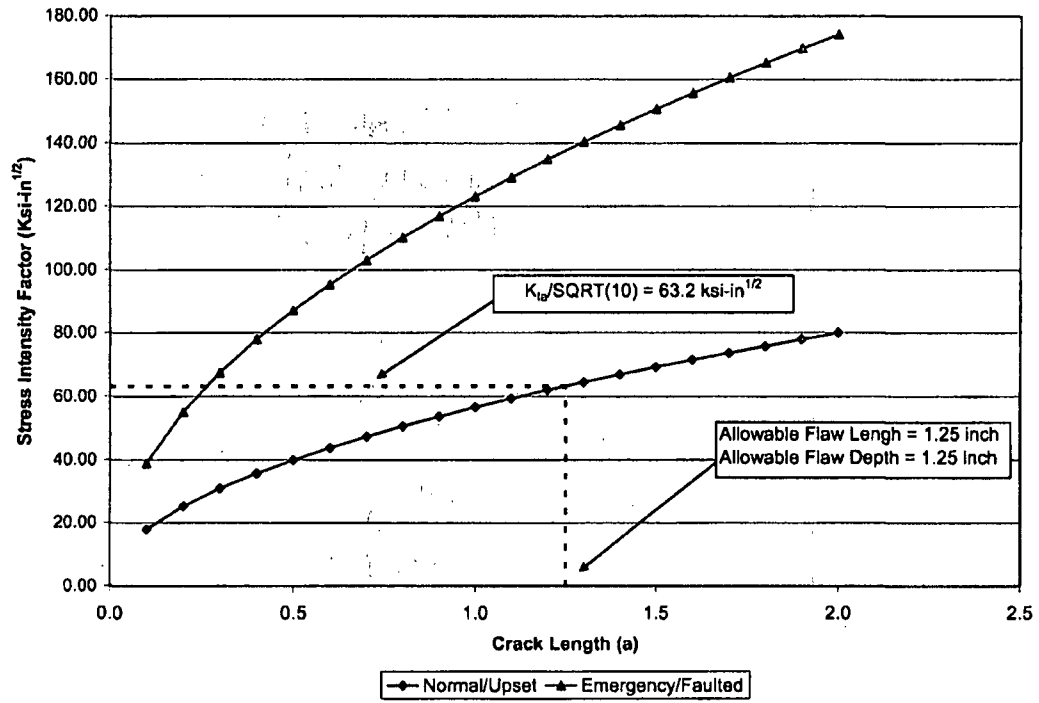
Figure 7-2

The critical flaw depth for such quarter-circular flaw was determined as discussed in Section 4.0 and based on the acceptance criteria discussed in Section 2.0. The resulting allowable flaw depth at the end-of-evaluation period, defined as a_f, is shown in Figure 7-2.

Allowable Flaw Size Determination for Pressurizer Seismic Lug Without Including
Fatigue Crack Growth
