The High Level Vibration Test Program

Final Report

Prepared by
Y. J. Park, J. R. Curreri, C. H. Hofmayer

Brookhaven National Laboratory
Upton, NY 11973

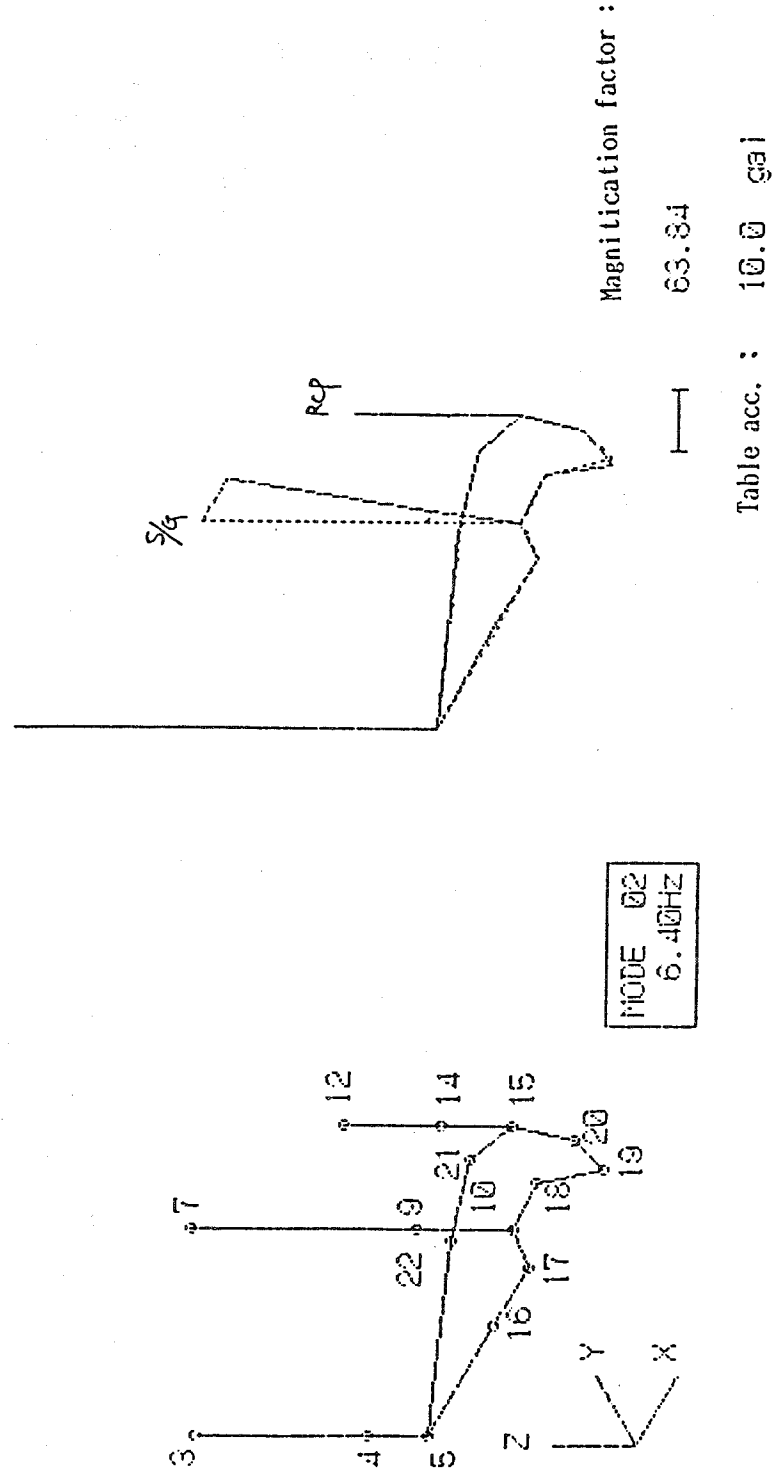
Figure 5.5 Vibration Mode Shape

The predominant vibration mode of the test model, as illustrated in Figure 5.5, represents a rigid body-like rotation of the SG around the pin-support. The damping ratio and vibration frequency regarding this particular mode are studied below.

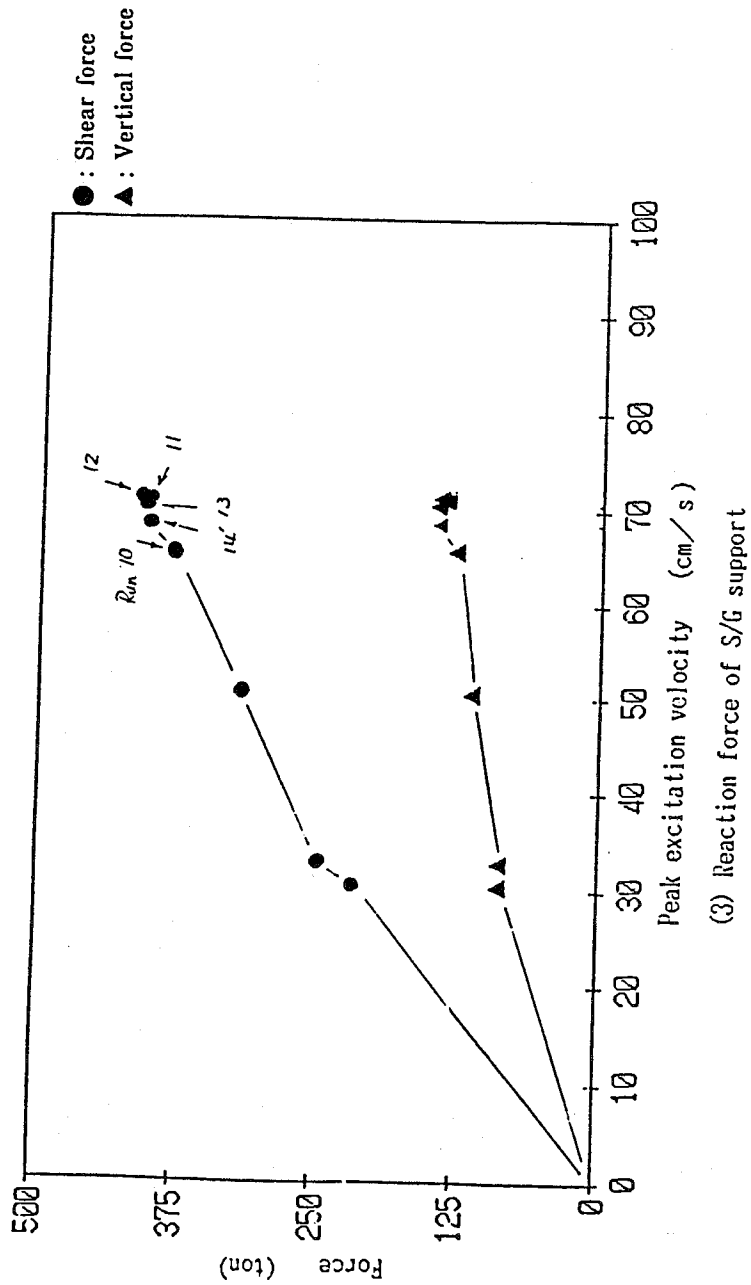
Figure 5.9.(3) Maximum Response Versus Excitation Level
(Force at SG Pin)

<u>Excitation level and maximum responses</u>: The maximum response values of the SG responses and the strains in the hot leg pipe are plotted against the peak velocity of the vibration table in Figure 5.9. It can be seen from Figure 5.9 (3) that the measured value of the shear force at the SG pin-connection is considerably higher than those from the Part 1 tests and analytical values. Figures 5.10 and 5.11 show some plots for the predominant frequency and the equivalent damping ratio calculated from the hysteresis loops.

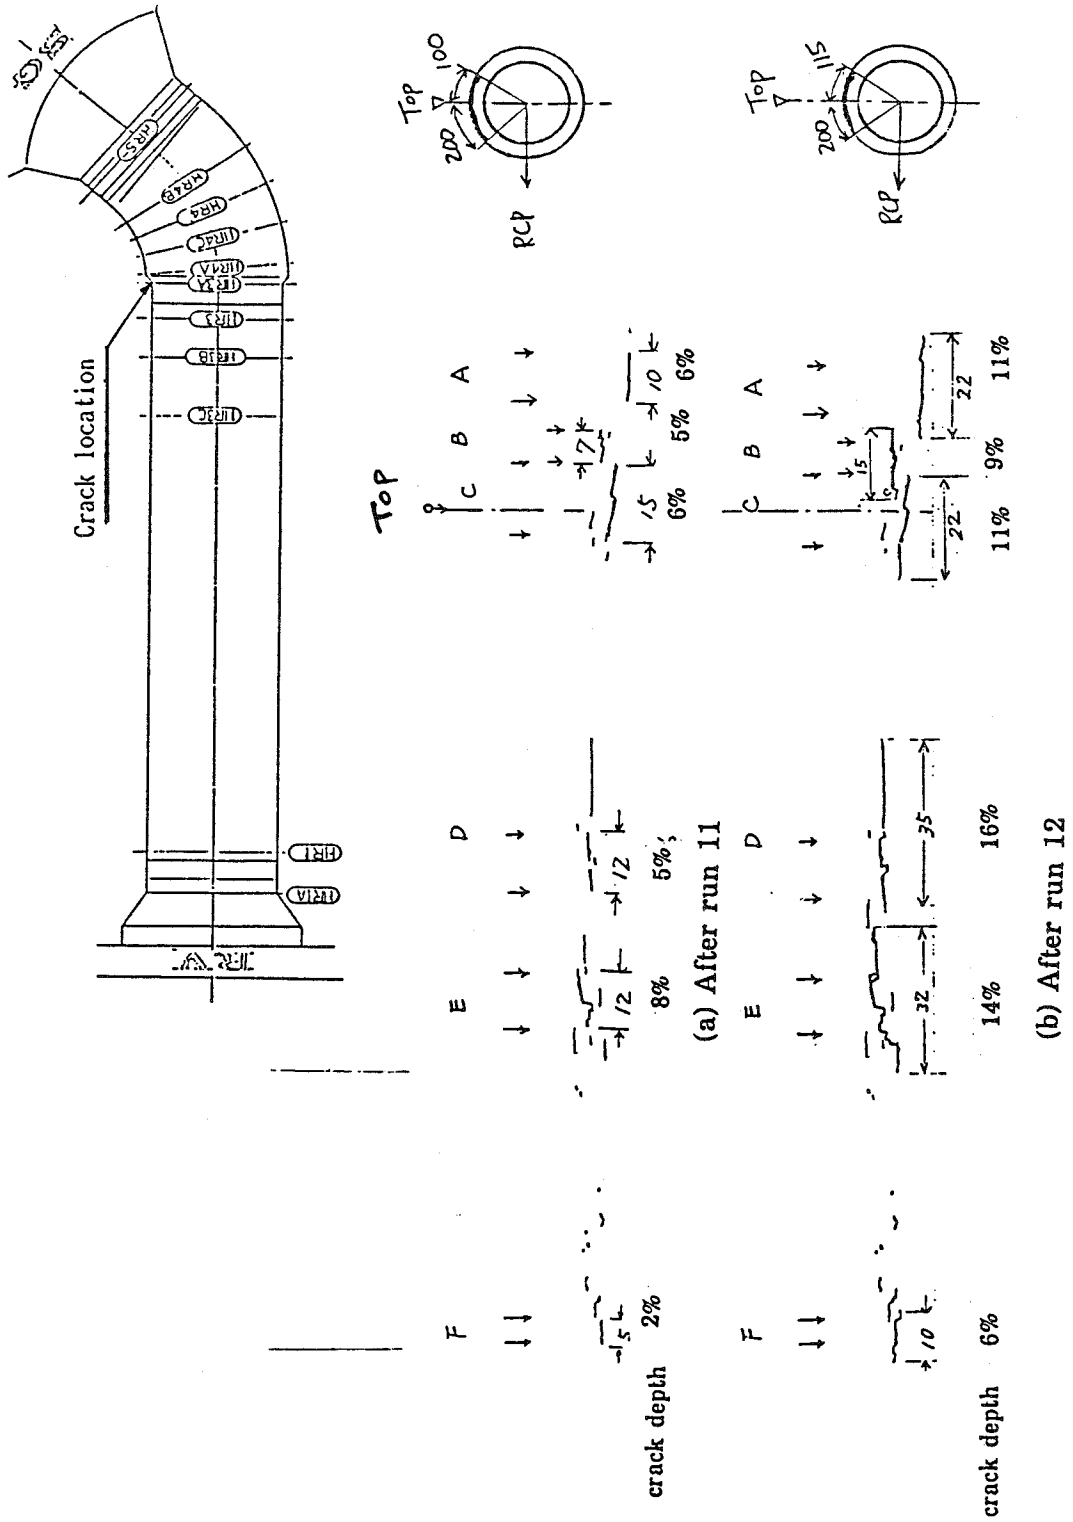
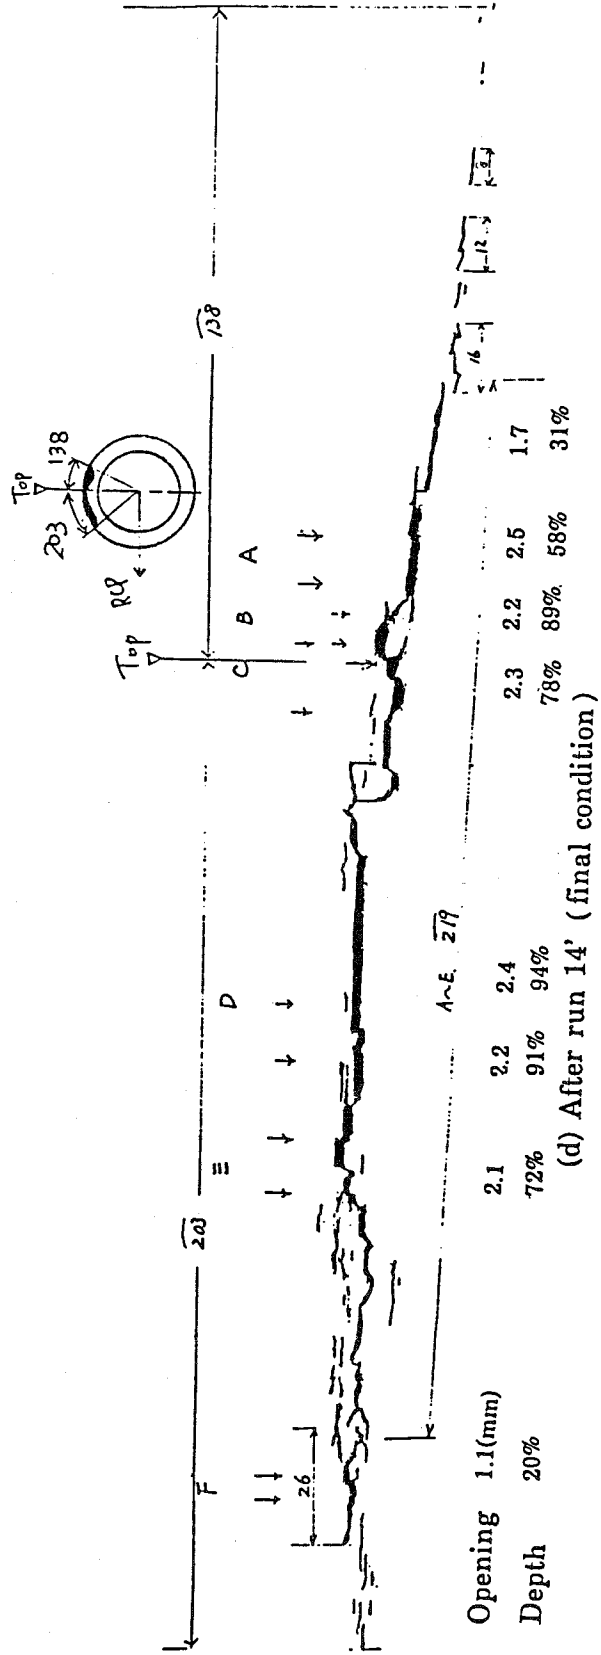
Figure 5-12 (1) Observed Crack Dimension

During the subsequent 1.0 MPR runs, the cracks grew and merged together to form a large crack. At the same time, the bulging seemed to stop growing as the crack growth continued. Only the first segment (A-segment) was used for the final run (No. 14') to avoid the possibility of any table damage due to pipe leakage or a catastrophic failure.

Figure 5.12 illustrates the observed size of the crack after each excitation run. The crack depth measured by the Electro-Resistance Method is shown in Figure 5.13. The crack depth was also measured by directly installing a thin piano wire into the crack. It showed the crack depth was more than about 24mm.

(c) After run 13

Depth 13%

(d) After run 14' (final condition)

Opening 1.1(mm)

Depth 20%

Figure 5.12 (2) Observed Crack Dimension (Continued)

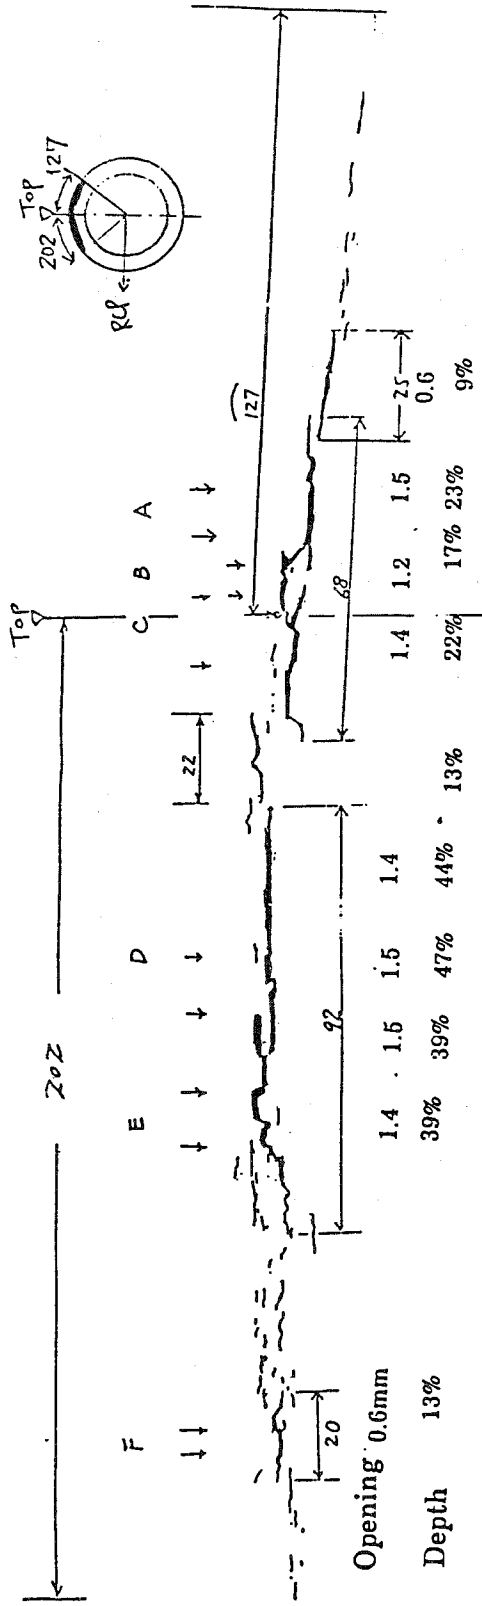
Opening 0.6mm

The existance of any cracks other than the dominant crack as shown in Figure 5-12 was determined by visual inspections and dye penetrant tests on the inner surface of the piping. The dimensions and locations of any additional cracks were measured.

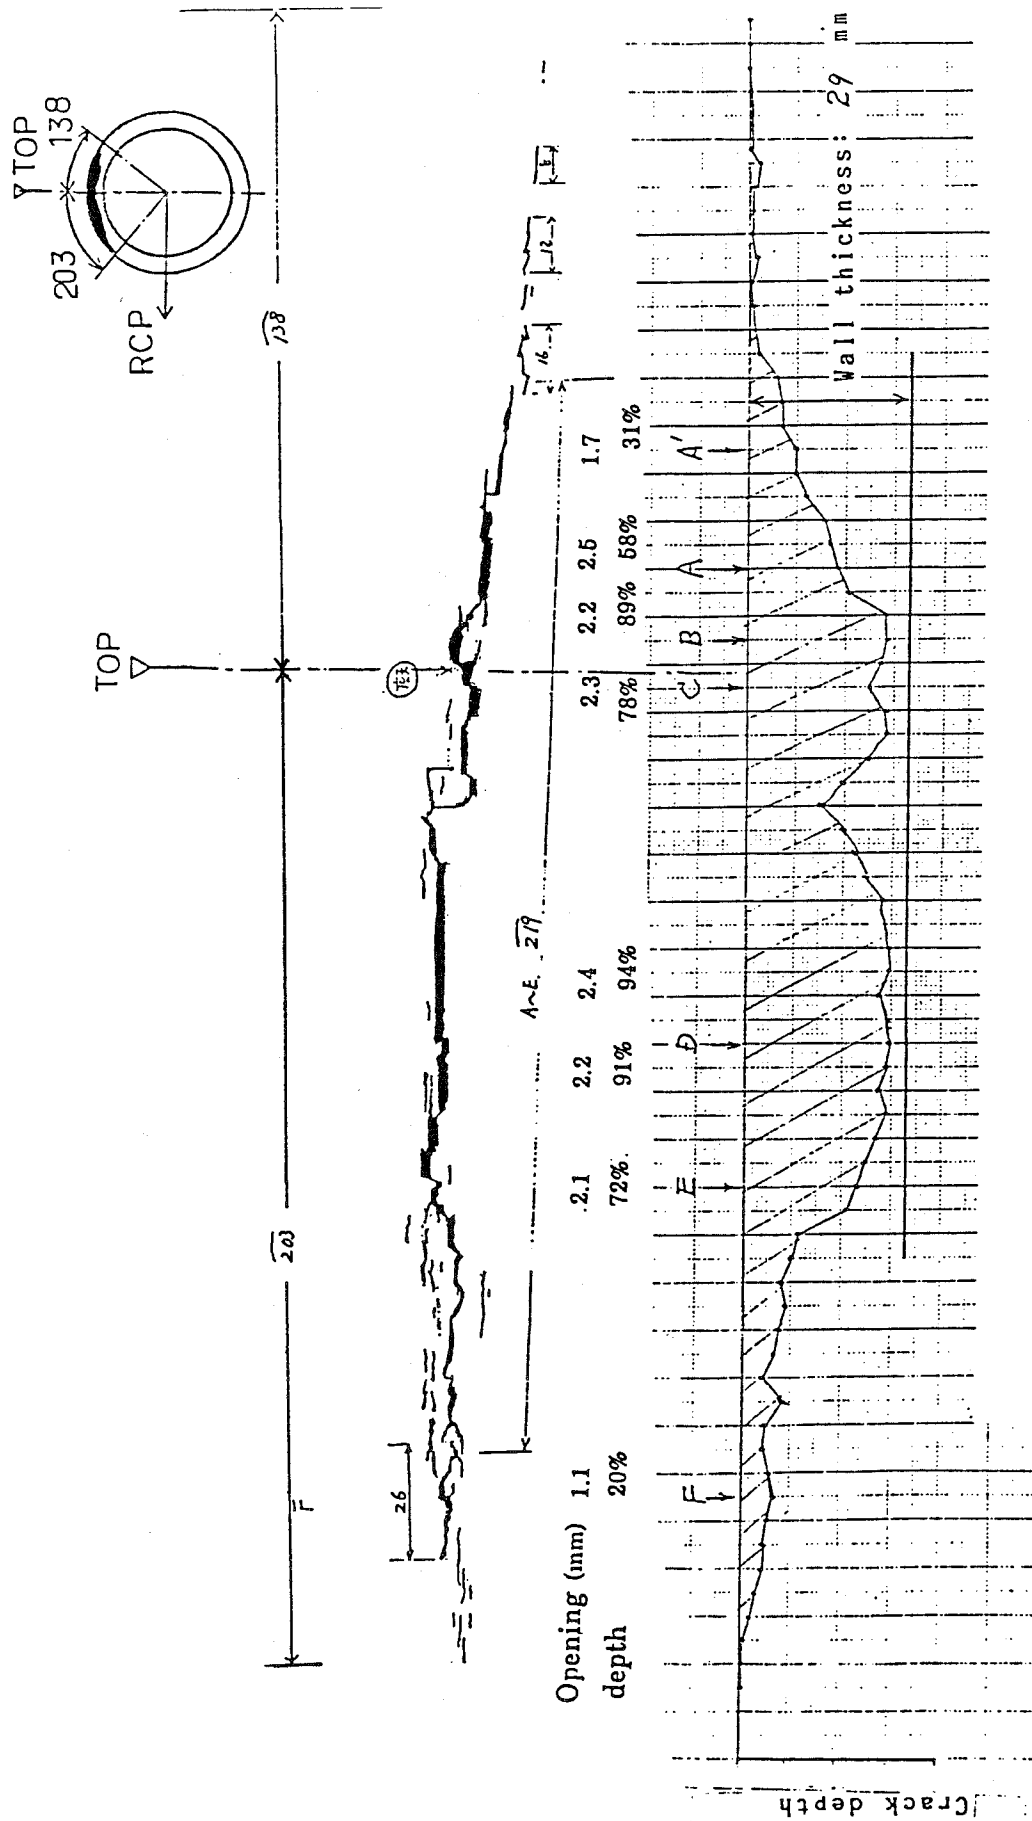
Figure 5.13   Measured Crack Depth (After run 14'; Final Condition)

Note that the results of the crack depth measurements were obtained as the ratio of the crack depth to the thickness of the pipe wall, and the measured results in Figure 5.12 and 5.13 are shown as the percentage of the crack depth to the wall thickness. The crack growth process and the final crack profile are illustrated in Figure 5.14.

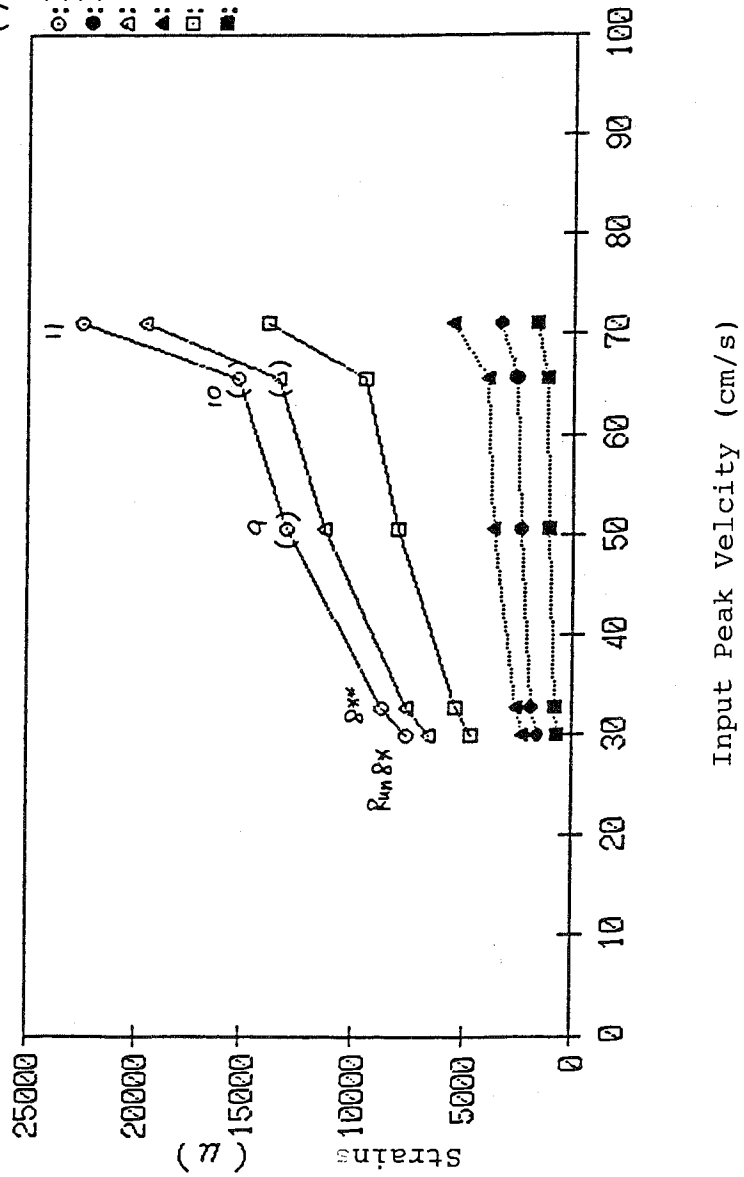
Figure 5.22 Input Level and Strains

Figure 5.22 shows the same plots for the peak strain values of the hot leg pipe. At locations where higher strain values are recorded, a significant plastic strain increase is observed at the higher excitation level, indicating the development of a localized concentration of plasticity.

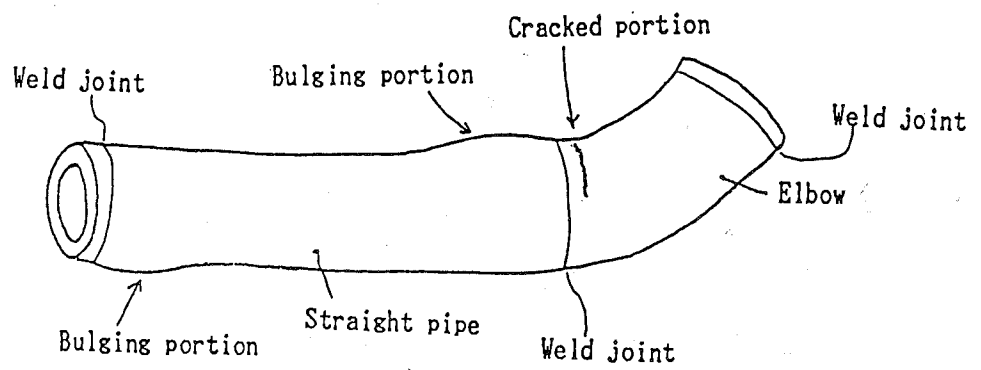
Figure 6.1   Bulging of the Test Pipe

The cracks and bulging in the hot leg pipe that were observed after the HLVT are illustrated in Figure 6.1. The details of the crack growth process are shown in Figures 5.12 to 5.14. To support the evaluation of the HLVT results, detailed measurements were made of the bulging and cracks, and material properties were investigated. Included in this chapter are discussions of the following items:

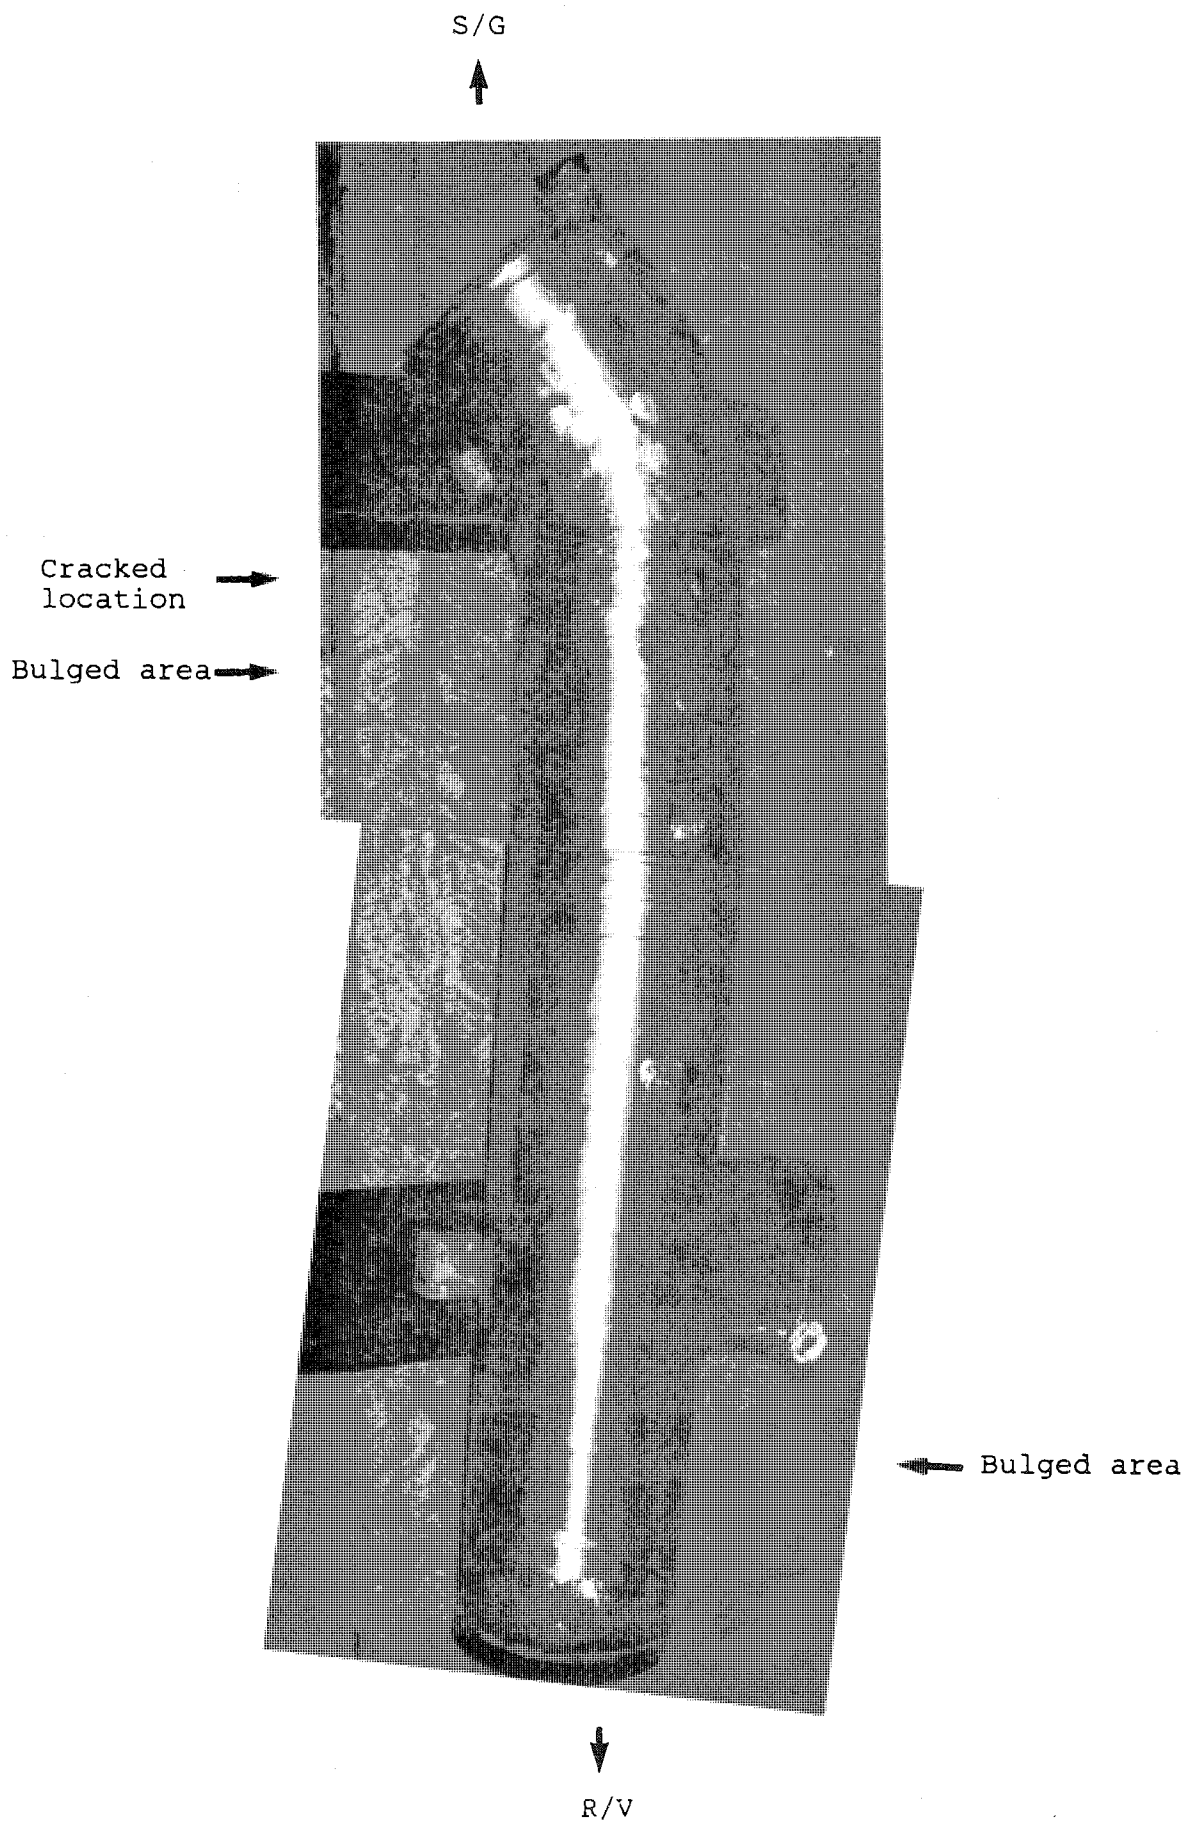
Figure 6-4   Overall View of the Hot Leg Pipe

The overall view of the hot leg pipe when it arrived at the Takasago R&D Center is shown in Figure 6.4. A close up view of the dominant crack is shown in Figure 6.5.

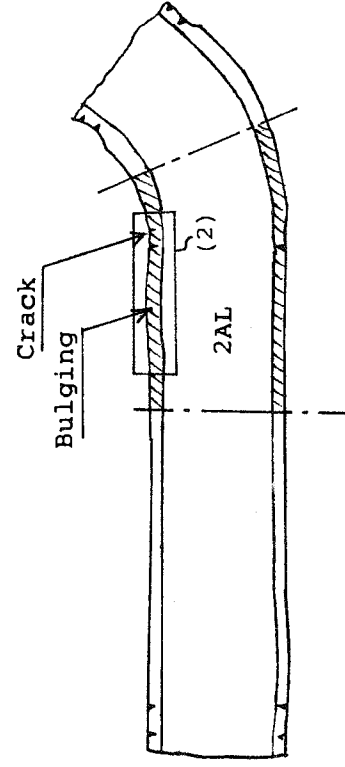
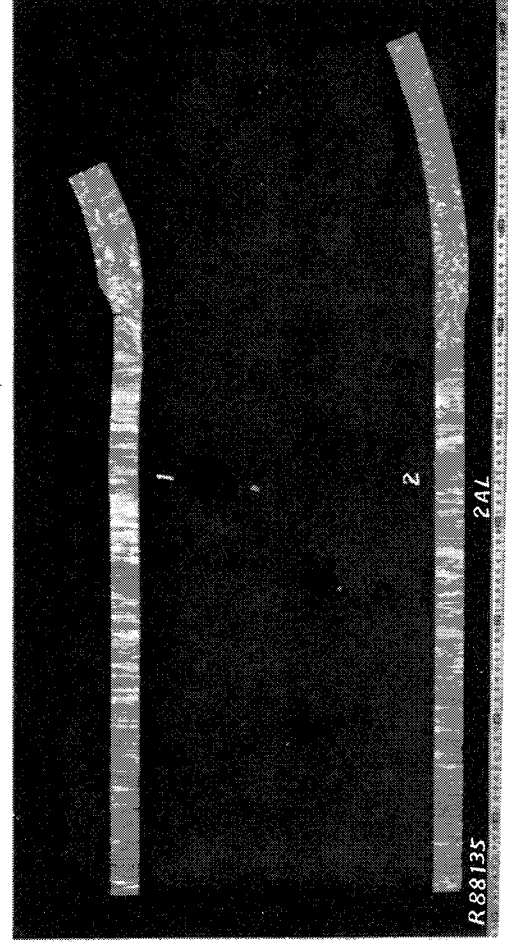
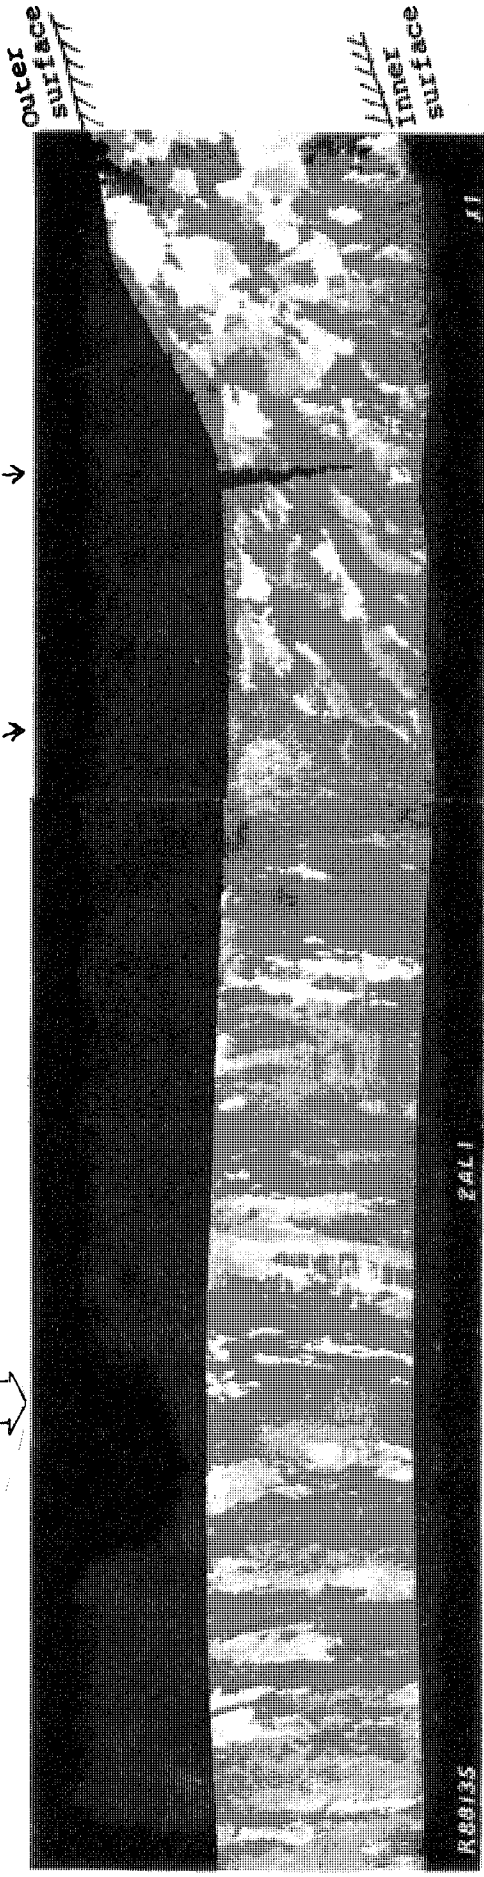
Figure 6.6 Macrostructure of Block #2A Longitudinal Cross Section

Figure 6.5 Outer Surface of Cracked Area

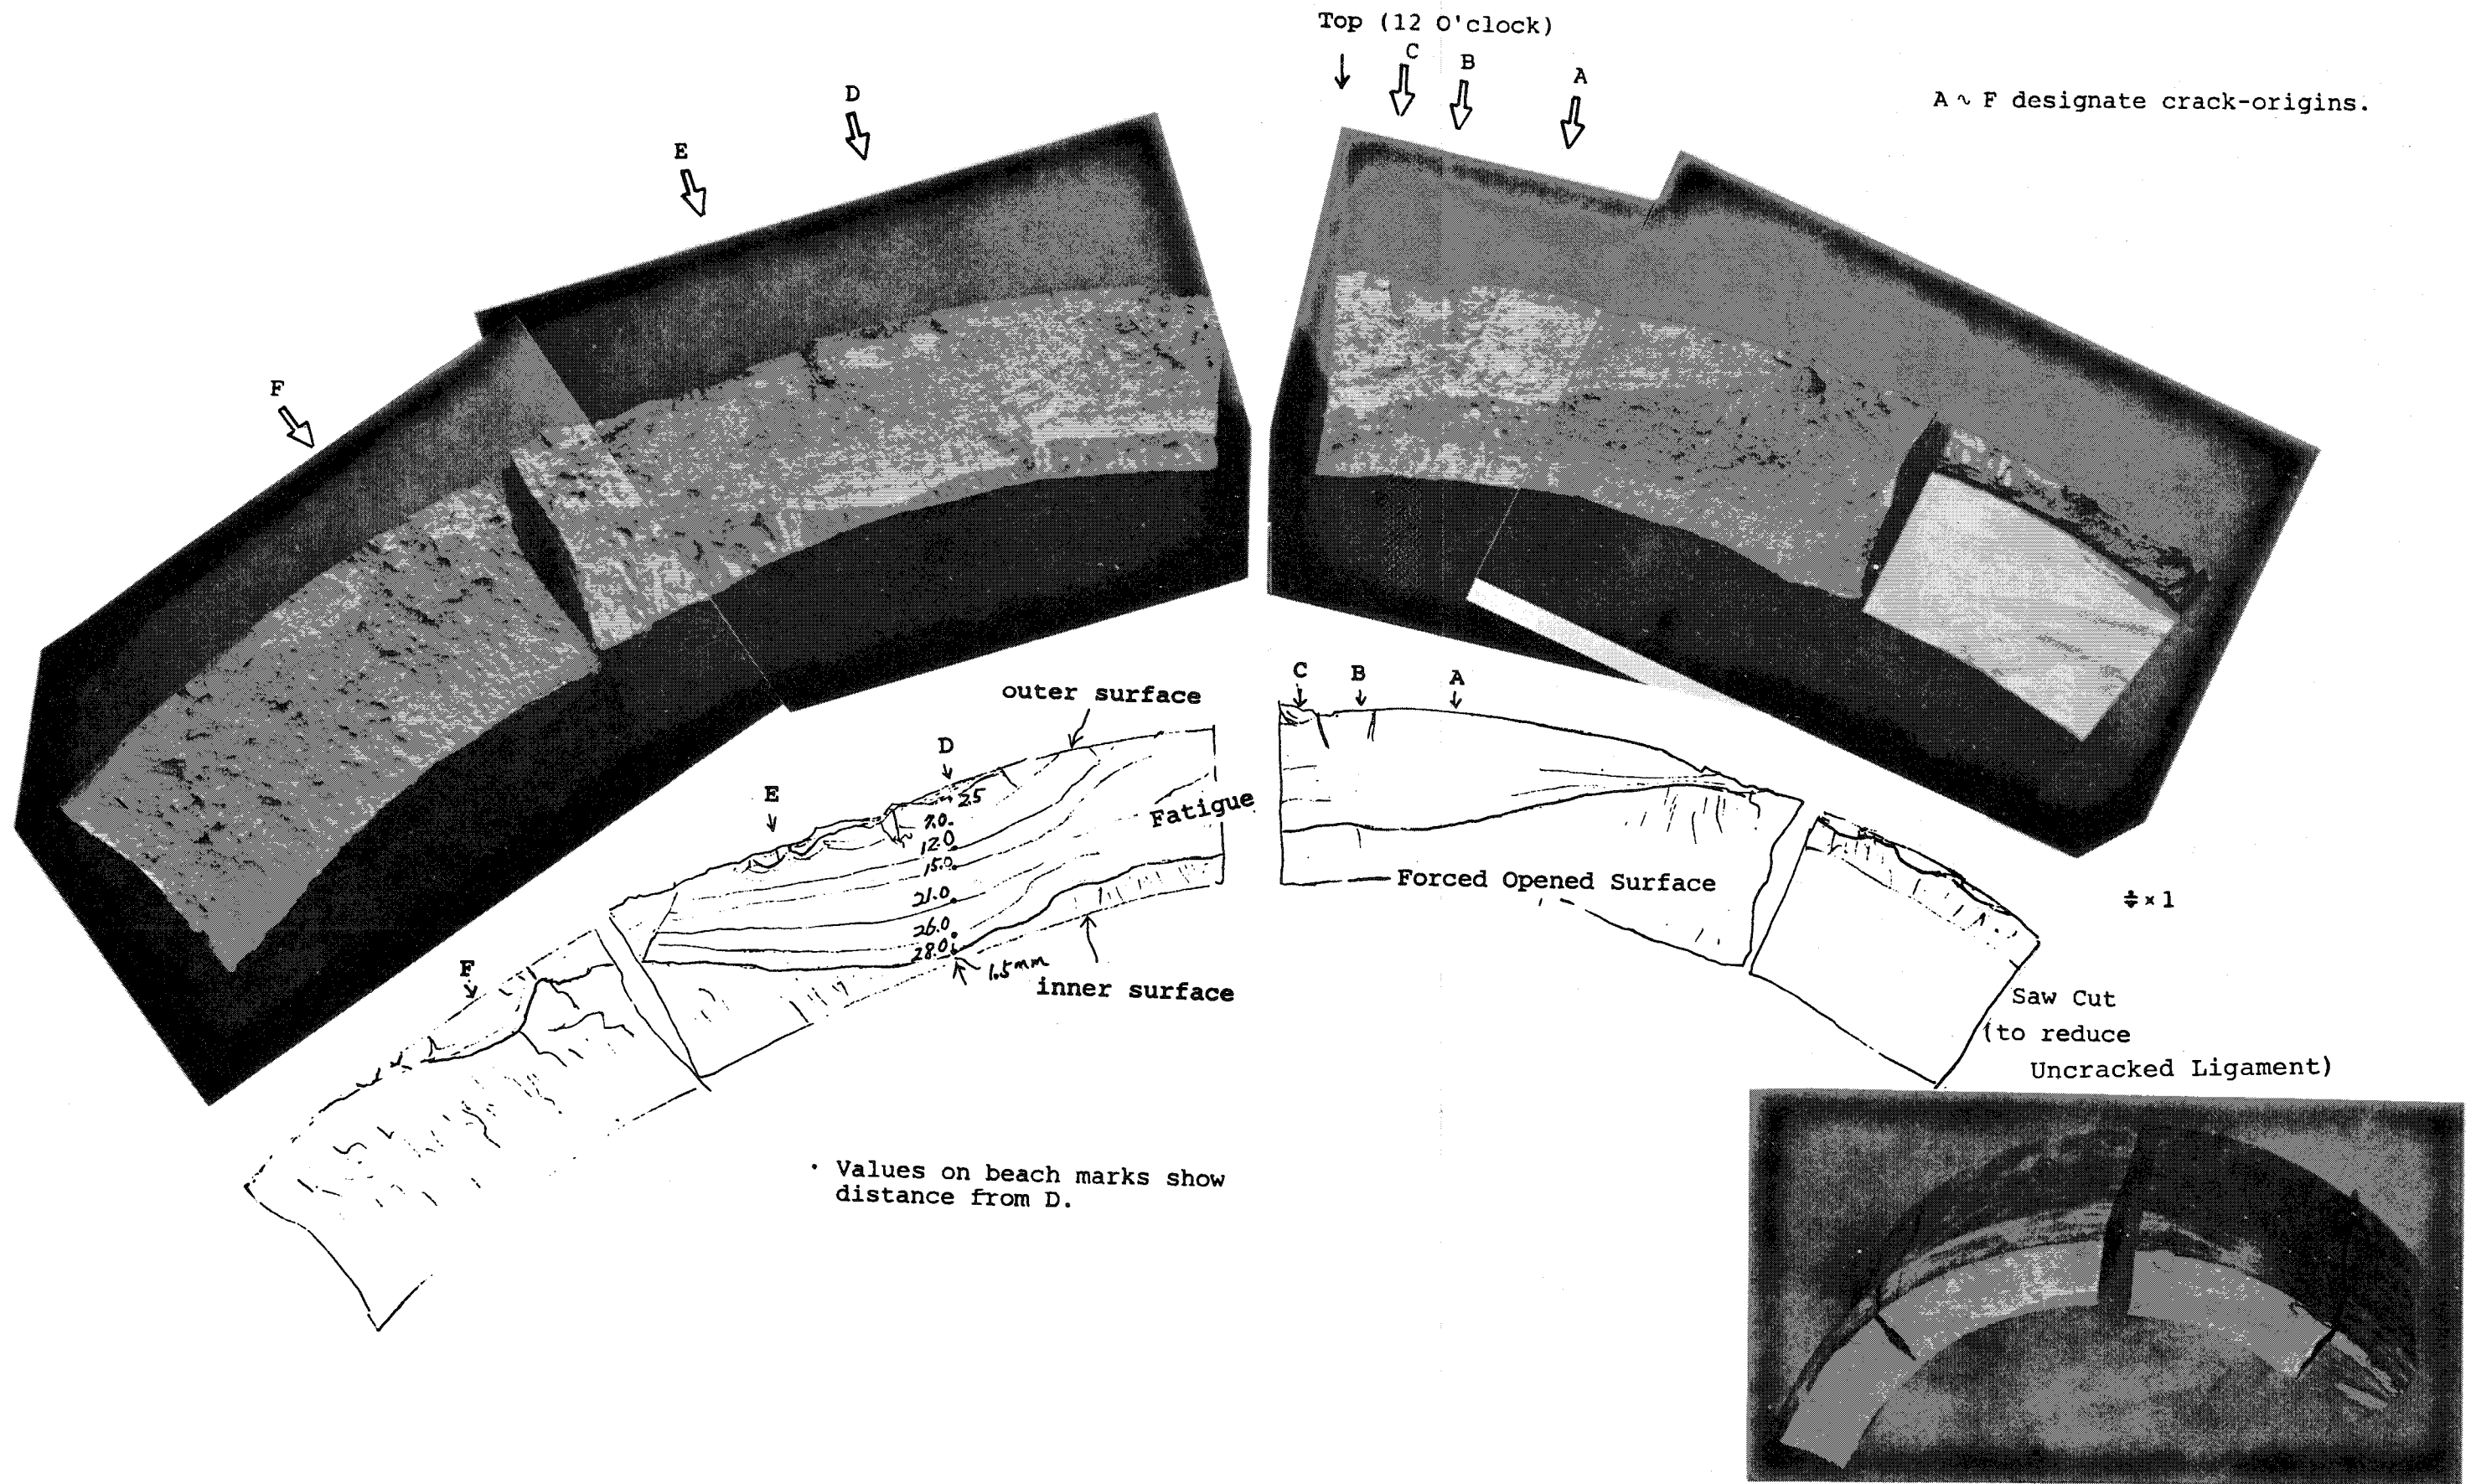
Figure 6.7   Crack Propagation Behavior

· Values on beach marks show
  distance from D.

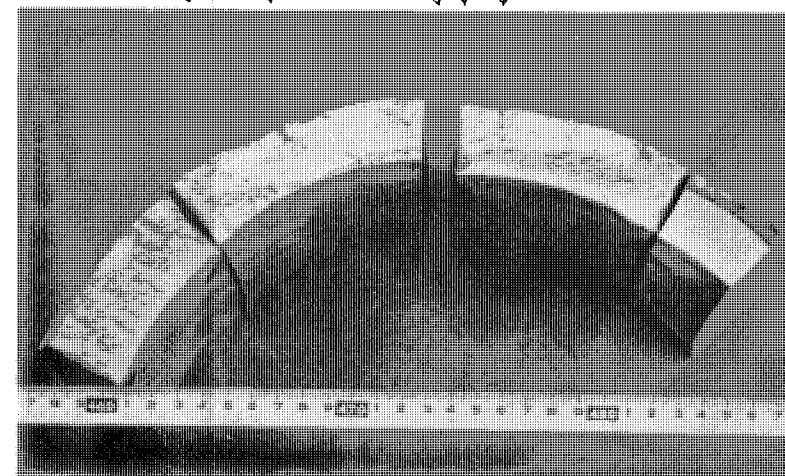
Figure 6.9   Details of Crack Origins

Location E

Location B

Overall view

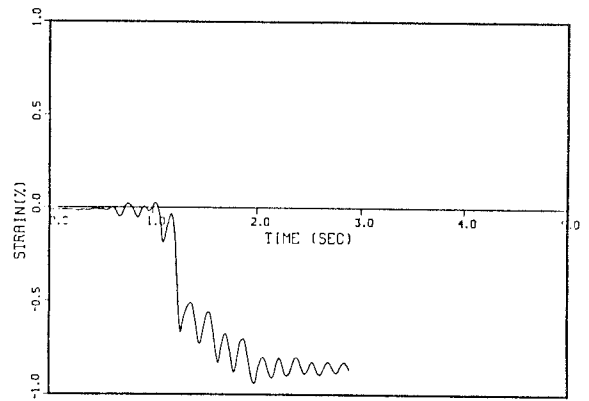
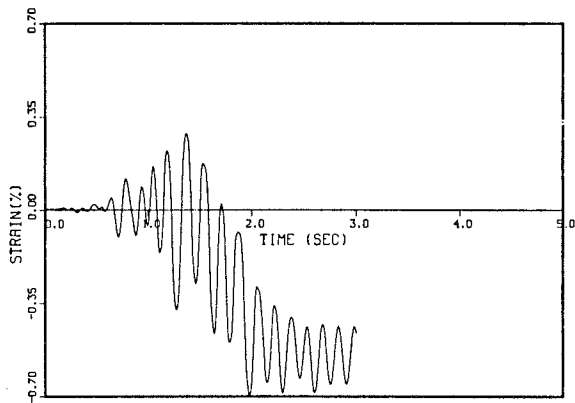
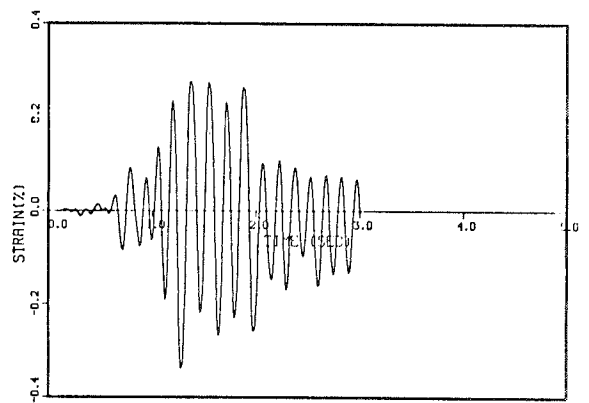
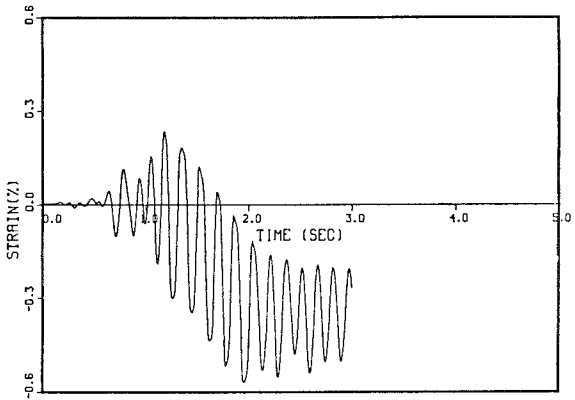
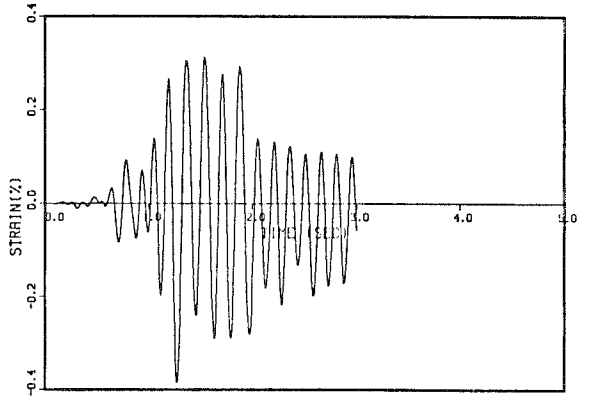
Figure 7.50 Axial Strain at 207X (1.0 MPR)

At the 0.4 MPR and 1.0 MPR levels, discrepancies between analysis and test results become clearer. The comparisons of strain time histories in Figures 7.37 to 7.41 and Figures 7.47 to 7.51 show a "ratchetting phenomenon" in the analysis results using elbow models which is not present in the test results. These time histories indicate a significant bulge in the hot leg pipe and the axial strains drift to either the tension or the compression side. These trends are more prominent in the ABAQUS analyses than in the MARC analyses. During the tests, bulging was observed in the hot leg pipe about one pipe diameter from the transition point. However, the observed bulging is much smaller than the elbow model analyses indicate. Moreover, virtually no drifts are observed in the measured time histories of axial strain. The comparisons of the peak strains at the 1.0 MPR level in Table 7.6 and Figure 7.54 indicate that the ABAQUS beam model gives a much better prediction of axial strain than the MARC and ABAQUS elbow models. Since the beam model yields no shell-type deformations, these comparisons

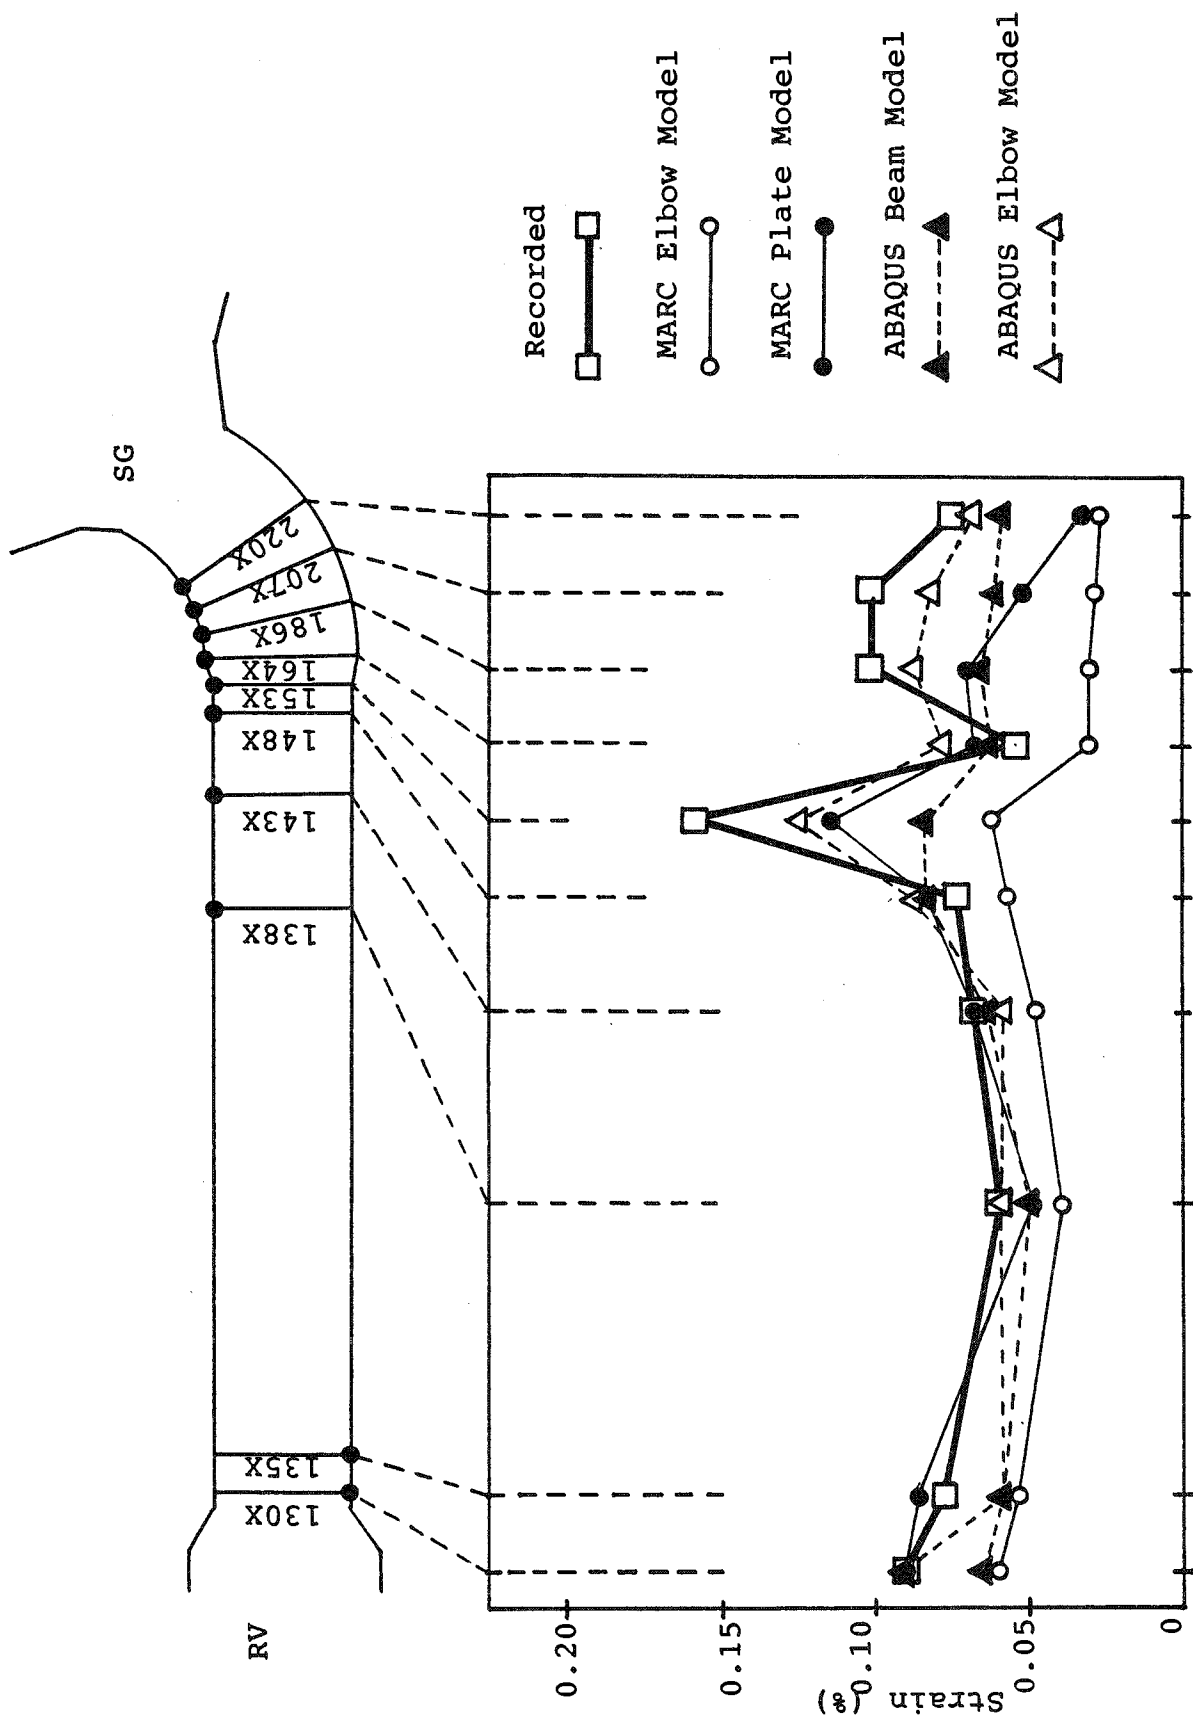
Figure 7.52 Axial Strain Distribution at 0.1 MPR (A-Segment)

At the 0.1 MPR level, the peak responses in Table 7.4 indicate that all the analyses underestimate the axial strain at 153X. Comparisons in Table 7.4 and Figure 7.52 show that the ABAQUS elbow model gives the best prediction and the MARC plate model also provides a fairly good prediction. The MARC elbow model consistently underestimates the axial strain and overestimates the hoop strain compared to test results and other analysis results. It should be noted that the initial yield strain of the stainless steel used for the hot leg pipe is about 0.1%. Since the strains calculated using the MARC elbow model and the ABAQUS beam model are within this yield limit, these two analysis results are purely elastic solutions. For the ABAQUS elbow model, a purely elastic analysis gives a lower strain value for 153X (e.g., by assuming the linear property in the ABAQUS elbow model, the peak strain value at 153X is reduced from 0.124% to 0.11%). The circumferential strain distributions, particularly by the ABAQUS elbow model, agree well with the measured ones (see Figures 7.58 and 7.59) except the axial strain distribution obtained by the MARC elbow model (see Figure 7.55).

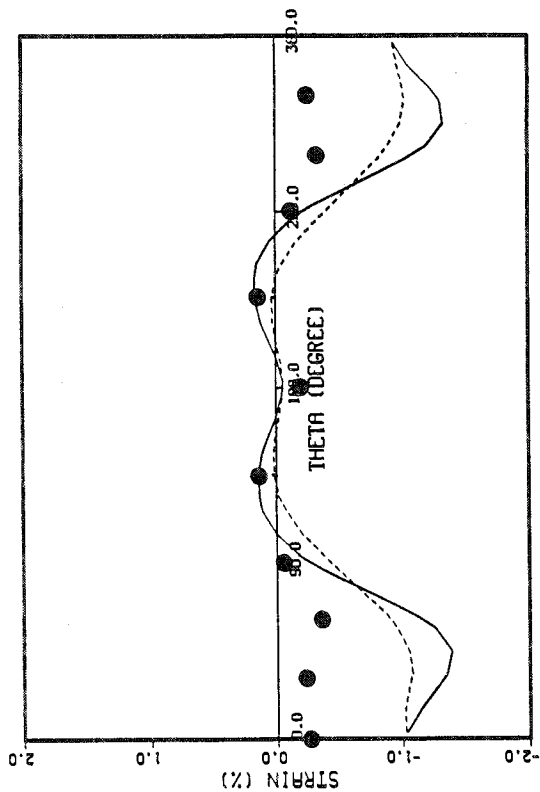
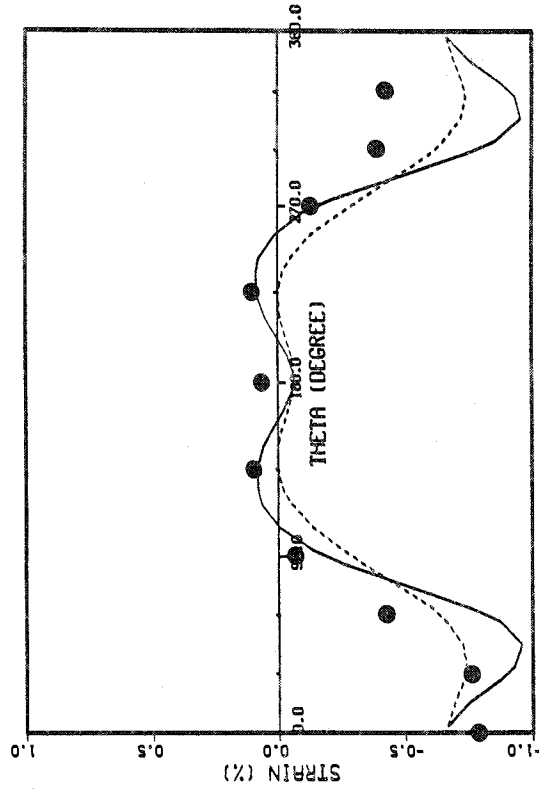
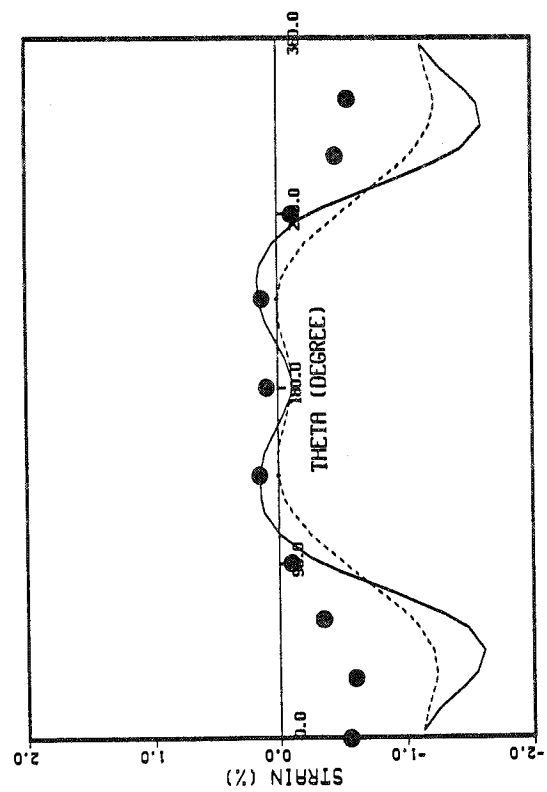
Figure 7.62 Axial Strain Distribution at Maximum Peak Response
of 1.0 MPR by MARC Elbow Model

The ovalization behavior can be more clearly compared in the form of circumferential strain distributions. Figures 7.62 and 7.63 show the comparison of the circumferential strain distribution by the MARC elbow model at the time the analysis predicted the peak axial strain at 153X location. Clearly, the analysis considerably overestimates the ovalization deformation in the plastic region. Figures 7.64 to 7.66 show the comparisons using the MARC plate model and the ABAQUS elbow model at the time the analysis predicted the peak displacement of the steam generator. Fairly good agreement can be seen in these comparisons. However, the "ratchetting" starts right after this peak in these analyses.
