The High Level Vibration Test Program

Final Report

Prepared by
Y. J. Park, J. R. Curreri, C. H. Hofmayer

Brookhaven National Laboratory
Upton, NY 11973

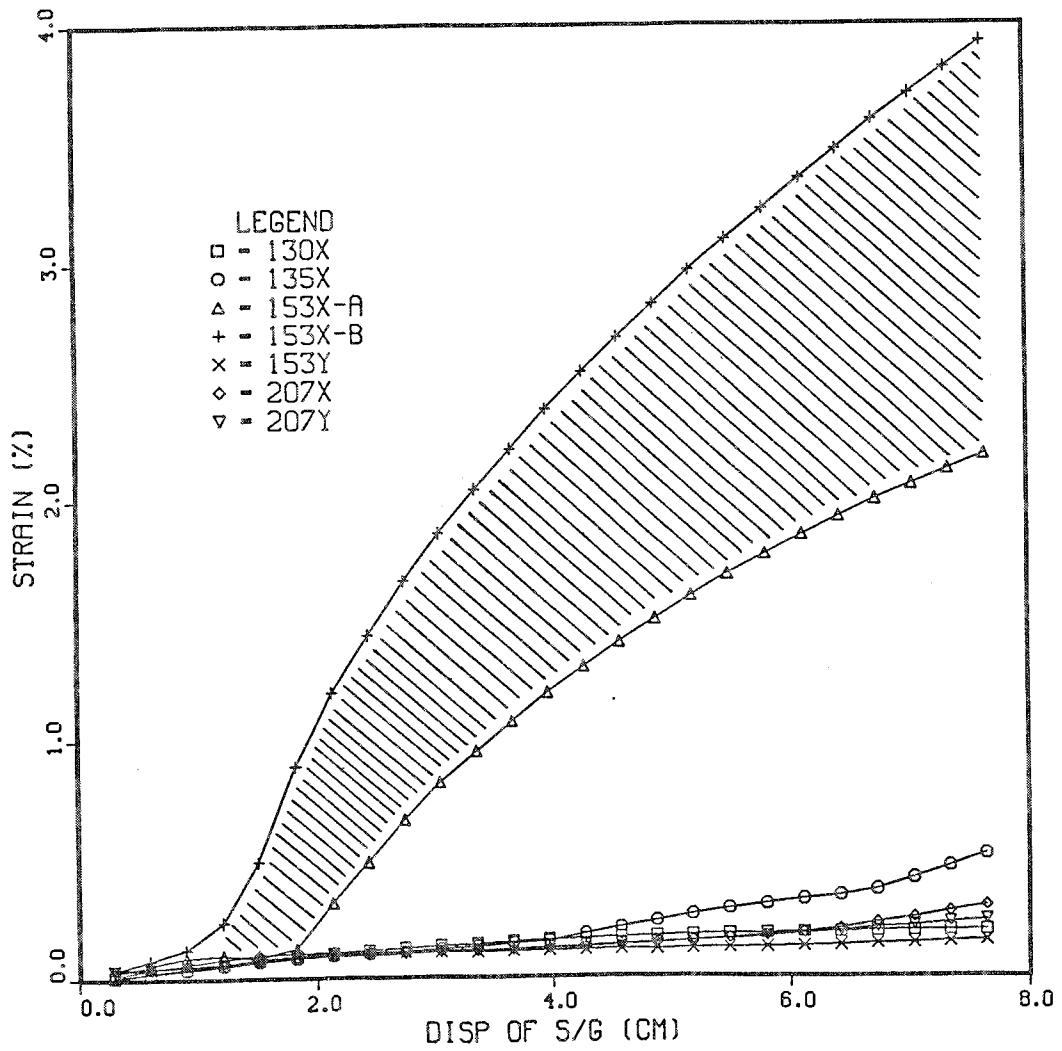
Figure 7.83 Results of Static Analysis (Displacement at Top of S/G vs. Strain in Hot Leg Pipe)

Figure 7.83 shows the calculated relationship between the applied SG top displacement and strain values at several locations. Within the element nearest to gage 153X, the axial strain varies from 2% to 4% along the pipe axis. Also, the ratio of the average strain over the gage length of 153X to the strain value at the crack location was calculated to be about 1.3 based on the shape function of the shell element. From the same figure, it can be observed that plastic strains around 153X develop rapidly after reaching the yield value. Figures 7.84 and 7.85 show the strain contours at 20% and 100% of the SG displacement, respectively. A clear formation of a plastic hinge is observed at the transition point from the straight and elbow parts of the hot leg pipe. The strain concentration around gage 153X increases at larger displacement levels. However, the hoop strain is much less concentrated. At the maximum displacement level, the calculated shear force at the SG pin-connection is 218.0 tons; which is closer to the value of the ABAQUS elbow model than the recorded value.

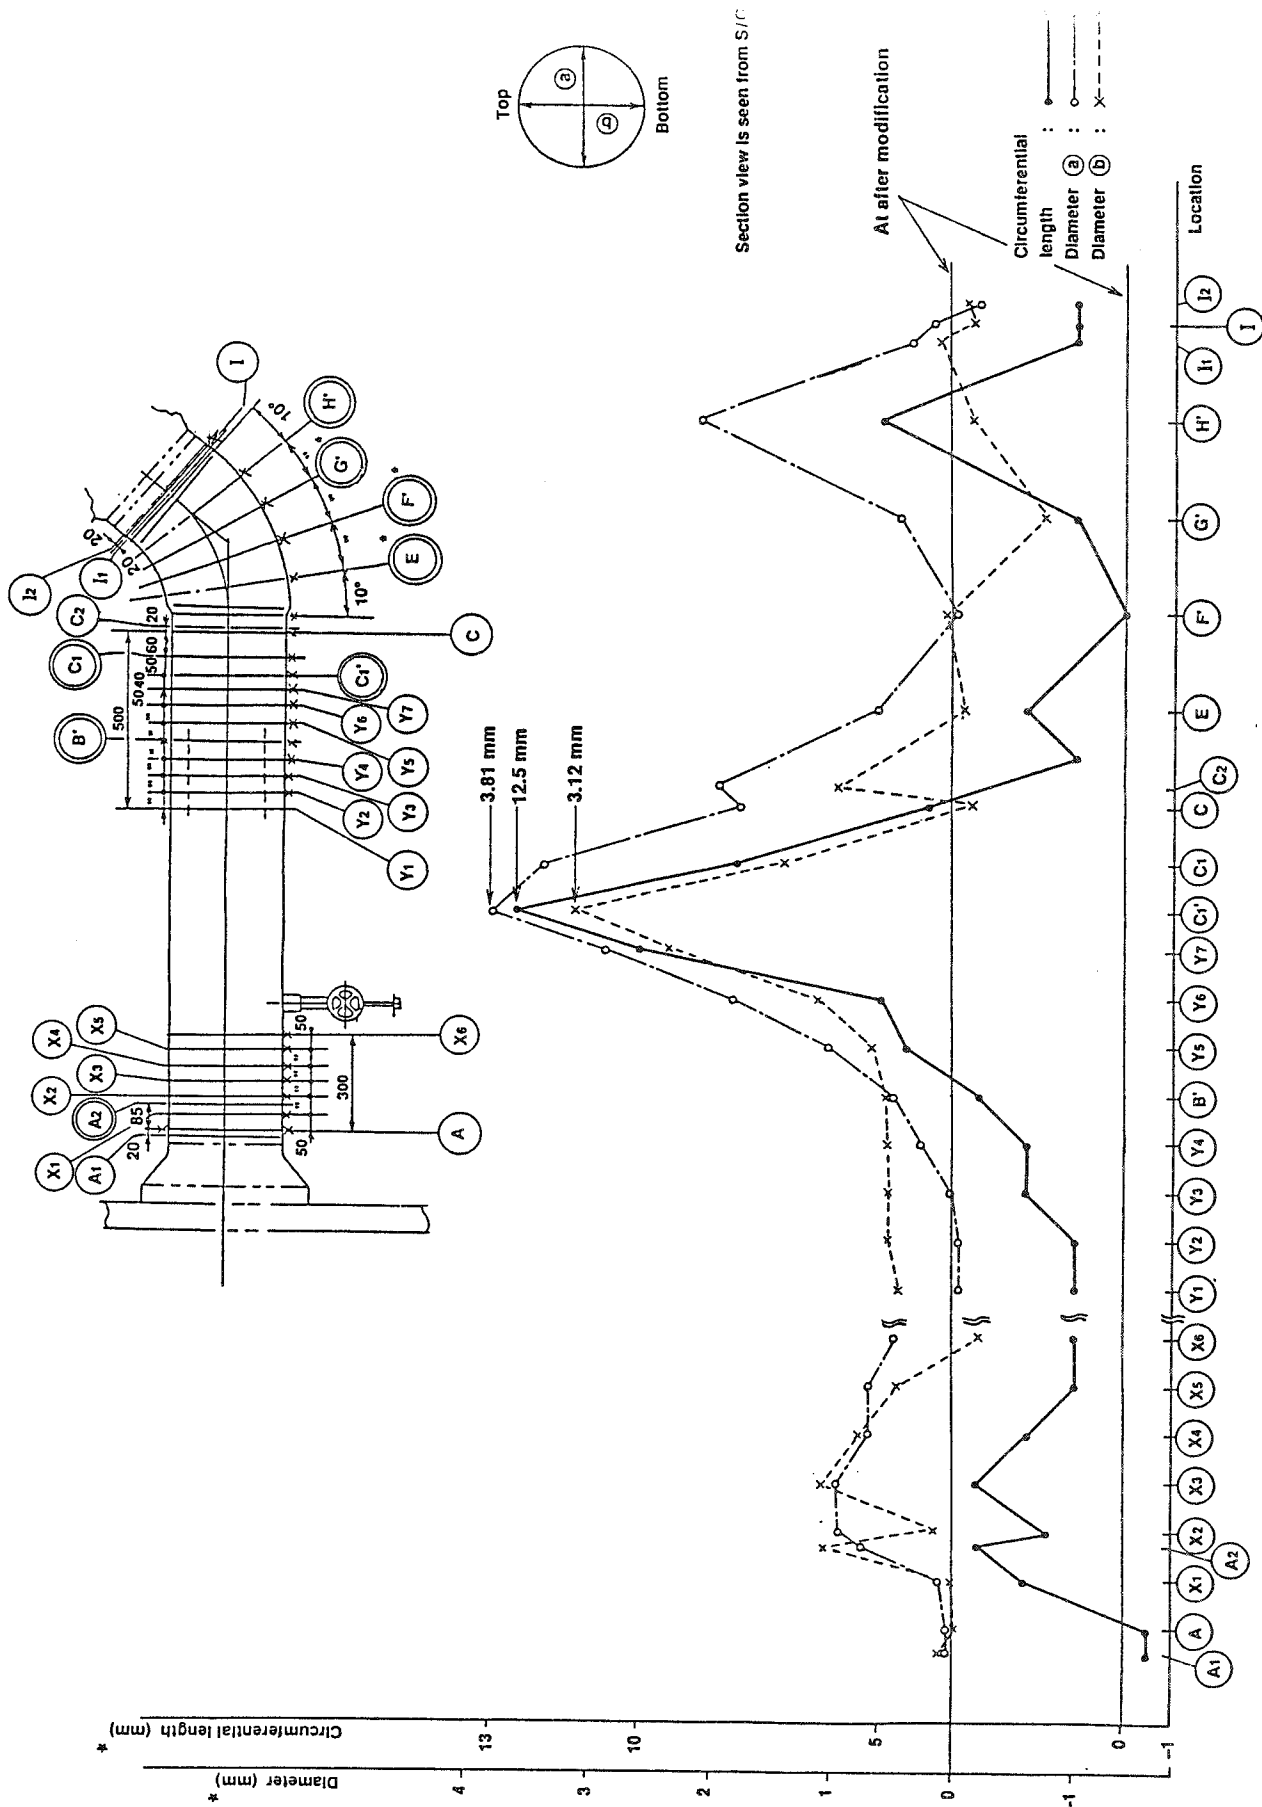
Figure F.13 Dimensional Change of Hot Leg

* : (After HLVT) − (After Modification)

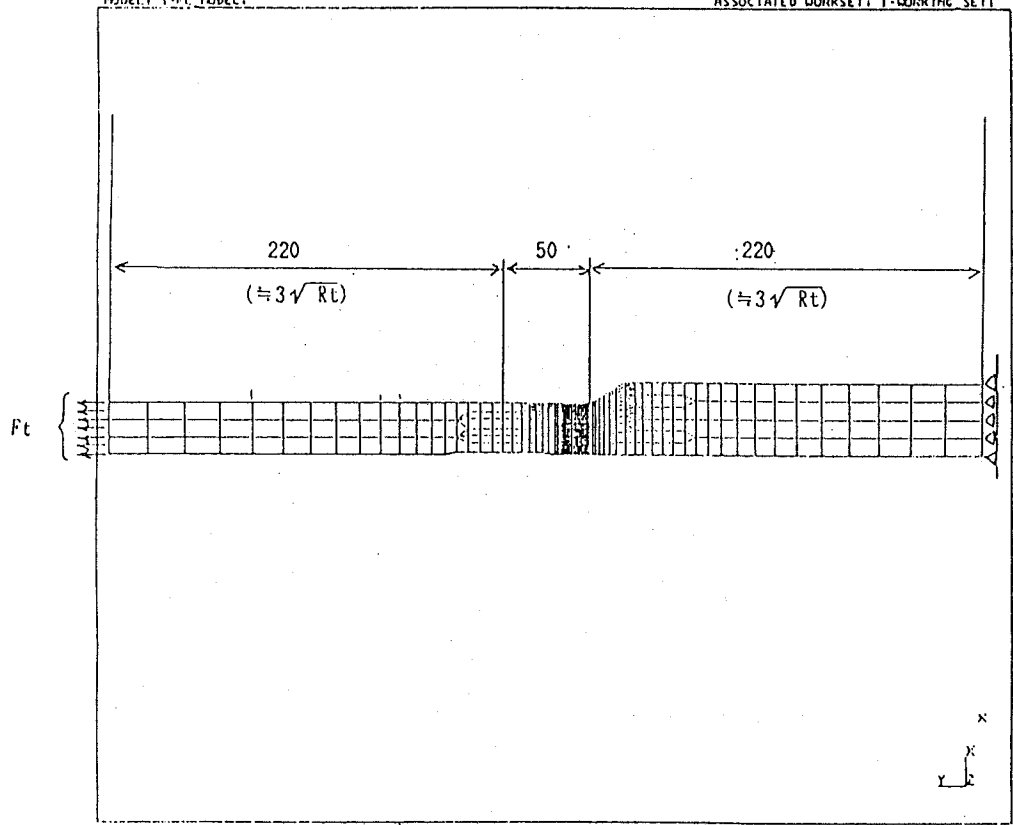
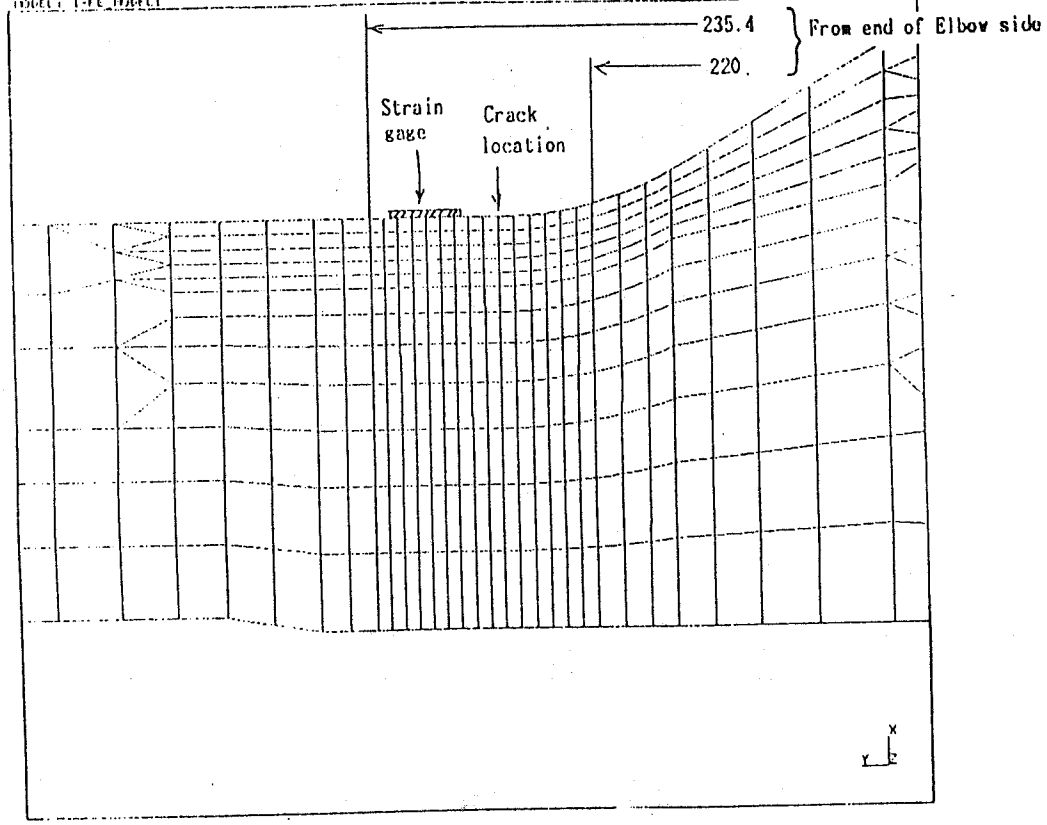
Figure H.1 (1) FEM Model

Figure H.1 shows the finite element model used for the stress calculation. The axial axi-symmetric, two dimensional solid element of the ABAQUS code was employed, and a static tensile load was applied to the left side boundary of the model. Figure H.2 shows the maximum principle stress distribution in the vicinity of the crack and the strain measuring point.

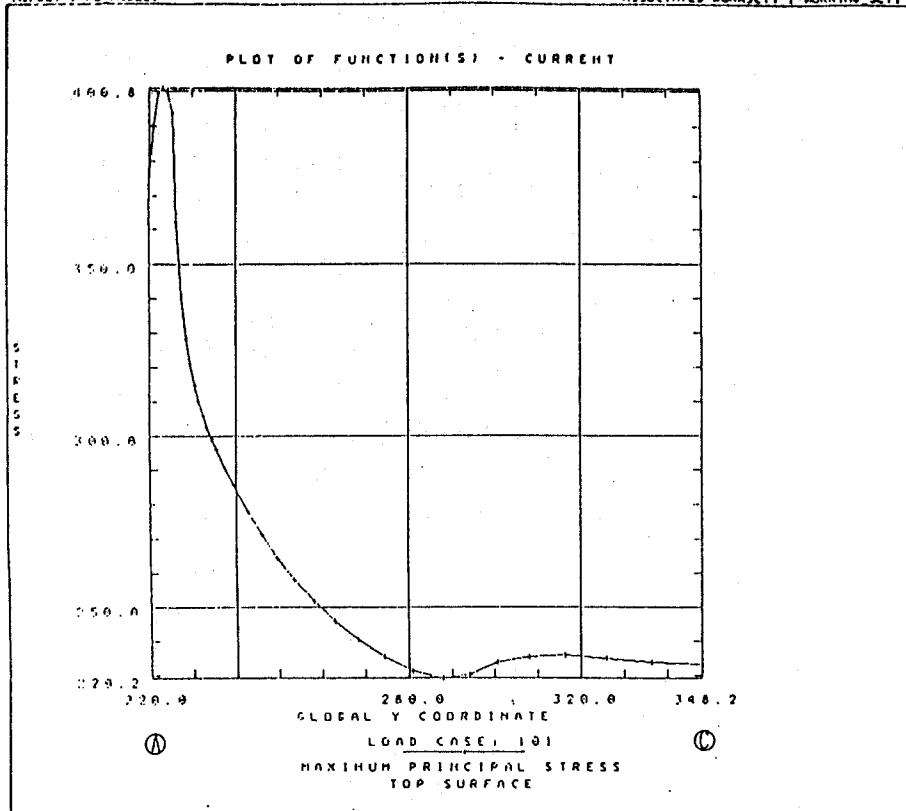
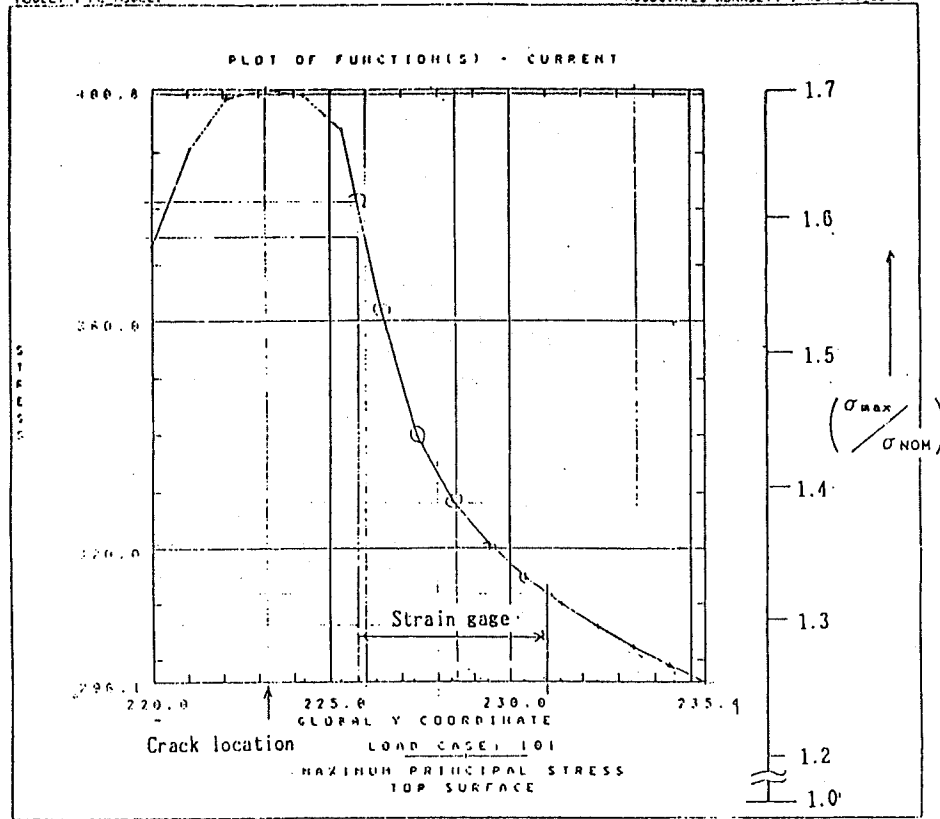
Figure H.2 (2) Stress Distribution Near Crack

When the crack location is considered to coincide with the maximum stress location, the magnification (K) of the stress at the crack location to the gage location becomes;

$$K = \frac{\text{stress at crack location}}{\text{average stress in the gage length}} = \frac{401 \ [kg/mm^2]}{341 \ [kg/mm^2]} = 1.2$$

thus, the stress at the strain measurement location should be multiplied by K =1.2 for the fatigue damage assessment at the cracked location.

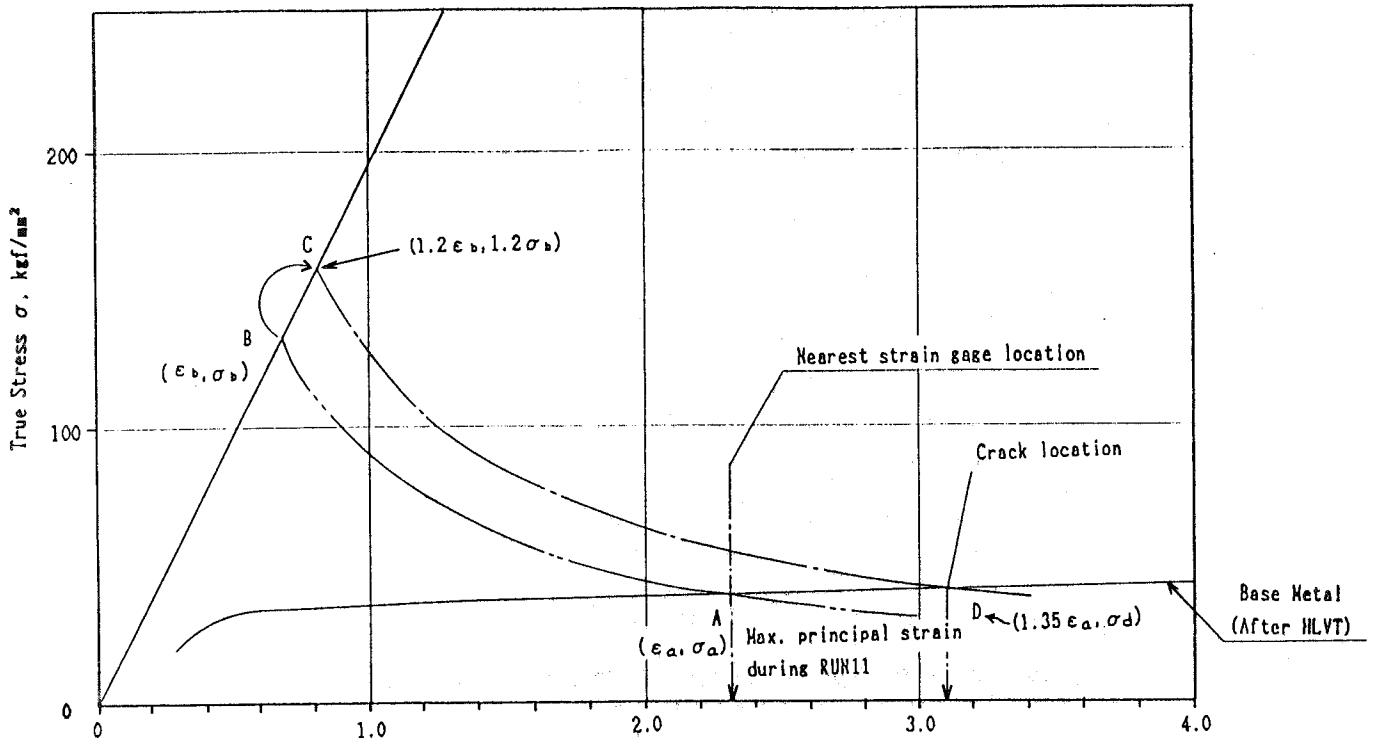
Figure H.4 Estimation of Strain Concentration Factor

Using the above ralationship, a strain concentration factor of k_ϵ = 1.35 is obtained as illustrated in Figure H.4 (k_t = 1.2).

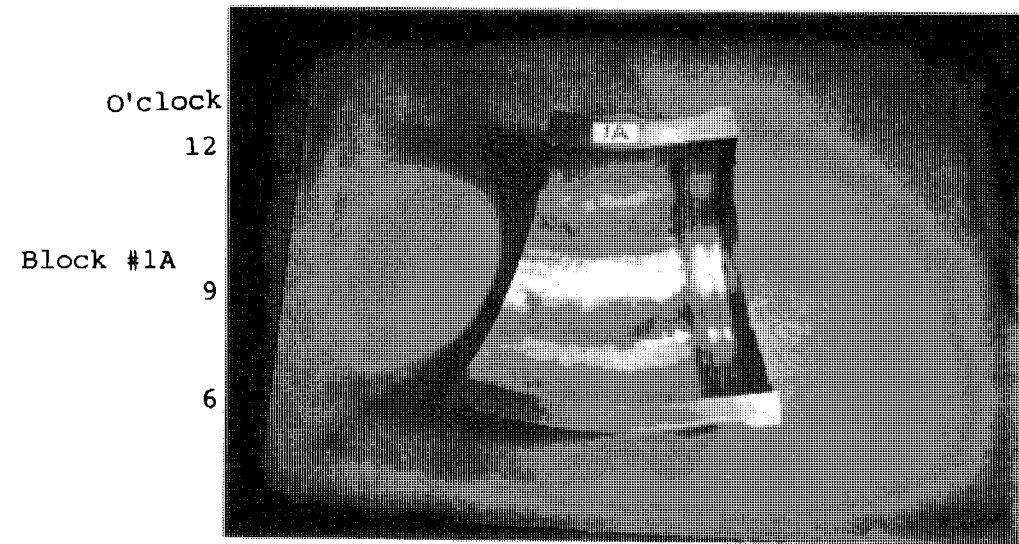
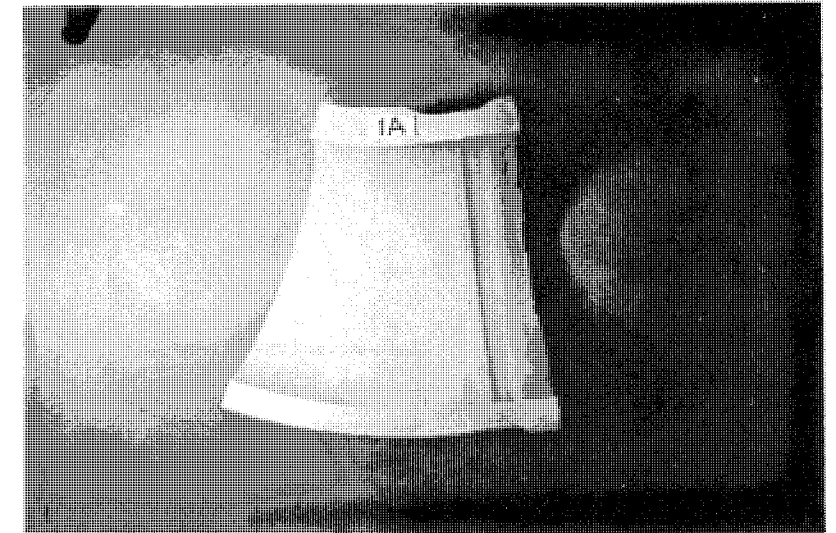
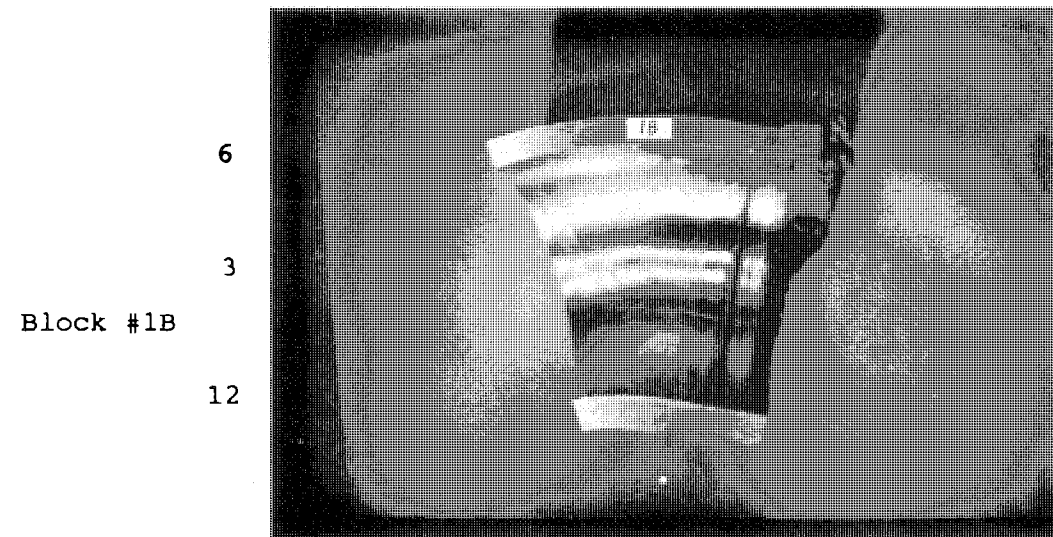
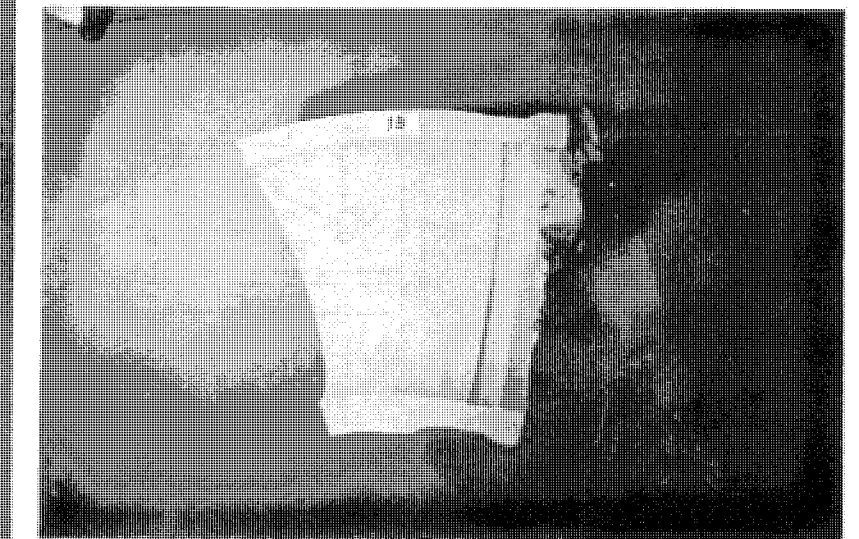
Figure K.3 Inner Surface of Blocks #1A and #1B

Cracks

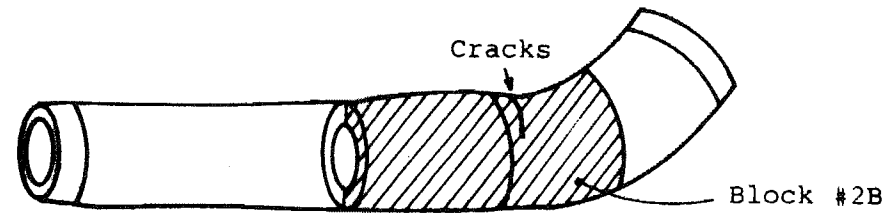
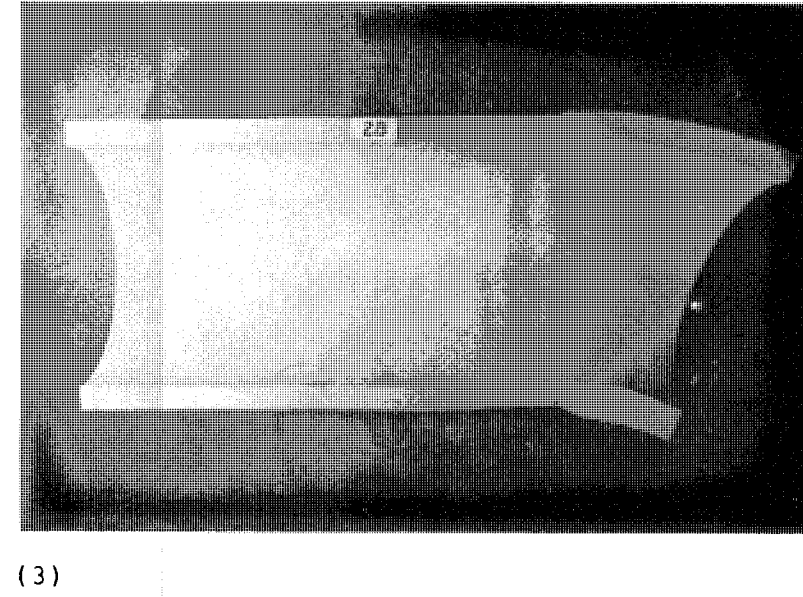
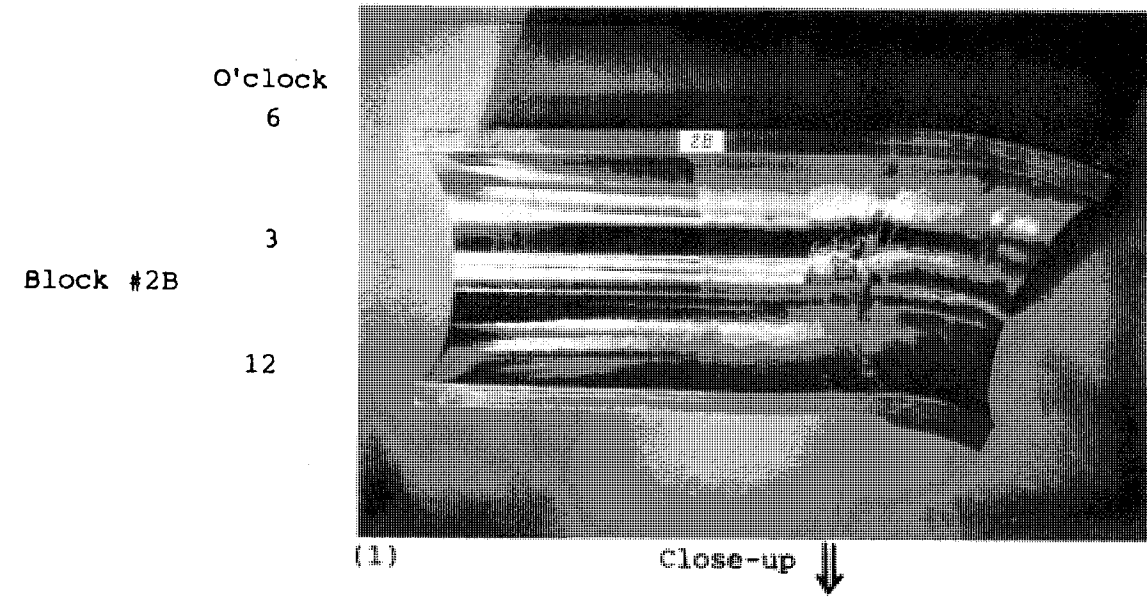
Figure K.5   Inner Surface of Block #2B

Cracks

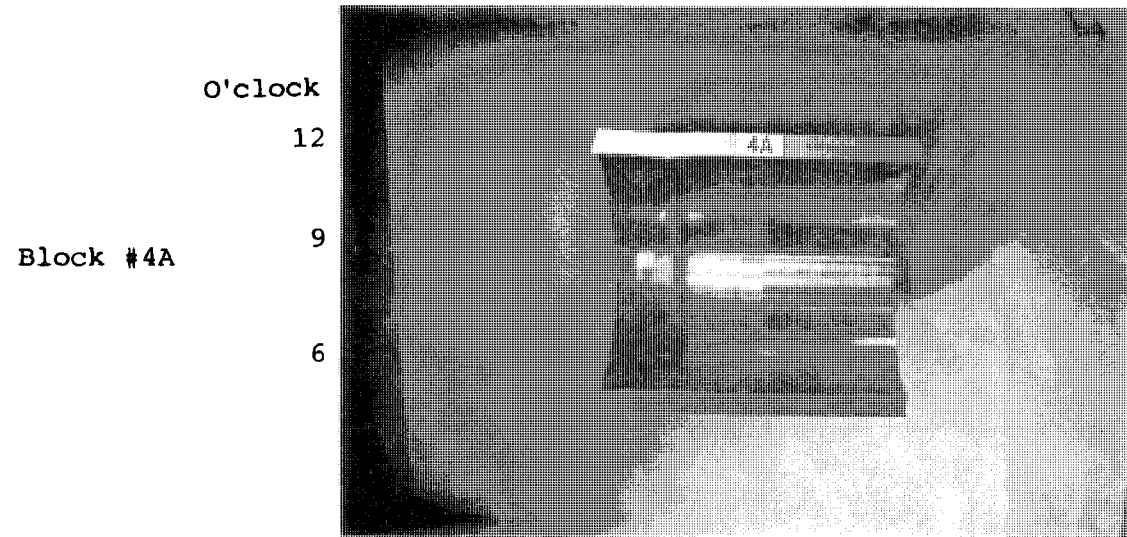
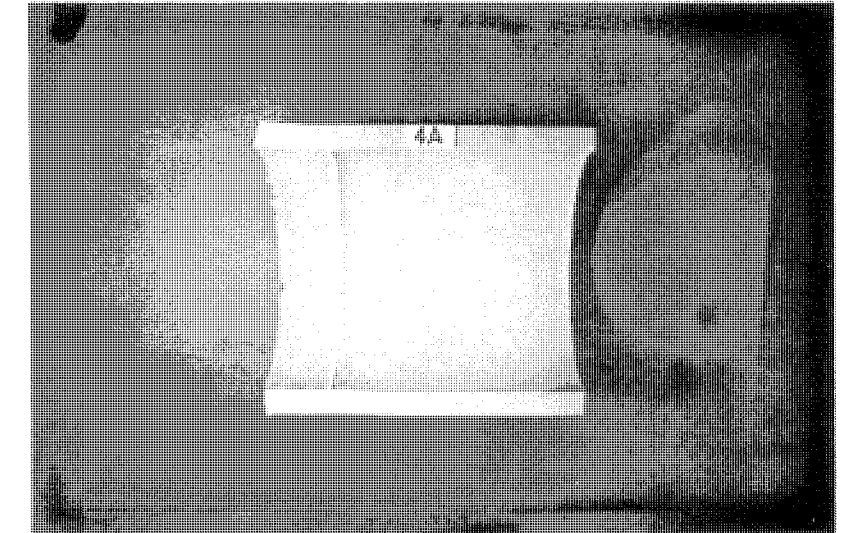
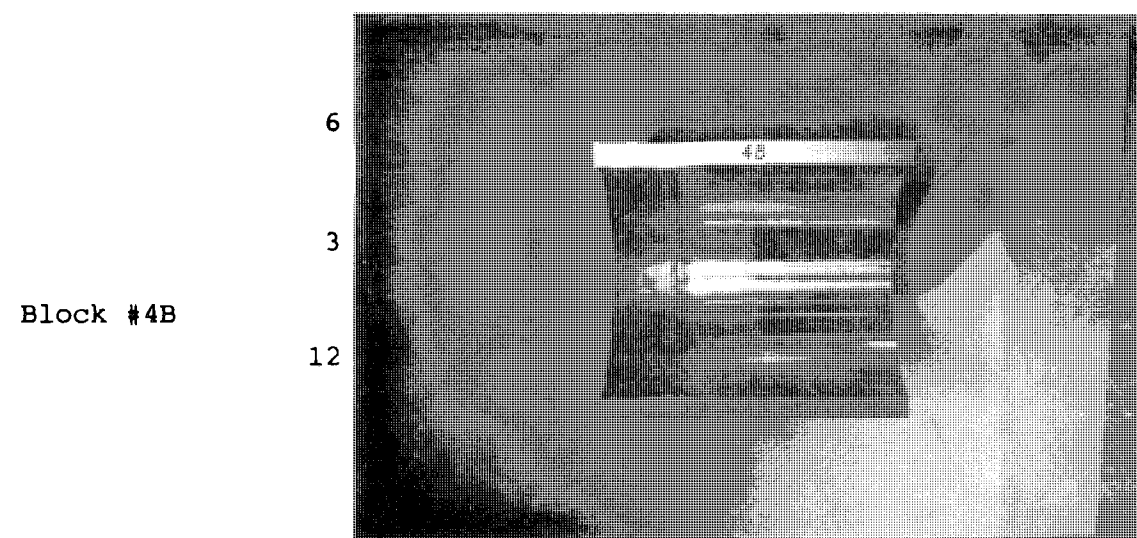
Figure K.6 Inner Surface of Blocks #4A and #4B

Weld joints
Cracks

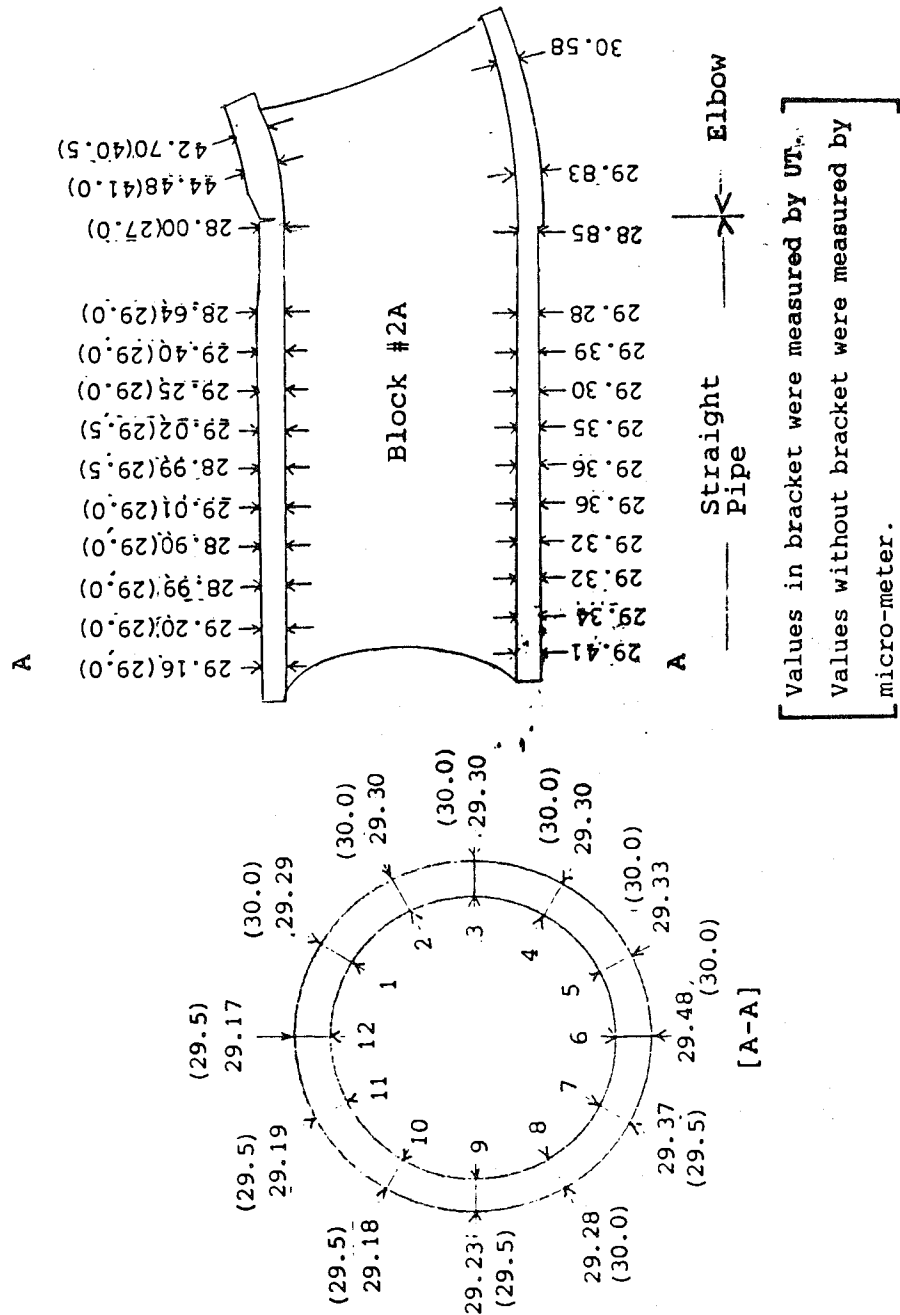
Figure K.8 (2) Thickness of the Test Pipe (2/5)

(1) Block #2A

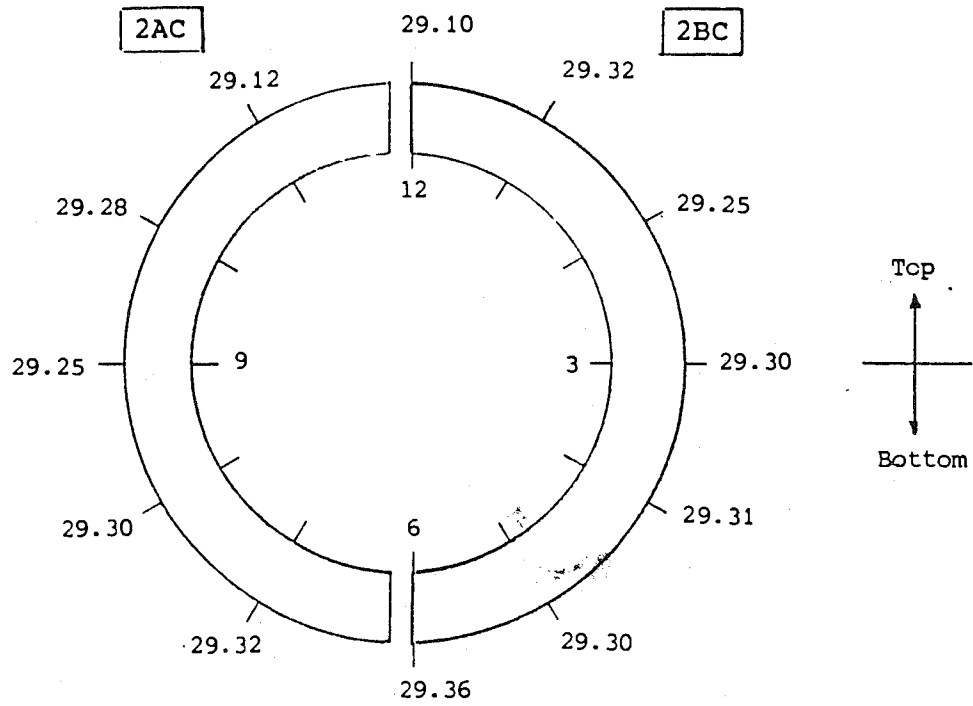
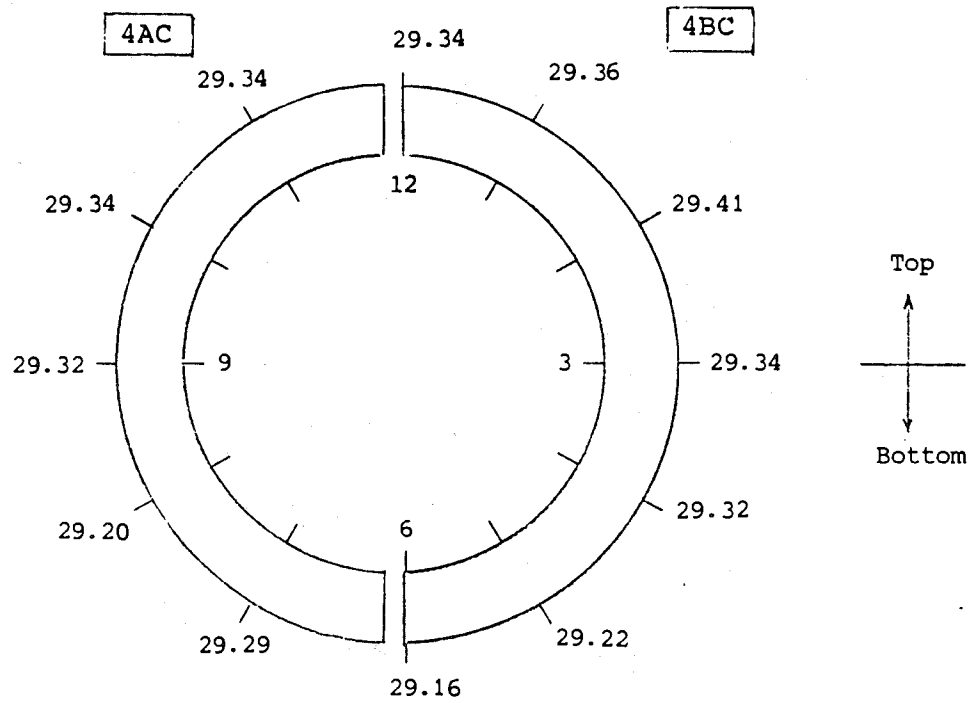
Figure K.8 (3)   Thickness of the Test Pipe (3/5)

(2) Typical cross-section of top bulging region

(3) Typical cross-section of bottom bulging region

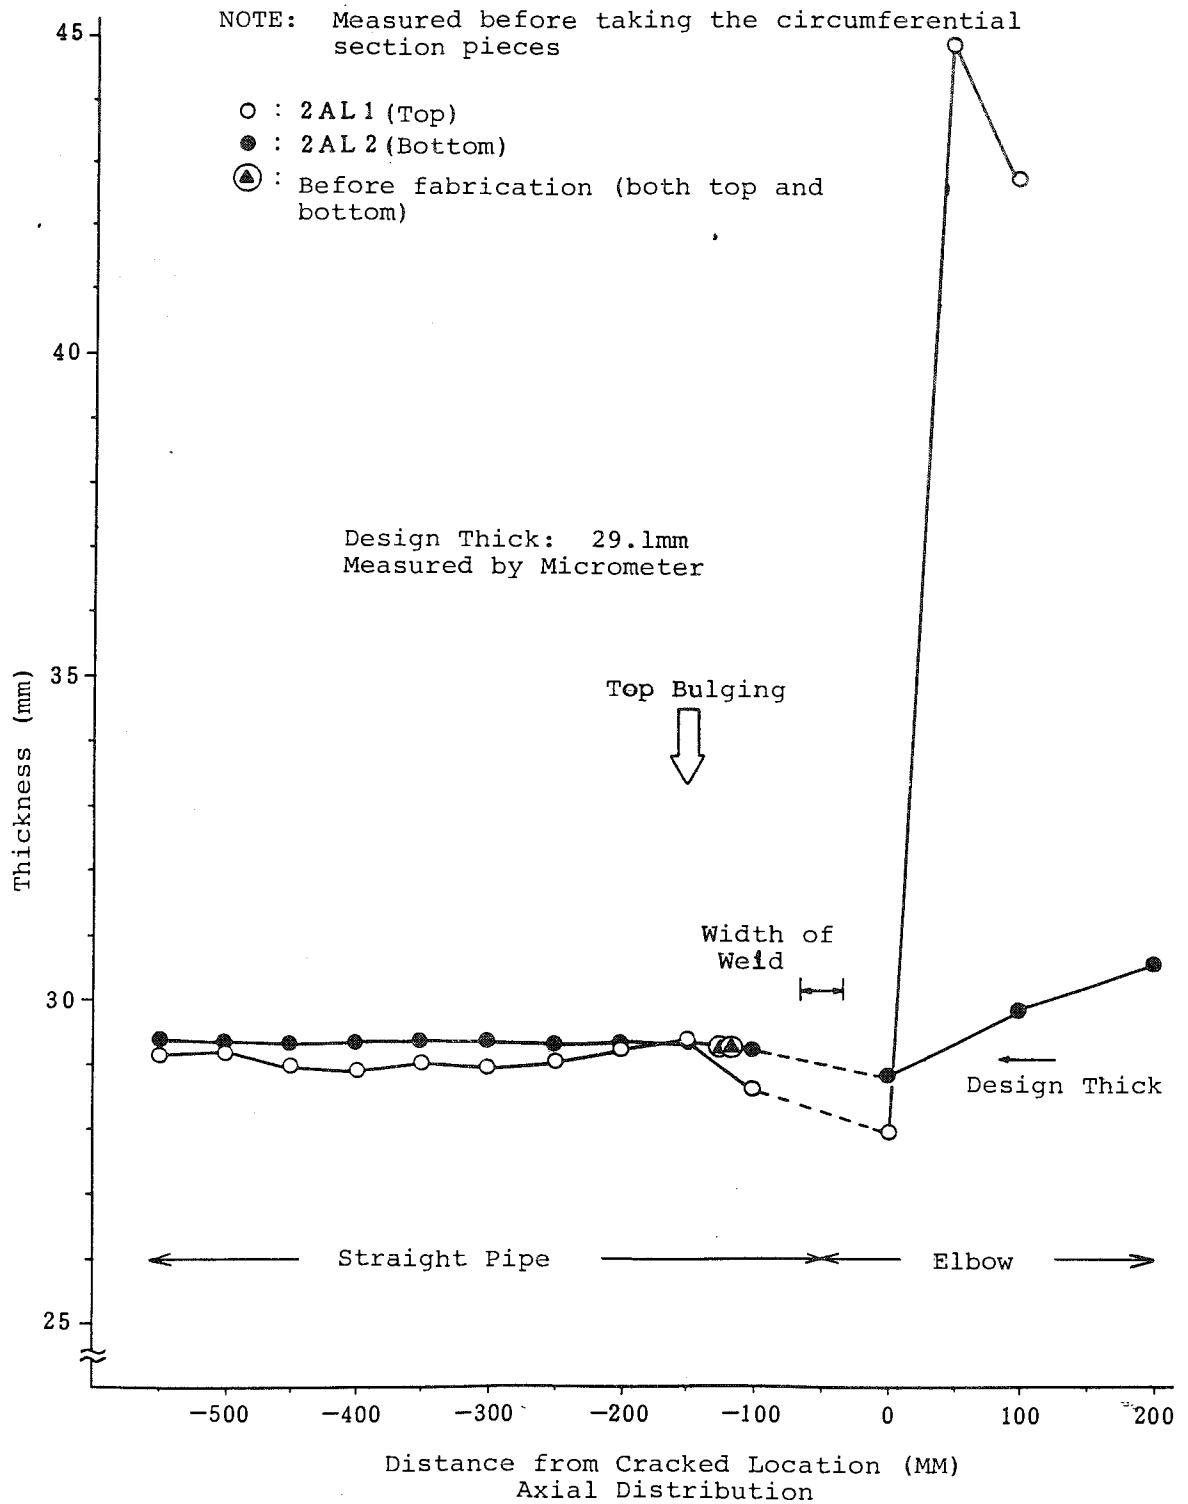
Figure K.8 (5) Thickness of the Test Pipe (5/5)

NOTE: Measured by Micrometer

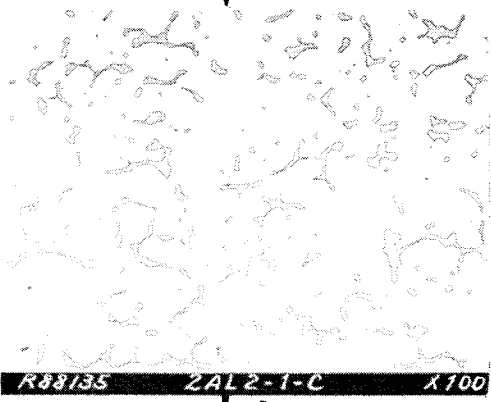
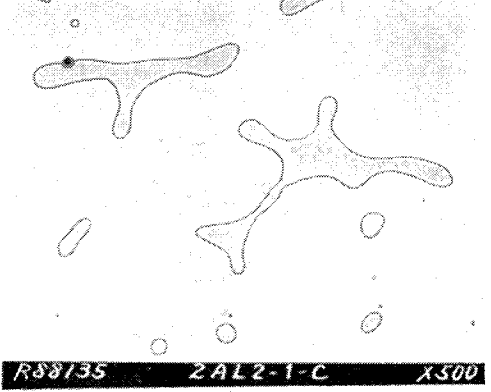
Figure K.13 Microstructure of Cracked Region (Sample No. 2AL1-1)

Close-up of a crack

ⓔ crack tip

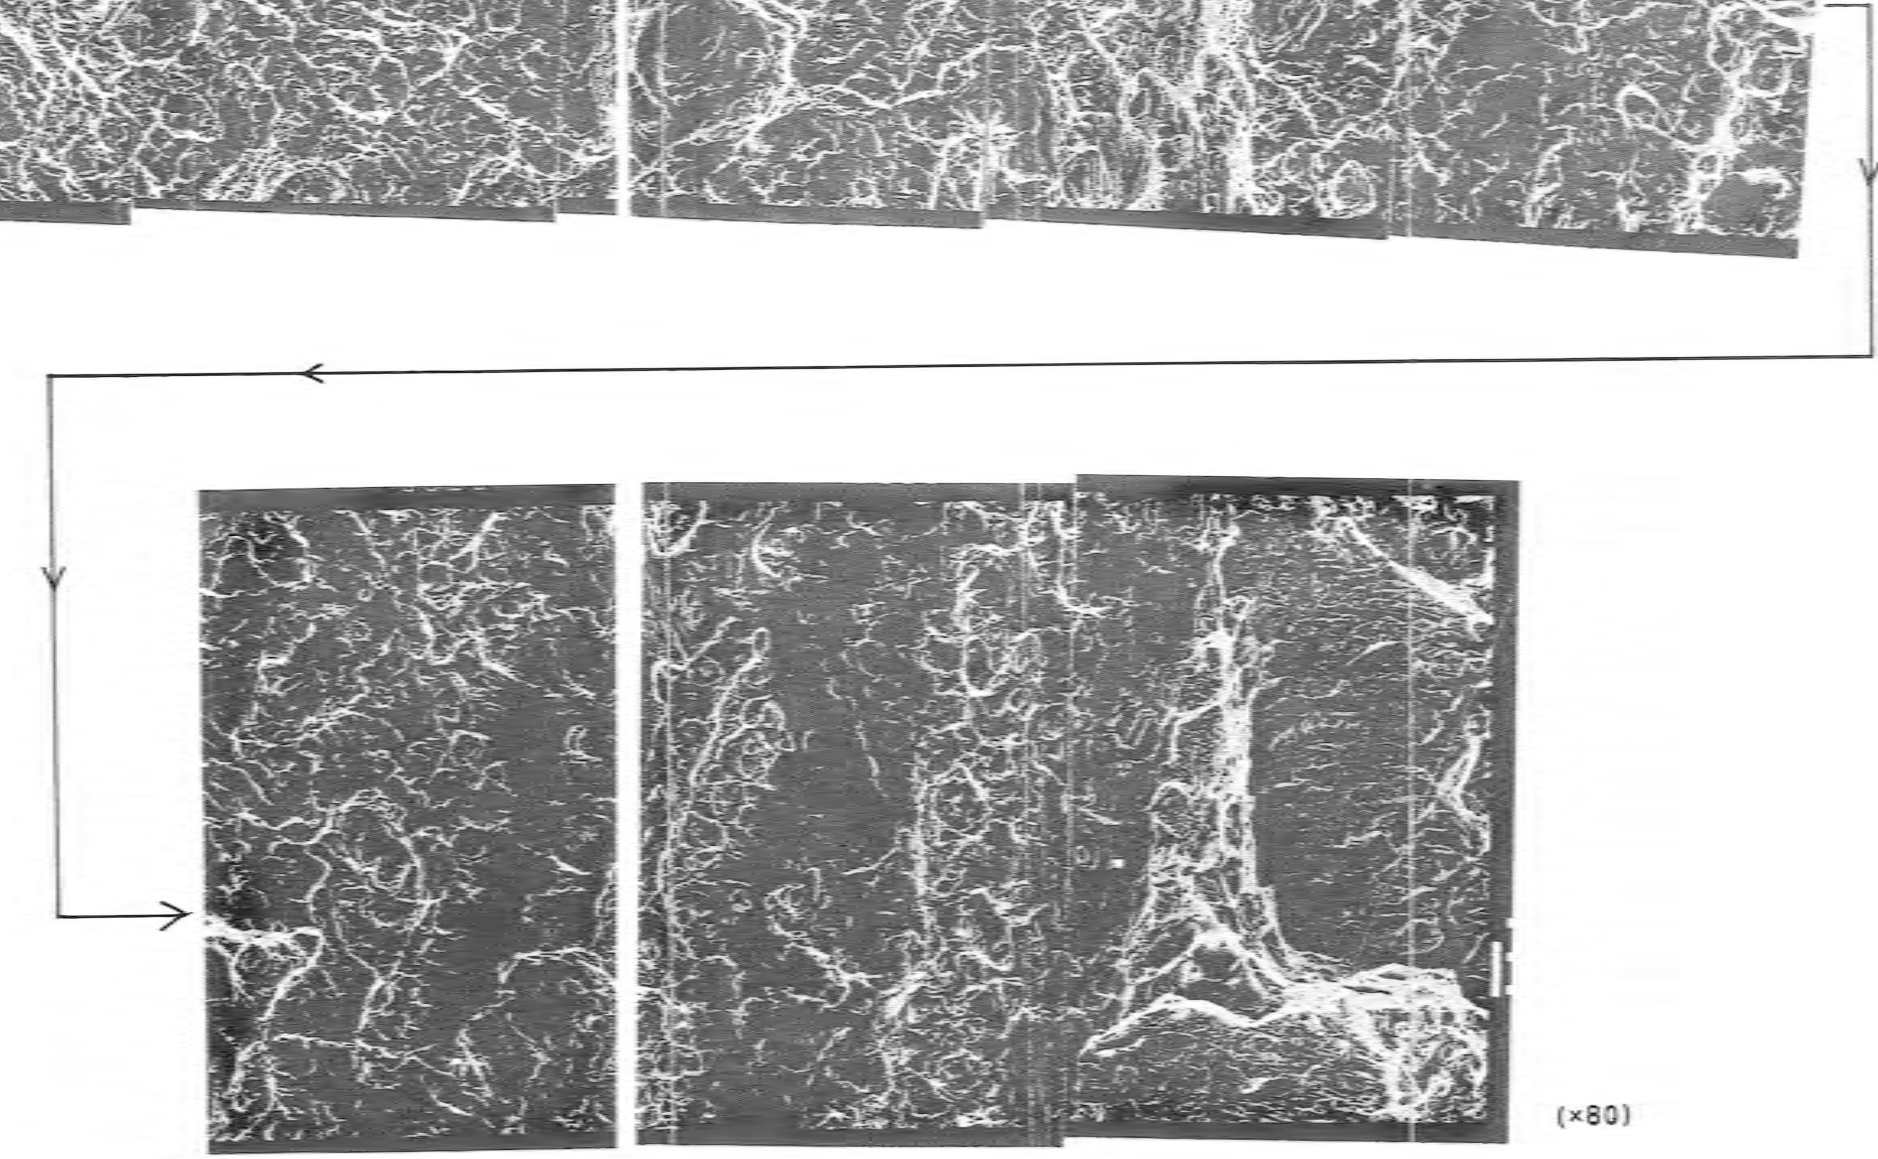
Figure K.17 (2)   Observation by SEM (2/3)

Crack Front

Surface
Mode ⟹ St   St + SL   St + SL   St + SL

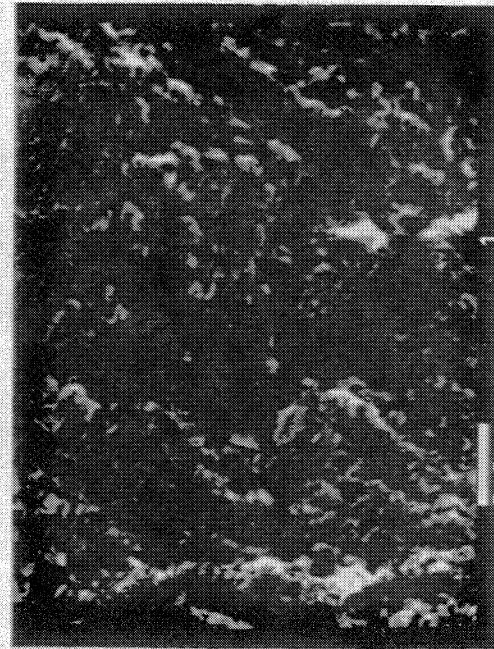
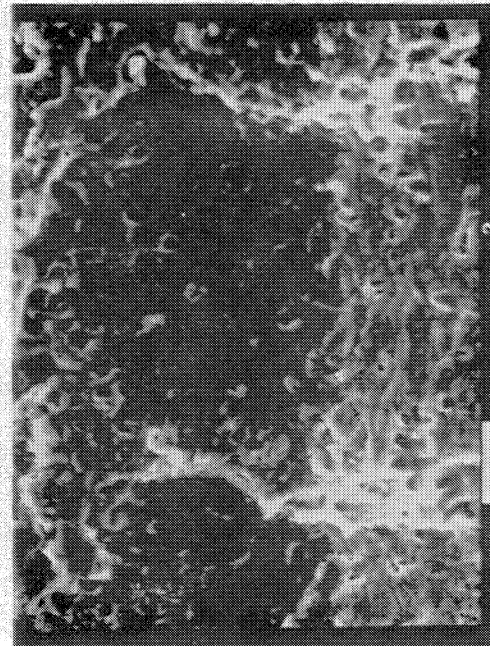
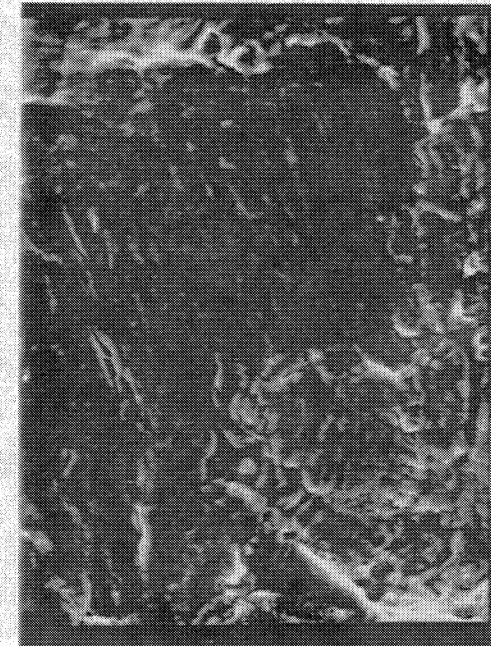
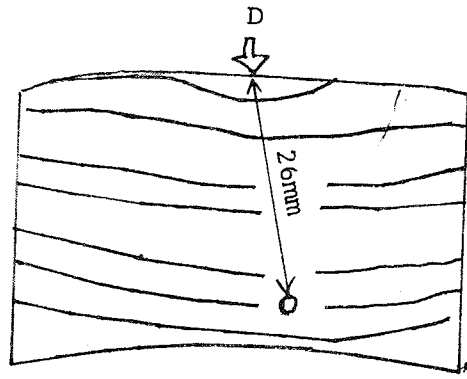
① $\Delta\ell = 0.375$, $t = 0.1$
$\Delta S = 2.5 \sim 5.8 \times 10^{-3}$

② $\Delta\ell = 0.0625$, $t = 2.7$
$\Delta S = 4.6 \sim 5.8 \times 10^{-2}$

③ $\Delta\ell = 0.40$, $t = 3.7$
$\Delta S = 2.5 \sim 4.2 \times 10^{-2}$

④ $\Delta\ell = 0.15$, $t = 4.6$
$\Delta S = 3.75 \sim 5.2 \times 10^{-2}$
(Continued)

| $N_1 = \dfrac{0.375}{2.5 \sim 5.8 \times 10^{-3}} = 150 \sim 65$ |
