The High Level Vibration Test Program

Final Report

Prepared by
Y. J. Park, J. R. Curreri, C. H. Hofmayer

Brookhaven National Laboratory
Upton, NY 11973

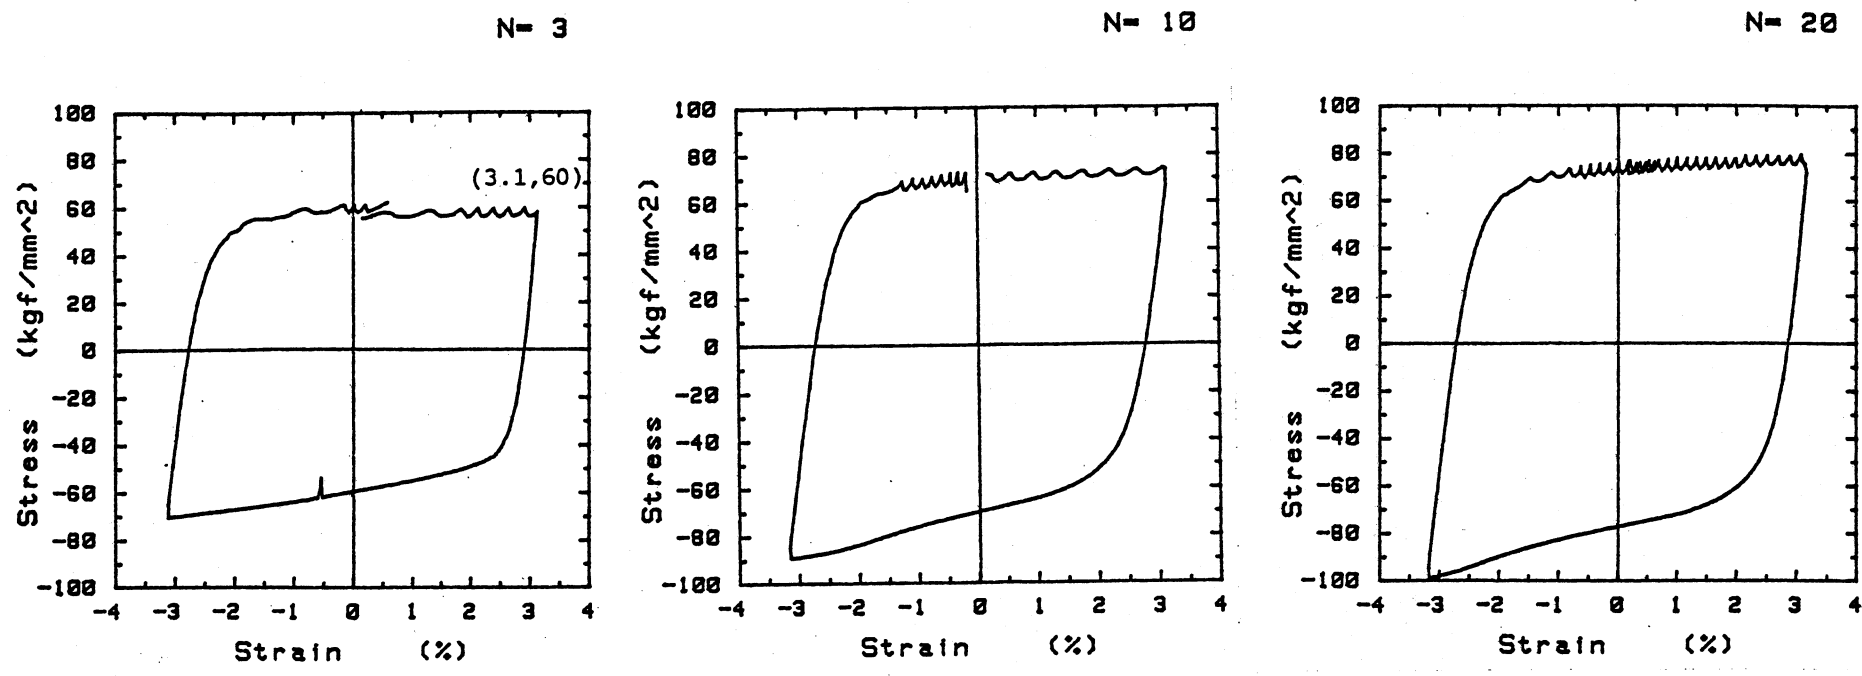
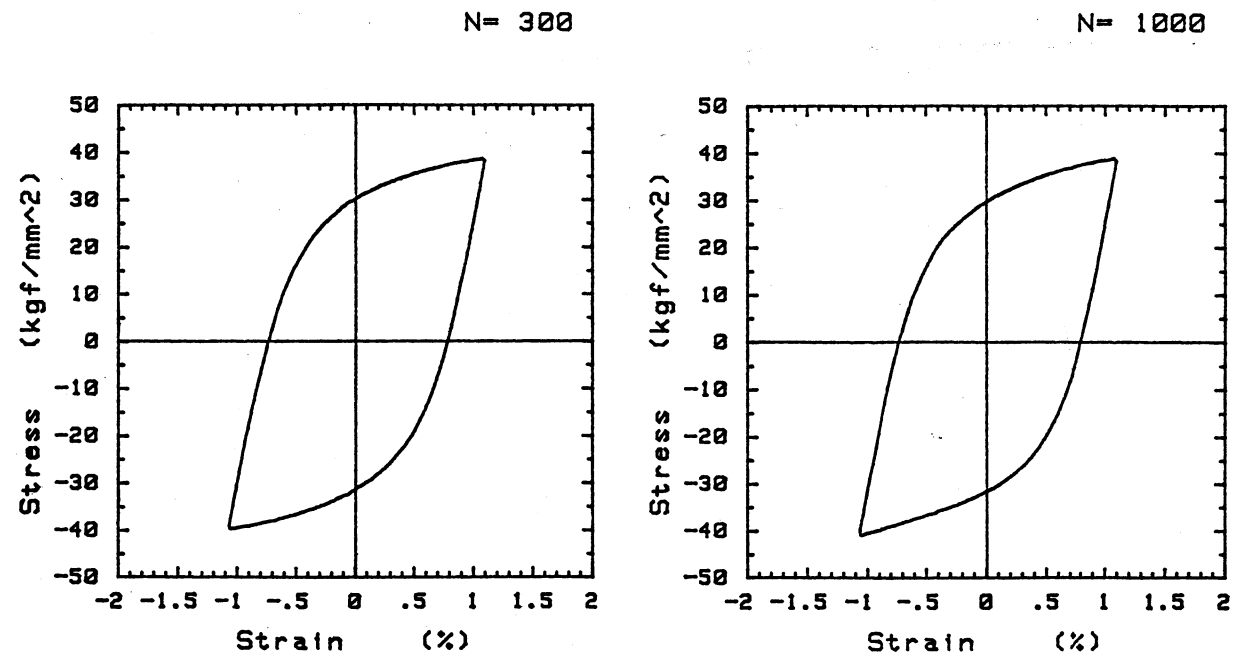
Figure K.23 (1)   Examples of Hysteresis Loops (1/3)

(1) TP NO.4 ($\Delta\varepsilon_t = 6.28\%$, $N_f=25$)

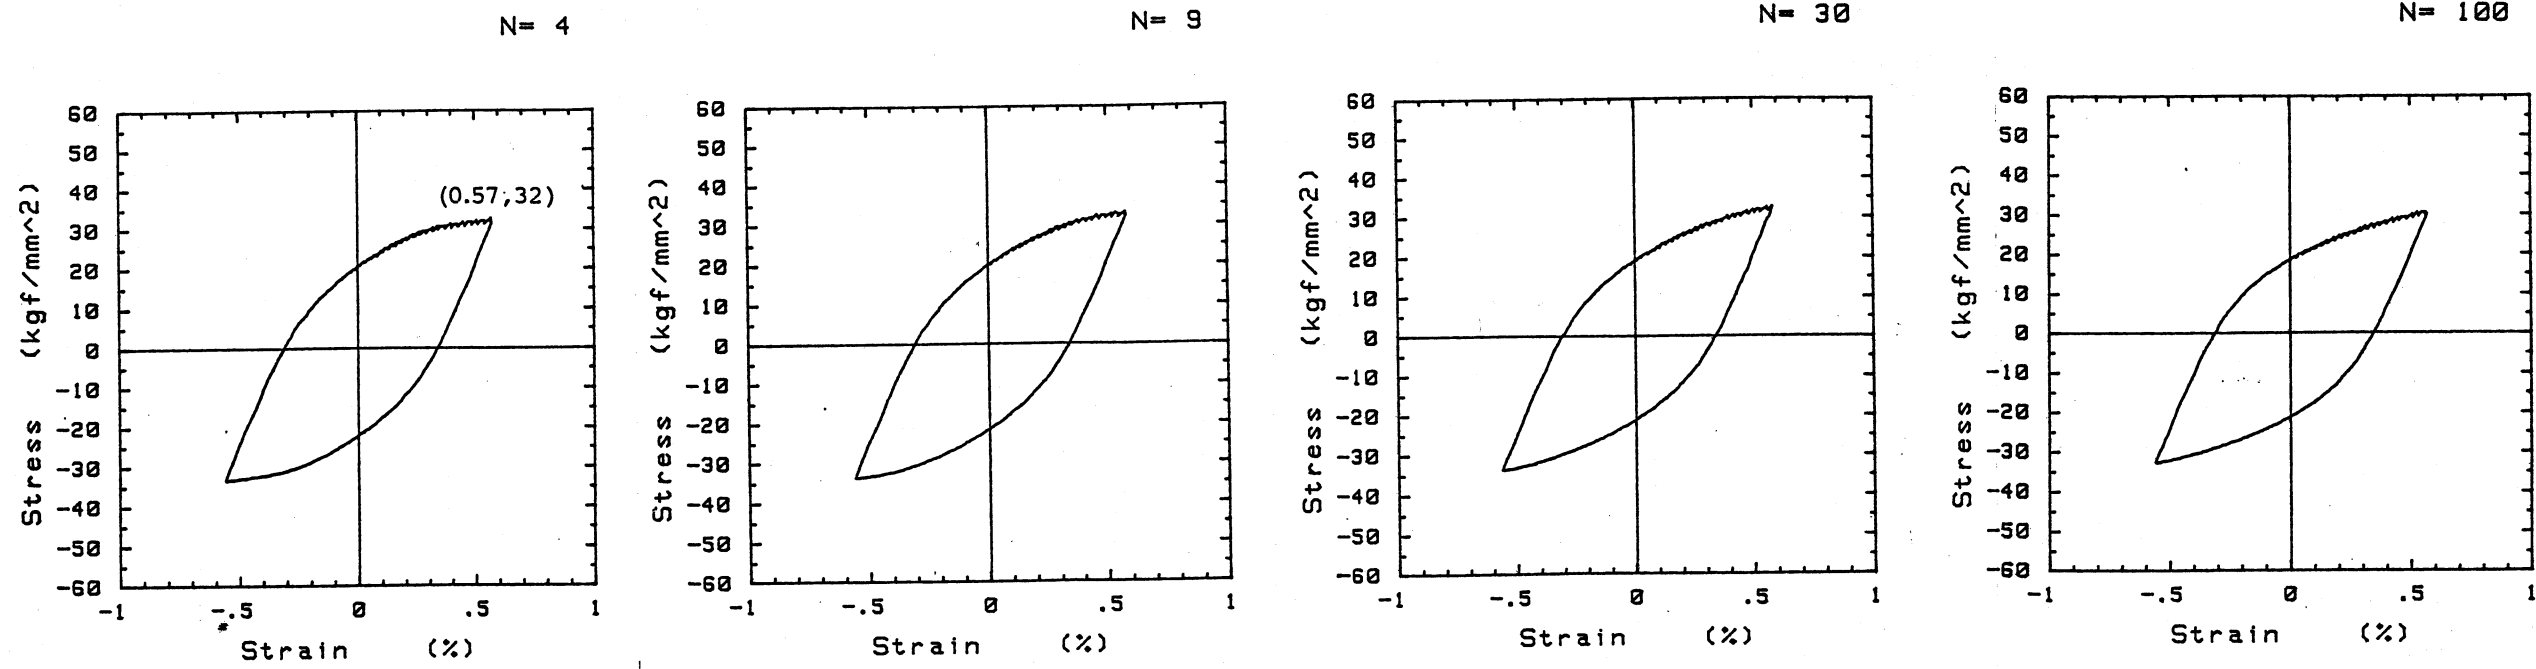
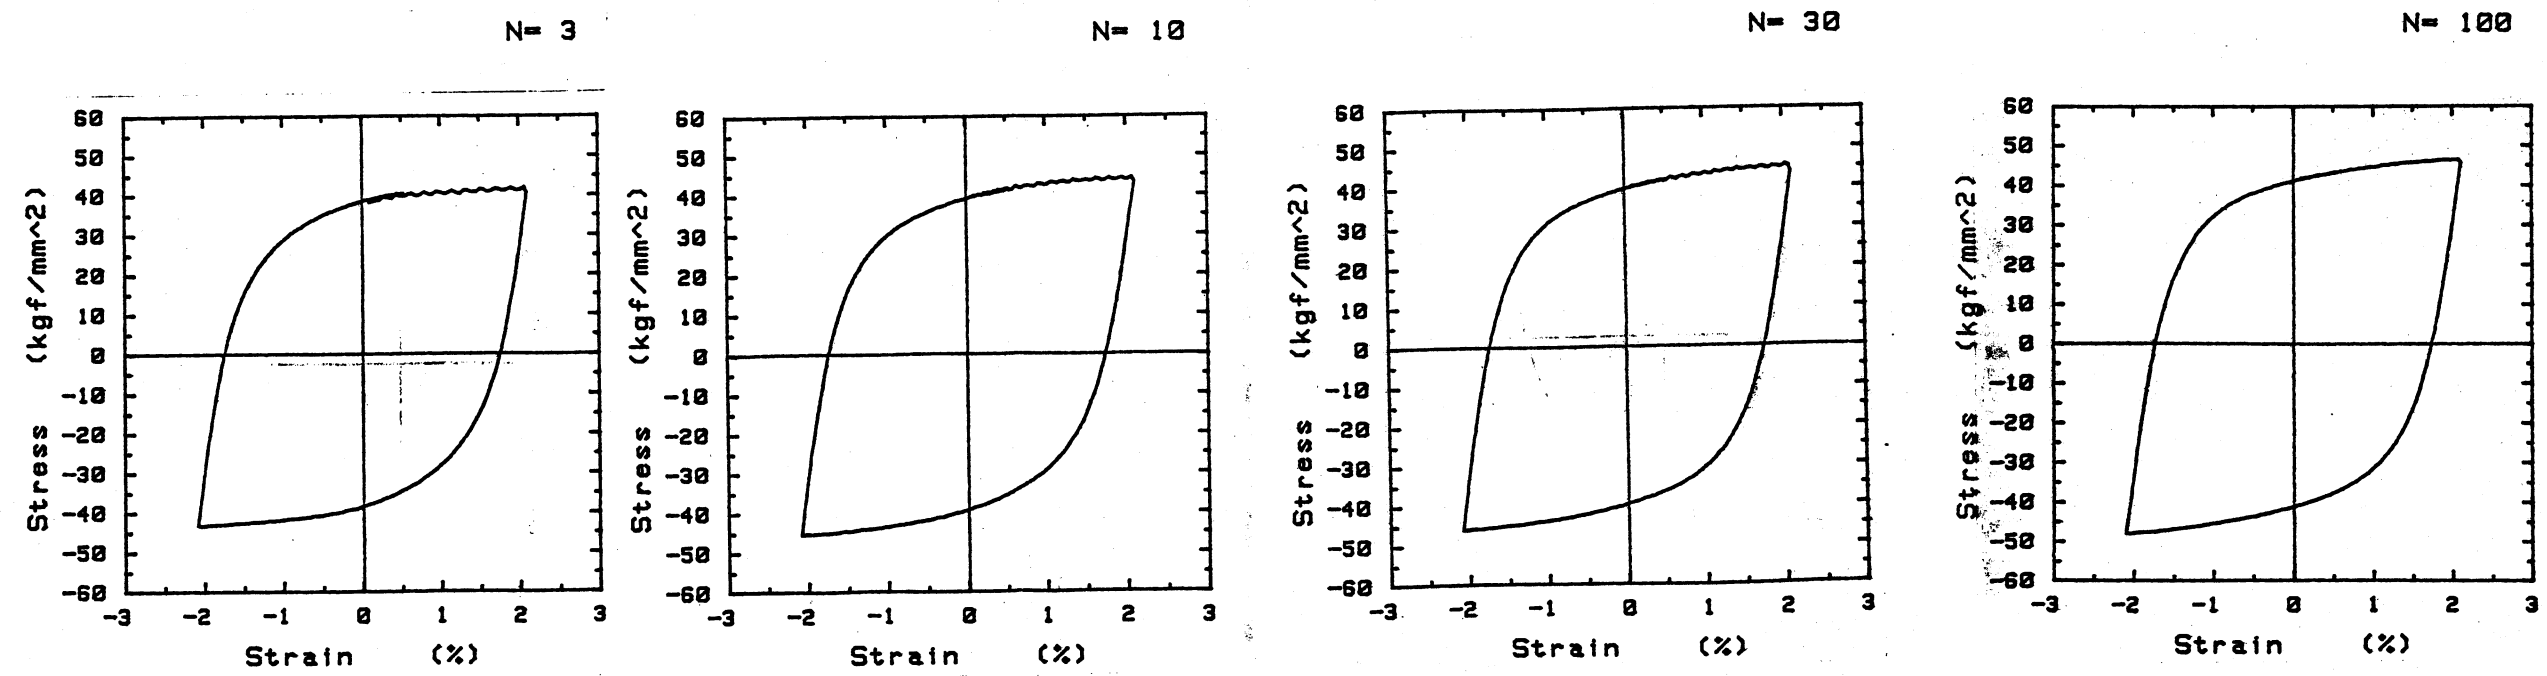
(2) TP NO.3 ($\Delta\varepsilon_t = 4.20\%$, $N_f=220$)

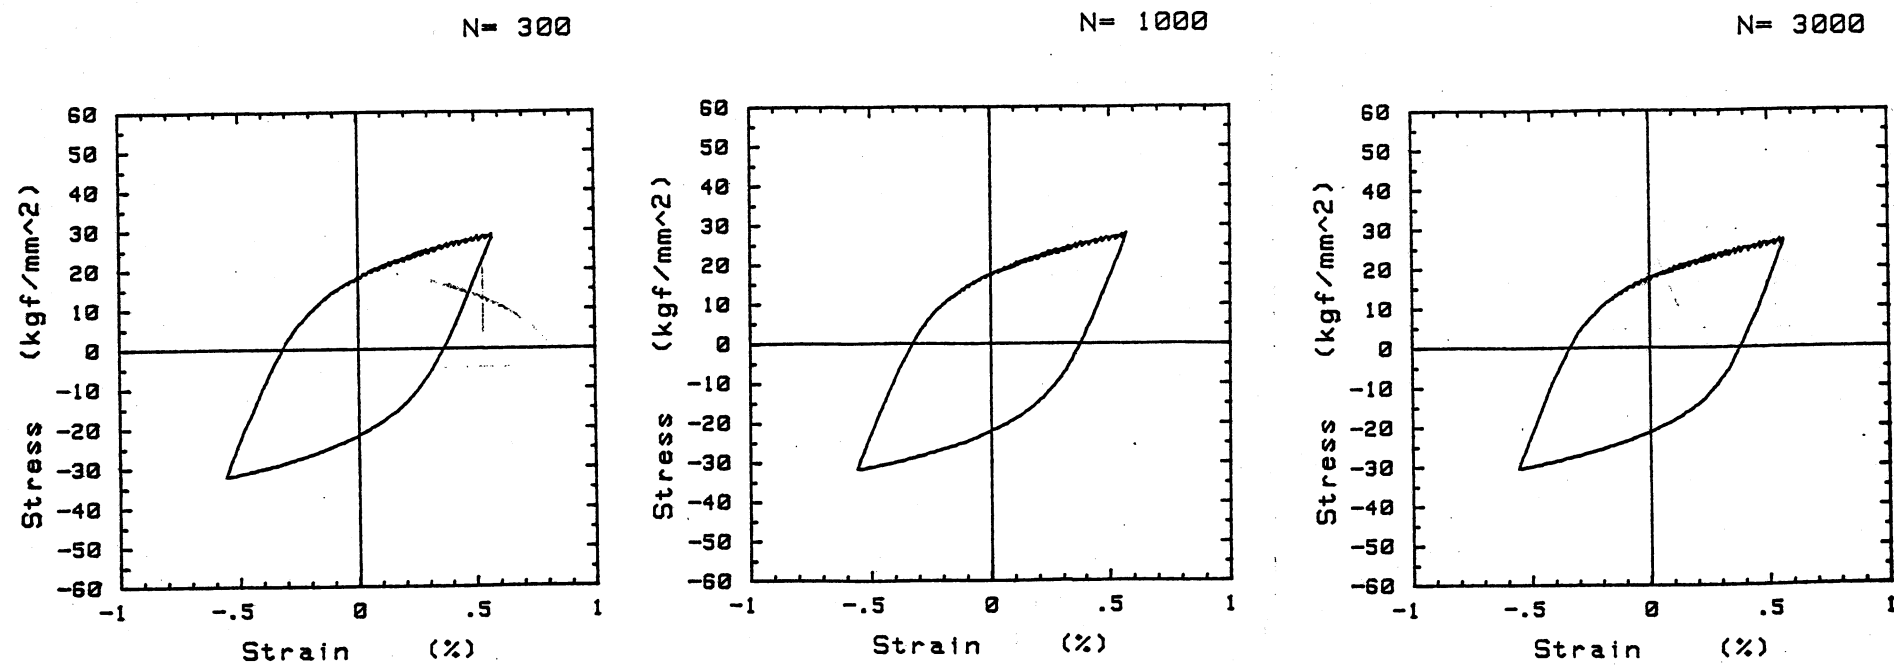
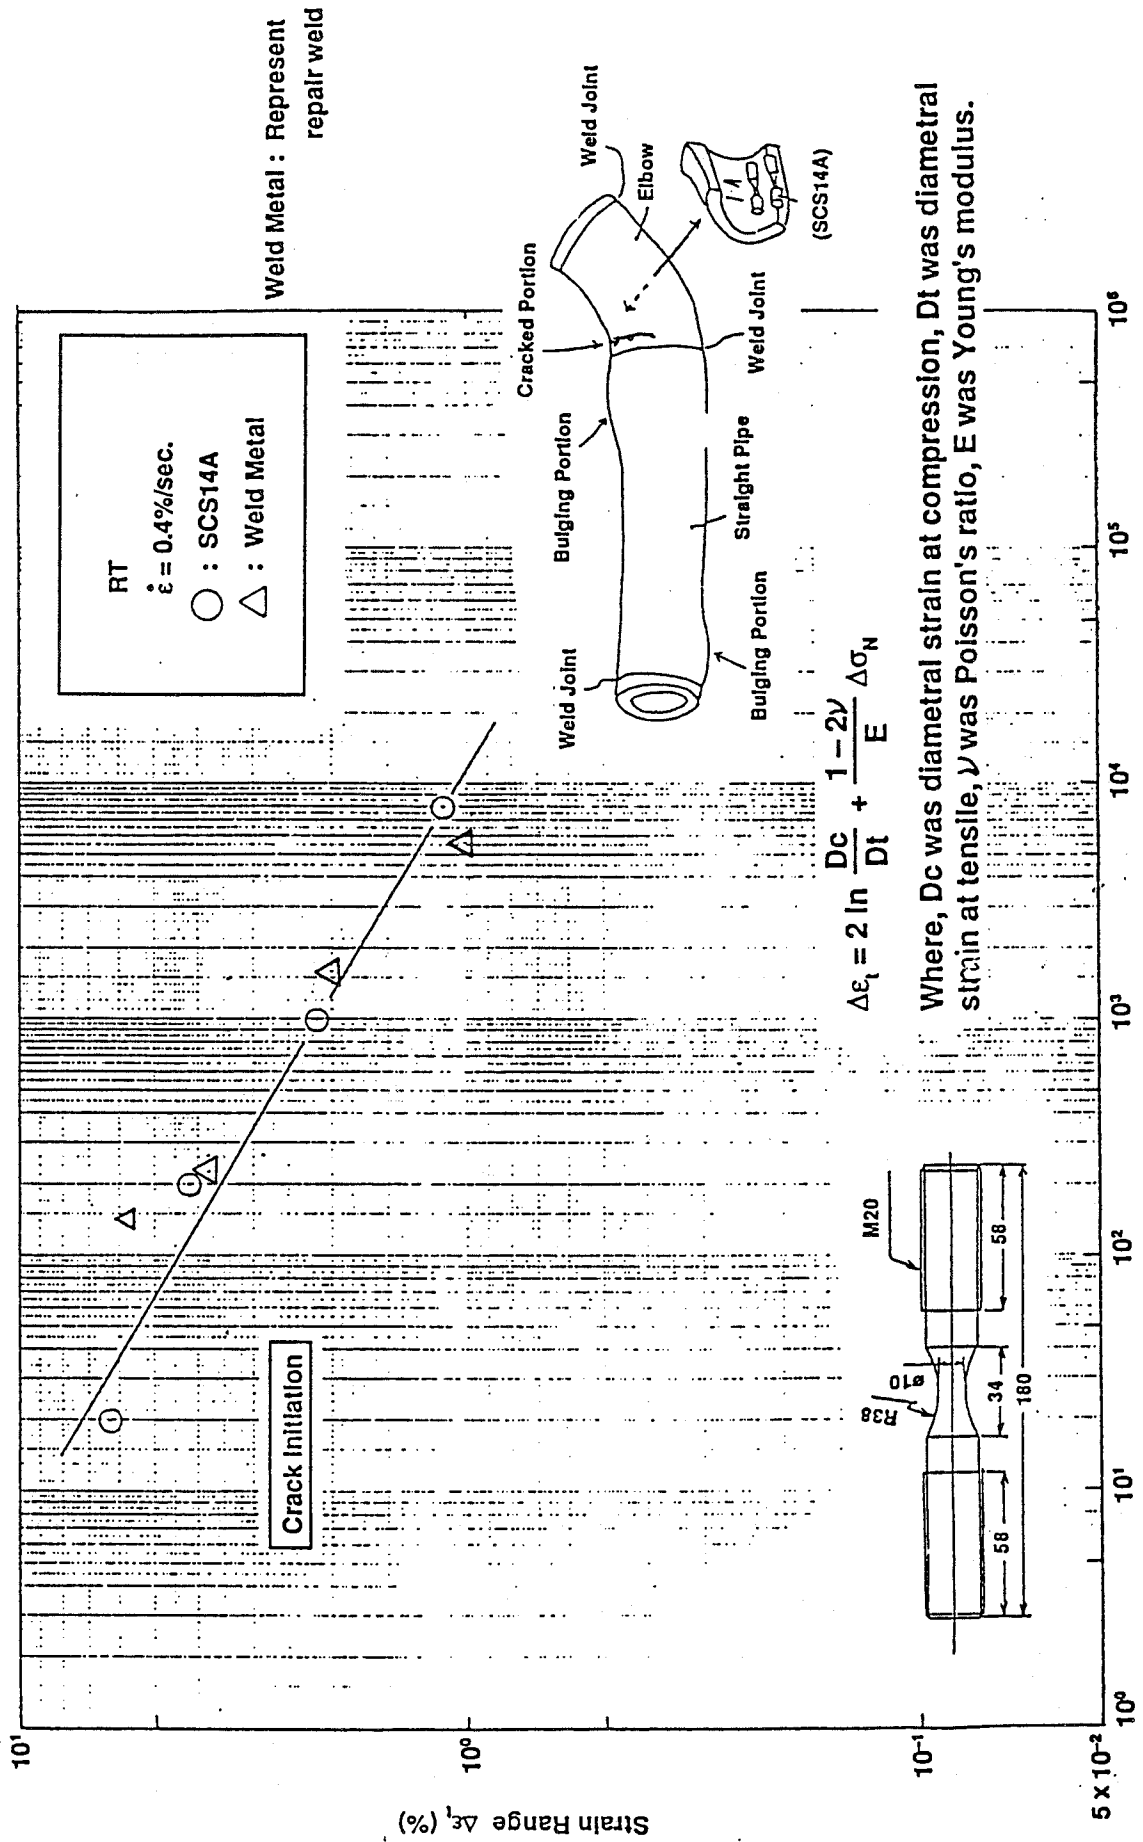
Figure K.23 (2) Examples of Hysteresis Loops (2/3)

(3) TP NO.2 ($\Delta\varepsilon_t = 2.16\%$, $N_f = 1270$)

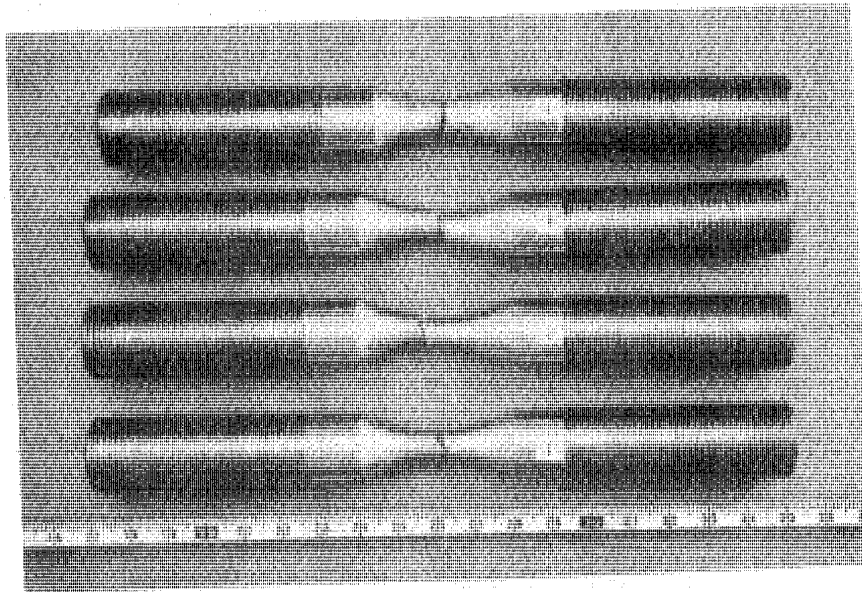
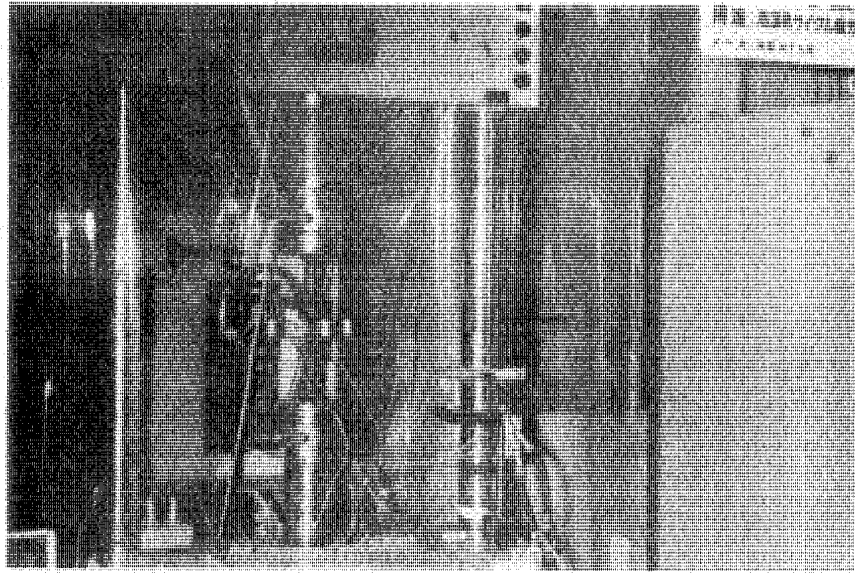
Figure K.26 Specimens after Test

(1) Side

(2) Fracture surface

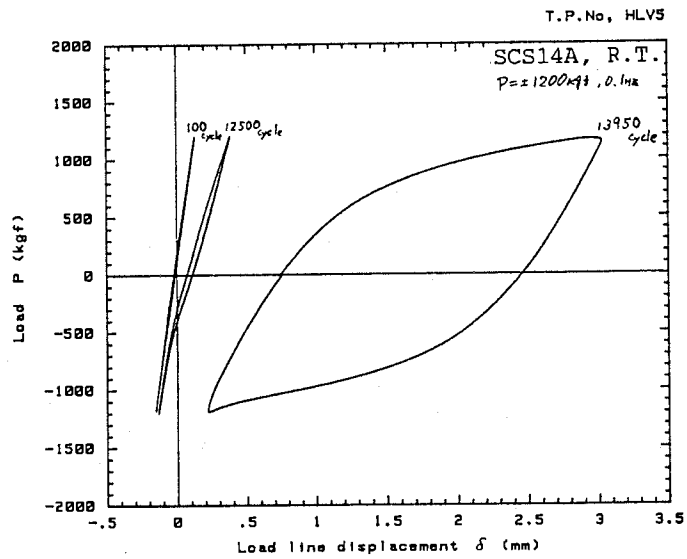
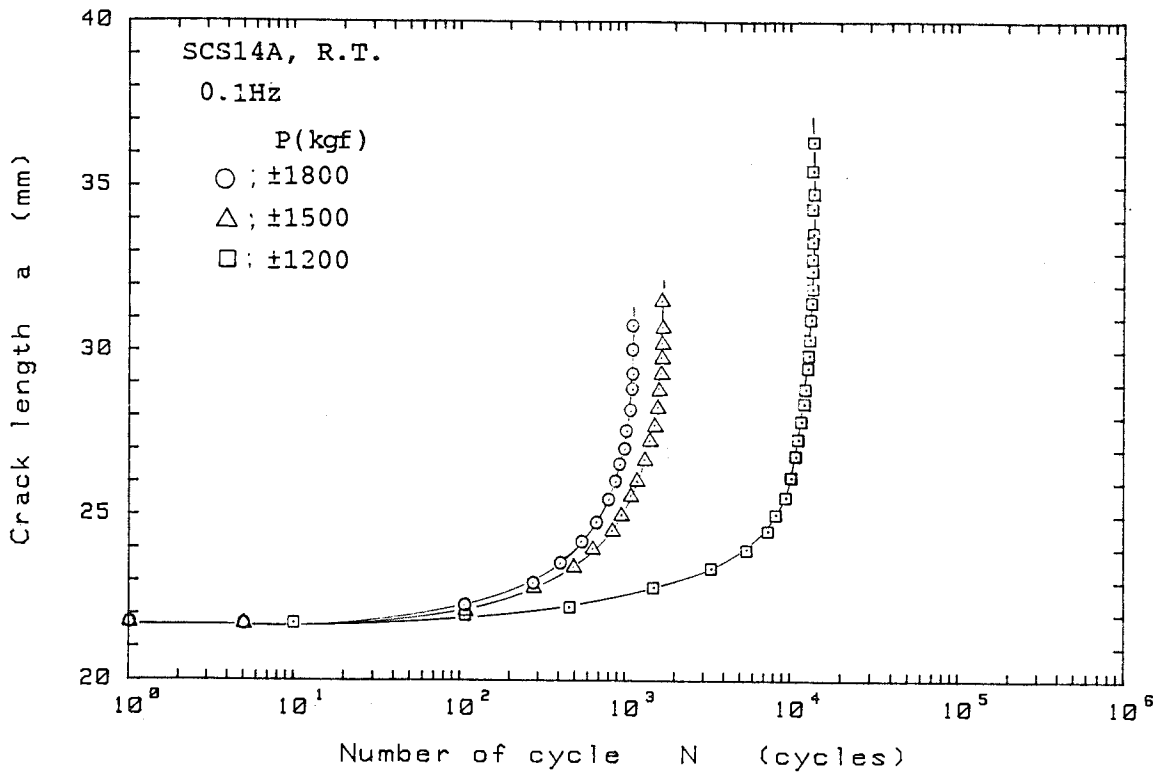
Figure K.28   Examples of P- δ Curve

(1) TP : HLV1

(2) TP : HLV3

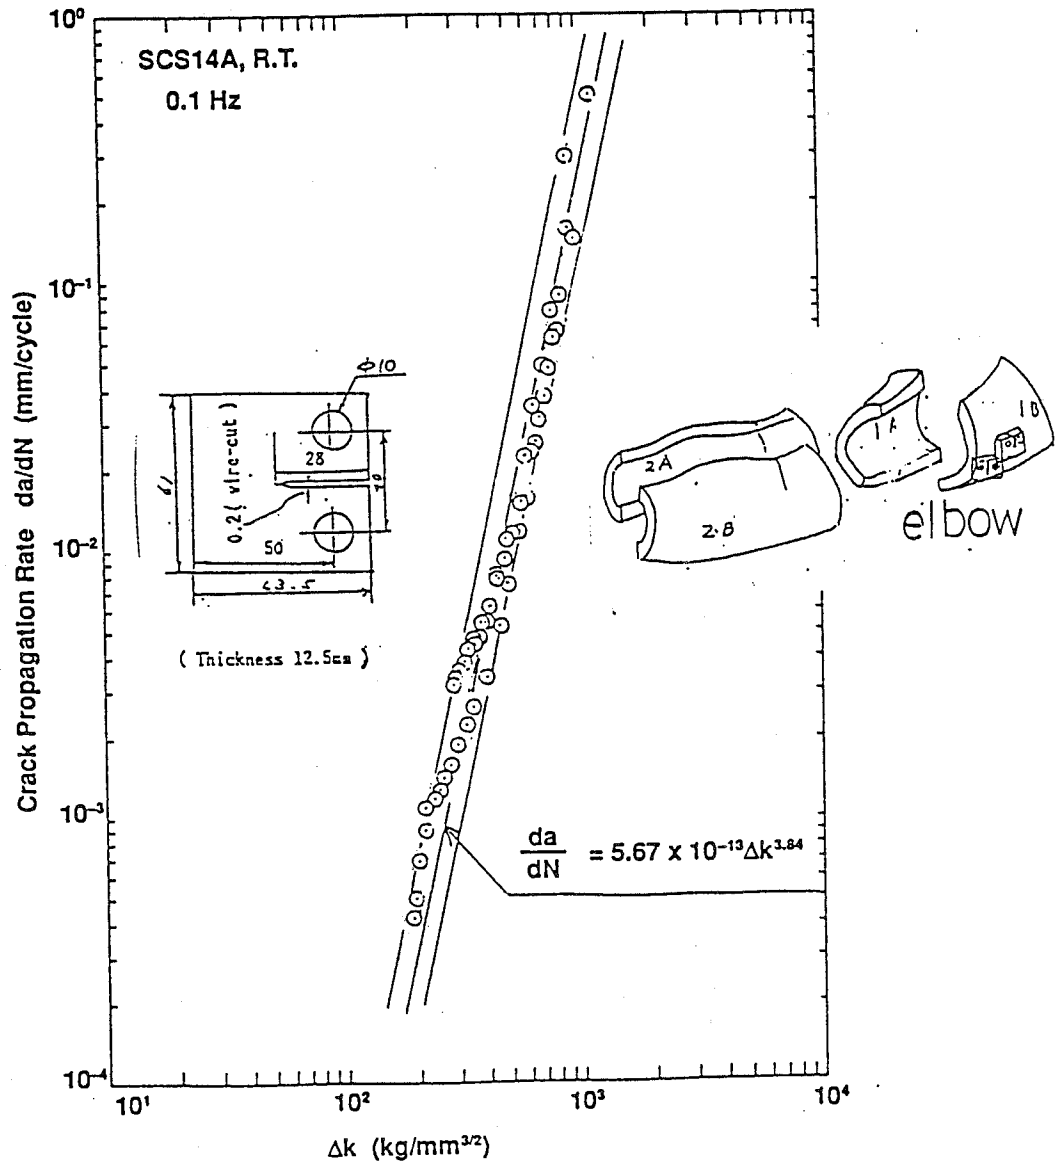
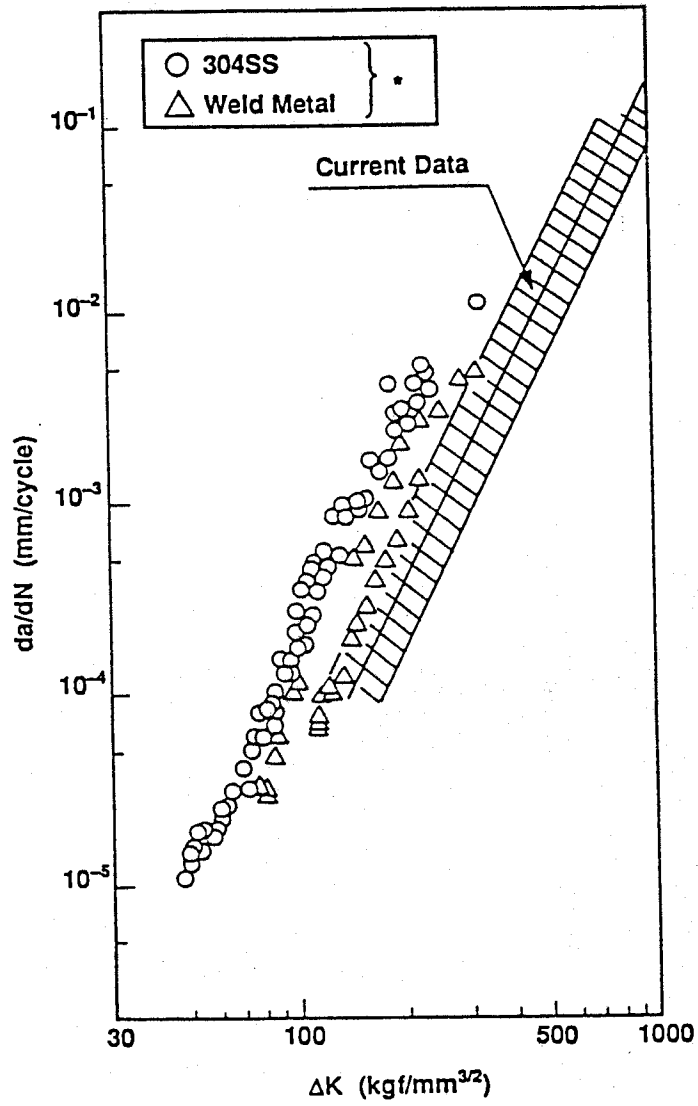
Figure K.31 (2)   Fatigue Crack Growth Rate (2/2)

$$\dot{\Delta J} = \frac{2A}{Bb} \cdot \frac{1+\eta}{1+\eta^2} \rightarrow \Delta K = \sqrt{\frac{E\Delta J}{1-\nu^2}}$$

where, A was Applied energy, B was Thickness, b was ligament length, η was shape factor.
