Part 21 Report No: P21-04302015, Rev. 1

Subject: **Update** - Report of potential 10CFR Part 21, Allen Bradley Timing Relay Model 700RTC – NRC Event Number 51030, Accession Number ML15134A016

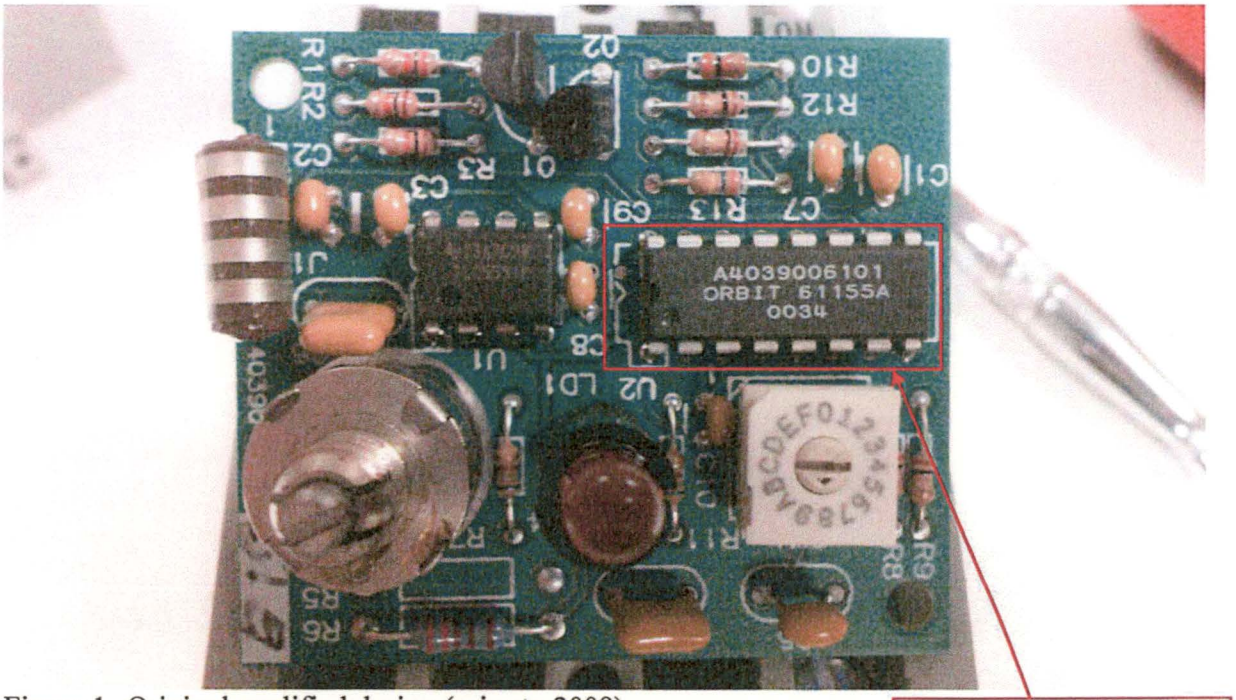
Figure 1- Original qualified design (prior to 2009).
Relays supplied prior to 2009 are not affected by this issue.

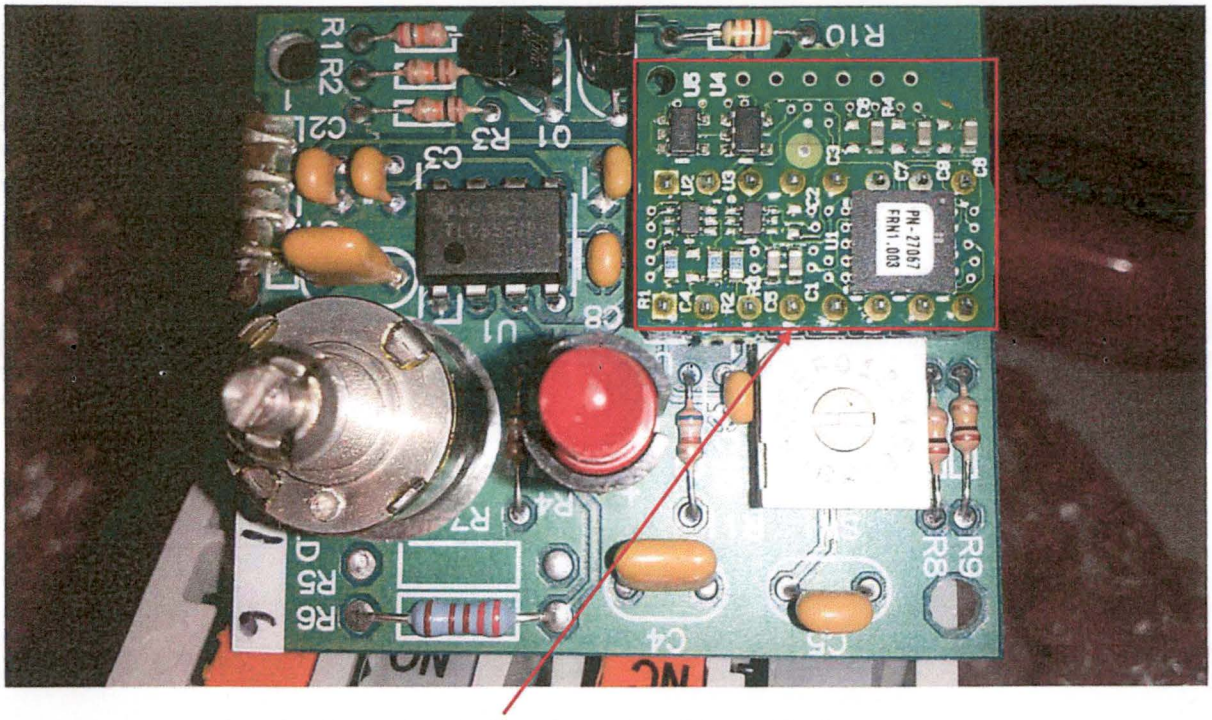
Between 2009-2010, Allen Bradley made a design change without changing the part number of the commercial relay or providing any documented evidence of a design change. The manufacturer specification data sheets maintain the classification that the relays are "solid state", which would imply that there are no digital devices installed in the relay. However, after inspection of the internals of the timing relay (Figure 2), it has been identified that the unit does contain a CPLD which meets the definition of a digital device under the guidance of NEI 01-01. See Figures 1 and 2 below:

Figure 2 - New design circuit board and CPLD that replaced the original component.

The results were satisfactory with exception of the following condition: During Conducted Susceptibility CS114 onto the power lines, with the timing circuit in operation, the timing contacts exhibited chatter in the range of 2.6 MHz to 20.3 MHz. The unit requires a ferrite to be installed onto the input power lines of the relay with 3 turns through the ferrite core. In this modified configuration, the relay was not susceptible to Conducted Susceptibility and successfully passed the required test per CS114.

The relays are dedicated for generic application usage in timing applications. The specific plant application(s) is unknown by NLI. The EMC qualification of the relay is dependent on the installed configuration and location in the plant. The plant should evaluate whether the installed relays are subjected to the specific EMI/RFI condition Conducted Susceptibility CS114 between the frequencies of 2.6 MHz to 20.3 MHz identified above.
