Response to NRC Review Comments
Transmitted by Letter Dated June 22, 2001,
to the Nuclear Energy Institute Relating to

PWR Materials Reliability Program
Interim Alloy 600 Safety Assessment for US PWR Plants (MRP-44)
Part 2: Reactor Vessel Top Head Penetrations
EPRI TP-1001491, Part 2, May 2001

MRP 2001-050NP

June 29, 2001

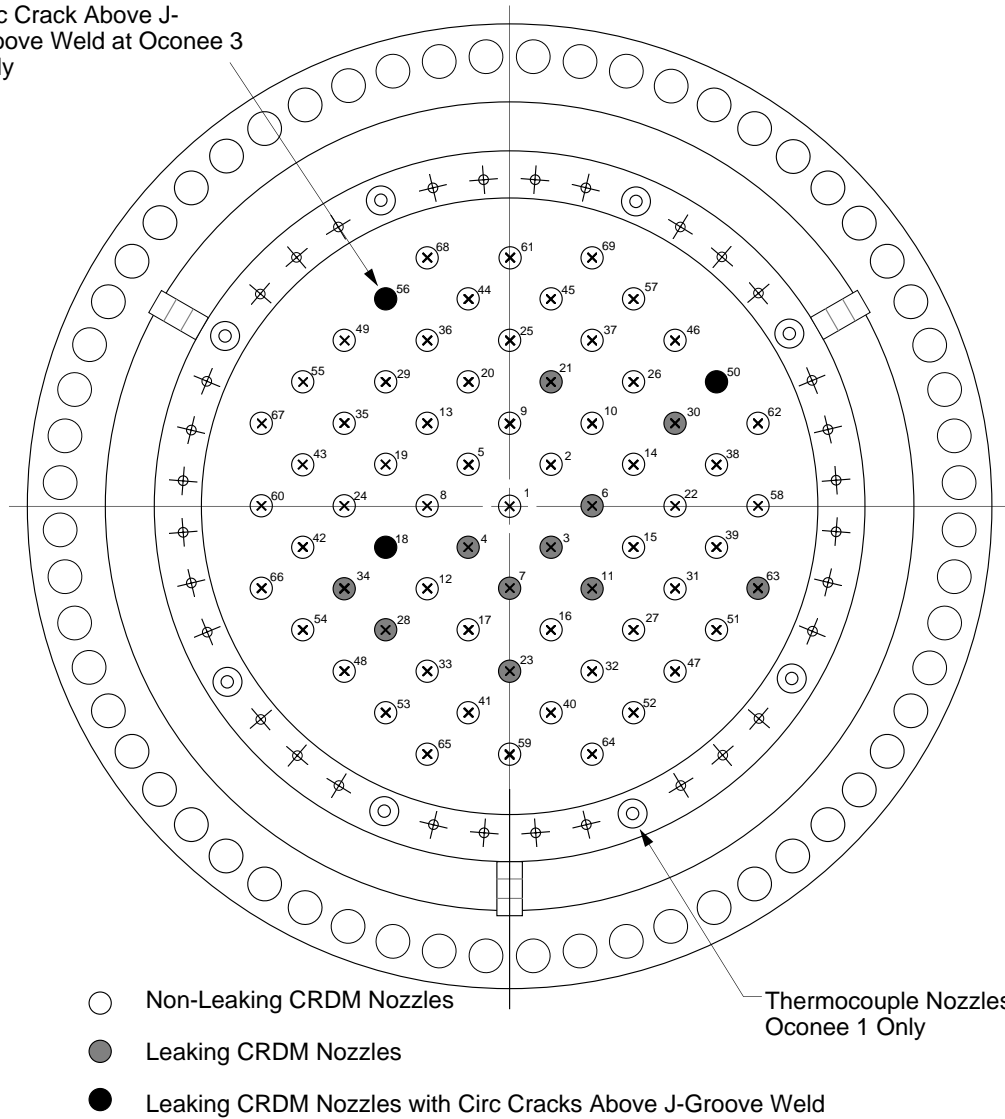
Figure 1
Locations of Leaking CRDM Nozzles at Oconee and ANO-1

- As shown in Figure 1, Oconee and ANO-1 experience demonstrates that leakage can be detected from nozzles adjacent to the central nozzle and in peripheral locations. This provides confidence that leakage can be detected regardless of location on the head.

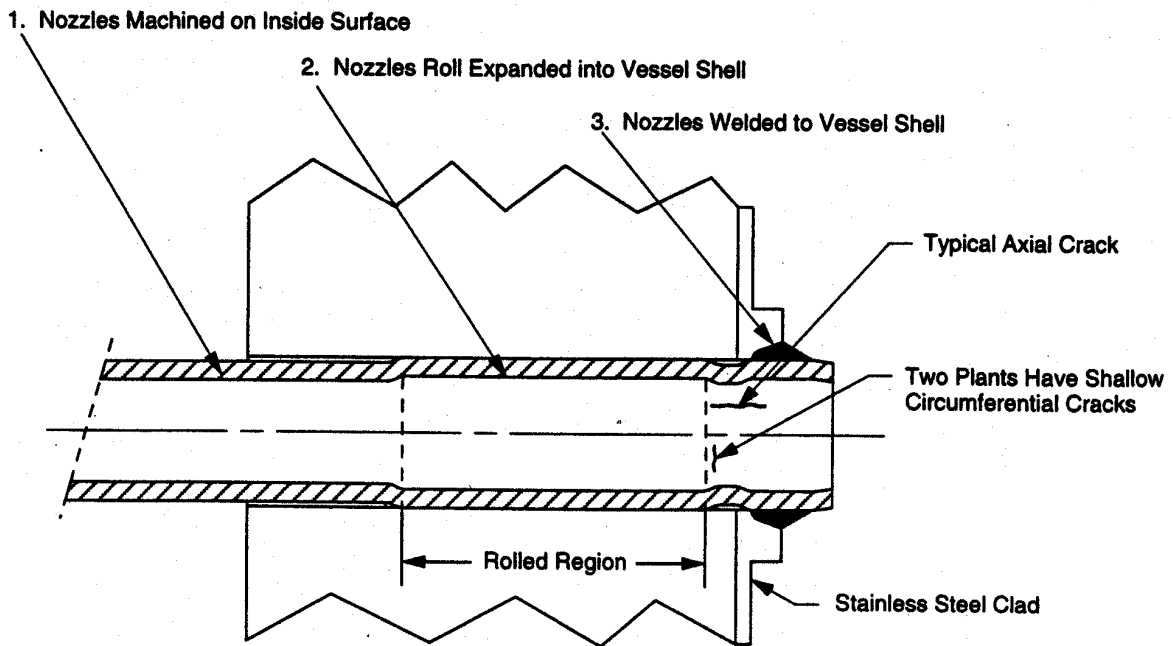
Figure 2
Rolled and Welded Pressurizer Instrument Nozzle in EDF Plants

- As shown in Figure 2, Alloy 600 pressurizer instrument nozzles in EDF plants were roll expanded into the vessel shell prior to making the J-groove weld. Leaks were discovered from nozzles in two plants (Nogent 1 and Cattenom 2) after one operating cycle. The roll expansions did not prevent leakage in these nozzles.

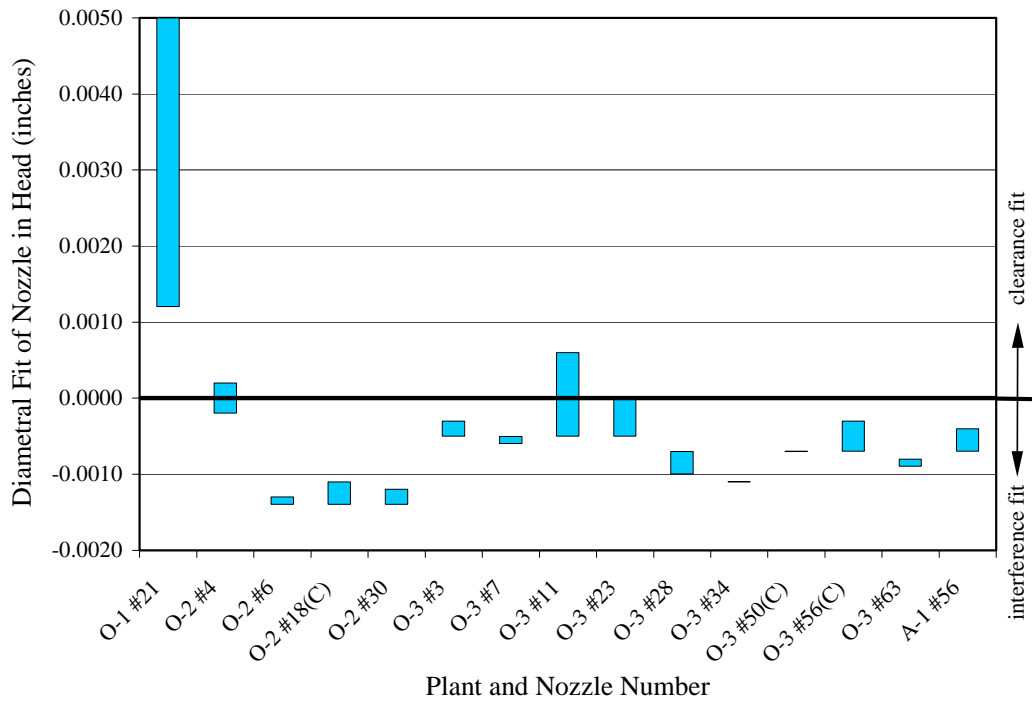
Figure 3
Actual Interference Fits of Leaking CRDM Nozzles at Oconee 1, 2 and 3 and ANO-1

Figure 3 shows the range of fits for the leaking CRDM nozzles at Oconee and ANO-1. The information provided during the June 7 meeting for Oconee 1, Oconee 3 and ANO-1 has been supplemented with data for the four leaking nozzles at Oconee 2. The three nozzles found to have circumferential cracks above the J-groove weld are appended with "(C)" in the figure.

The data in Figure 3 show that one nozzle had a clearance fit rather than the specified small interference fit. The remaining nozzles had at least one end of the interference fit region within the specified tolerance. It should be noted that three of the four leaking nozzles at Oconee 2 had interference fits of 0.0014 inches at one end and at least 0.0011 inches at the other end. In summary, leaks have been confirmed from fourteen nozzles with confirmed initial interference fits, including three nozzles with at least 0.0014 inches of assembly interference.

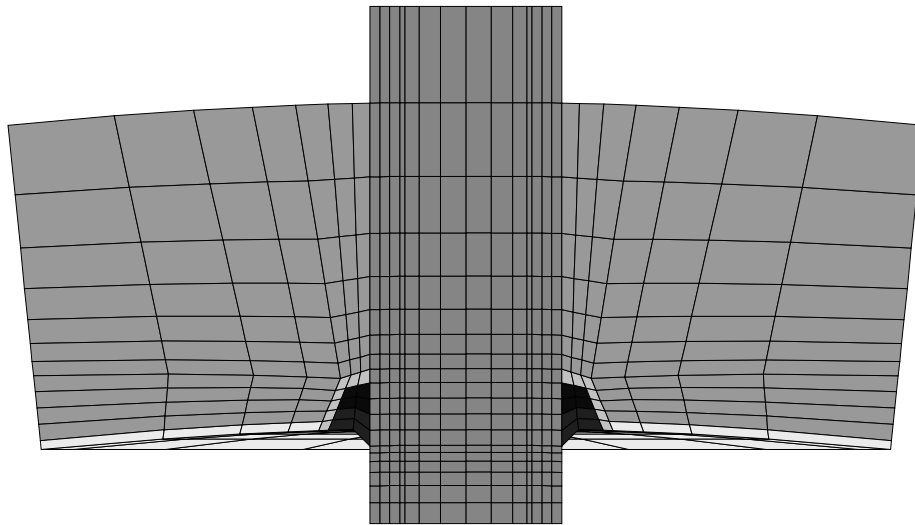
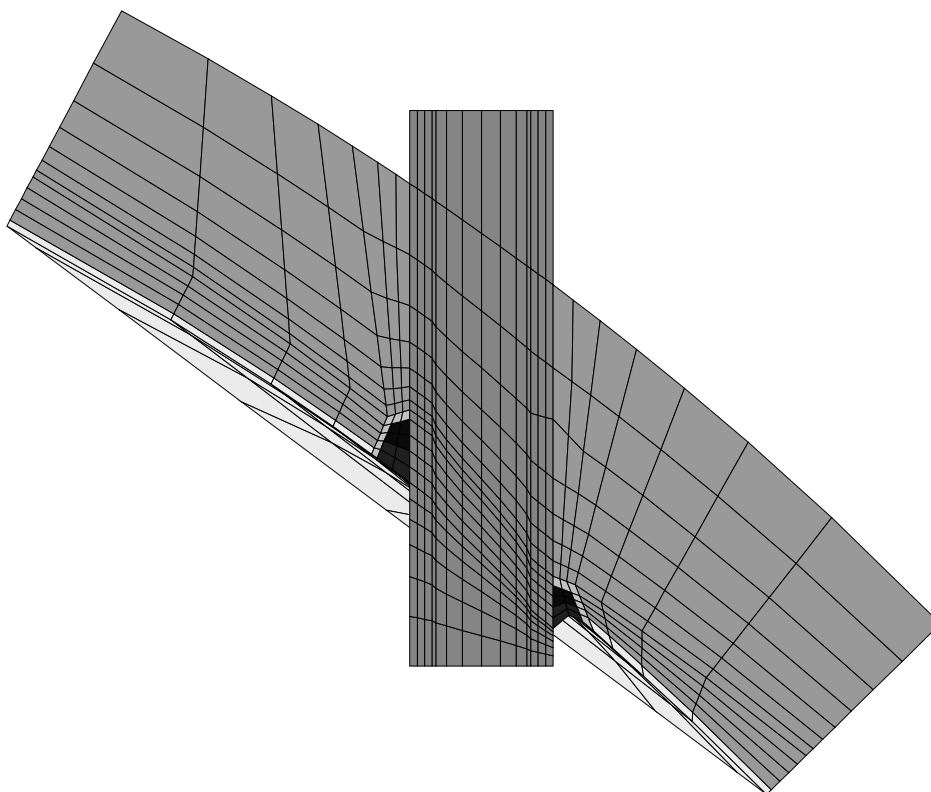
Figure 4
Typical FEA Model of Central CRDM Nozzle

Finite element analyses show that oblique CRDM nozzles displace laterally if a clearance opens up between the nozzle and bore under operating conditions. The resultant displacement reduces the leak path at some locations and increases the leak path at other locations. Typical analysis results for a peripheral CRDM nozzle are shown in Figure 6. The net effect shown in this figure is to open up a spiral leak path which has less flow resistance than a uniform annular gap.

Finite element analyses of a model including the nozzle, vessel shell, and flange show that flange tensioning and resultant rotation increase the ovality of peripheral row CRDM nozzles by approximately 20%. This effect is small and, as noted in the previous paragraph, should decrease the flow resistance.

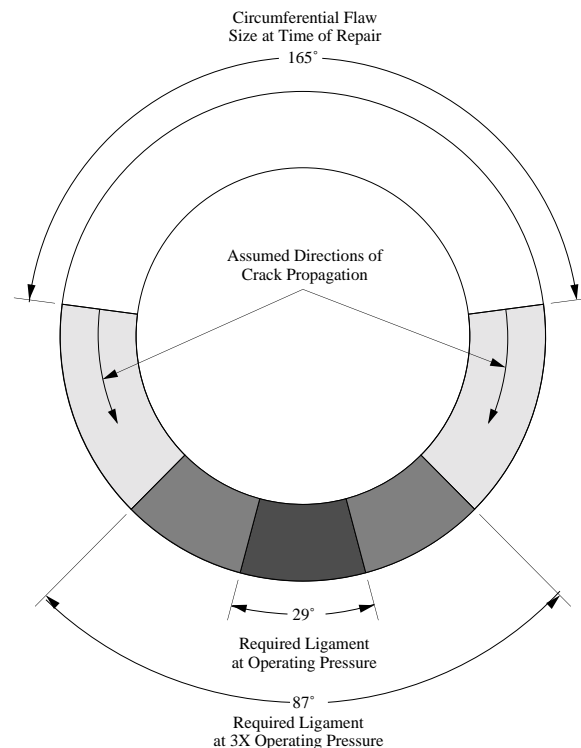
Figure 14
Direction of Crack Propagation

The time for the Oconee 3 circumferential cracks above the J-groove weld to grow from the reported 165° arc length to the allowable 273° arc length noted in Section 5.0 of MRP-44 was computed as at least 4-5 years by two independent methods.

Both calculations were performed assuming that the cracks propagate in a circumferential direction around the nozzle from both crack fronts as shown in Figure 14. This is consistent with inspection results from Oconee 3 which showed that the cracks had essentially the same arc length on the inside and outside surfaces and is also consistent with the expected direction of primary crack growth for a through-wall crack in a cylindrical shell under internal pressure loading. Note that the finite element stress analysis results reported under Section 5.0 Comment 3, show that when the crack has reached 180° arc length, the welding residual stresses have been significantly reduced such that the primary direction of crack growth is expected to be around the nozzle as shown.

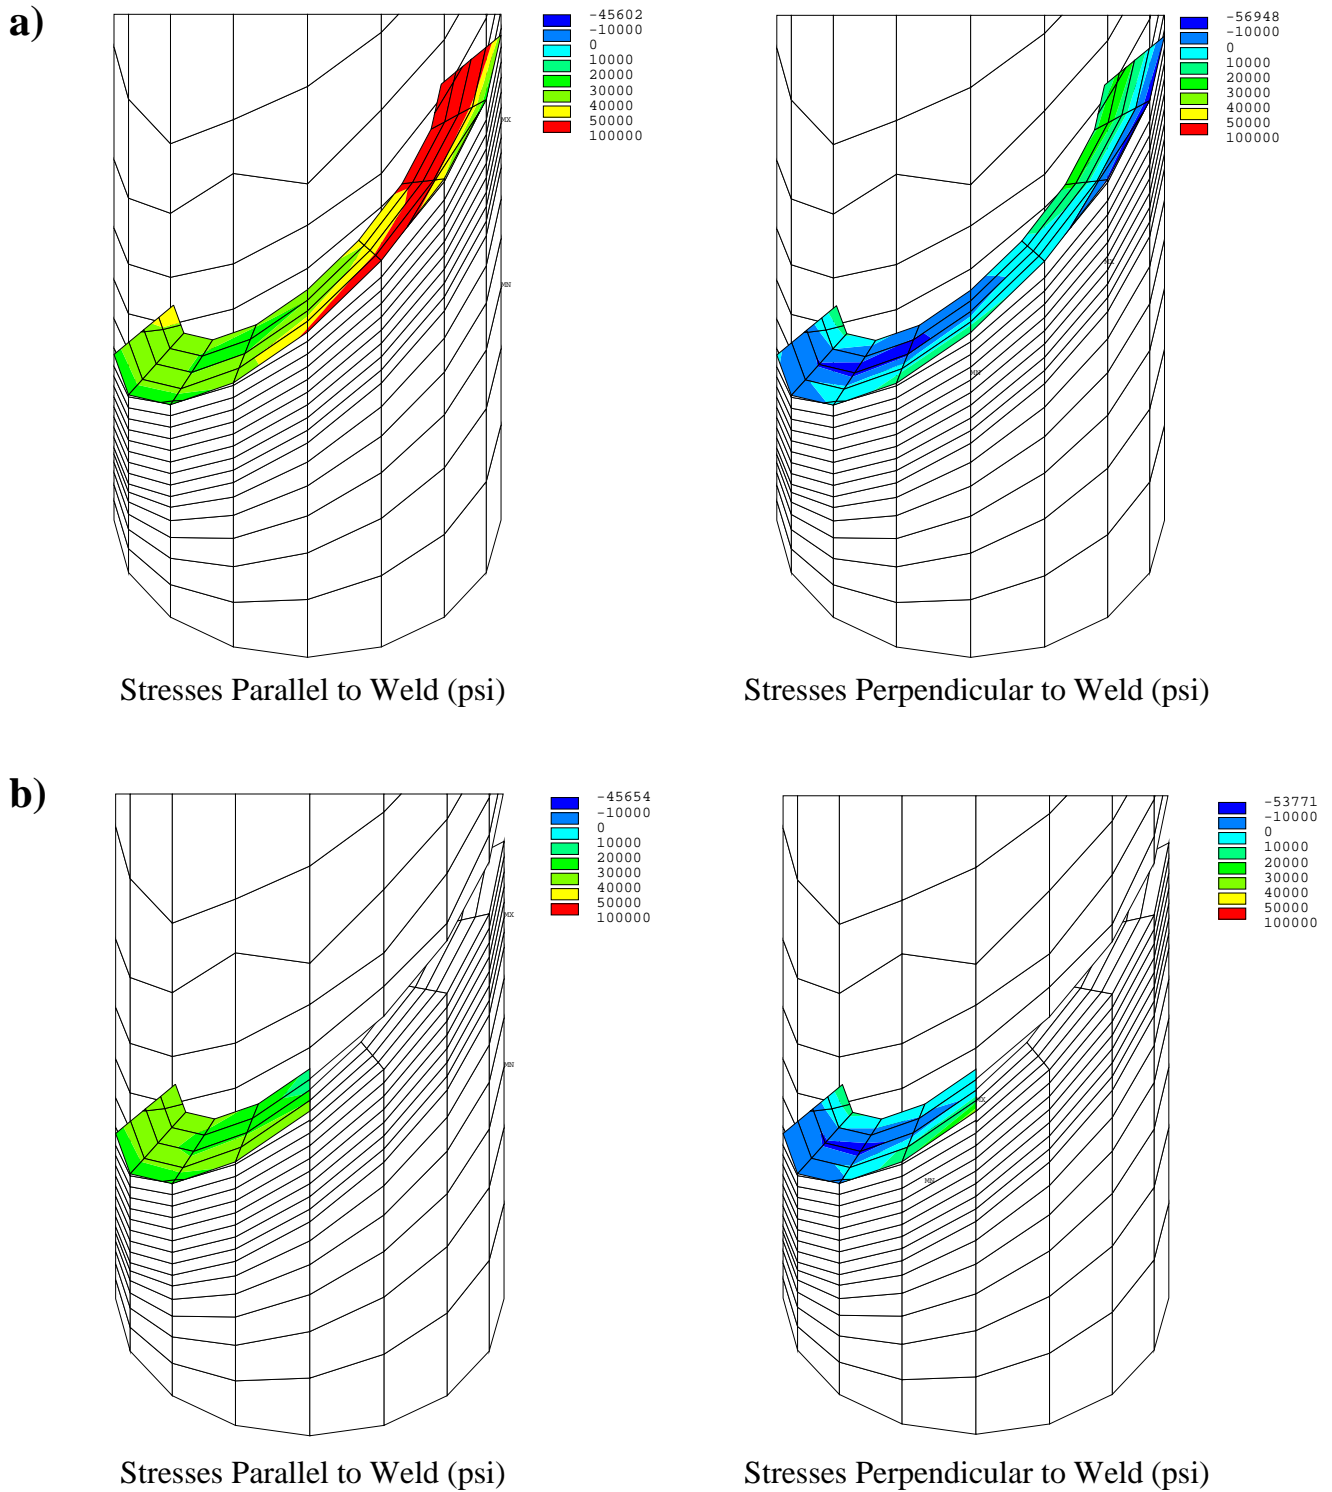
Figure 15
Stress Analyses of Peripheral CRDM nozzle in Intact (a) and Cracked (b) Configurations

Analysis results were presented at the June 7 meeting showing stresses parallel to and perpendicular to the J-groove weld for a peripheral nozzle in the intact operating condition, including the effects of welding residual stresses and hydrostatic testing prior to operation, and with the weld cracked 180° around on the uphill side of the nozzle at the elevation of the weld root. These results are repeated in Figure 15, which also shows the values for the stress contours. These data show that stresses are significantly reduced after cracking has removed some of the constraint that caused high welding residual stresses.
