Davis-Besse Reactor Vessel Head Damage
NRC UPDATE

March 2003

This is the seventh periodic update on the NRC response to the reactor vessel head damage at the Davis-Besse Nuclear Power Station. The updates will be available at public meetings of the NRC Davis-Besse Oversight Panel which is coordinating the agency's activities related to the damage. Each update will include background information to assist the reader in understanding issues associated with the corrosion damage.

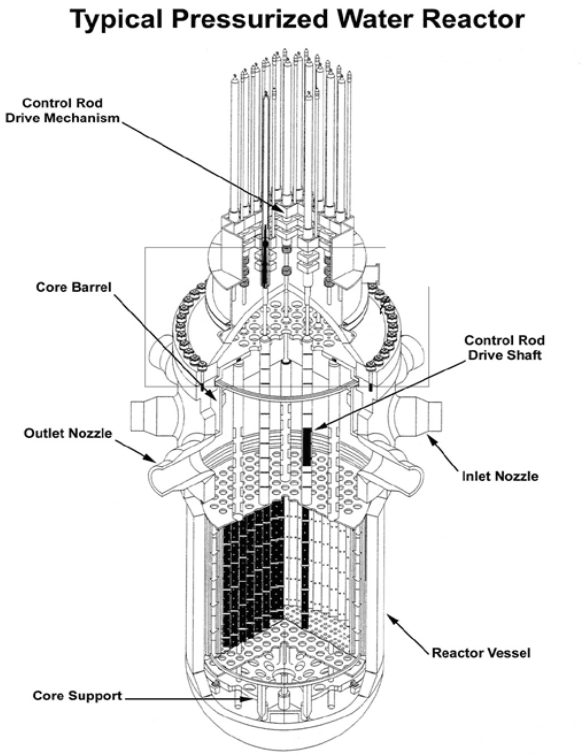
Corrosion, caused by the boric acid, damaged the vessel head next to Nozzle No. 3, creating an irregular cavity about 4 inches by 5 inches and approximately 6 inches deep. The cavity penetrated the carbon steel portion of the vessel head, leaving only the stainless steel lining. The liner thickness varies somewhat with a minimum design thickness of 1/8 inch. Subsequent examination by Framatome, FirstEnergy's contractor, found evidence of a series of cracks in the liner, none of which was entirely through the liner wall.
