DOCKET NUMBER
PETITION RULE PRM 40-28
(65FR3394)

SUBJECT: Comments on Proposed Rulemaking

Report: Repair and Refurbishment of Aircraft Counterweights

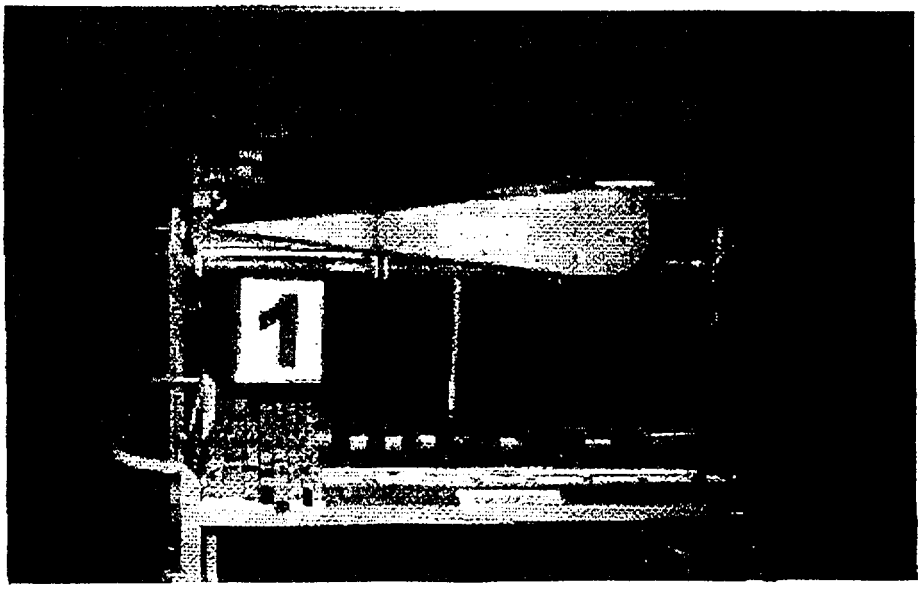
Figure 3, Counterweights Removed From Elevator 1

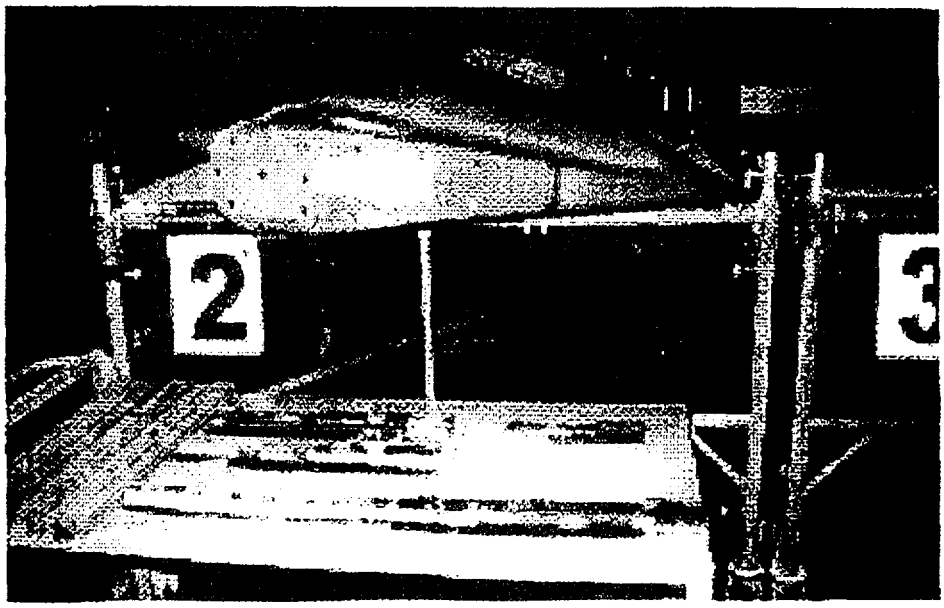
Figure 4, Counterweights Removed From Elevator 2

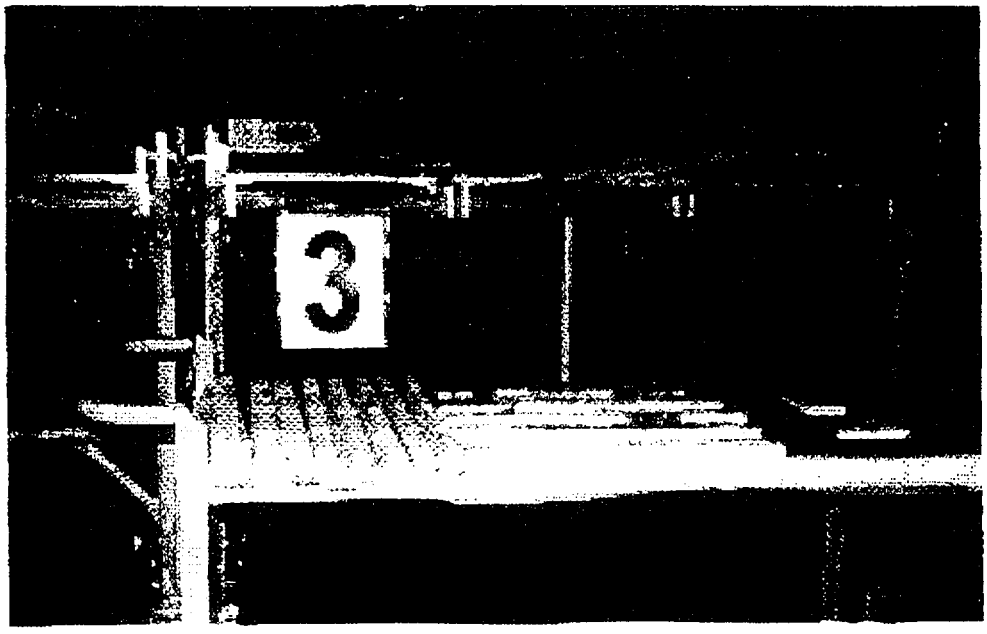
Figure 5, Counterweights Removed From Elevator 3

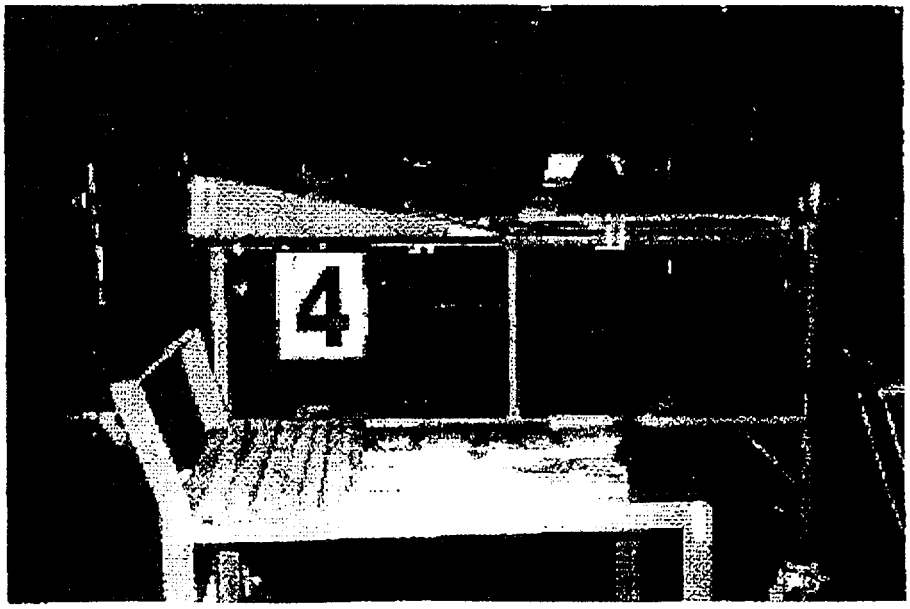
Figure 6, Counterweights Removed From Elevator 4
