Steam Generator Tube Integrity Program/Steam Generator Group Project

Final Project Summary Report

Pacific Northwest Laboratory
Richland, WA 99352

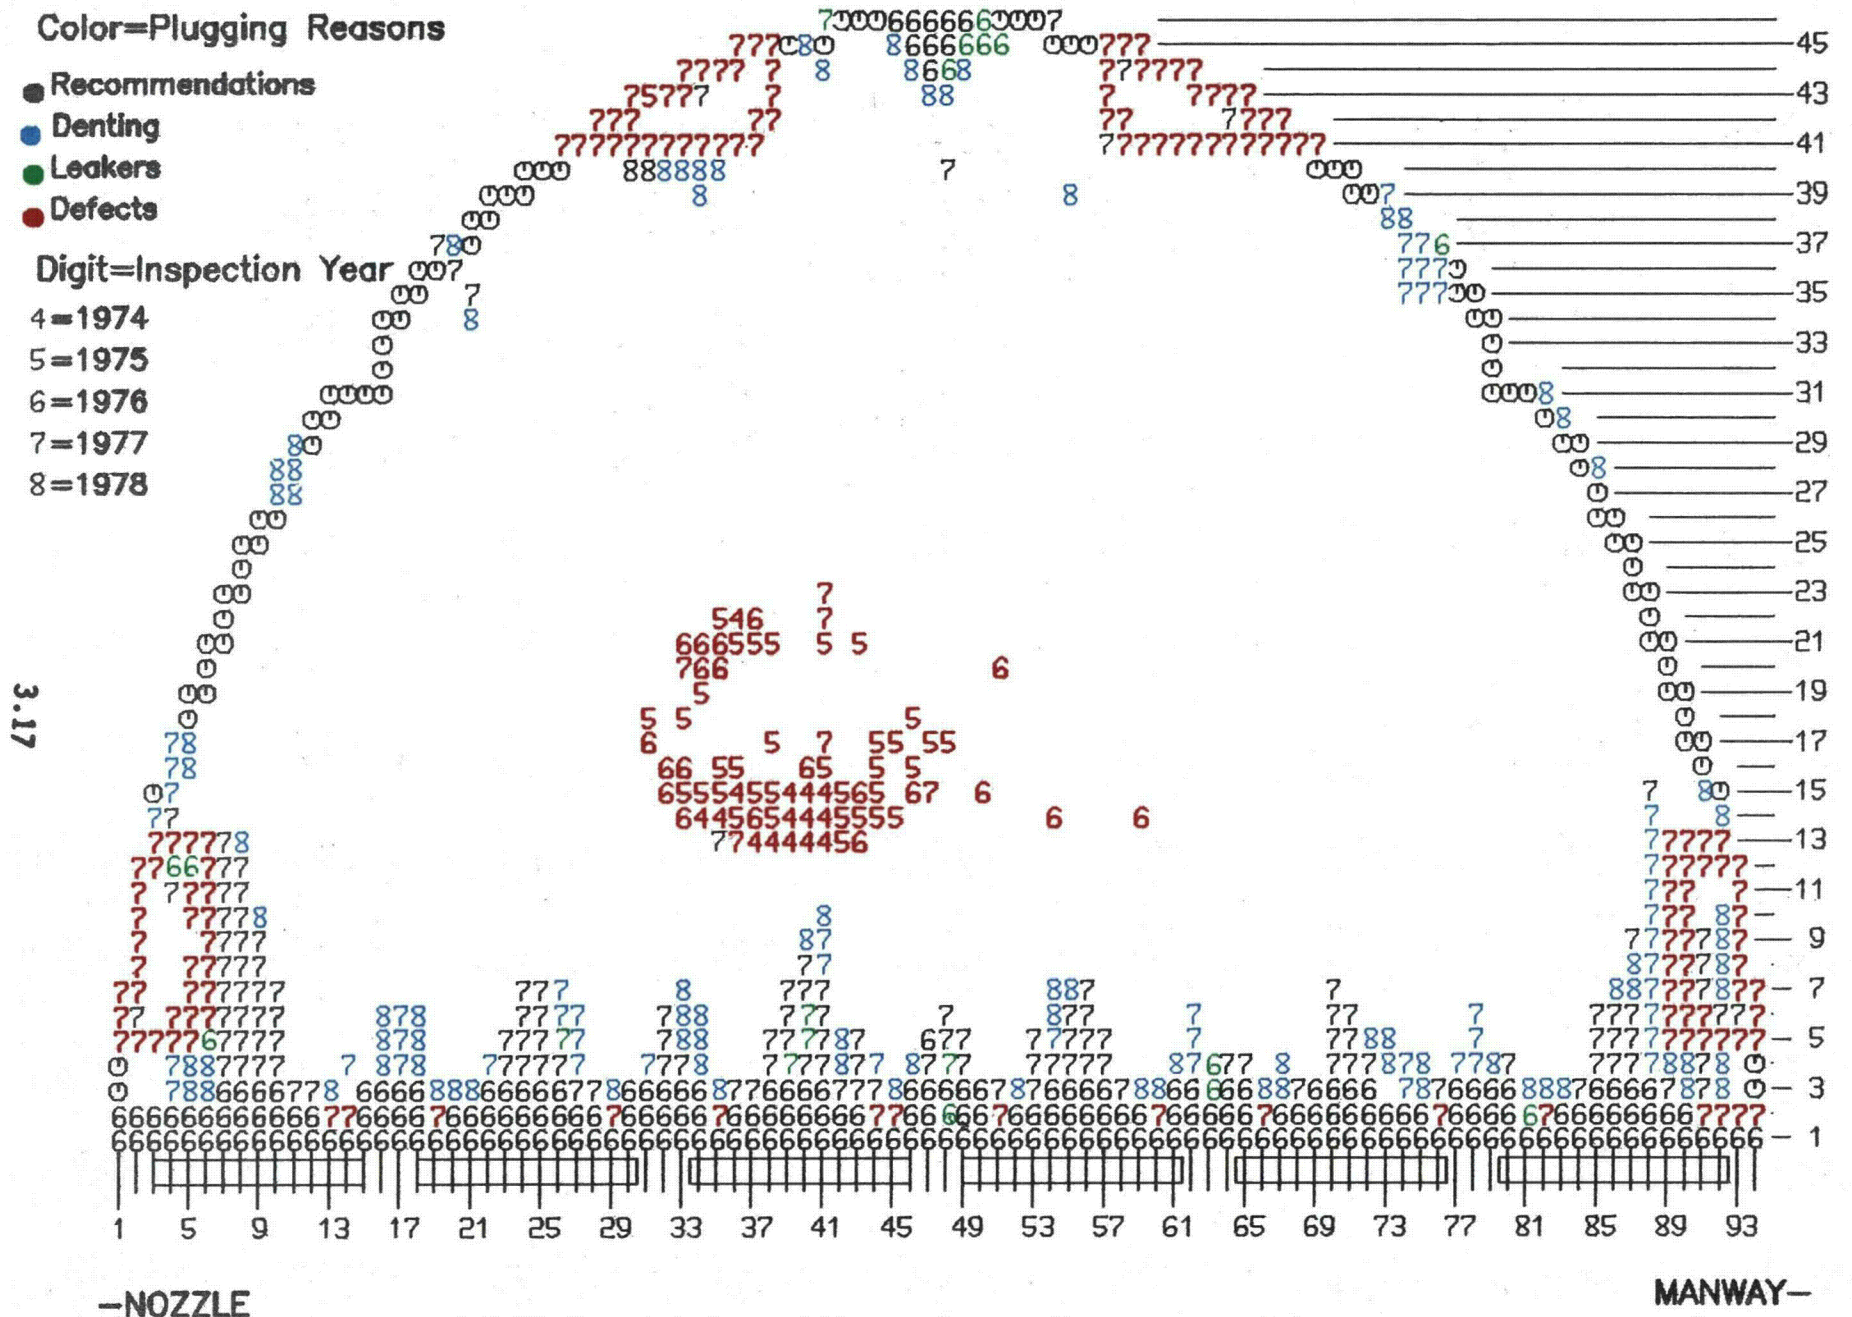
FIGURE 3.9. Surry 2A Steam Generator Tube-Plugging Map as of 8/8/78

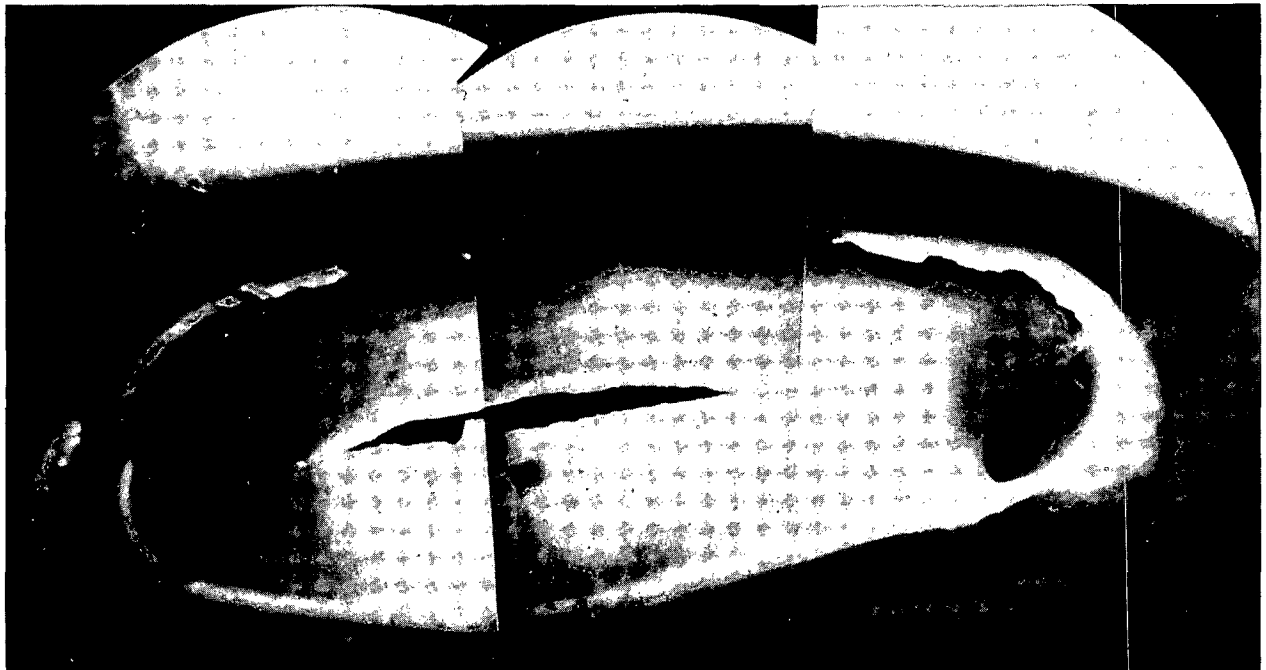
In general, visual and photographic inspection did not reveal cracks or shallow defects beneath the thin, brown-black outer scale found on most tubes. Instances of missing U-bend sections, such as shown in Figure 3.16c, were revealed. Since the inner two rows of U-bends were plugged after an initial U-bend failure, the numerous through-wall defects, and the missing tube sections, occurred after plugging. The cracking could, in part, be attributable to the increasing applied stresses as the support plates continued to corrode. No other U-bend damage was observed via the in situ secondary-side inspections.

FIGURE 3.16. Probable Burst-Type Fracture, U-Bend R1C85;
a) Penetration Below Seventh TSP, b) Looking Up
(Intrados Region), c) Looking Down (Extrados Region)

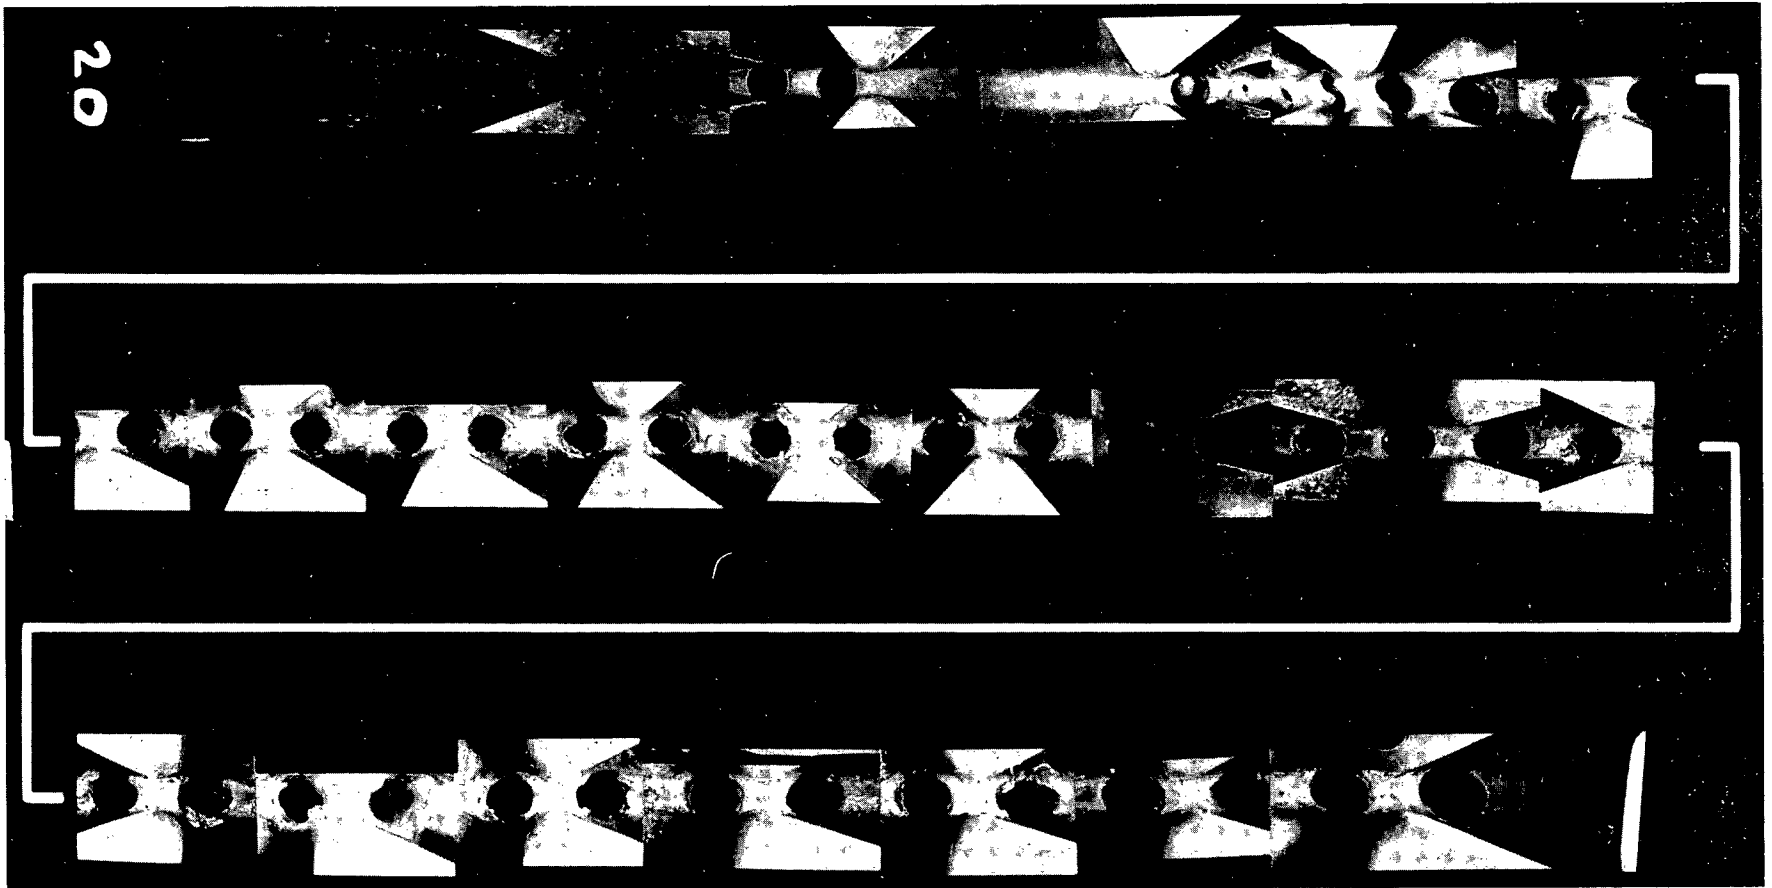
FIGURE 3.18. Montage Photo Looking Up at the Second Support Plate from Shell Wall (Hot Leg Side) to the Cold Leg Side at Column 62-63

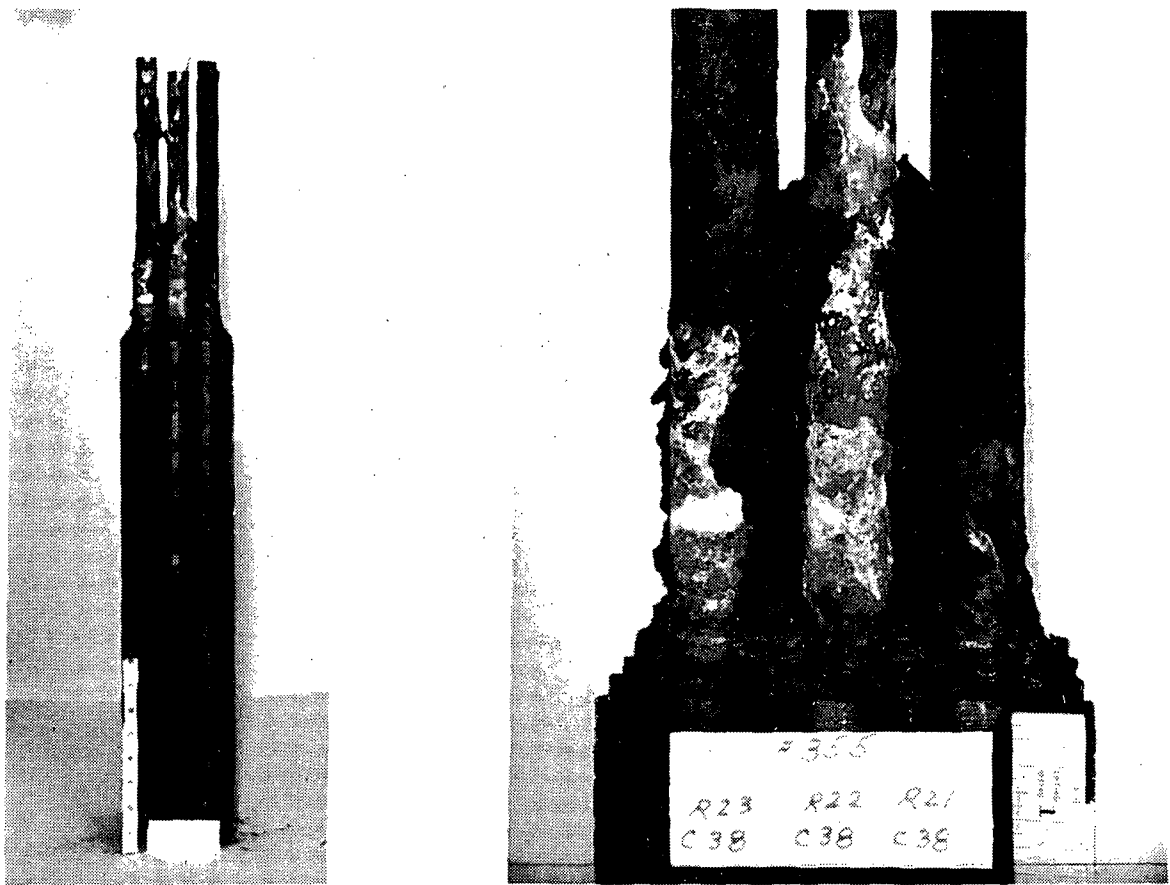
FIGURE 3.19. Overview and Sludge Pile Closeup of Hot Leg Tube
Sheet Section #355

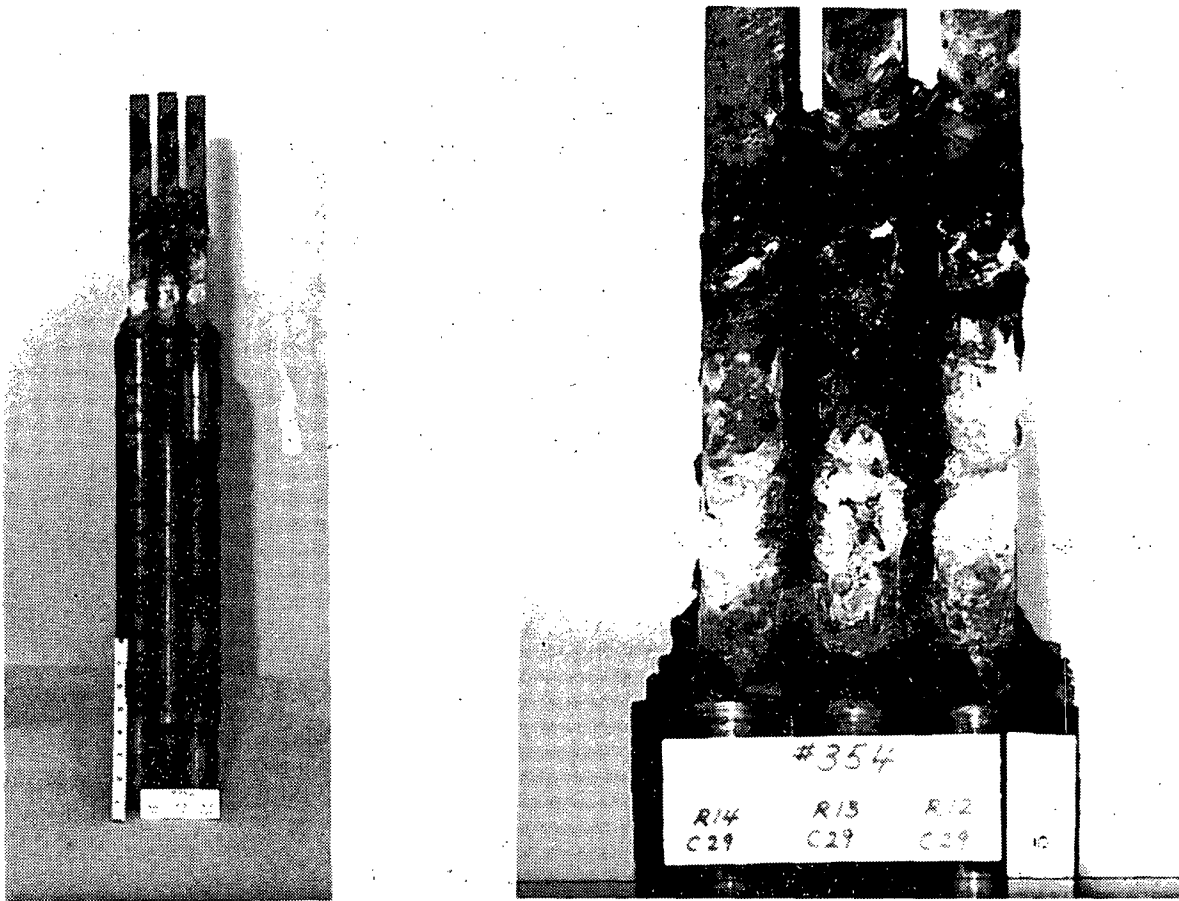
FIGURE 3.20. Overview and Sludge Pile Closeup of Cold Leg Tube
Sheet Section #354

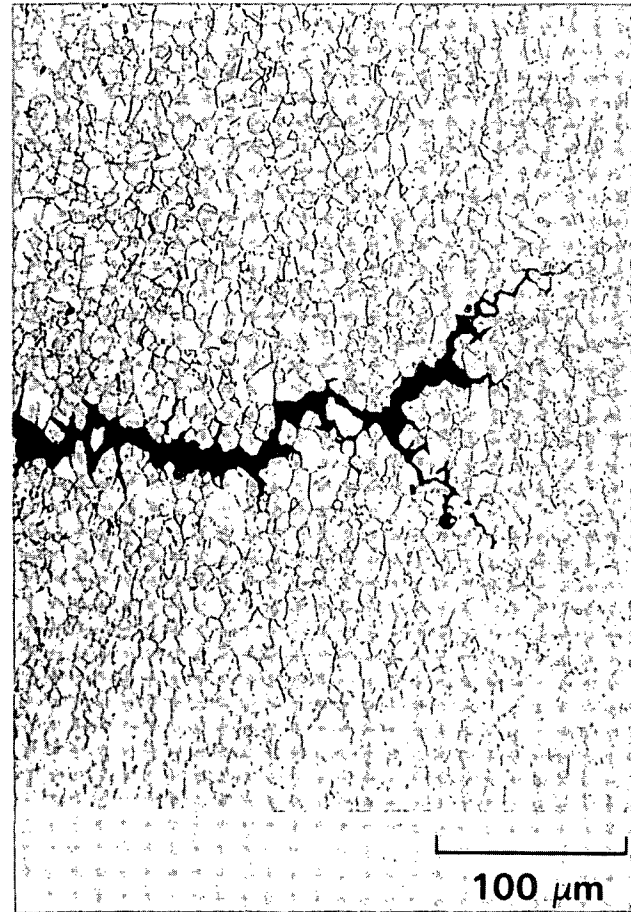
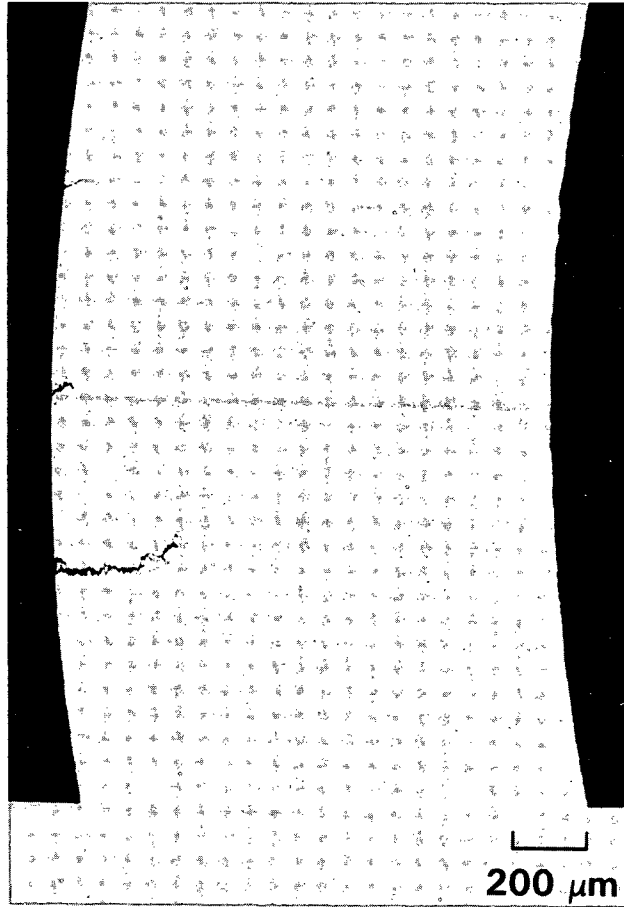
For the defects found during validation, the two grinder marks were the
only U-bend defects detected by the EC inspection teams. However, Row 1 and
2 U-bends were not inspected because of severe denting at support plates and
tube ovalization at the U-bend apex. The lack of detection of the AVB contact
wear is likely associated with the shallow nature of the defects and possible
interference from the AVB and copper-containing deposits on the OD surface
surrounding the AVB wear location.

FIGURE 3.28. Optical Micrographs Showing Axial IGSCC at the Apex of U-Bend Specimen 1049 (R2 C27)

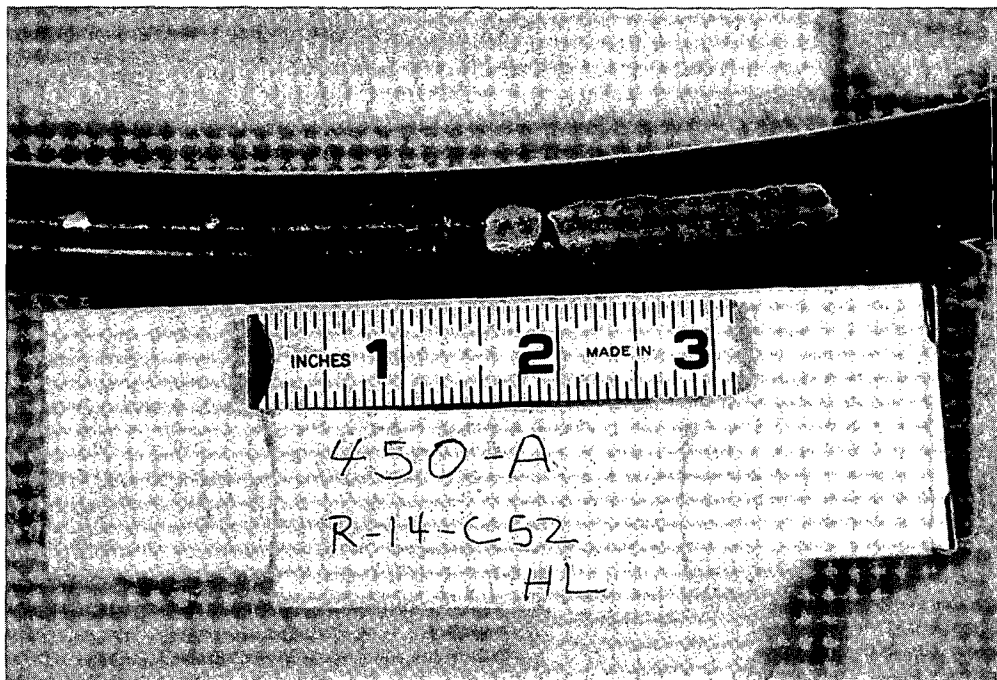
Metallographic examination showed that the thickness of the deposits varied around the circumference of the tube. Deposit thicknesses ranged up to 10 mils for the tubes examined. The deposits had a layered microstructure with metallic Cu particles observed throughout. As described below, these Cu-rich surface deposits were found to be the primary cause of false calls made by the various inspection teams. Post-removal EC inspection indicated that interruptions in the Cu-rich deposit gave rise to indications similar to defects. Chemical cleaning of specimens to remove the Cu-rich deposit followed by reinspection revealed that EC indications had disappeared.

FIGURE 3.29. U-Bend Specimen 450A (R14 C52 HL) Showing Discontinuities in the Copper-Rich OD Surface Deposit

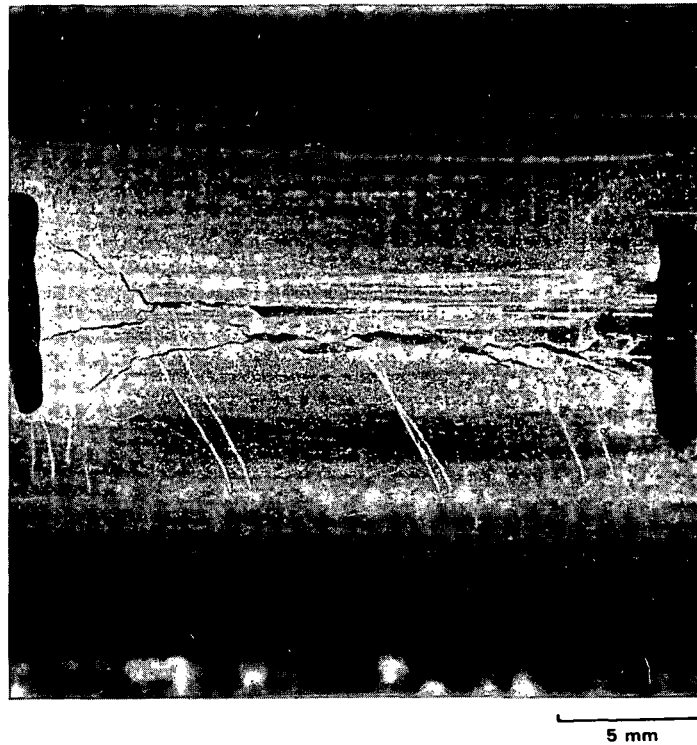
FIGURE 3.31. First TSP Specimen 1041 (R4 C51 HL) Showing ID Cracking
(26.9% strain)

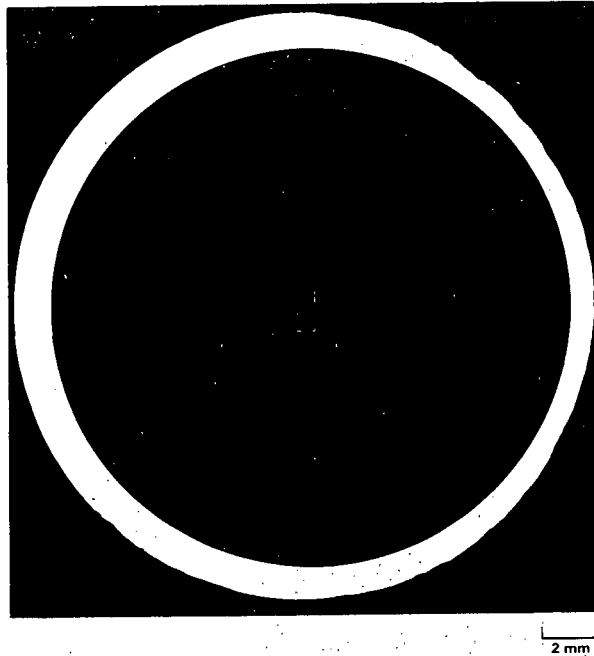
FIGURE 3.32. Optical Micrograph Showing Ring Type Wastage on
              Hot-Leg TTS Specimen 632 (R13 C37 HL)

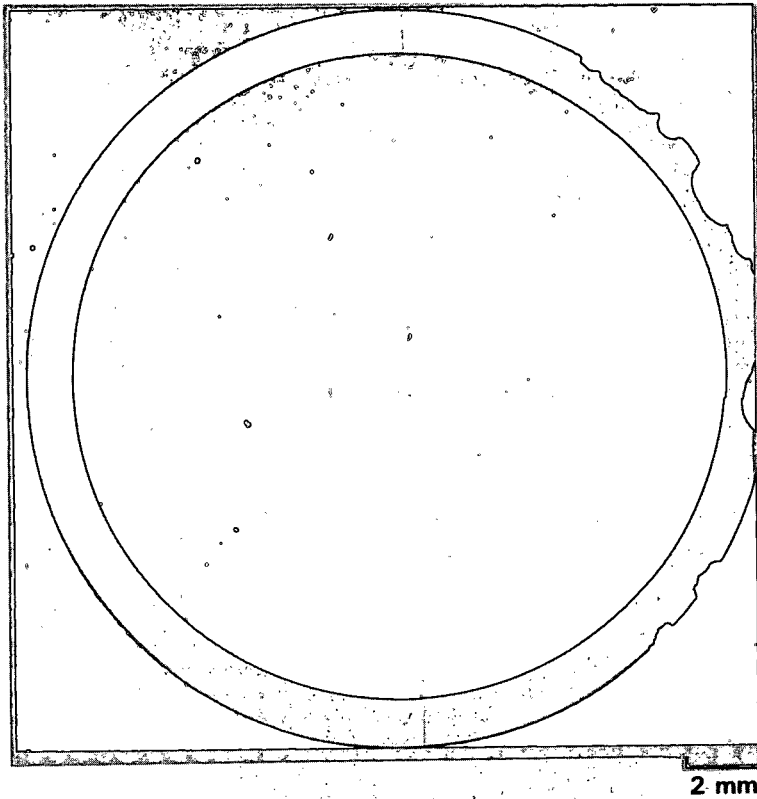
FIGURE 3.33. Pitting/Wastage Type Degradation of a Hot Leg TTS Specimen

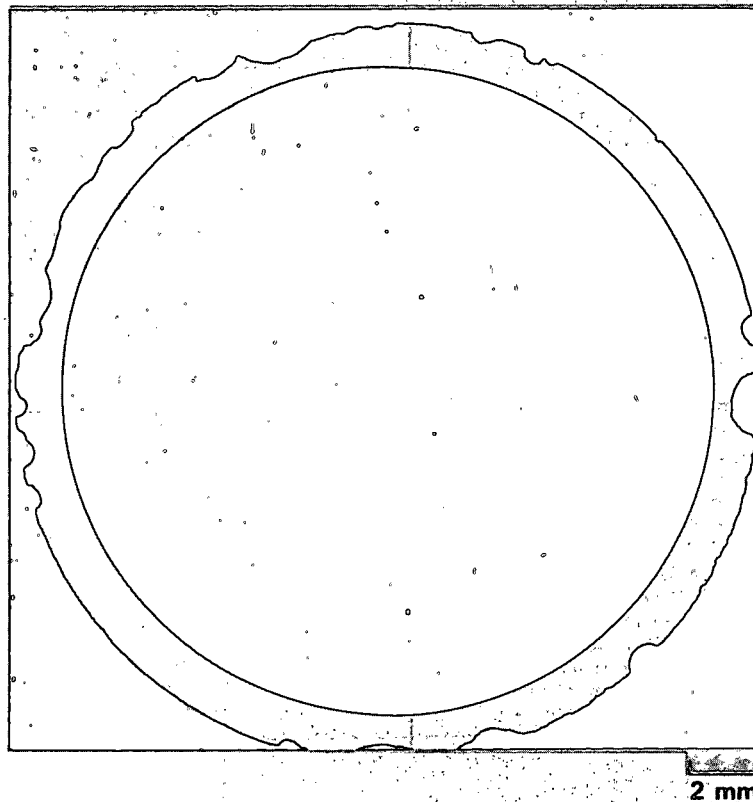
FIGURE 3.34. Pitting/Wastage Type Degradation of a Hot Leg TTS Specimen

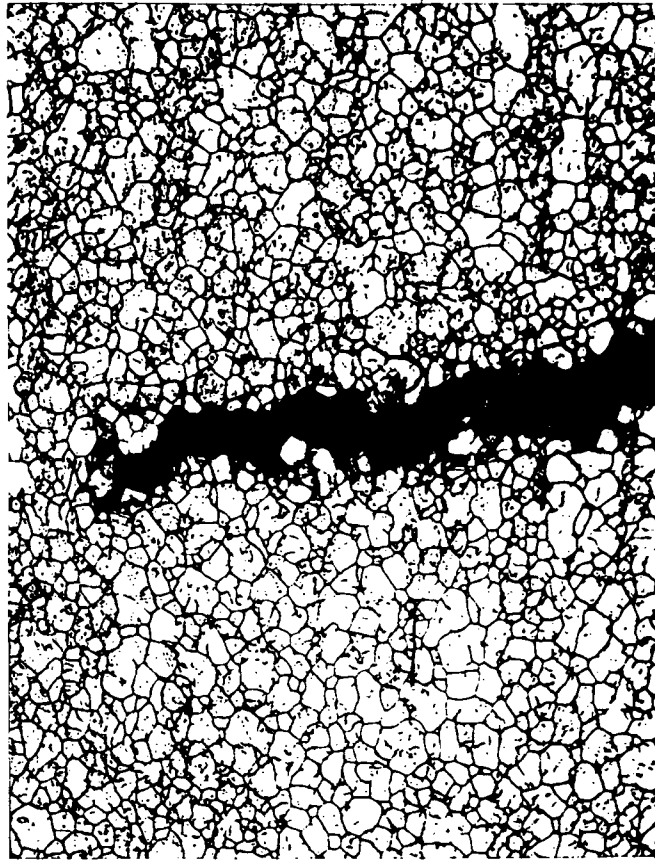
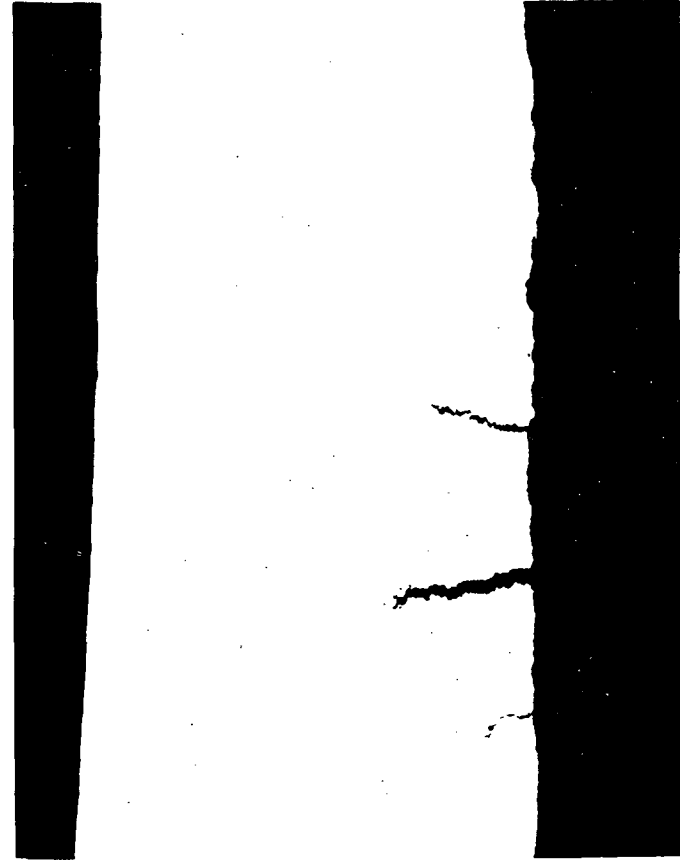
FIGURE 3.35. Optical Micrographs from a Longitudinal Section Showing OD Circumferential
Cracking of TTS Specimen 633C (R13 C44 HL at TTS + 0.2 in.)

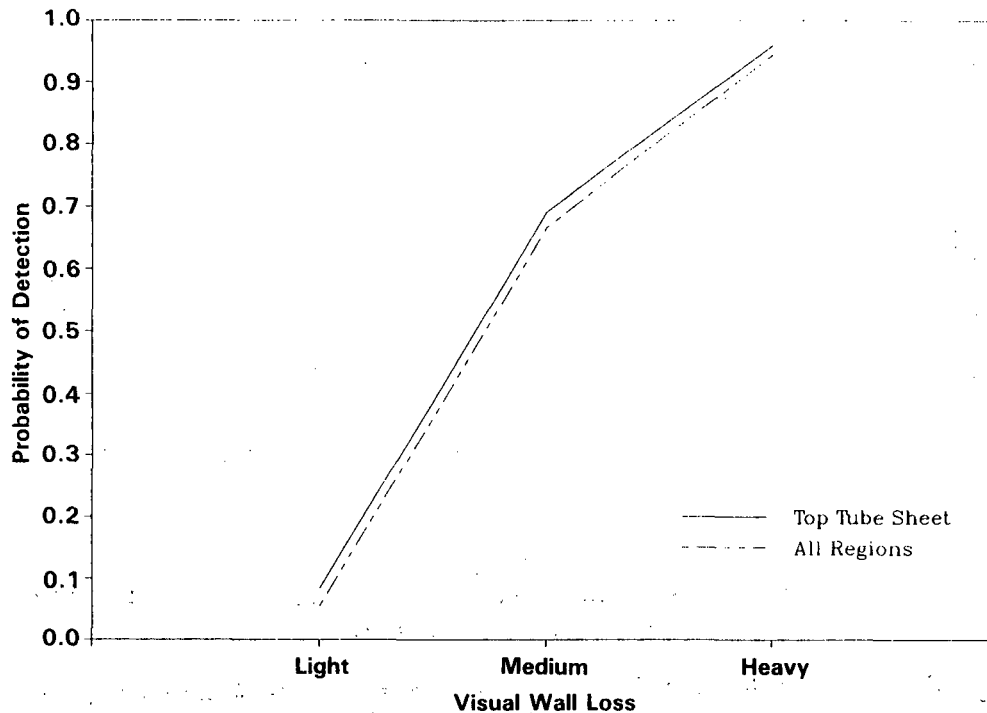
The probability of detection was determined for both the visual wall-loss estimates and the metallography data. The visual data provided a larger number of specimens, while a more precise estimate of wall-loss was obtained by metallography. Similar POD responses were observed for the Base-Line and DAARR inspection teams. A plot of the median POD from these seven inspection teams as function of visual wall-loss is shown in Figure 3.36.

FIGURE 3.36. Median Probability of Detection of DAARR and Base-Line Inspection Teams Based on Visual Determination of Wall-Loss

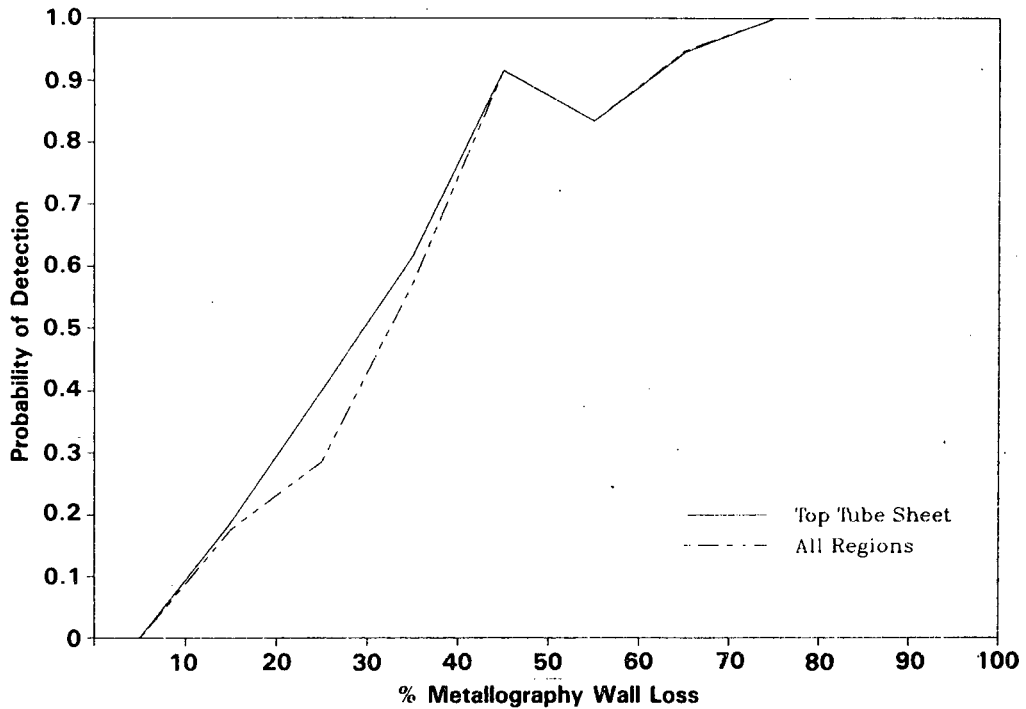
The PODs calculated from the metallography data show similar trends to those from the visual estimates of wall-loss. Figure 3.37 shows the median POD from the Base-Line and DAARR inspection teams; the metallography data are grouped into increments of 10% wall-loss. As before, the POD increased with wall-loss and the average POD for wall-loss more than 40% was greater than 0.9. Below 40% wall-loss, definite team-to-team variations in the POD curves were observed. However, there are inadequate data in each size category to

FIGURE 3.37. Median Probability of Detection of DAARR and Base-Line Inspection Teams Based on Metallographic Determination of Wall Loss

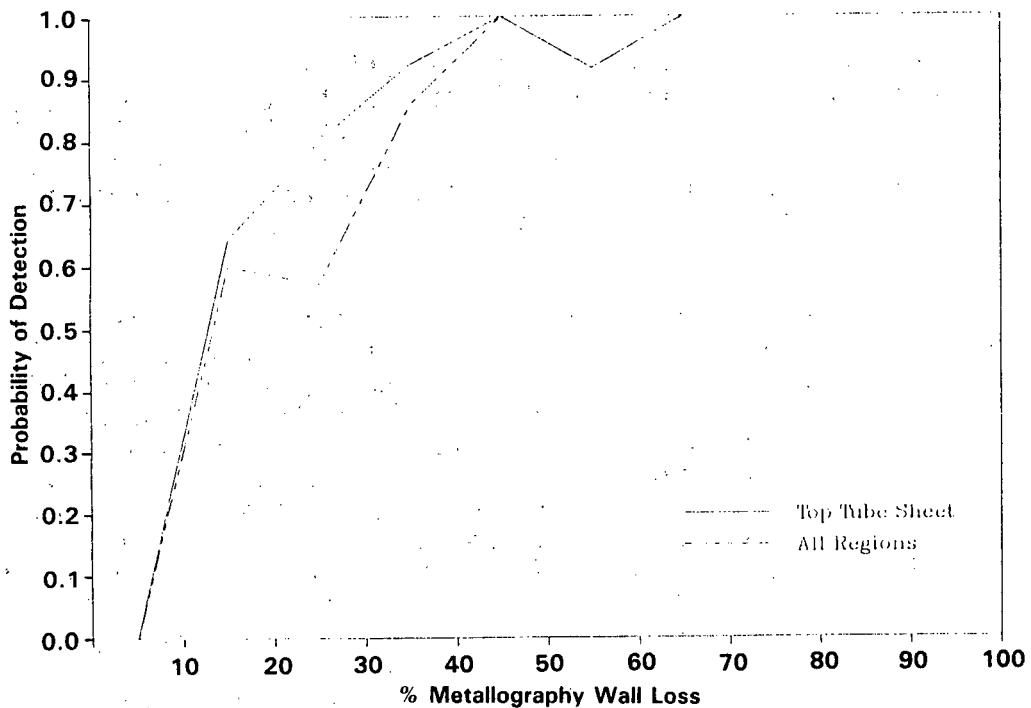
assess the statistical significance of these variations. An apparent improvement in the POD curve of one AATRR inspection team was observed, as shown in Figure 3.38. The POD curve increased more rapidly than the typical Base-Line or DAARR team and the average POD was higher above 40% wall-loss. This team utilized an automated data screening system to sort through their data prior to analysis by a human. This was probably, in part, responsible for the better POD performance.

FIGURE 3.38. Probability of Detection of an AATRR Inspection Team Based on Metallographic Determination of Wall Loss

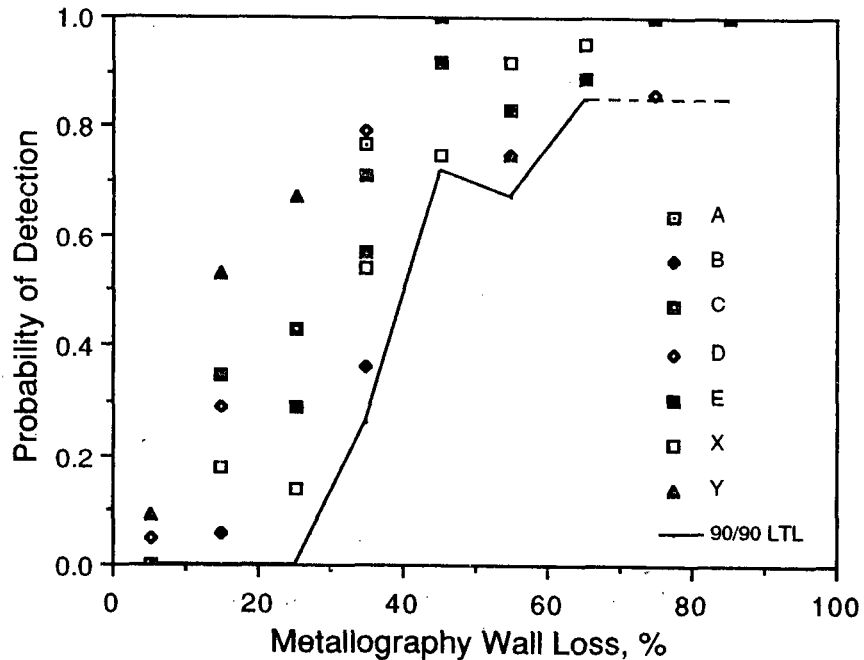
Figure 3.39 gives a plot of the individual POD performance for the DAARR and Base-Line teams for each 10% wall-loss increment. To estimate the lower bound POD, an approximate 90/90 lower tolerance limit (LTL) was computed (curve in Figure 3.39) from the teams participating in the DAARR and Base-Line inspections. These teams are assumed to be typical of the total population of teams performing ISI; therefore, if each team in this population had inspected the same set of tubes, we can be about 90% confident that about 90% of the individual team POD values would be above this LTL. The dashed segment of the curve indicates that the number of specimens with deep through-wall degradation was inadequate to provide a meaningful estimate of the LTL. Thus, the LTL at 65% wall loss is extended as a conservative approximation of the LTL (i.e., the POD is assumed to either increase or stay the same as wall-loss increases). This information was developed as an appropriate lower bound estimate of POD for field EC inspection and was used to validate the selection POD curves used in the evaluation of various sampling/inspection schemes described in Section 3.6.

FIGURE 3.39. Individual POD Performance for the DAARR and
Base-Line Teams for Each 10% Wall-Loss Increment

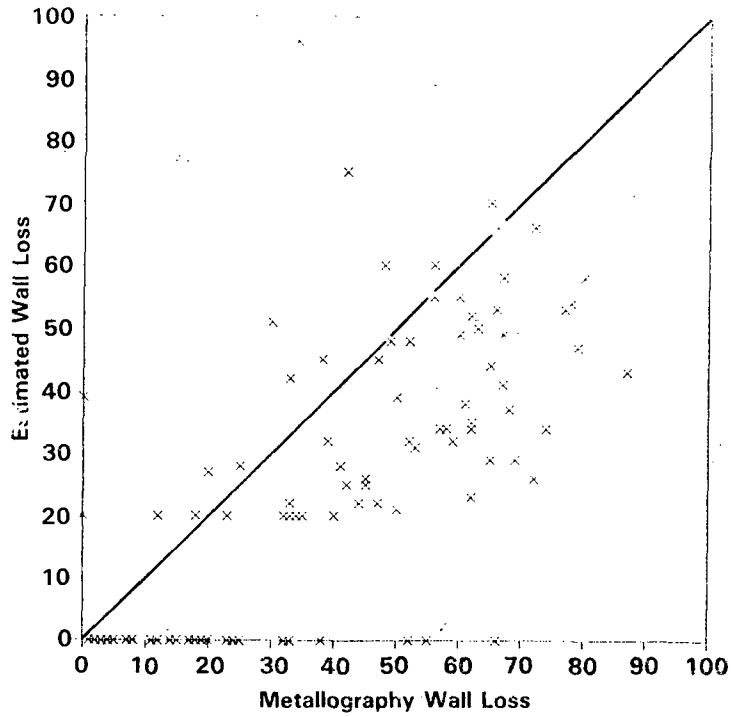
Comparing the EC and metallography data shows that EC generally tended to underestimate the defect depth as measured by metallography, especially for the more severely-degraded specimens. Figure 3.40 shows the relationship between the EC and metallographic results for a typical inspection team using standard bobbin-coil techniques. Points plotted along the horizontal axis are nondetections and points shown on the vertical axis are false calls. Team-to-team variations were observed, but the general tendencies shown in Figure 3.40 were apparent for all of the Base-Line and DAARR inspections. Wide variations in the EC depth estimates were reported for specimens with similar wall-loss and also for the same specimen but from different teams. A better correlation between the EC and metallography wall-loss was observed for one of the AATRR teams, as shown in Figure 3.41.

FIGURE 3.40. Typical Plot of EC Estimated Flaw Depth Versus
Actual Depth from Metallographic Analysis

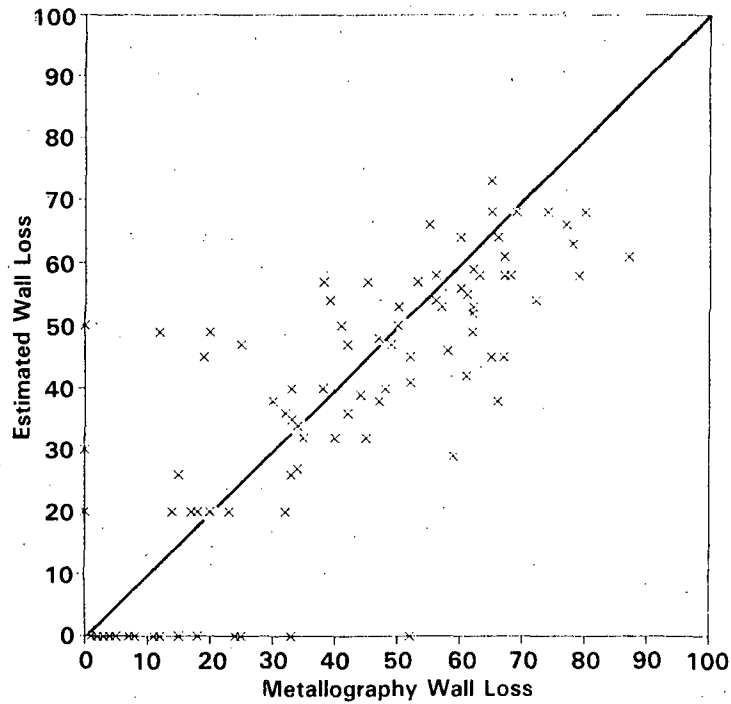
FIGURE 3.41. Plot of Best Observed EC Estimated Flaw Depth
Versus Actual Depth from Metallographic Analysis

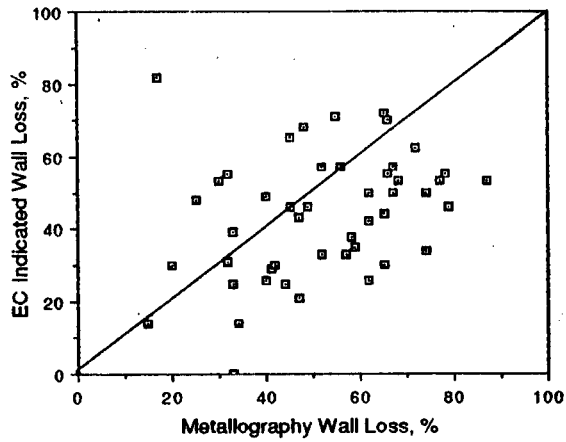
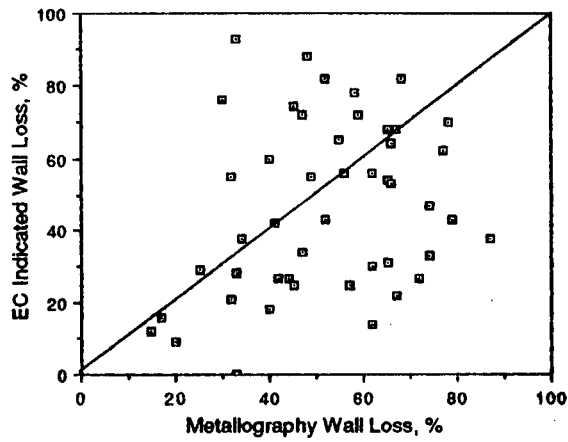
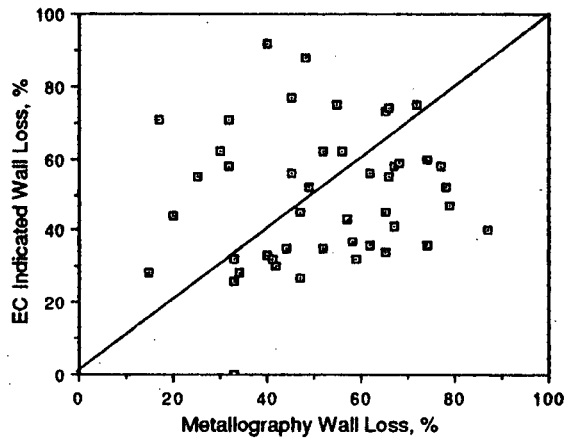
The EC data from TTS specimens with metallographic data available were reanalyzed to determine if a consistent analysis method and or frequency would improve the correlation between EC and metallography wall-loss. The EC data tapes from one of the DAARR inspection teams were analyzed at 400 kHz, 100 kHz, and a 400/100 kHz mix. The defect signals were measured at all three channels by always taking the location within the signal which produced the deepest wall-loss. This location usually was a tangent point of a deflection on the vertical channel of each output. A comparison of the resulting EC depth estimates with the metallographic data is shown in Figure 3.42. No definite improvement in the variability of the EC depth estimates is seen in the three sets of data, although a consistent analysis method was employed.

FIGURE 3.42. Comparison EC Data Reanalyzed at Various Frequencies With Metallography

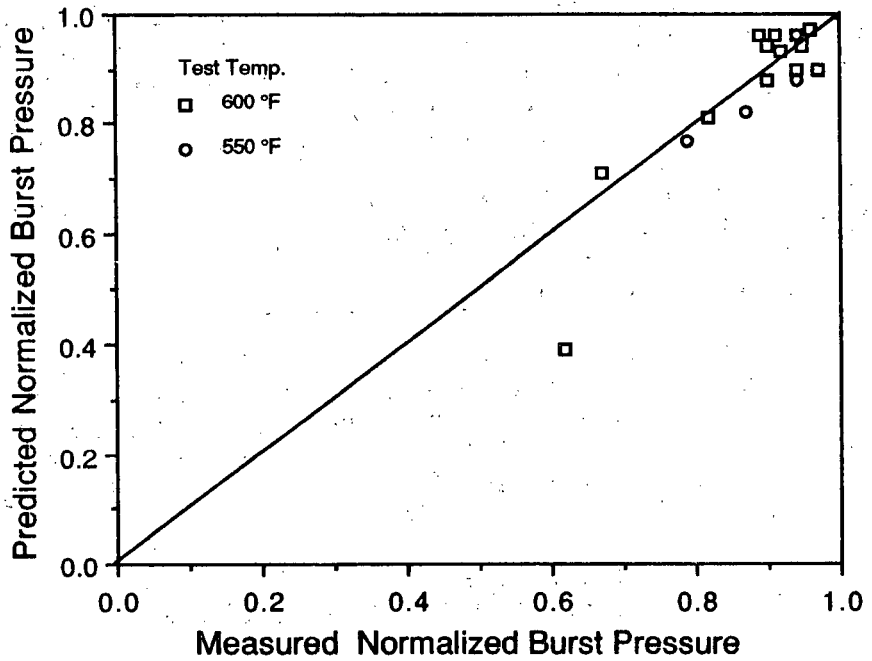
Figure 3.47 shows a plot of the calculated normalized burst pressure against measured values. Excellent agreement was obtained between calculated and measured values for the Phase I EDM notch empirical model. Similar results were obtained for the uniform-thinning model, but the elliptical-wastage model predicted burst pressures substantially below actual values. This model tended to overpredict burst pressure because it was developed from burst-test results on tubes with long axial elliptical wastage. All data points, except one, were within ±10% of perfect agreement. The one data point outside the ±10% range was from a tube in which failure was caused by an OD initiated SCC. The actual burst pressure of this tube was about 20% greater than the predicted value. This result was partially due to the method employed for characterizing the crack dimensions. The cracked portion of the tube was, in fact, composed of several small closely spaced cracks. To conservatively characterize the flawed area, an overall crack length consisting of the sum of the smaller cracks was used. The crack depth was estimated from post-test fracture surface measurements and a metallographic section taken through the center point where the crack had penetrated the tube wall. It is clear that the EDM notch empirical equation gave conservative results for the axial SCC when bounding dimensions were used to characterize its size.

FIGURE 3.47. Calculated Normalized Burst Pressure From EDM Slot Equation

vs Measured Normalized Burst Pressure for Tubes
Removed From the HLTTS Region With P/W Defects

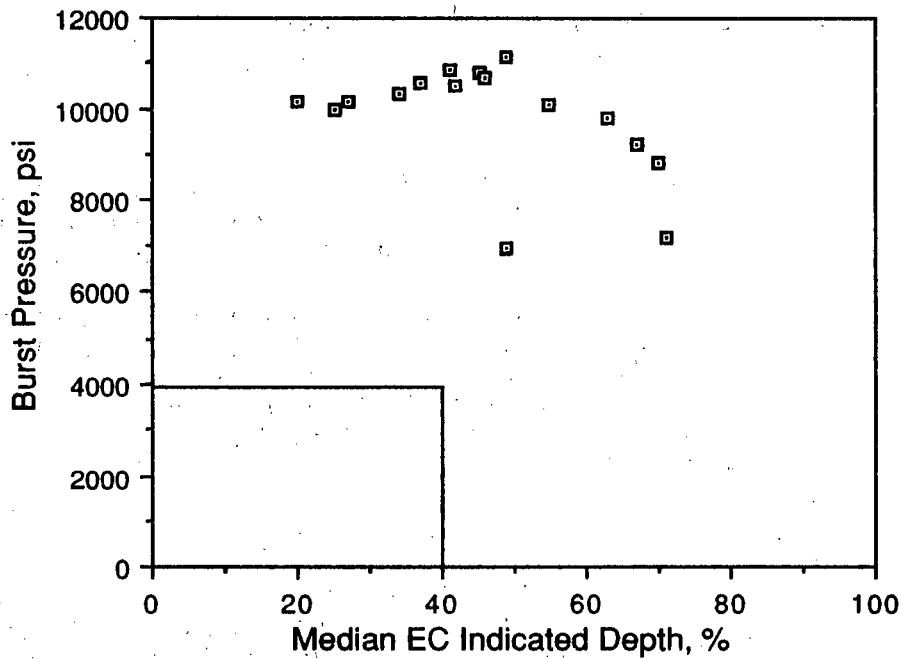
The burst-test results illustrate how bobbin-coil EC depth measurements provided a conservative estimate of remaining tube integrity even with significant undersizing. Figure 3.48 gives a plot of burst pressure versus median EC estimated defect depth for the Base-Line and DAARR teams. The boxed area in the lower left-hand corner of Figure 3.48 defines a zone bounded by the present 40% plugging limit and three (the present factor of safety specified in Regulatory Guide 1.121) times normal operating pressure differential. Note that none of the data fall within the nonconservative zone. This was because of the short axial extent of the pitting/wastage. Large uncertainty in the EC depth estimate can be tolerated when the true defect length is short (<0.25 in.). Thus, the 40% plugging limit is conservative for these defect types. Accurate measurement of defect depth becomes much more important when the defect length is greater than about one tube diameter.

FIGURE 3.48. Burst Pressure vs Median Eddy-Current Depth for
Tube Segments From the Surry Steam Generator

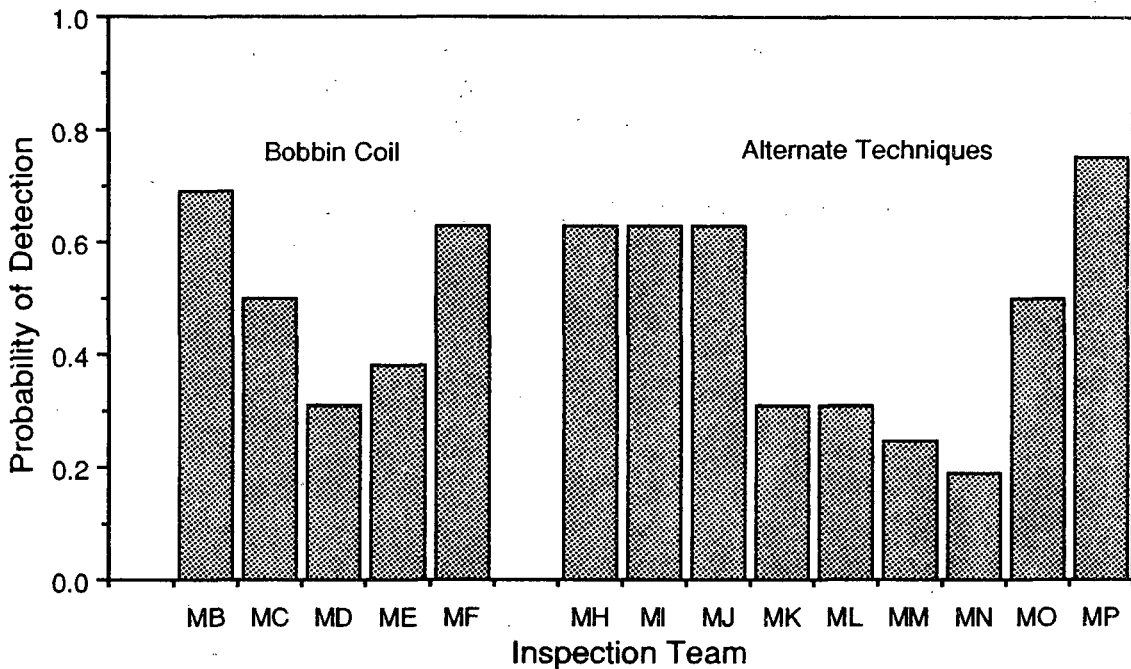
Figure 3.60 summarizes the POD results for the fourteen teams/techniques that inspected the tube bundle blind. Due to the limited amount of data, no attempt was made to determine POD as a function of crack dimensions. However, it should be noted that in 12 of the 16 tubes the crack depth was greater than 40% through-wall. To summarize, the average probability of detection of SCC for teams using bobbin-coil techniques was 0.5. Surprisingly, the alternate bobbin-coil techniques performed significantly below techniques using the conventional bobbin-coil probe. The best detection was obtained from teams utilizing rotating pancake-coil (RPC) or array-coil techniques either alone or as a supplemental technique for conventional bobbin-coil inspection. The average POD for teams using rotating pancake-coil techniques was 0.63.

FIGURE 3.60. Summary of POD Results for IGSCC Round Robin Teams
