Steam Generator Tube Integrity Program/Steam Generator Group Project

Final Project Summary Report

Pacific Northwest Laboratory
Richland, WA 99352

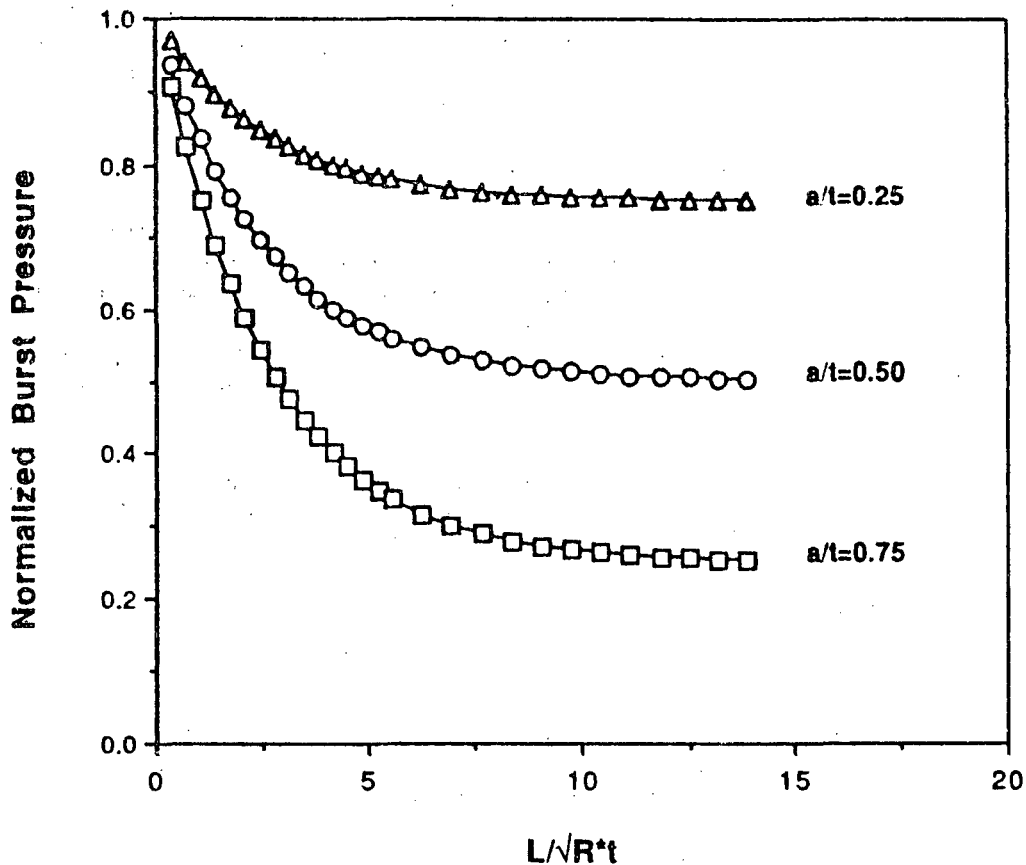
the ASME Code, 1986 Edition, is recommended as a suitable model for evaluating these conditions. The bounding trends of tube burst tests are summarized in Figure 5.4 for degradation geometries and loads such that the circumferential stress governs predictions of tube integrity. This figure is an example of the data recommended for predicting the integrity of degraded tubes. The curves indicate percentage reductions in allowable pressure as a function of both degradation depth and length. Figure 5.5 gives curves that are recommended for evaluating circumferentially-oriented degradation for which the critical stress is in the axial direction. These curves are purely for pressure loading. Limited tube burst tests served to confirm the trends of these curves. The technical basis for generating these curves was the IWB-3640 tables for net section collapse of the remaining wall cross section of the degraded tube. Extension of these results to account for bending loads could be made using the net section collapse methodology.

FIGURE 5.4. Burst Parameter Prediction Curves for Axially Oriented EDM Notches in Steam Generator Tubes. L = Degradation Length, a = Degradation Depth, R = Tube Inner Radius, and t = Tube Wall Thickness

An extensive amount of information on the effect of flaw type and severity on remaining tube integrity was developed during the SGTIP. Empirical equations were developed relating the extent of degradation to remaining tube integrity. It is recommended that evaluations of the effect of degradation on tube integrity should be based on the empirical equations of burst tests of tubes with artificial and/or service-induced degradation. Since the empirical data on tube failure are limited to pressure loadings, the effects of bending loads need to be addressed by predictive models. If ductile fracture is assumed, then the net section collapse of the remaining cross section of the tube as presented in Section XI, Subsection IWB-3640, of

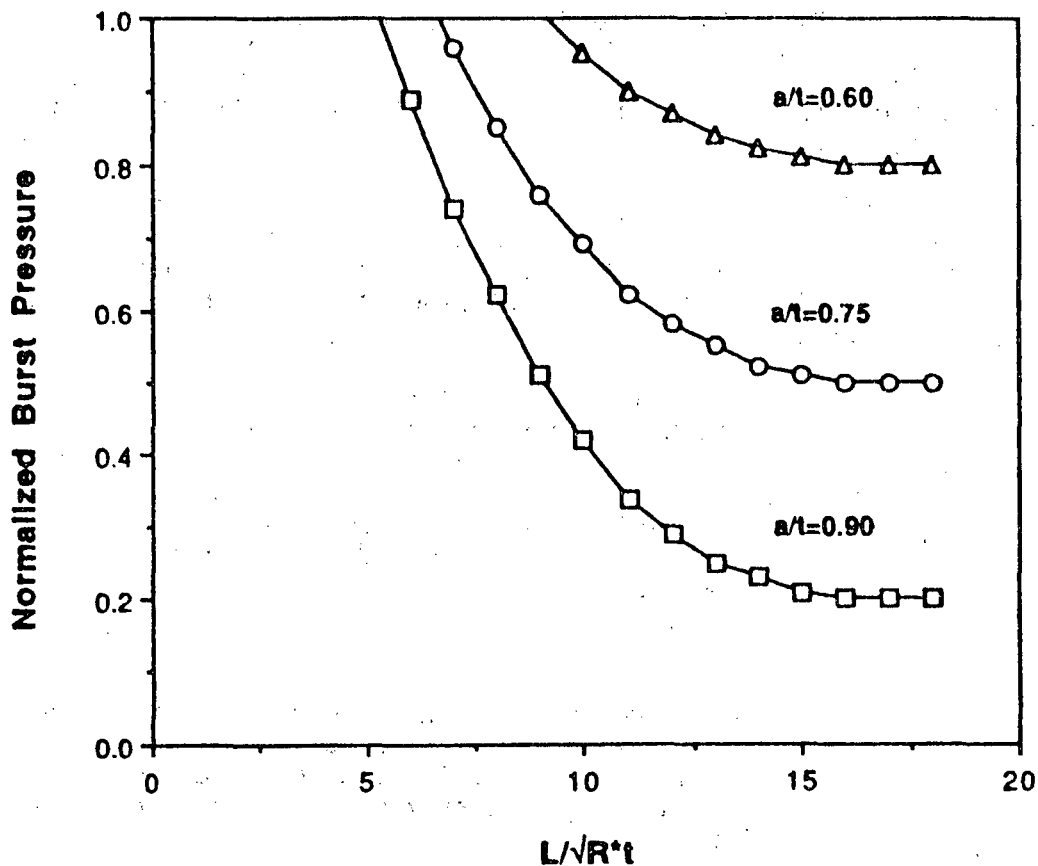
FIGURE 5.5. Burst Parameter Prediction Curves for Circumferentially
Oriented Cracks (based on IWB-3640). L = Degradation
Length, a = Degradation Depth, R = Tube Inner Radius,
and t = Tube Wall Thickness

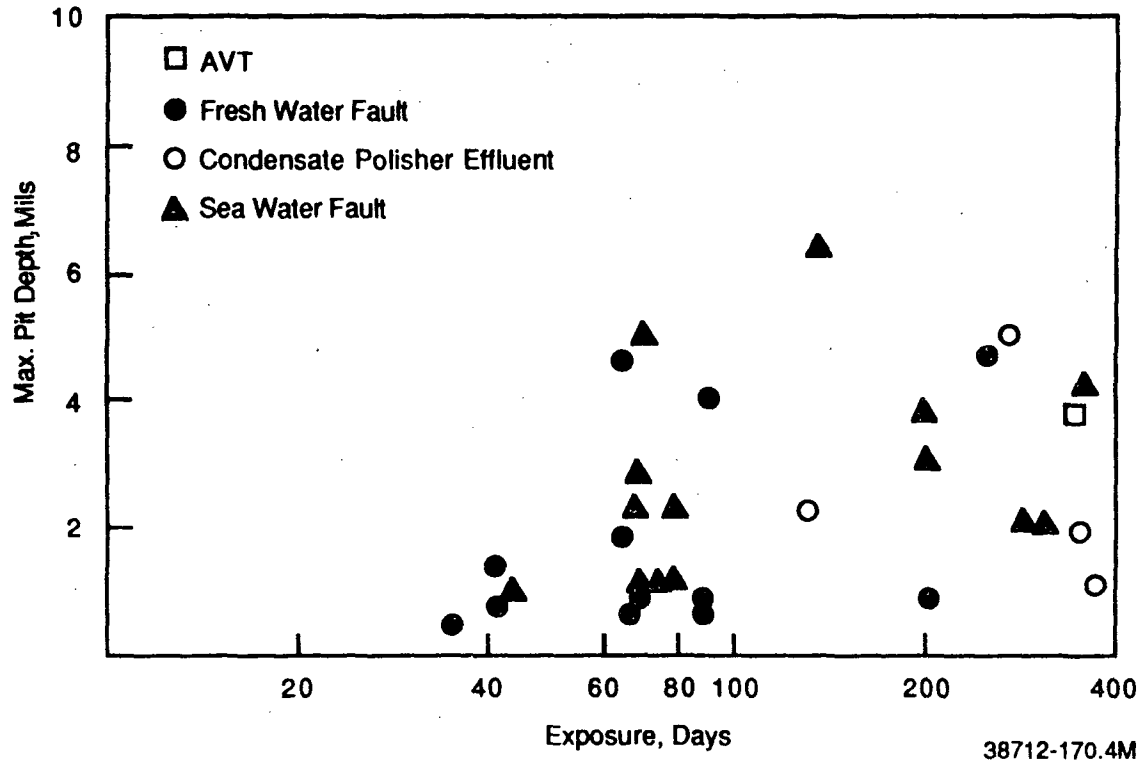
Since the in-service inspection and tube plugging history for the Surry generator did not identify tubes degraded by pitting, it was difficult to determine the pit growth rate. NDE detection of pitting is masked by copper deposits, so determination of pit growth from field NDE data is not reliable. One possible assumption might be one year for pit initiation followed by five years of growth. This assumption yields the results shown in Table A.6. These results compare reasonably well with the laboratory results given above. On the other hand, much of the recent laboratory data suggests that pit growth rates are highly nonlinear. Model boiler test results reported by Hall, et al. (1987), indicated that pit growth rates were initially rapid but were followed by stifling of further growth due to the formation of corrosion products that covered the outer surface of the pit.

FIGURE A.3. Pit Depth Versus Exposure Time in Alloy 600 Tubes in Model and Pot Boiler Tests (Hall 1984)

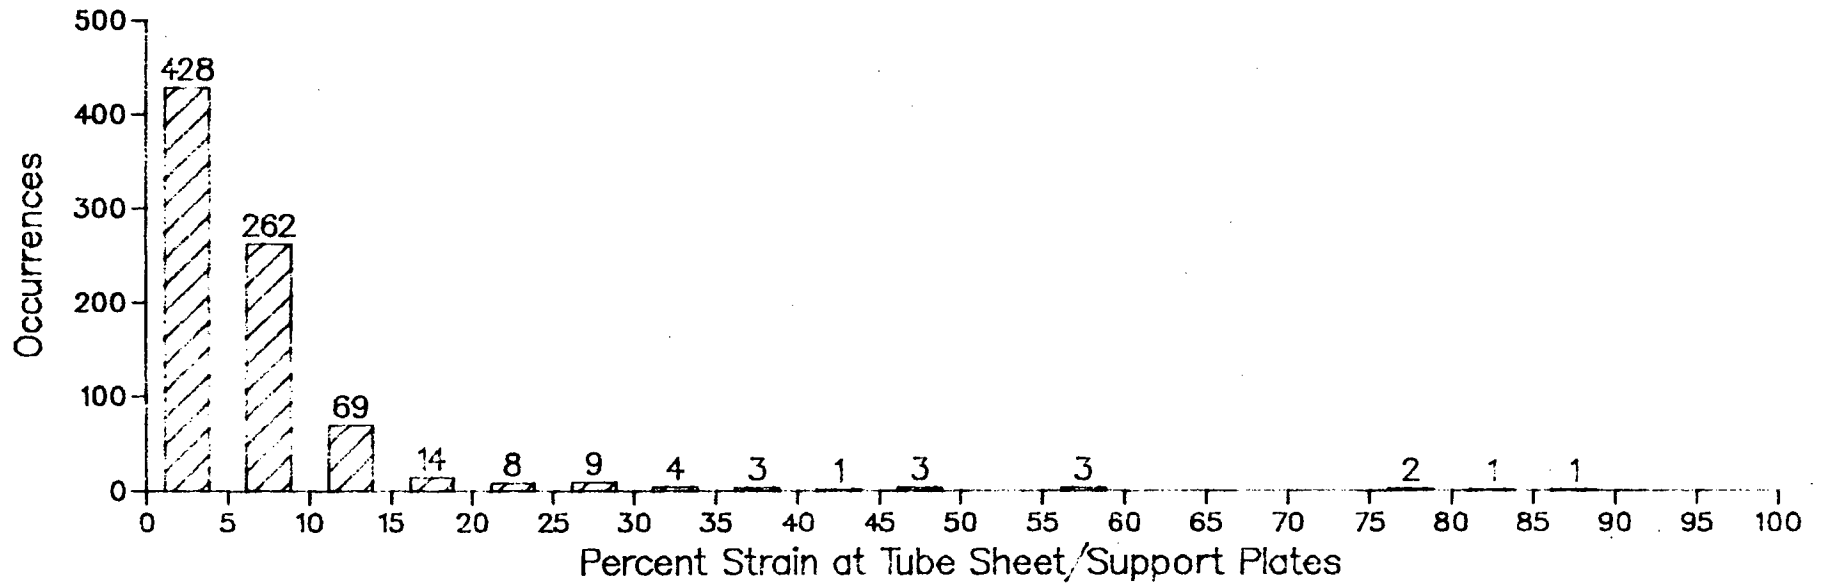
FIGURE A.4. Histogram Showing Strain Measurements From the PROFIL-360 Inspection (Doctor et al. 1988b)

It is recommended that plugging limits for dented tubes be based on either reduction in tube diameter or on peak strain at the dented location of the tube. Peak strains can be calculated from measurements of the profile of the dented tube as demonstrated during the PROFILE-360 examination of selected tubes from the Surry Generator.

Based on the work, an appropriate strain limit for plugging of dented tubes would be 10%. It is recognized that the susceptibility of tubes to SCC is governed by factors such as strain rate, material microstructure, and plant water chemistry. Thus, strain-based plugging limits lower than 10% may be needed for particular plants. Development of an alternate plugging limit should seek to preclude crack initiation and limit denting severity such that effective tube inspection is possible.

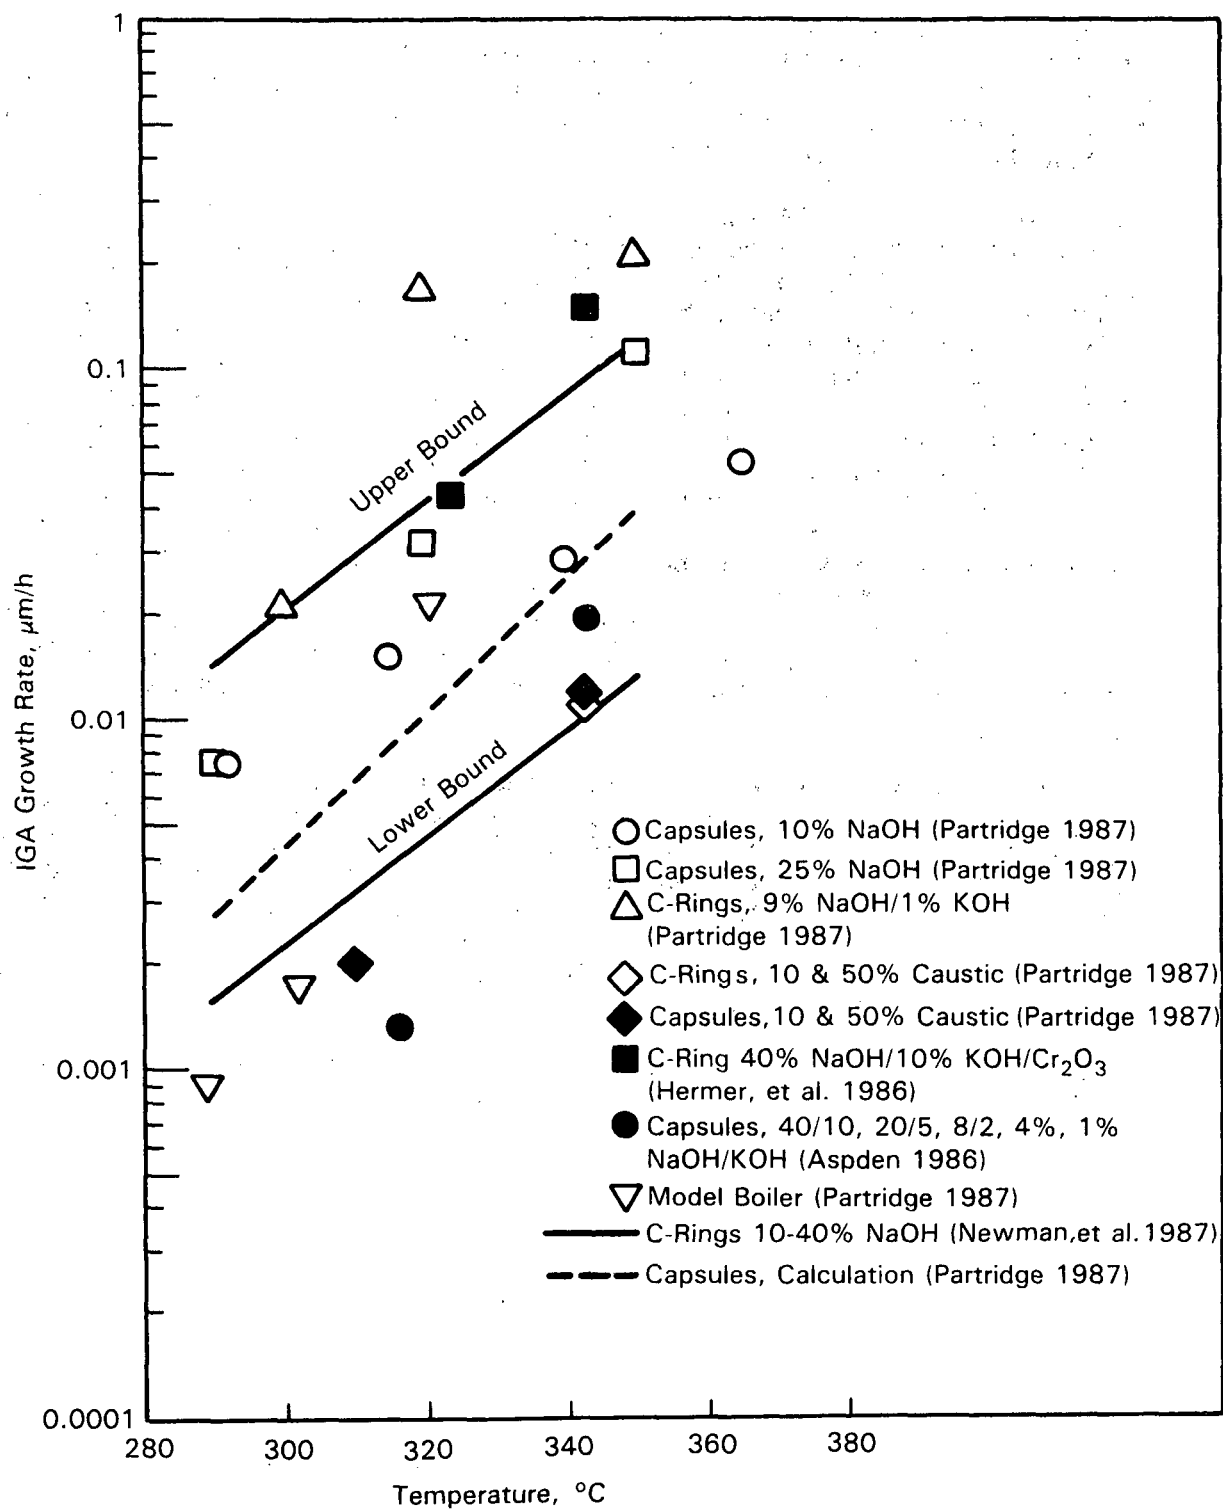
Upper bound estimates for growth rates at 550°F and 600°F obtained from Figures A.6 and A.7 are listed in Table A.7.

FIGURE A.6. Temperature Dependence of IGA Growth Rate

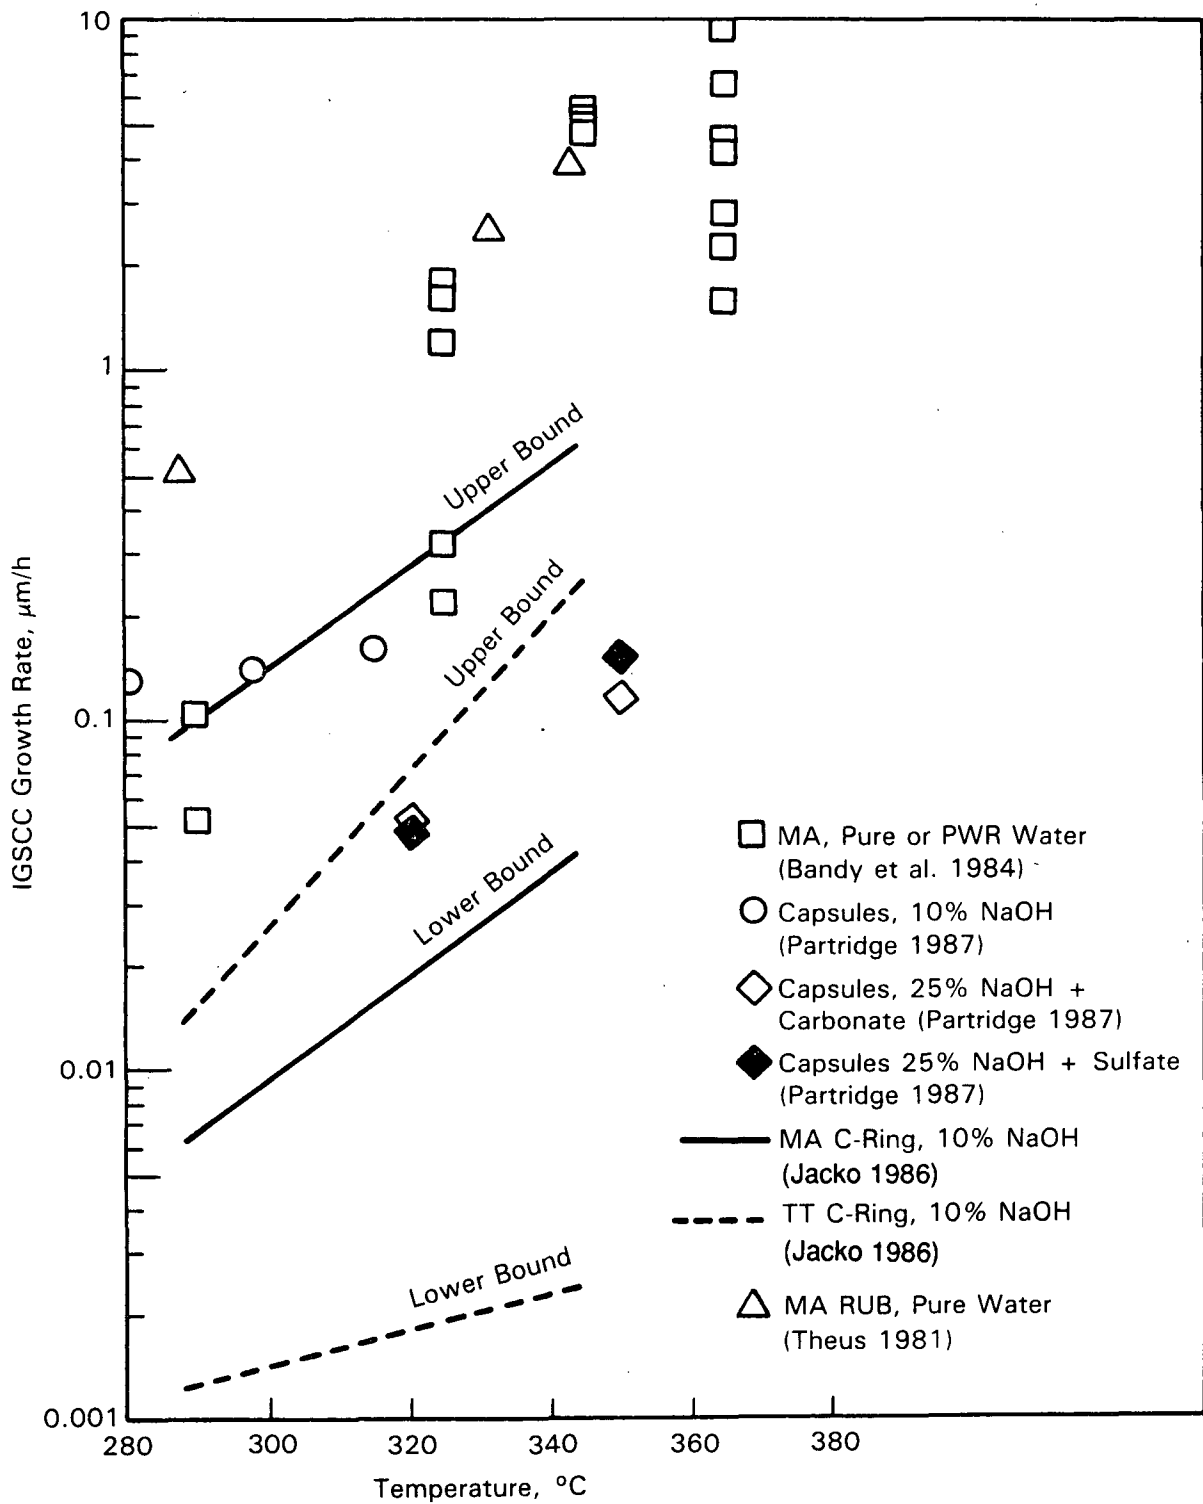
FIGURE A.7. Temperature Dependence of SCC Growth Rate

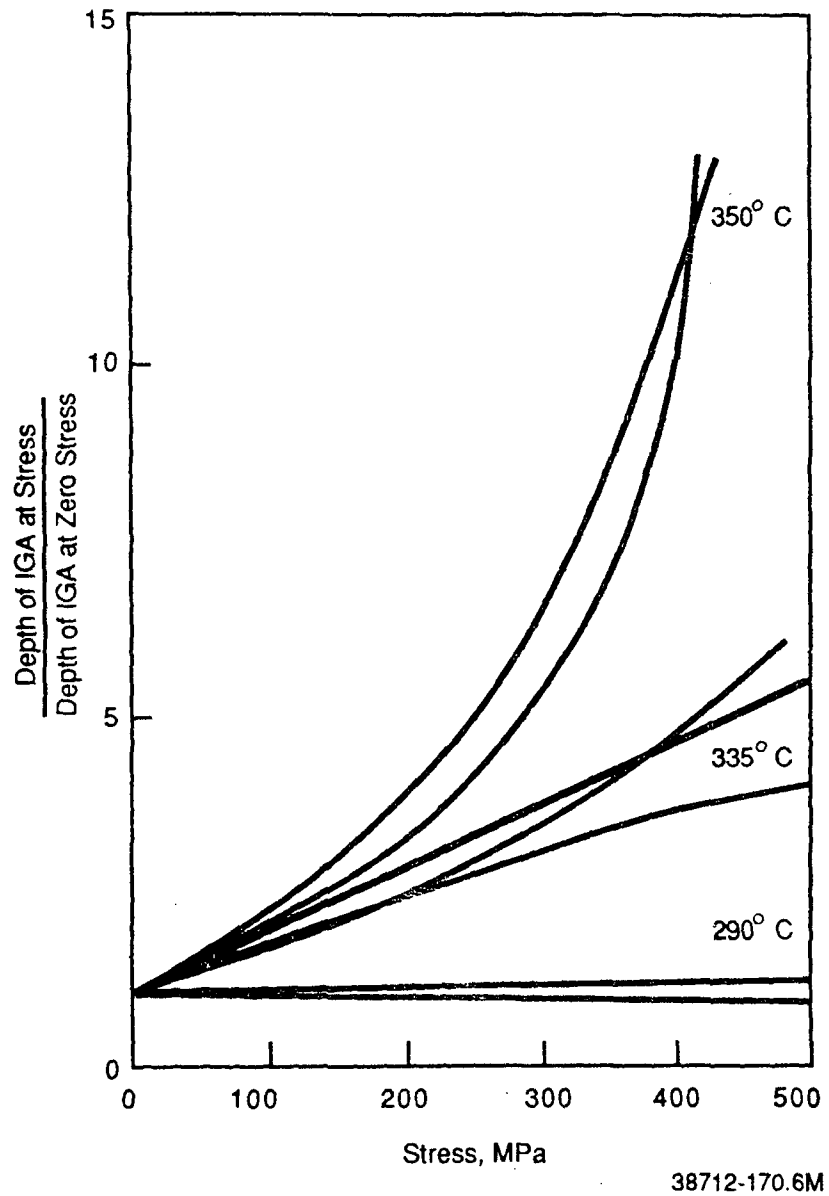
Figures A.8 and A.9 show the limited amount of data (Newman et al. 1987 and Berge 1986) suggesting a relationship between applied stress (or stress intensity) and growth rate for IGA and SWSCC respectively. For SWSCC at high applied stress levels, the curves in Figure A.8 suggest a saturation of crack growth rate. Also a significant dependence on caustic concentration was observed over the full range of stress intensity factors investigated. In addition, the results in Figure A.8 suggest a threshold below which no significant SWSCC is expected.

FIGURE A.8. Influence of Stress on IGA as a Function
of Temperature (Newman et al. 1987).

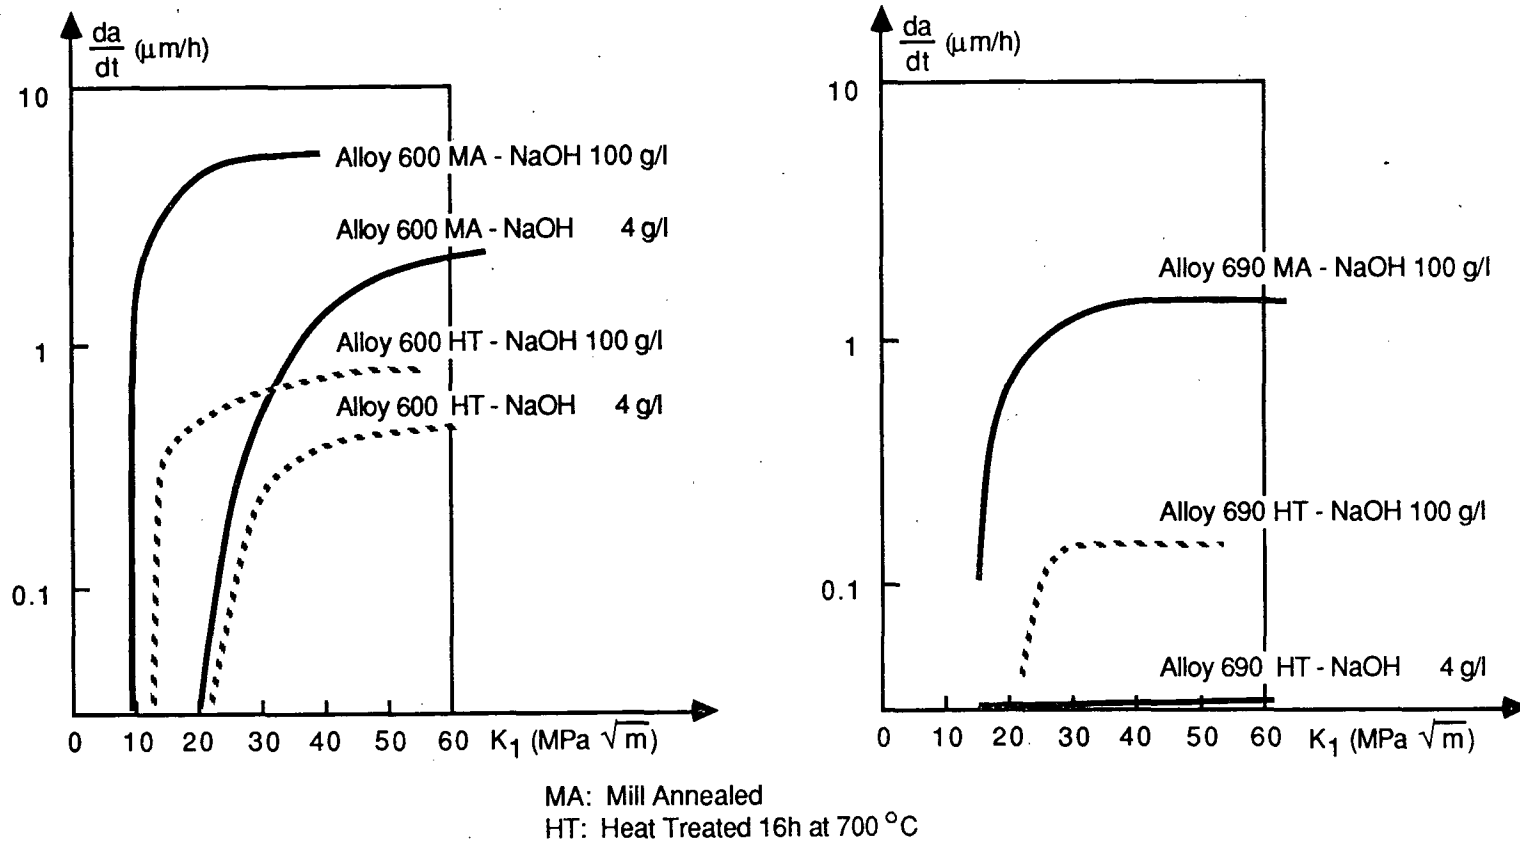
FIGURE A.9. Stress Corrosion Tests in Deaerated Sodium Hydroxide at 350°C on Fracture Mechanics
Type Specimens: Comparison of Alloy 600 and 690 Behavior. Effect of Heat Treatment
at 700°C. (Berge 1986)
