Entergy

Operational Assessment of ANO-2 Steam Generator Tubing for the Remainder of Cycle 14

February 3, 2000

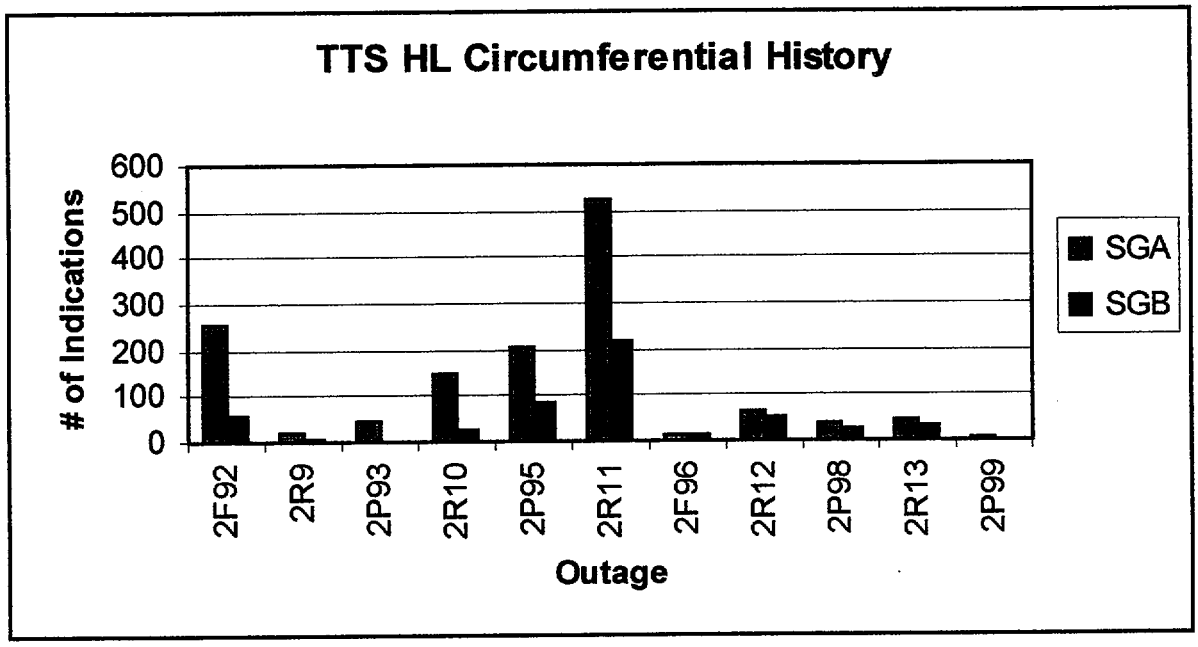
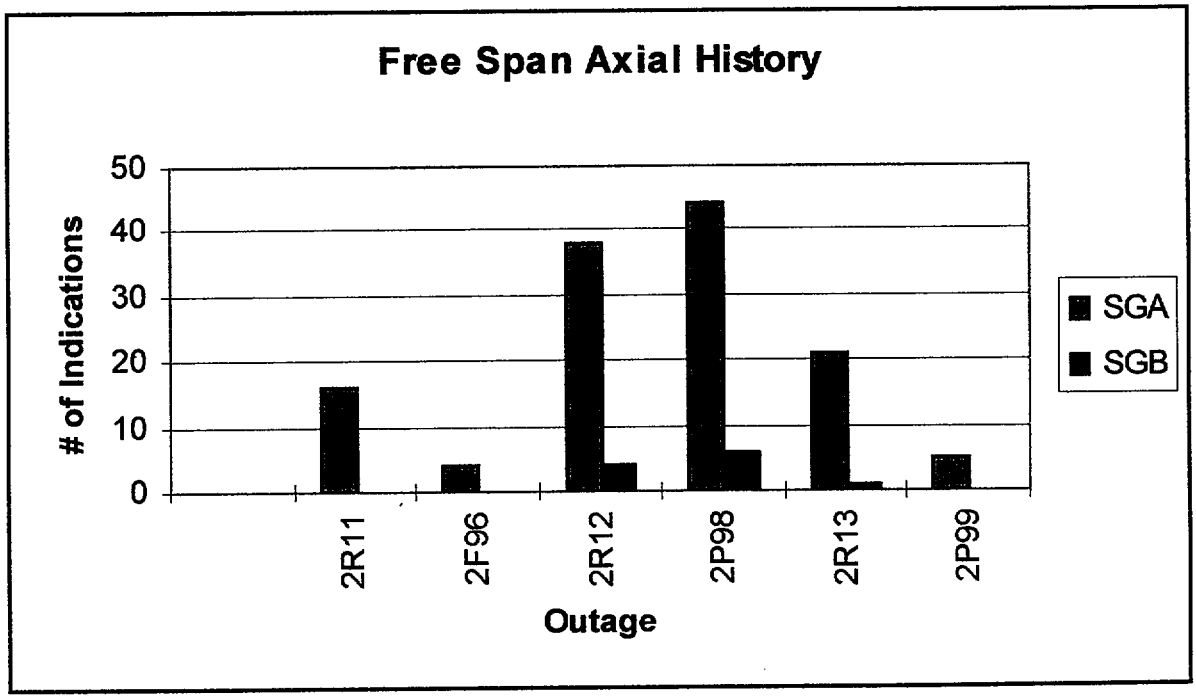
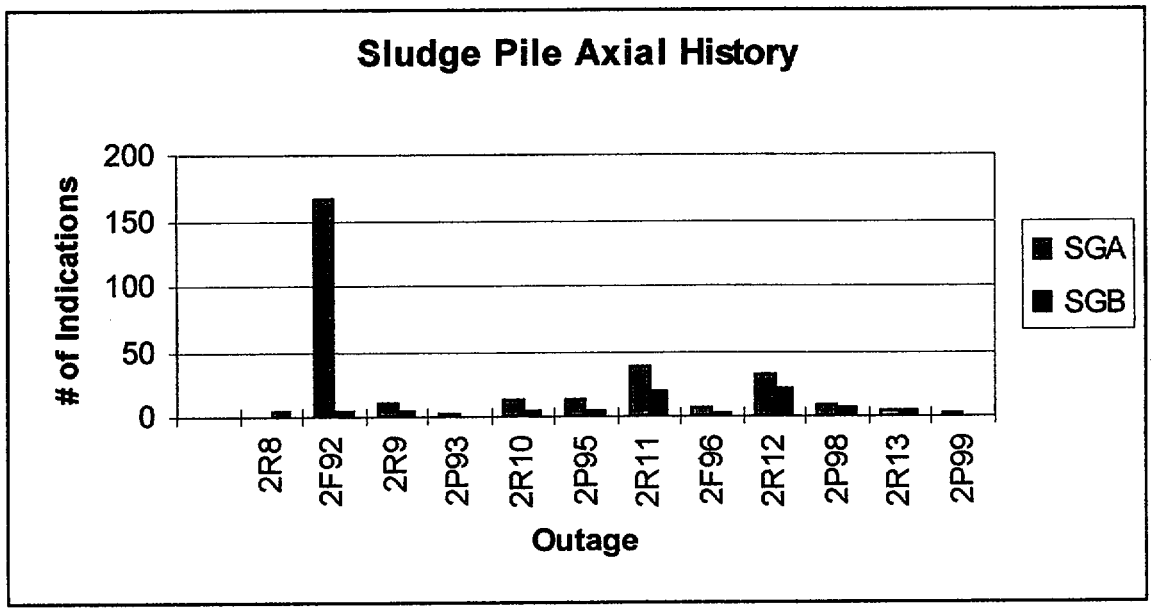
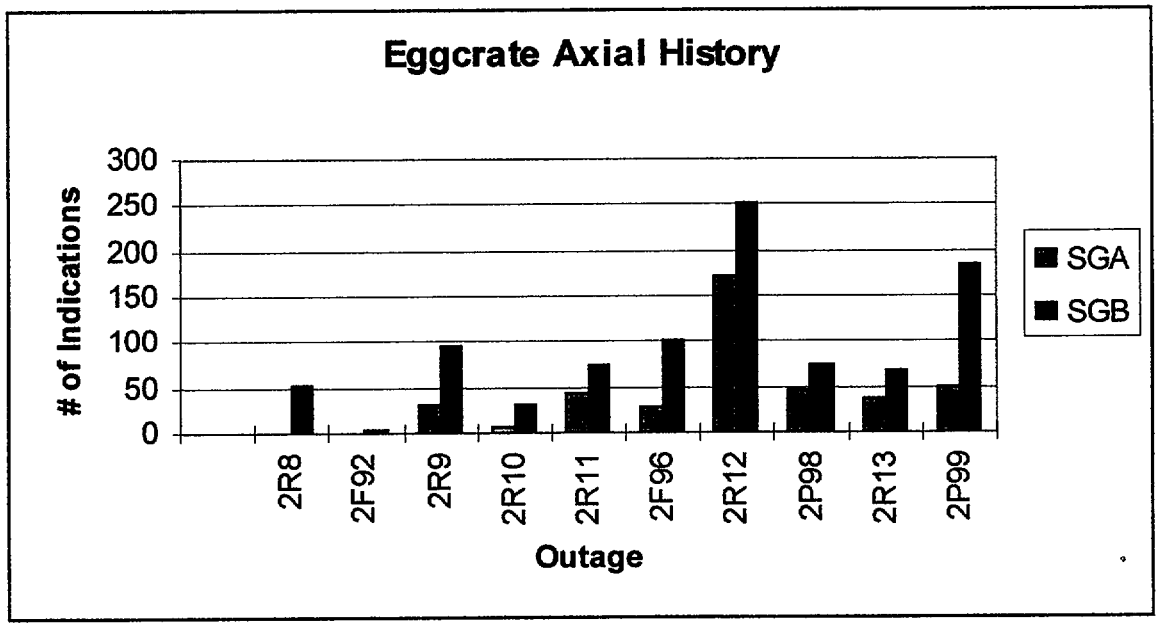
Graphic displays of the above data are presented below:

As noted in the condition monitoring report[3], a higher than expected number of eggcrate axial indications were identified in SGB

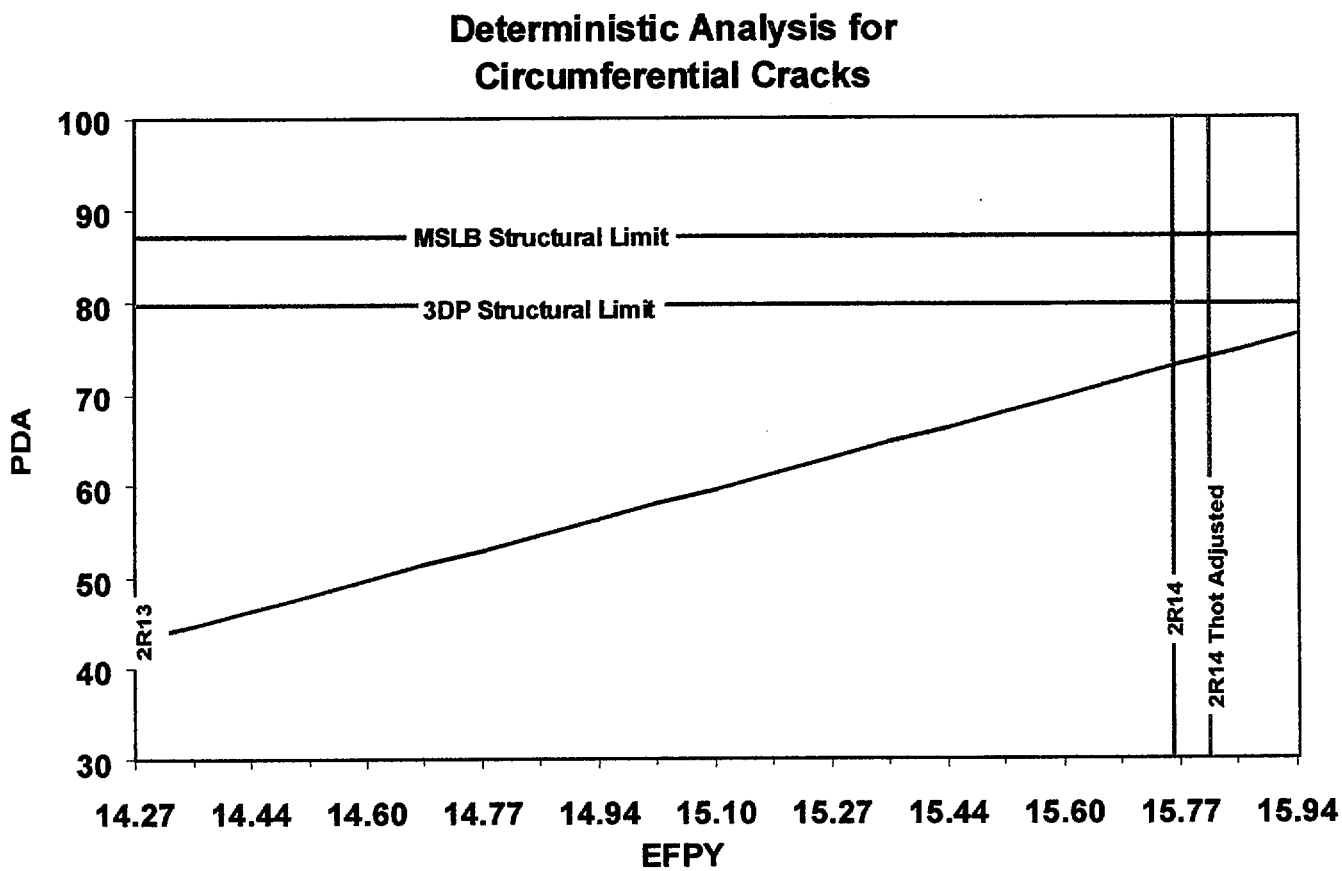
During 2P99, a limited inspection (503 tubes), was performed to mitigate potential leakage. The size and number of indications were well within the number projected in the previous operational assessment. No credit for this inspection was taken in the deterministic evaluation. Nine indications were identified and repaired. The beginning of cycle flaw size at a POD of 0.95 was used. This was equivalent to 43 percent degraded area (PDA)[4]. The growth rate used was the 0.95 value from the growth rate distribution based on a site specific sizing evaluation from 2R13. This value was equal to 20 PDA/EFPY[5]. Based on these inputs, operation for the full cycle is justified with added margin. This analysis was offset 3.7%[6] for increasing T-hot and is depicted in Figure 4.1 below:

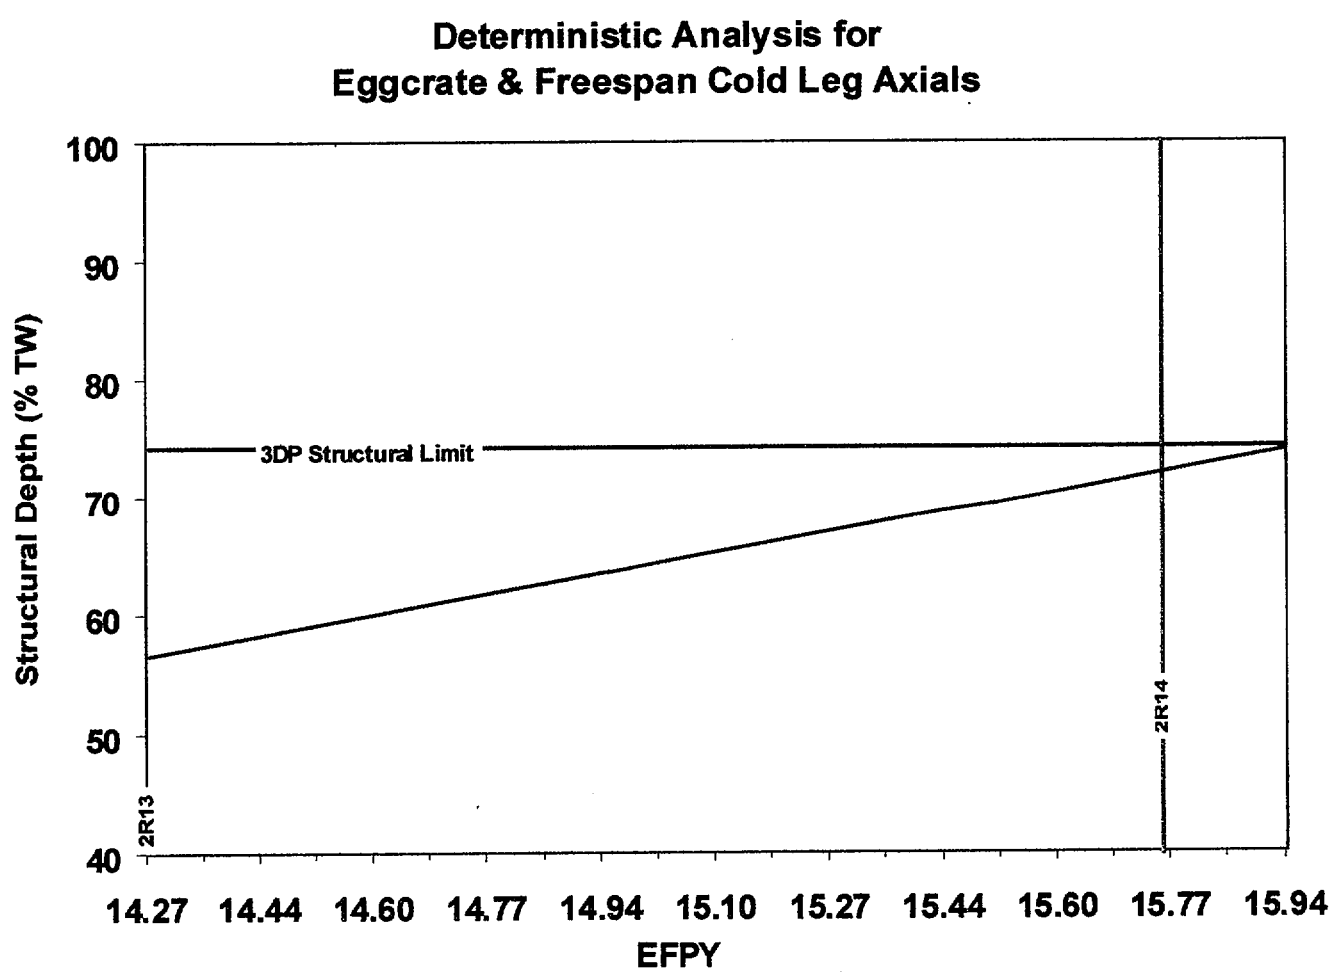
Figure 4.2

During 2P99, this area of the generator was not inspected. The operational assessment performed following 2R13 concluded operation for the full cycle was justified due to the limited number of indications and the size of the flaws, as well as the lower temperature this tubing experiences during full power operation. Based on these facts, it was not feasible to perform a growth rate study for this type of flaw. For the deterministic evaluation, the 0.95 growth rate of the hot leg eggcrates was used offset by a reduction in temperature of 15° F, which accounts for the location of the flaws high in the tube bundle. An approximate 50° F drop occurs across the bundle. The growth rate value is 10.35% per EFPY. The 0.95 POD value for this type of flaw is 56.6% structural depth with a length of 0.58 inch. These values result in a deterministic evaluation that meets the 3ΔP criterion at the next scheduled outage. This is depicted below in Figure 4.2.

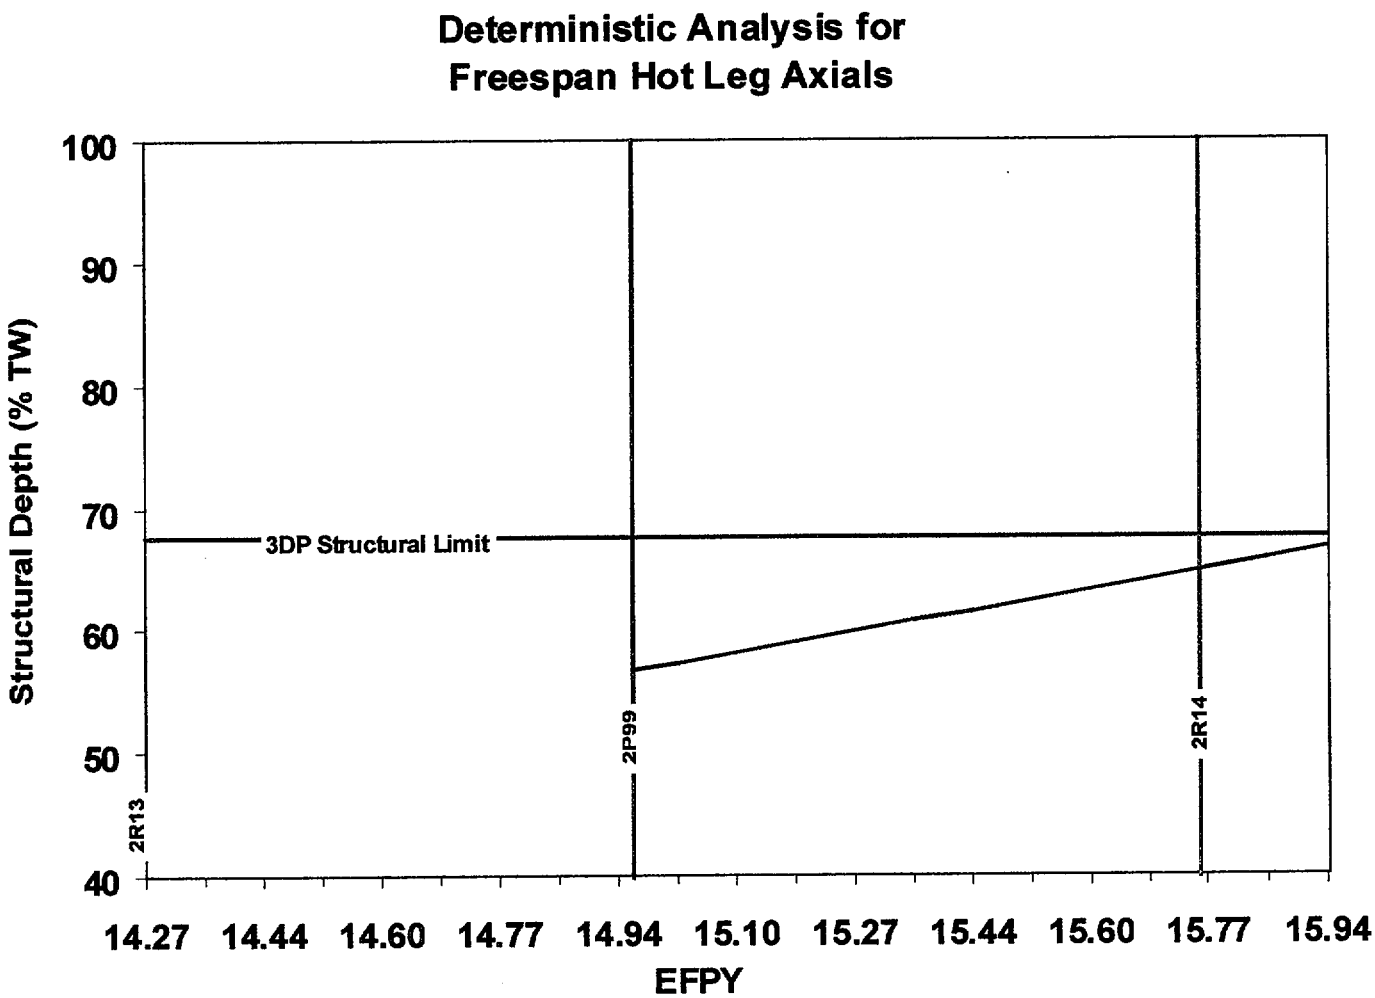
The hot leg free span area of the generator was included in the bobbin examination conducted during the 2P99 inspection. Five indications were identified and repaired. The sizes of the flaws were bound by the previous operational assessment. Once again, the 0.95 POD value was taken from the site specific performance demonstration (SSPD) performed following 2R13. This value was equal to 56.6% structural depth with a length of 1.48 inches. The 0.95 value on growth was offset by 15° F since the majority of the free span indications are found in the upper portion of the tube bundle. This value is equivalent to 10.35% per EFPY. This data is depicted in Figure 4.3 below:

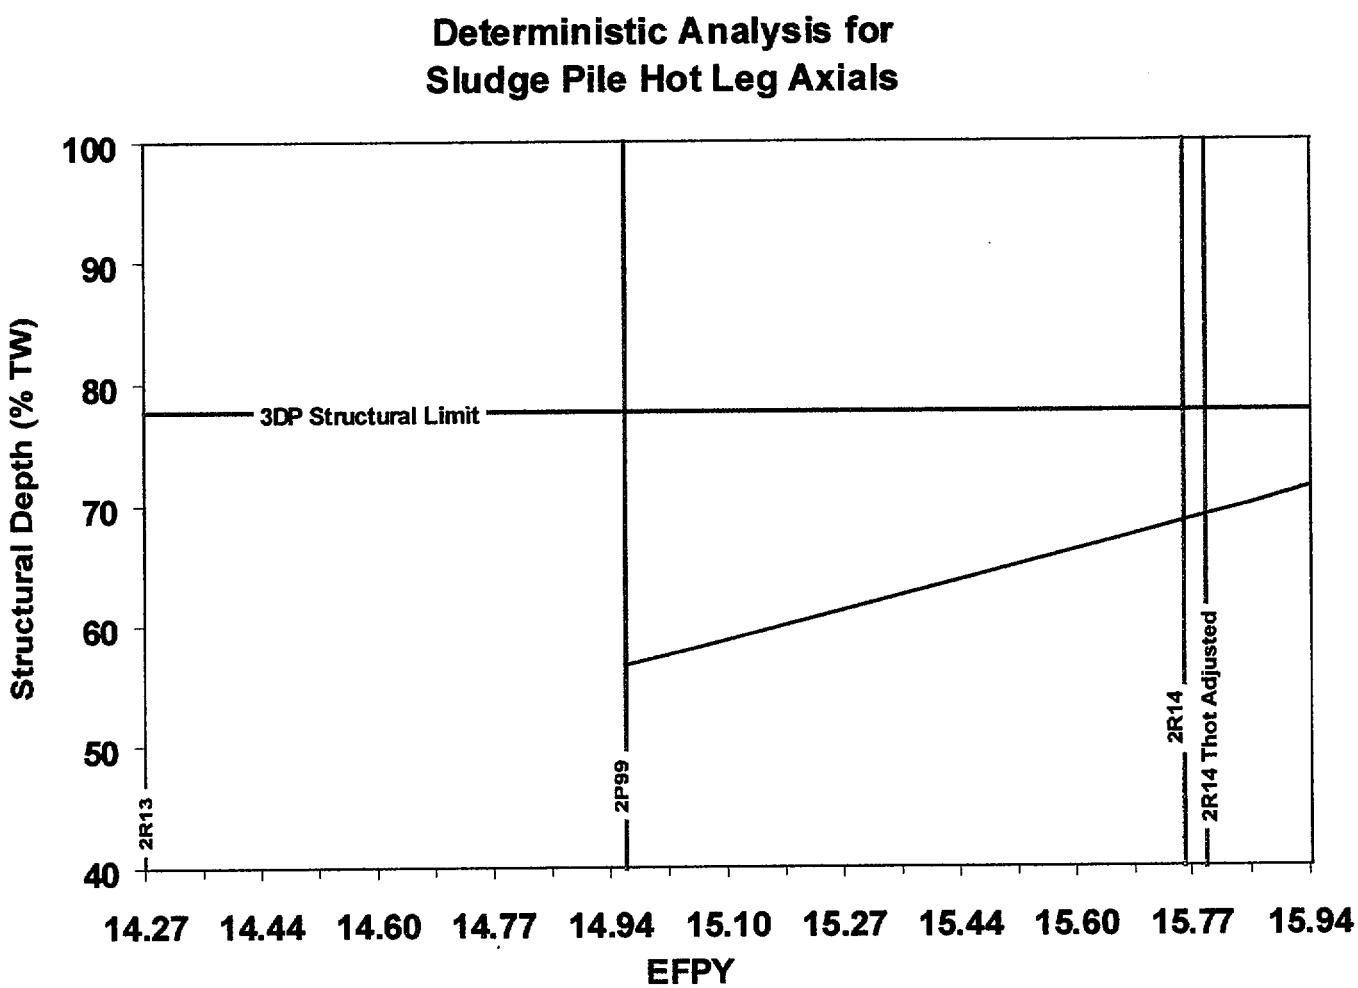
Figure 4.4

In previous outages, it was proven that consistent detection of axial cracking in the sludge pile was achieved with MRPC. Since the 2P99 inspection was performed in 100% of the tubes in the sludge pile area, credit was taken for the inspection. The 0.95 POD value for the sludge pile axials was a 56.6% structural depth with a 0.44 inch length. The 0.95 growth rate value was used due to the proximity of the flaws to the hot leg tube sheet. This growth rate was equivalent to 15.0% per EFPY. Additionally, a correction for increasing T-hot was used (3.7 %). This analysis is depicted below in Figure 4.4:

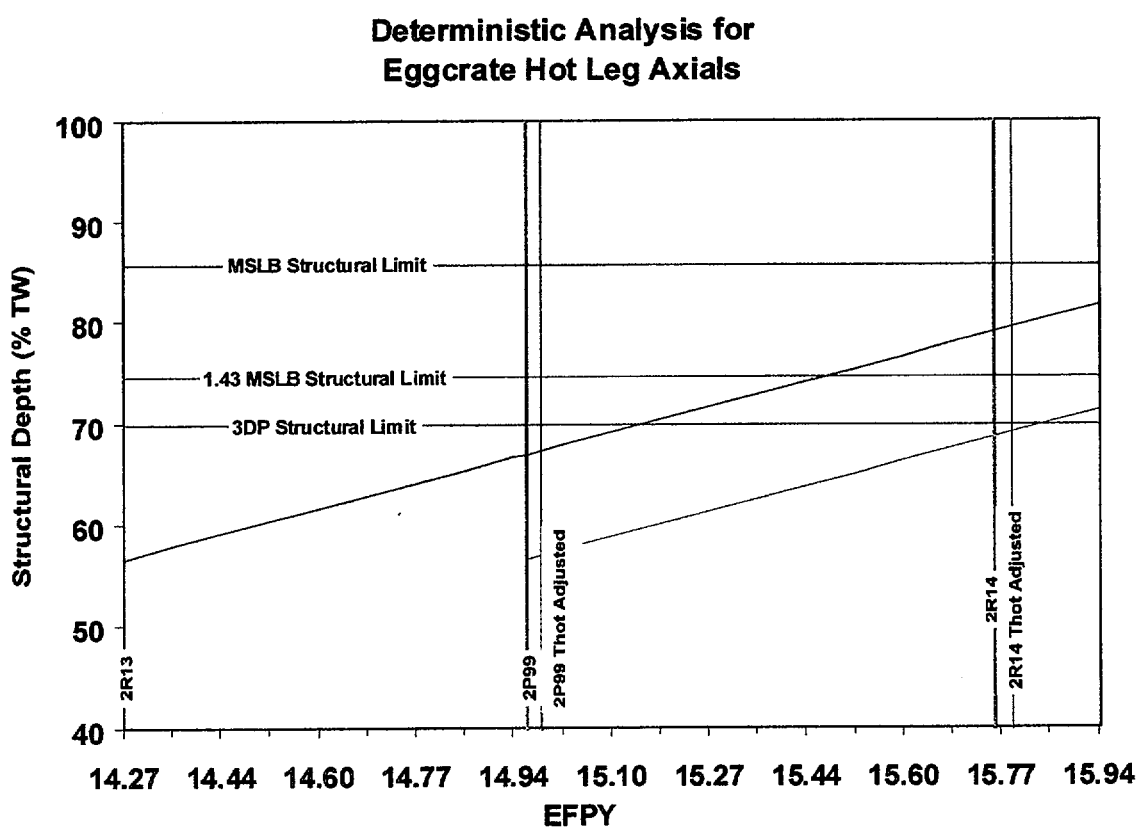
The initial deterministic evaluation for the eggcrate axial indications on the hot leg was performed during 2P99 to justify startup as part of the condition monitoring program. This initial evaluation justified approximately 7 months of operation and was submitted to the Staff December 21, 1999 (2CAN129911)[1], based on using the peak in-situ pressure achieved on the worse case flaw identified (R72L72). After analysis to determine the maximum achieved pressure and completion of the growth rate study, this evaluation was repeated using the data in accordance with the EPRI Steam Generator Integrity Assessment Guidelines[2]. A 0.95 growth rate value of 15.0% per EFPY was used. The growth rate data was developed using information from the last three outages. To calculate the beginning of cycle flaw, the 0.95 value from the POD curve was used. The POD curve was developed from the SSPD performed following 2R13. The SSPD was previously described in the operational assessment submitted following 2R13 (2CAN069911). The 0.95 value for beginning of cycle structural depth was determined to be 56.6% with a length of 0.98 inch.

Based on the attached evaluation, tube R72L72 had a 278 psi of margin above the 3ΔP criterion. The inputs to the model were benchmarked against the previous outage (2R13) to evaluate if the values were appropriate. This data is depicted in Figure 4.5 below. The point at which 3ΔP would have been exceeded for the first half of the cycle was approximately 0.12 EFPY beyond 2P99. Using the same input values for the remainder of the cycle, the 3ΔP criterion would not be reached until after the designated EOC. This evaluation also accounts for the increase in operating temperature.

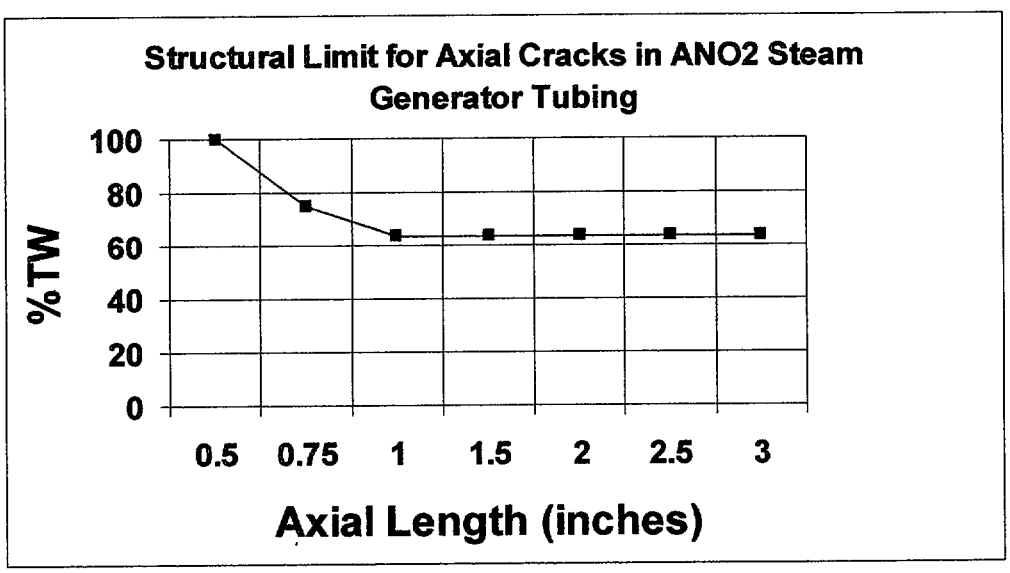
It is not possible to review data from previous inspections to quantify the growth rate, since 2R13 was the first time these intersections were tested with a rotating coil. However, due to the limited length of the indications, a deterministic approach was utilized. A structural limit curve is shown in Figure 4.6 that was derived from a study sponsored by the Combustion Engineering Owners Group[7] to determine the structural length vs. depth. The structural limit curve was based on a conservative burst correlation and used for screening data.

As shown in the figure, the structural limit in the range of lengths observed during 2R13 is 100% through-wall (TW). The largest of the two flaws (R50L114) was 0.33 inch in length and had a maximum depth of 75% TW. Since 2R13 was the first time that this mechanism was examined, it is possible that a flaw could have been left in service if it was at the detection level of the test. Using the plus point coil, the minimum detectable depth would be approximately 20% based on the EPRI qualification. To be conservative, a 40% TW value was used. Applying a maximum growth rate based

on the eggcrate axial data, 40% TW would be added for a total of 80% TW. Based on the length and calculated depth, the largest postulated flaw would pose no threat from a structural or leakage standpoint. Based on the above results, it is acceptable to operate full cycle due to potential axial cracks in a dented eggcrate.

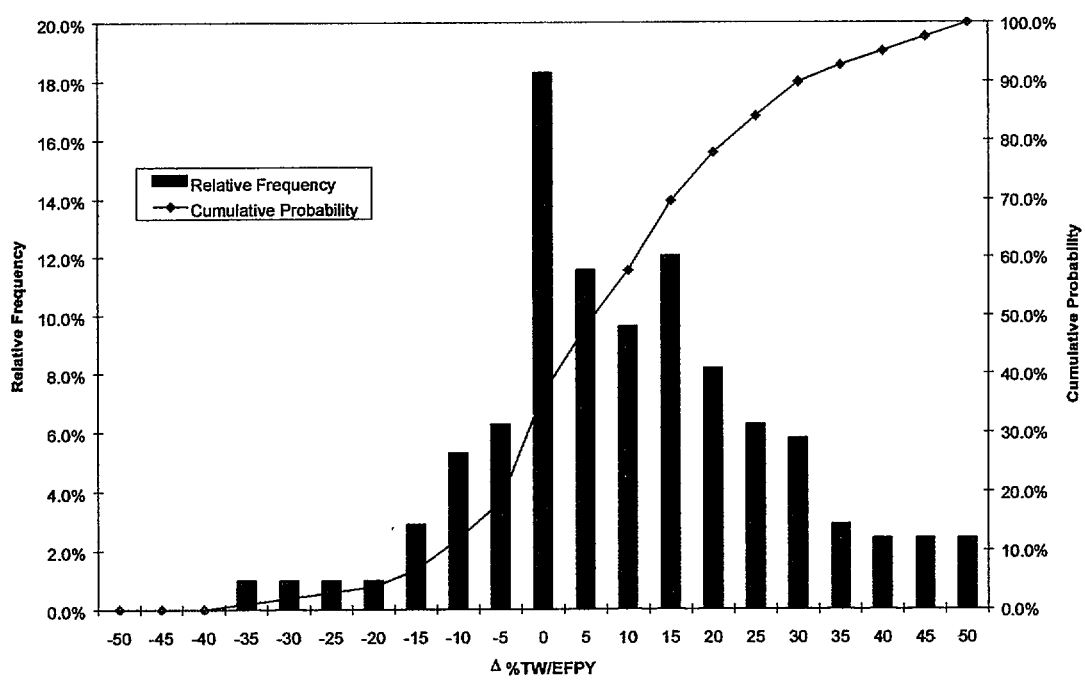
Figure 5.1
ANO Axial Flaw Growth/EFPY (2P99 – 2R13)

A depiction of the ANO growth data from 2P99 is presented as Figure 5.1 where negative growth values are explicitly indicated. Data from both SGA and SGB are included in Figure 5.1.

Figure 5.1 is normalized to the 1.48 EFPY of operation from 2P98 to the most recent inspection at 2P99. The data suggests the presence of a significant non-destructive examination (NDE) uncertainty component. That is, the overall shape of the distribution, its symmetry about a small growth value near zero and the preponderance of negative values, are consistent with a measurement process where NDE uncertainty is the dominant statistical component for the bulk of the distribution. The empirical data therefore suggest that apparent growth is the superposition of an NDE uncertainty distribution and a "true" depth growth distribution.

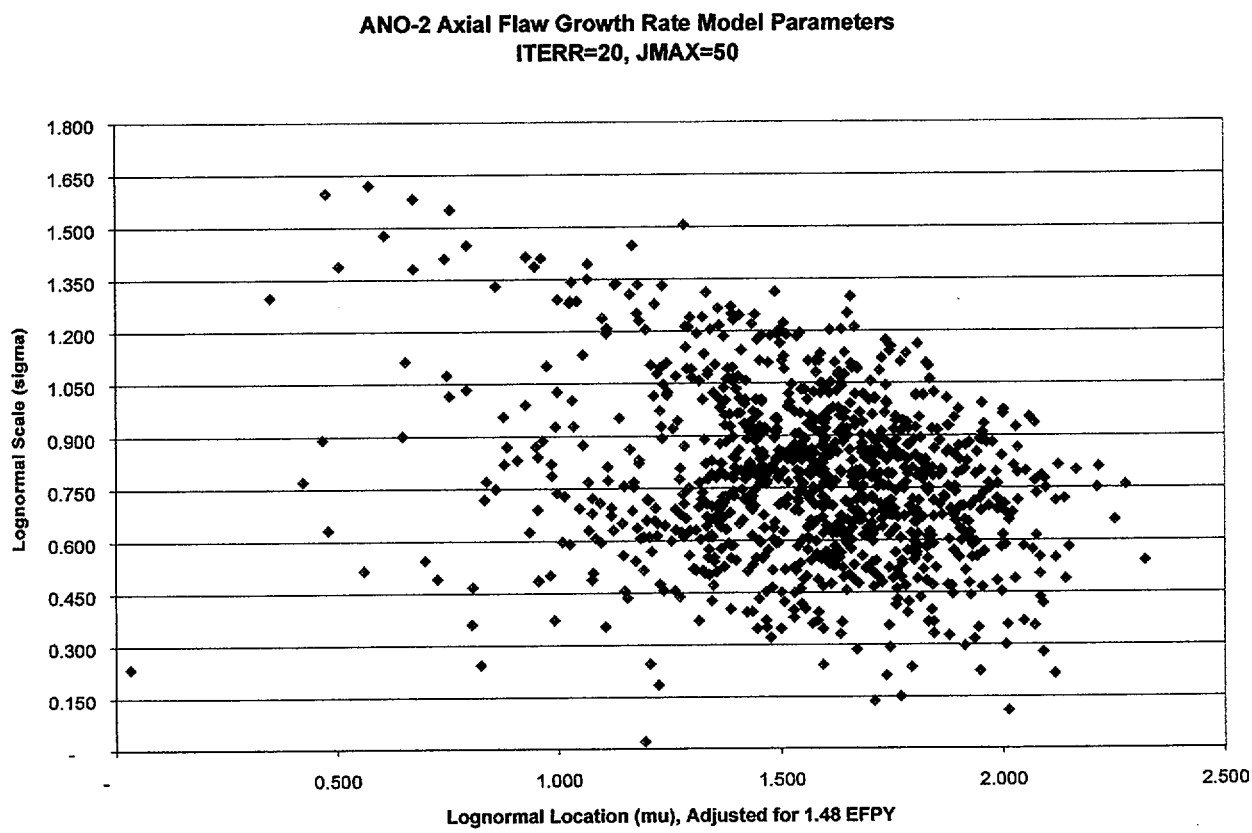
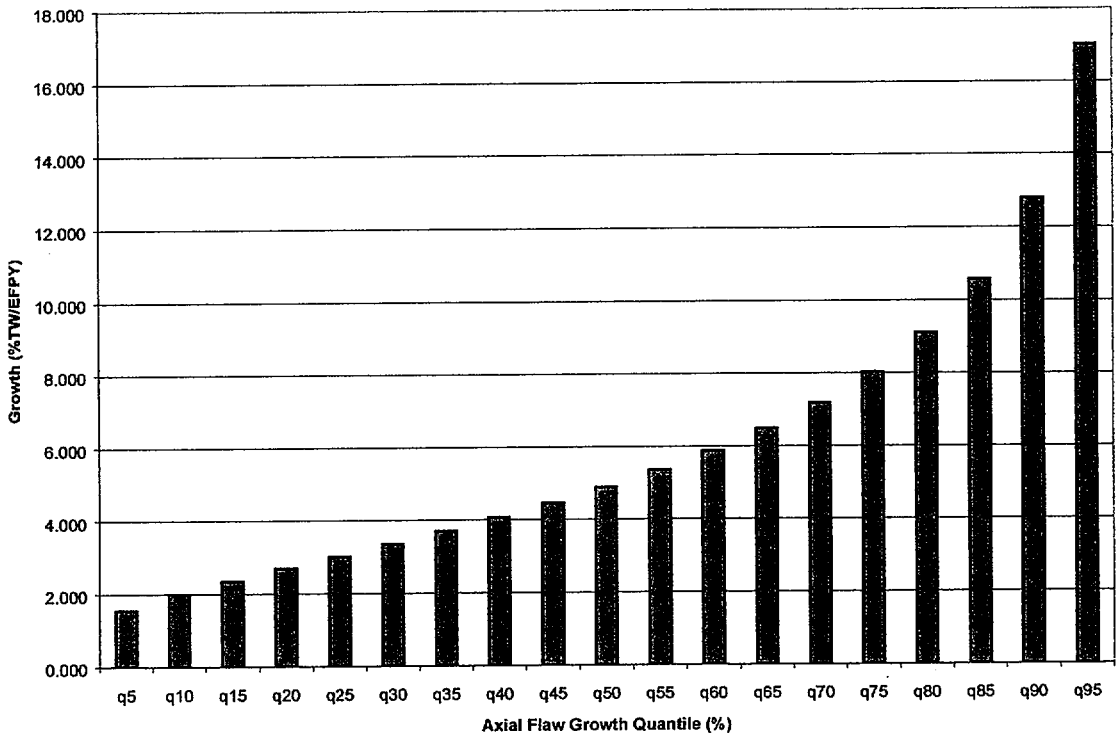
The superset of ANO-2 axial flaw growth model parameters are an important input to the probability of burst calculation. This family of lognormal models accounts for uncertainties in the relative contribution to the observed (apparent) growth data from NDE uncertainty and actual growth. The equivalent distribution of actual growth rates that corresponds to this model is provided in Figure 5.3.

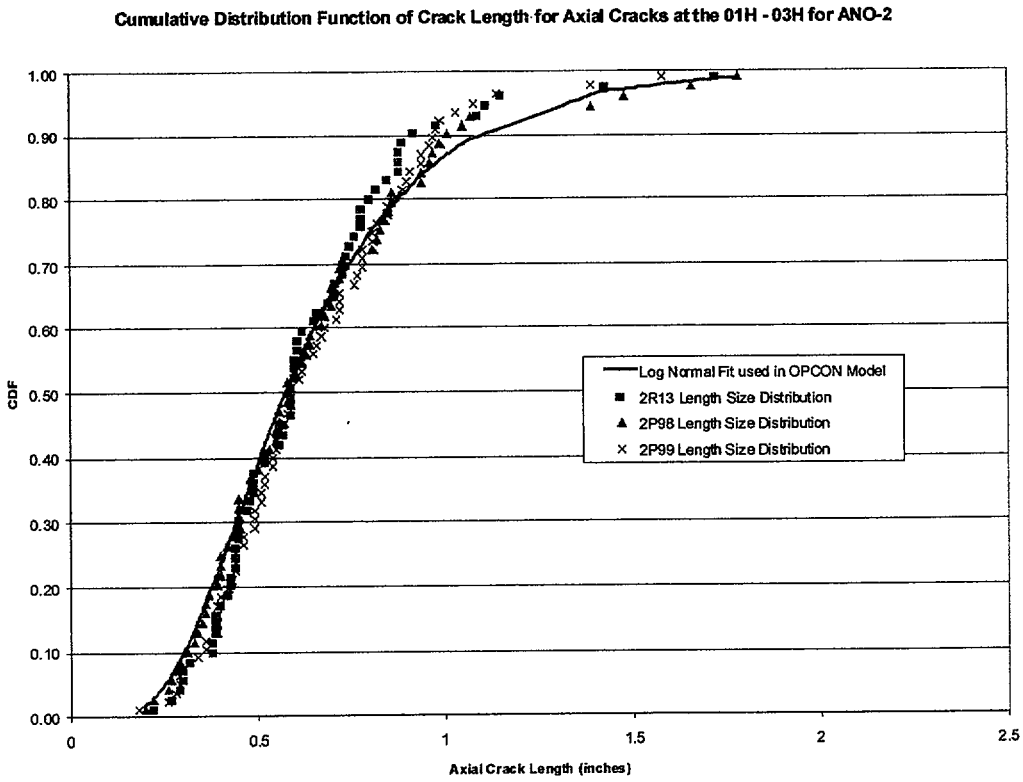
Figure 5.4 confirms that the distribution on crack lengths has not changed significantly in the last three outages.

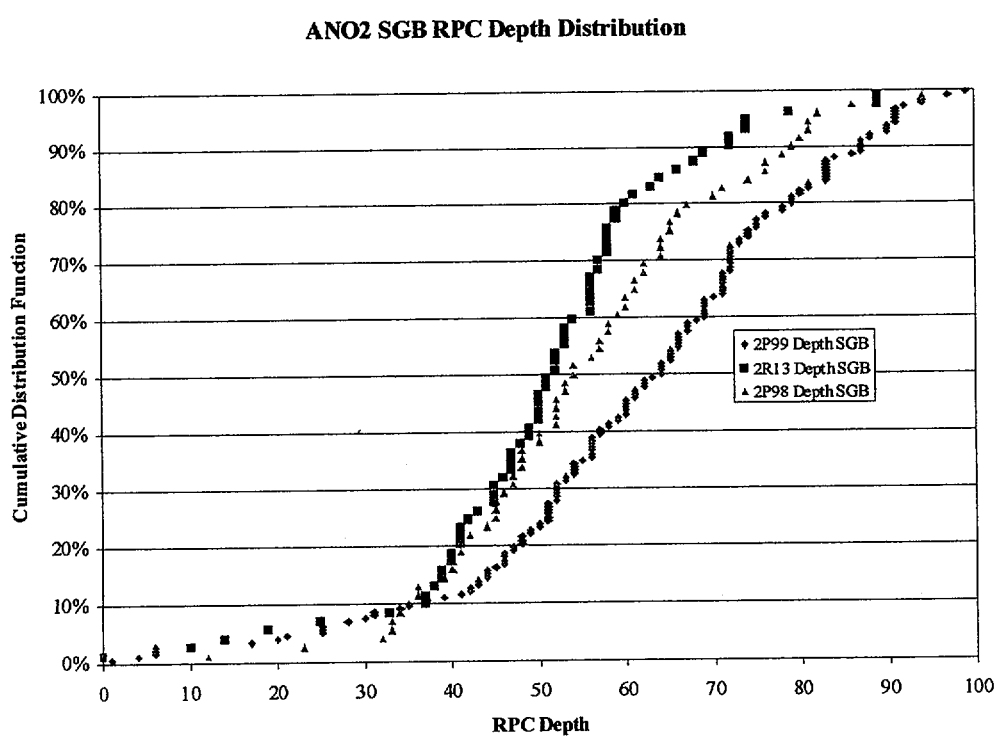
Figure 5.5 represents the distributions of maximum depths as measured by MRPC for the last three outages which was previously submitted in the condition monitoring report (2CAN129911)[3]. It is apparent in this figure that in the most recent outage (2P99), the depths were approximately 10-15% deeper than those sized in previous outages. Further investigation into the rationale for this result determined that several of the analysts were using channel 1 (300 KHz) instead of the mix channel P1 (300/100 KHz) to perform sizing of the flaws. This data was re-analyzed using the P1 mix. Both the 2P98 and 2R13 outages were performed using the P1 channel for sizing. This resulted in a reduction in depth consistent with the two previous outages. This is depicted in Figure 5.6:
