Consolidated Edison Company of New York, Inc.
Indian Point 2 Station
Broadway & Bleakley Avenue
Buchanan, New York 10511

Re: Indian Point Unit No. 2
Docket No. 50-247

Subject : Root Cause Evaluation For Steam Generator Tube Rupture Event of February 15, 2000

Root Cause Evaluation For Steam Generator Tube Rupture Event of February 15, 2000

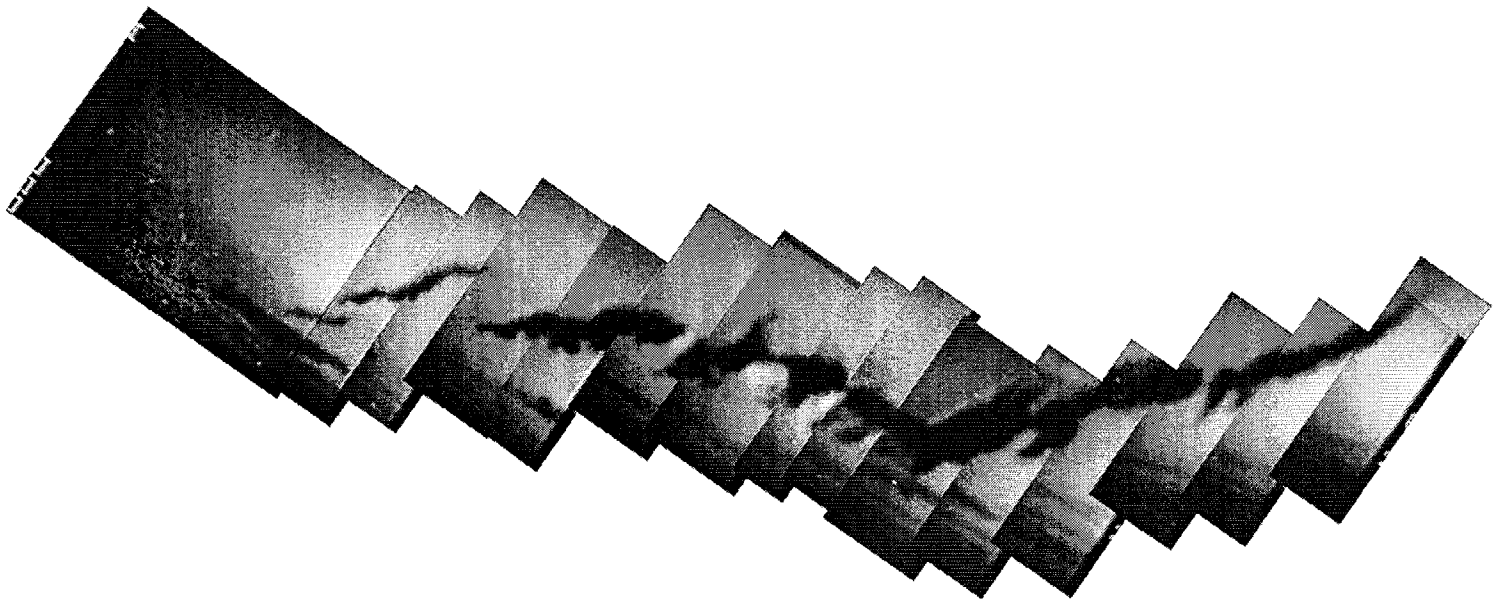
Figure 1 Photomontage of R2C5 U-bend Apex Crack

Visual examination of R2C5 was performed by inserting a Welch-Alyn fiberscope into the tube from the CL to beyond the apex of the U-bend. A crack was located approximately at the apex of the U-bend. Figure 1 shows a photomontage of the crack. The length of the crack was estimated at approximately 2.5 inches tip to tip by marking the lead of the probe at the tube end when the crack was first visible and at the point when the crack was no longer visible.

- The crack appears to be the coalescence of several cracks that were separated by ligaments. This pattern of corrosion cracks is consistently observed and results from crack initiation as short microcracks (<0.1 inch long) that grow to coalesce and form the longer macrocracks. It is postulated that the ligaments separating the individual cracks failed, causing a "zipper"-like effect and rupture of additional ligaments. At least five ligaments that apparently spanned the crack width prior to tearing can be seen in Figure 1.

- The scaled maximum crack opening width is 2% of the tip-to-tip length of the crack, or about 50 mils.

Photomontage of R2C5, SG24, Indian Point Unit 2 U-Bend Crack. Based on Images From the ID Video Inspection.

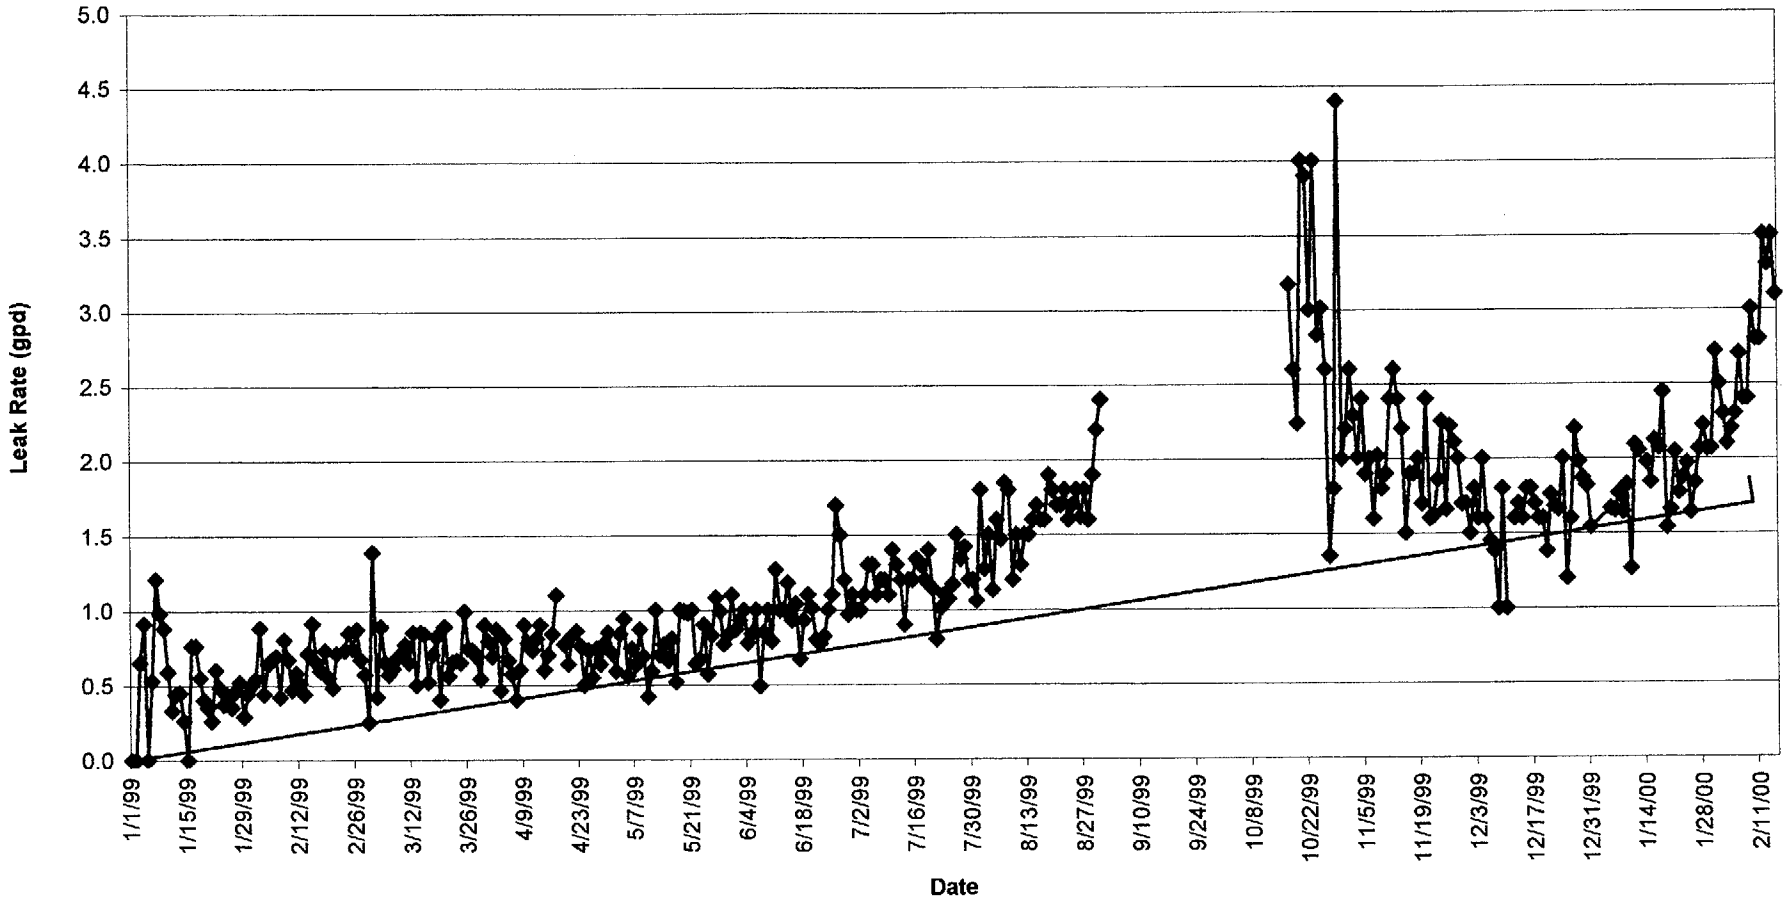
Figure 2 Indian Point 2 Leak Rate History

Although the N-16 monitor alarm signaled the leak, the recorder was out of operation at the time of the alarm. Consequently, the short-term leak rate data just prior to the shutdown are not available. However, the longer-term leak rate over a period of a year (1999) is available and shown in Figure 2. The trend of the long-term leak rate, although not conclusively verifying the postulated mechanism of coalescence of cracks, is consistent with that hypothesis. The low leakage indicated on Figure 2 may have been due to R2C5 or may have resulted from other sources in the SG, such as tube plugs.

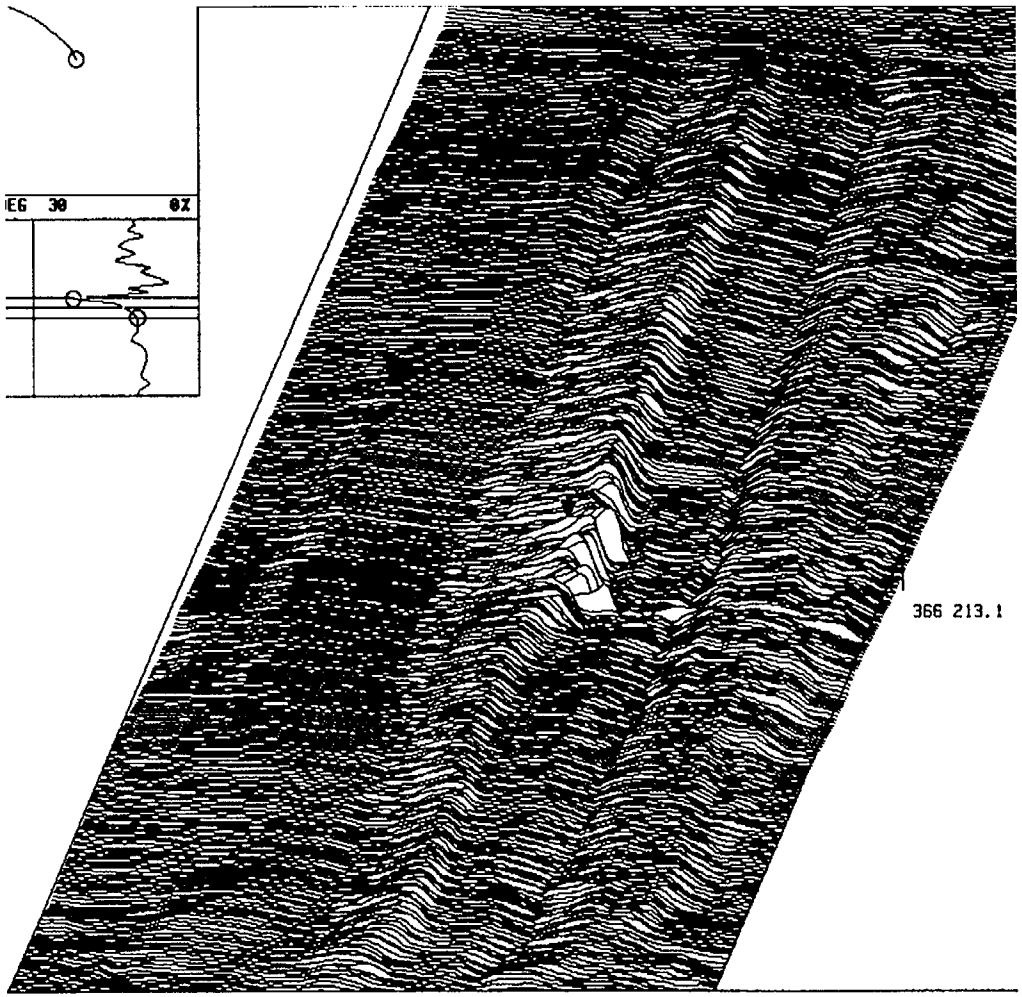
of the signal, proved to be an indication of a flaw that developed into the leak. However, background noise was apparent on the Plus Point C-scan plot due to tube geometry and the presence of deposits (Figure 3). The irregularities (offsets) in the ridges shown on Figure 3 can occur as a result of the probe rattling in the tube. The noise levels seen in Figure 3 would not typically permit the signal to be identified as an indication. This conclusion was consistent with that reached in the 1997 interpretation of the data.

C-Scan of R2C5; 1997 Data

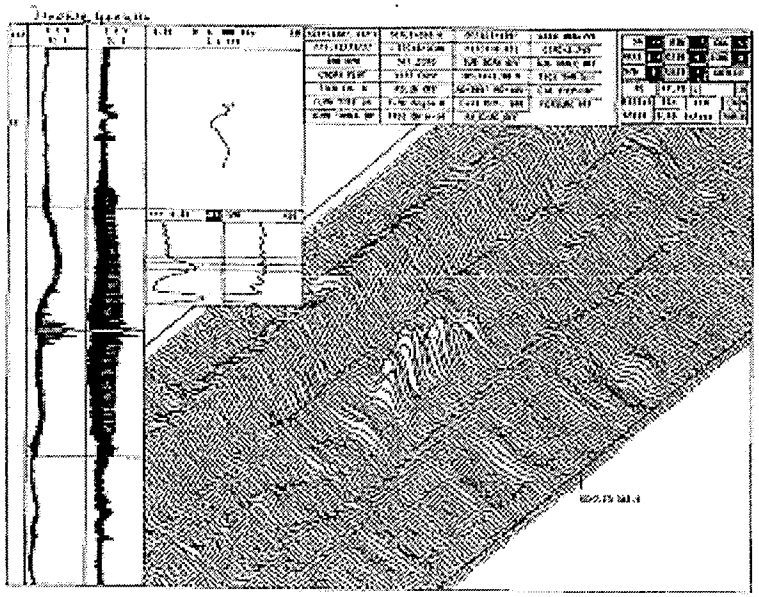
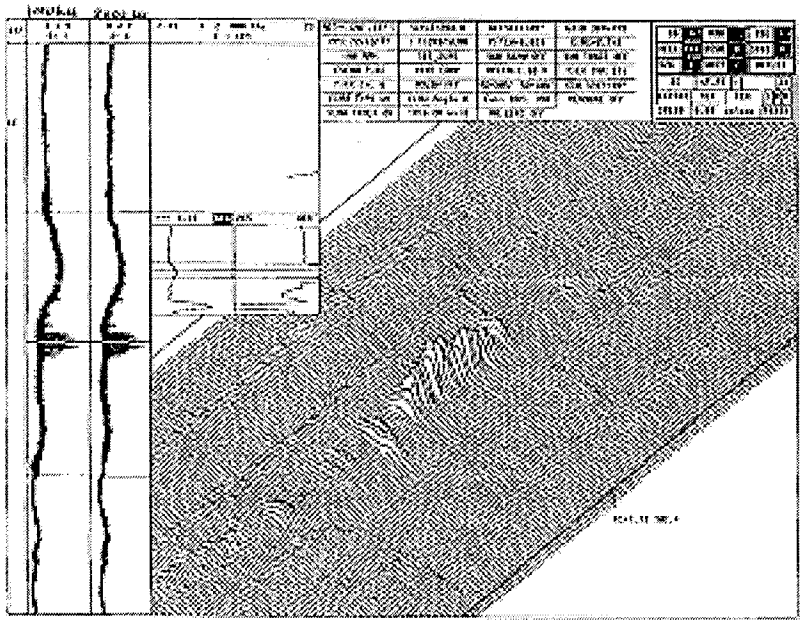
Figure 4
Comparison of Signal and Noise for Mid-Range and High Frequency Plus Point Probe

Mid-Range +Point
R2C69
2000 Data

High Frequency +Point
R2C69
2000 Data

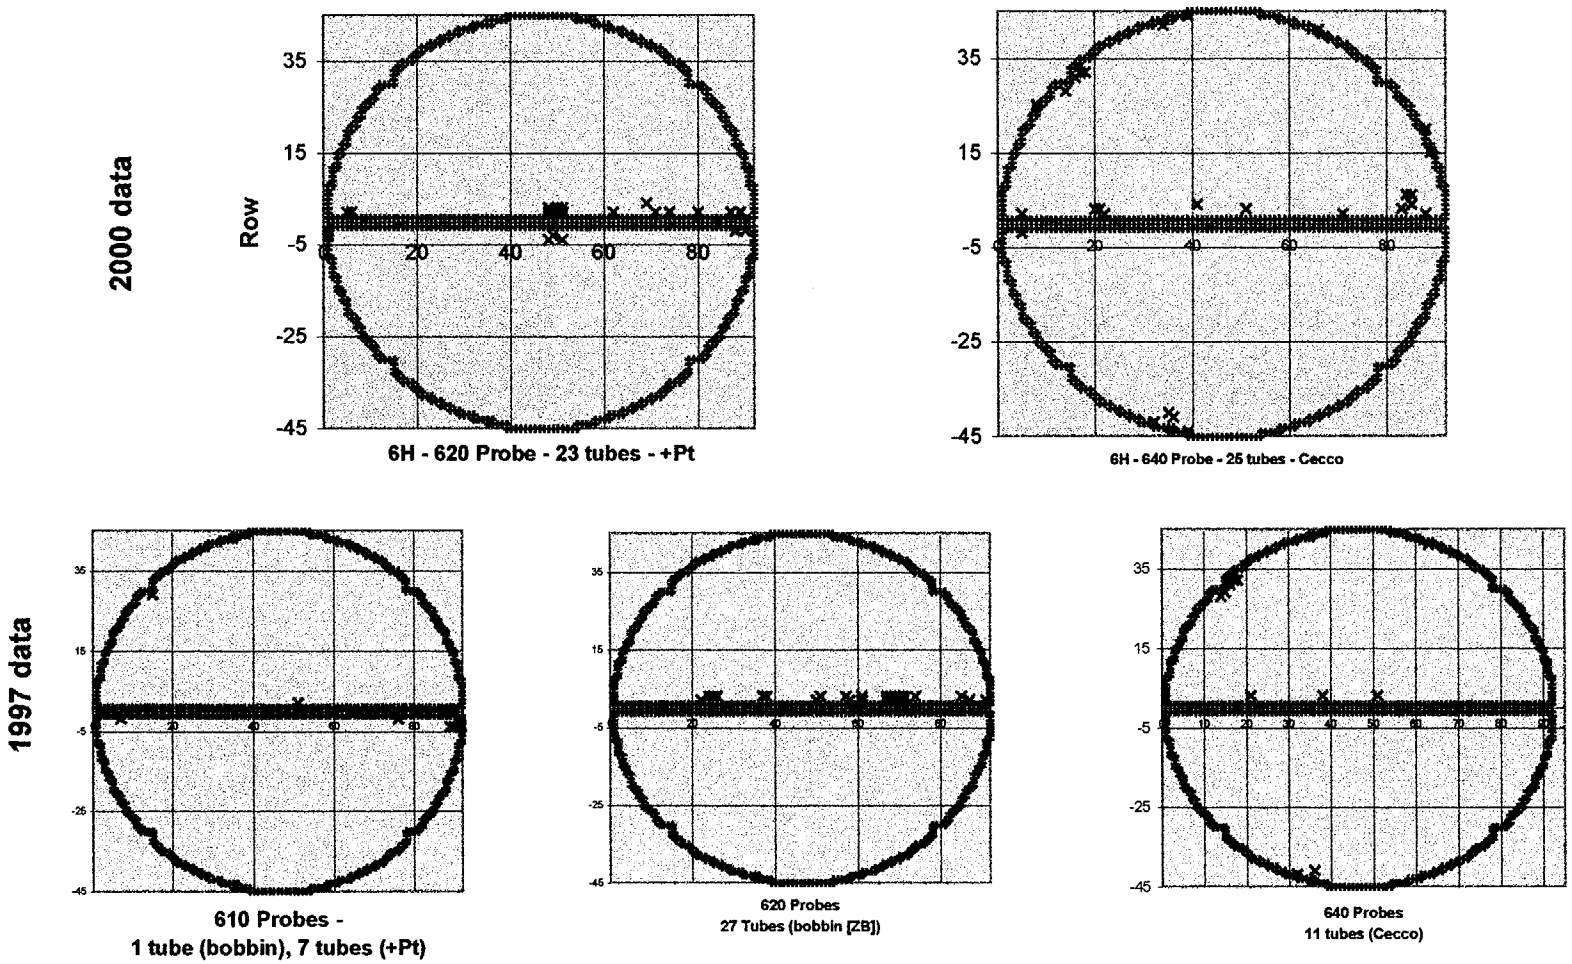
Figure 5
SG 24, TSP6 Probe Restrictions; 1997 Data Compared to 2000 Data

These observations are consistent with a general conclusion that the denting process is continuing at a slow rate. The rate of denting progression cannot be quantified from the increased number of restrictions since there is no available correlation between restrictions and denting. Also, variations between inspections on probe restrictions can occur due to differences in probe types, probe pushers and tolerances on probe length and diameter. However, the restriction study leads to the qualitative conclusion that, if additional restrictions are observed for the same probe type, it is reasonable to conclude that denting is continuing.

Indian Point 2 S/G 24 Composite Restriction Map

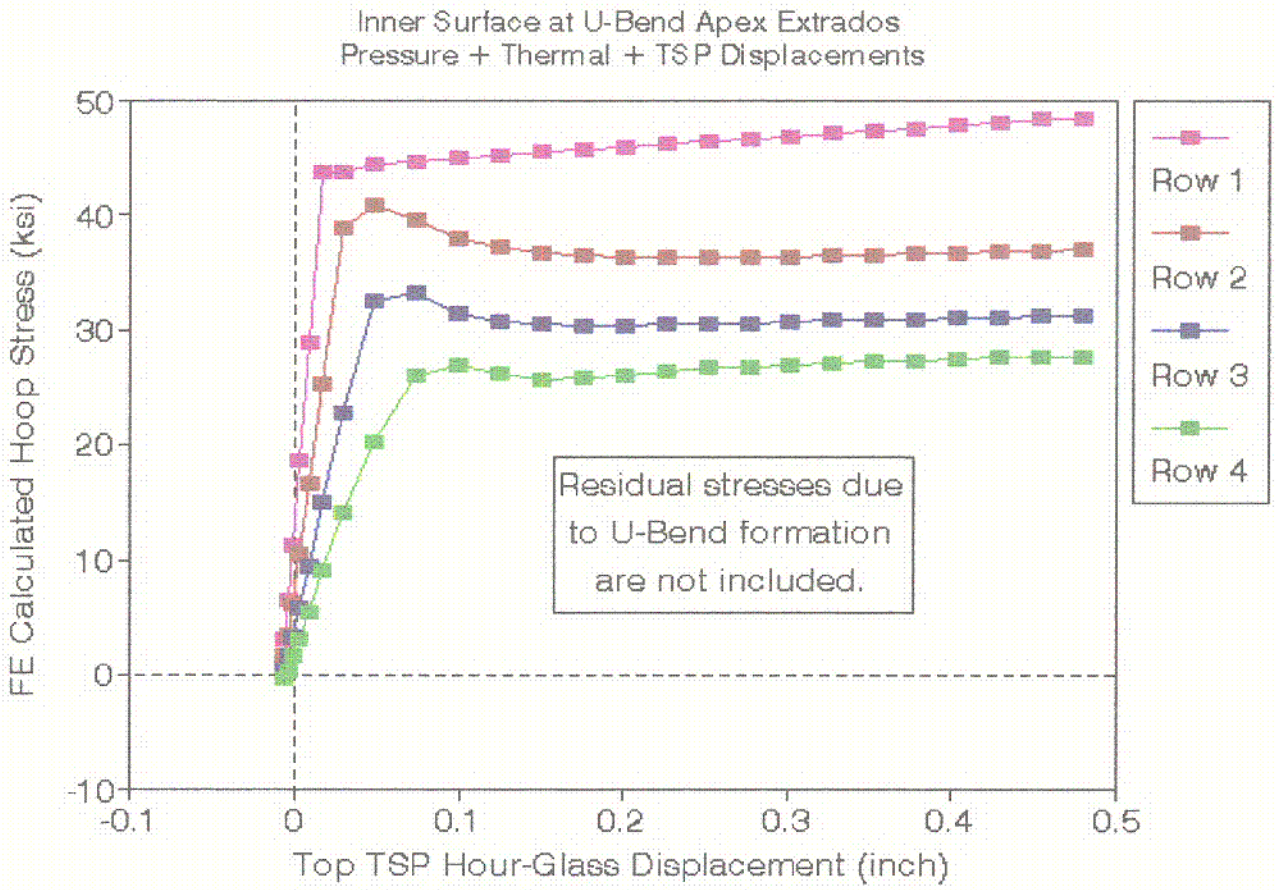
Figure 6

Stress analysis of the low row u-bends, R2, R3 and R4, was initiated with the objective to evaluate the sensitivity of the tube stresses to pinching of the straight legs resulting from hourglassing of the TSP flowslots. An analysis was performed, as described below, that assumed no residual stresses resulting from the bending process. A second analysis, to be included as part of the Condition Monitoring and Operational Assessment Report, seeks to establish the residual stress condition due to bending and ovalization on the tubes prior to imposing various leg spacing boundary conditions. The objective of the analyses is to evaluate if the predicted stresses are consistent with the observed cracking, i.e., PWSCC, and its location at the apex of the U-bend. Further, it is the objective of these analyses to estimate the comparative stresses and, therefore, sensitivity to cracking of the row 2, row 3 and row 4 tubes for the condition monitoring and operational assessments.

The results of this analysis support the observation that the leak is due to PWSCC at the apex of the tube, since the point of maximum predicted stress is at the inside surface of the tube wall at the extrados of the tube at the apex of the tube. The preliminary stress results also indicate that the row 3 tubes are expected to be less susceptible to PWSCC due to the larger TSP displacement required to reach the maximum stress condition and due to the lower stress in the row 3 tubes compared to the row 2 tubes.

Finite Element Model Calculated Hoop Stresses vs Reduction in Straight Leg Spacing from Nominal Dimension

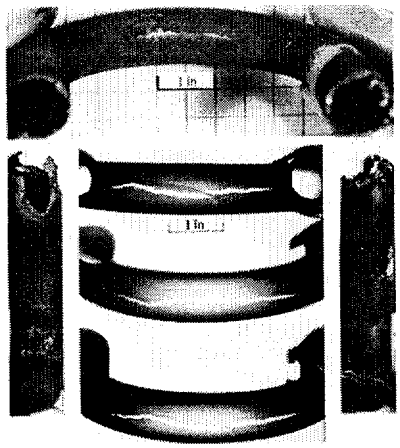
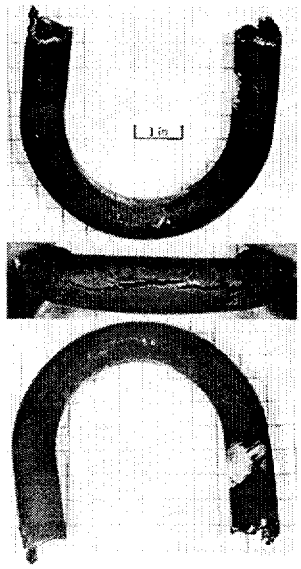
The rapid leakage event is characterized by the Surry 2, row 1 U-Bend tube rupture event of September 15, 1976, (Figure 7), which is described in NUREG/CR-6365[7]. The NRC estimate of leakage for this event was 330 gpm, in contrast to the 80 gpm reported by the plant operator. The source of the leak was attributed to high stresses from dent related hourglassing of the top TSP flow slots and the resultant strain placed on the U-bend. Stress corrosion cracking had occurred from the primary side at both the top and bottom (extrados and intrados) of the U-bend (Figure 8). The leak occurred at the top (extrados). The sudden, high leak rate occurred because an approximately four-inch long crack network had formed over the entire top of the U-bend. The leakage from this network was low because the individual through-wall sections of the crack were each relatively short, and, although several through-wall sections may have been leaking, the combined leak rate was still very small. The essentially parallel cracks however, overlapped each other and were separated by ligaments of sound metal that continued to decrease in cross section as the cracks grew in length and branched into a three-dimensional network. This resulted in the burst resistance of the network decreasing without a substantial increase in the leak rate. At the time that the network could no longer contain the normal pressure differential, the crack network opened over about a four-inch length, resulting in the large increase in leak rate.

Radiography Reveals Both
Intrados and Extrados Cracking
in Surry 2 U-Bend

Figure 7. Apex crack location, on row 1 U-bend, which leaked in September 1976.

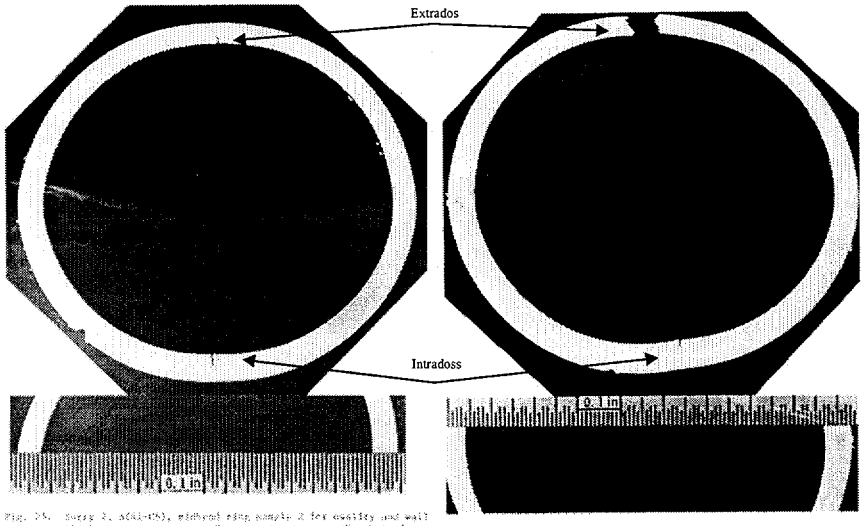
Metallographic Examination Confirms PWSCC
For Both U-Bend Cracking Locations

Figure 8. Cross section of row 1 U-bends for columns 6 and 7 illustrates the PWSCC crack networks on the extrados and intrados.

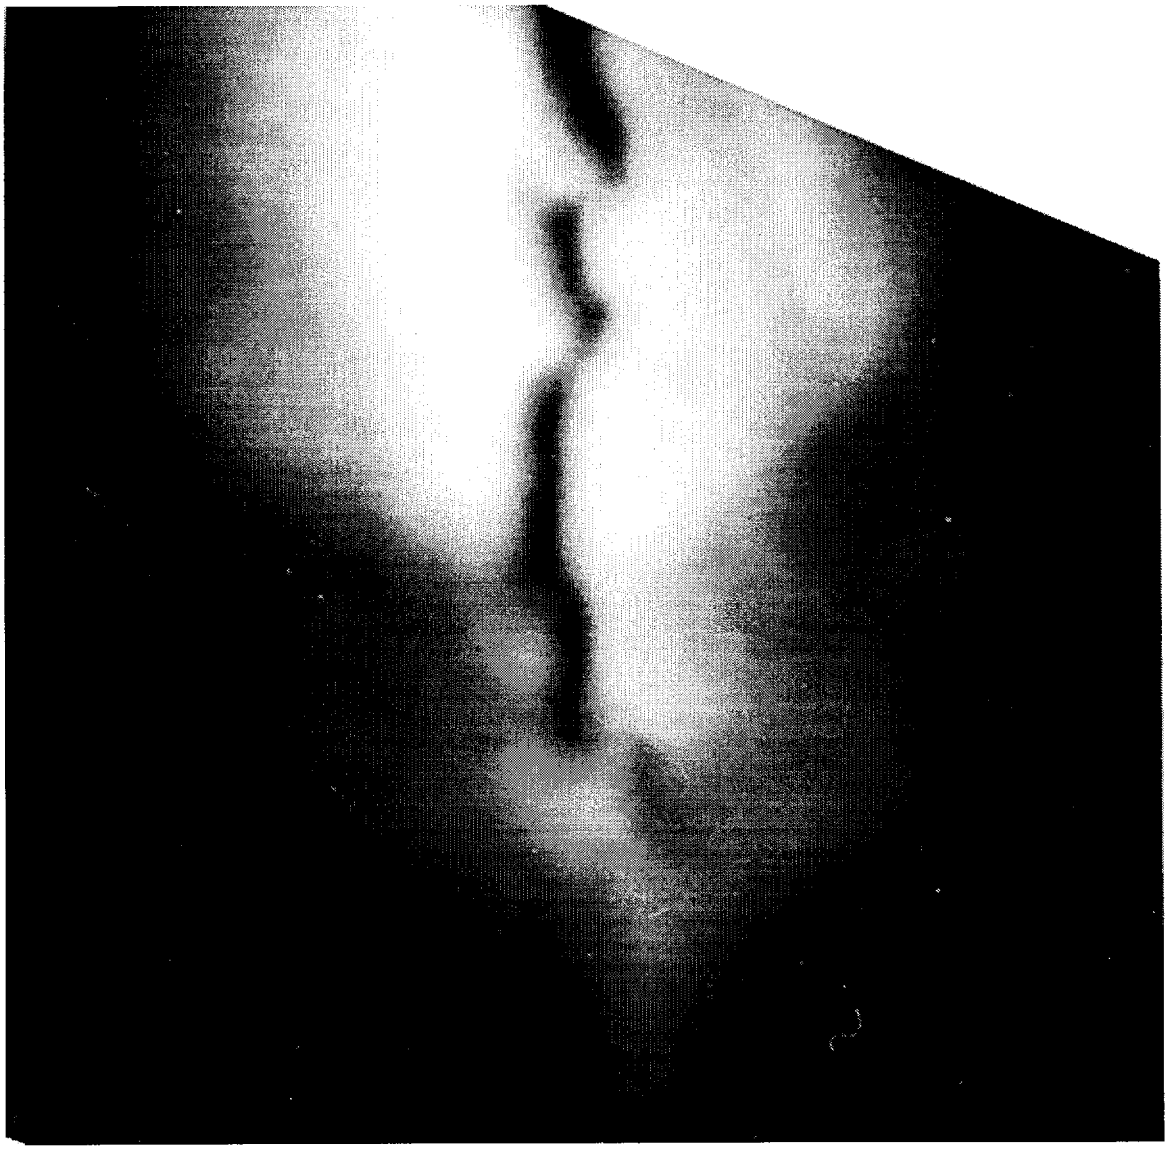
A second example of large leakage, also described in NUREG/CR-6365, is a 135gpm leak in a Row 1 U-bend in SG-B at Doel Unit 2 (a Belgian plant), which occurred on June 25, 1979. The leaking crack was characterized as a "relatively long axial crack". Ovalization of the tube was identified as the cause of the cracking. The reported reduction of the nominal ID for 24 of the inner row tubes, measured by pushing various size ball bearings through the tubes, was greater than 0.058 inch. Figure 9 is a photograph of the crack in the ruptured tube.[8]

Figure 9. Photograph of Apex Crack in Tube R1C24, Doel Unit 2; June 1979

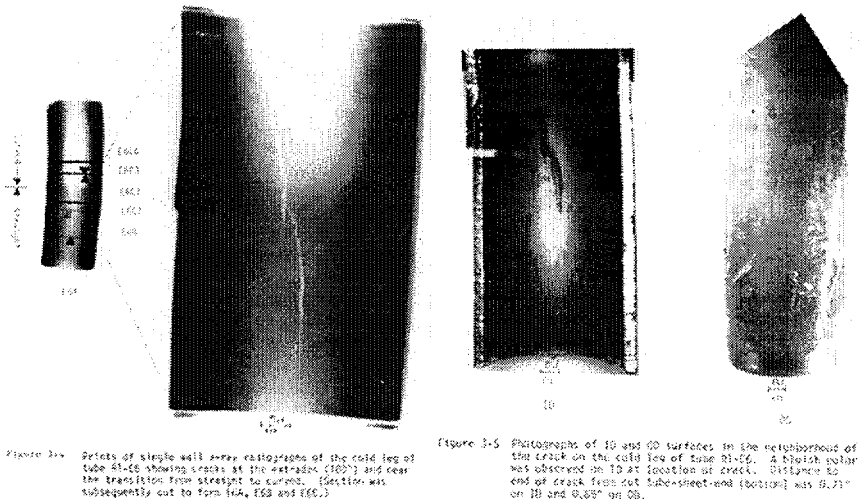
The slowly progressing leak rate leakage is typified by the degradation observed at the Trojan power plant (Figure 10). In this case, the row 1 stress corrosion cracking occurred at the tangent point on one side of the U-Bend. This tangent point was irregular, as a result of the bending process and apparently, high residual stresses in the irregular geometry, contributed to the onset of PWSCC. Because of the local geometry, the cracks do not extend for a great distance and there is reduced potential for large,

R1 U-Bend Cracking At Trojan Occurred at the Extrados Tangent Point Location

Figure 10. Radiographs, to the left of the figure, show the overall tangent point region and crack network. The visual appearance of the crack is shown to the right.

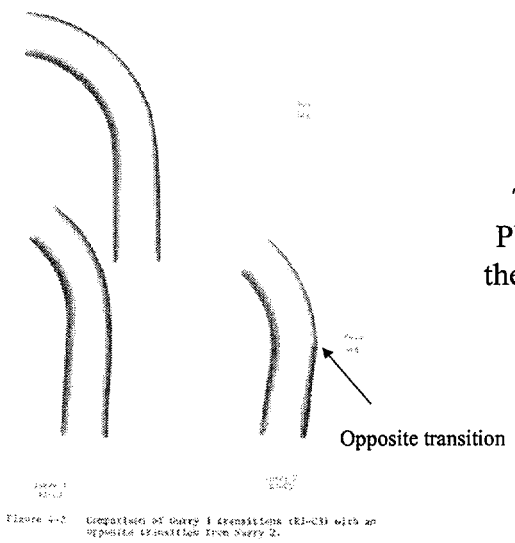
As part of this tube examination effort, additional examination was made of some U-bend samples previously removed from Surry 1 and 2 and Turkey Point 4. These comparisons showed that the Surry 1 and Turkey Point 4 U-bends had only smooth transitions on both sides and no cracking was observed at the tangent locations. Surry 2 U-bends displayed both the smooth and opposite tangent point transitions and one of the locations evaluated displayed a PWSCC crack (Figure 11). This was on R1C7, the same tube with the apex location leak.

Tangent Point U-Bend PWSCC is Influenced by the Shape of the Transition

Figure 11. The radiographs to the left show the smooth tangent point transitions of a row 1 U-bend from Surry 1. The hot leg is shown above the cold leg. To the right is a radiograph of the irregular tangent point transition from a row 1 U-bend of Surry 2
