SUBJECT: NRC AUGMENTED INSPECTION TEAM - STEAM GENERATOR TUBE FAILURE - REPORT NO. 05000247/2000-002

On March 3, 2000, the NRC completed an Augmented Inspection Team (Team) inspection at the Indian Point Unit 2 (IP2) Station. The enclosed report (Enclosure 1) presents the results of that inspection.

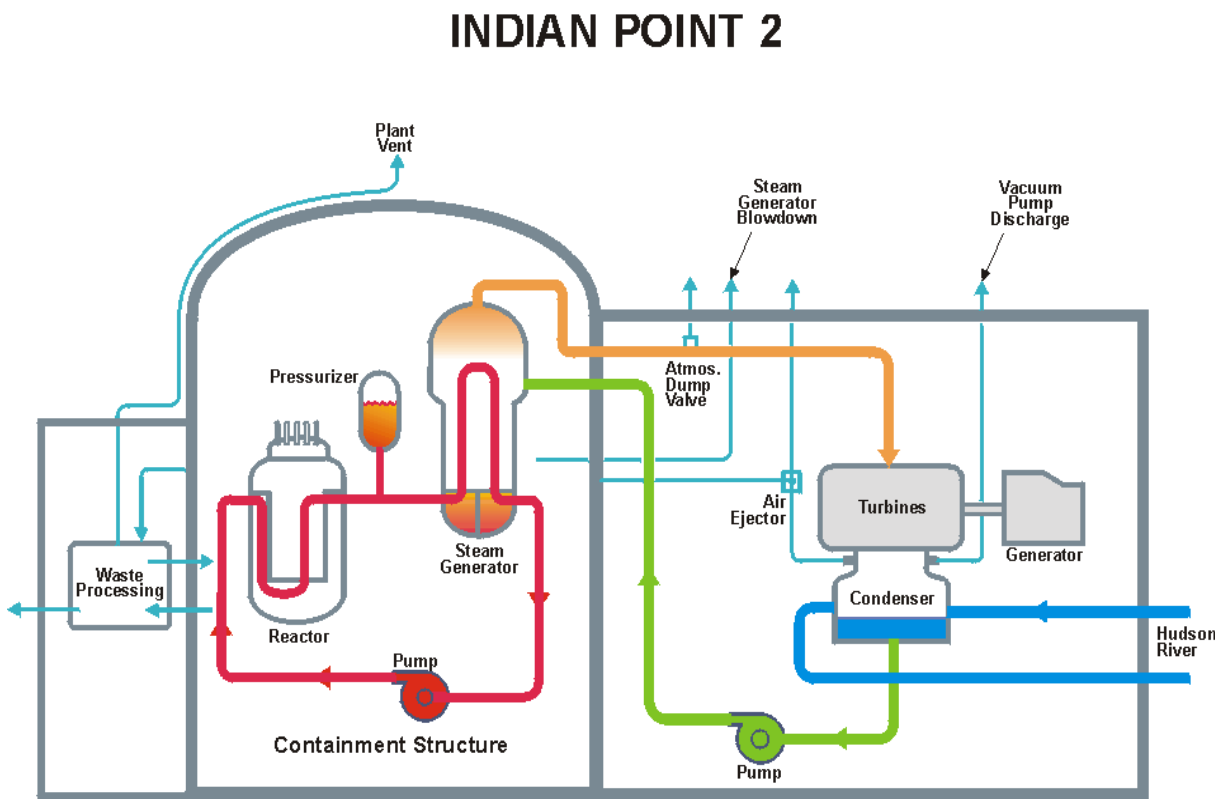
Illustration of the Release Paths:

IP2 STEAM GENERATOR TUBE LEAK (2/15/00)
RADIOLOGICAL RELEASE PATHS
