NUREG/CR-6677
INEEL/EXT-2000-00888

Evaluation of Risk Associated With Intergranular Stress Corrosion Cracking in Boiling Water Reactor Internals

Idaho National Engineering and Environmental Laboratory
Bechtel BWXT Idaho, LLC

U.S. Nuclear Regulatory Commission
Office of Nuclear Regulatory Research
Washington, DC 20555-0001

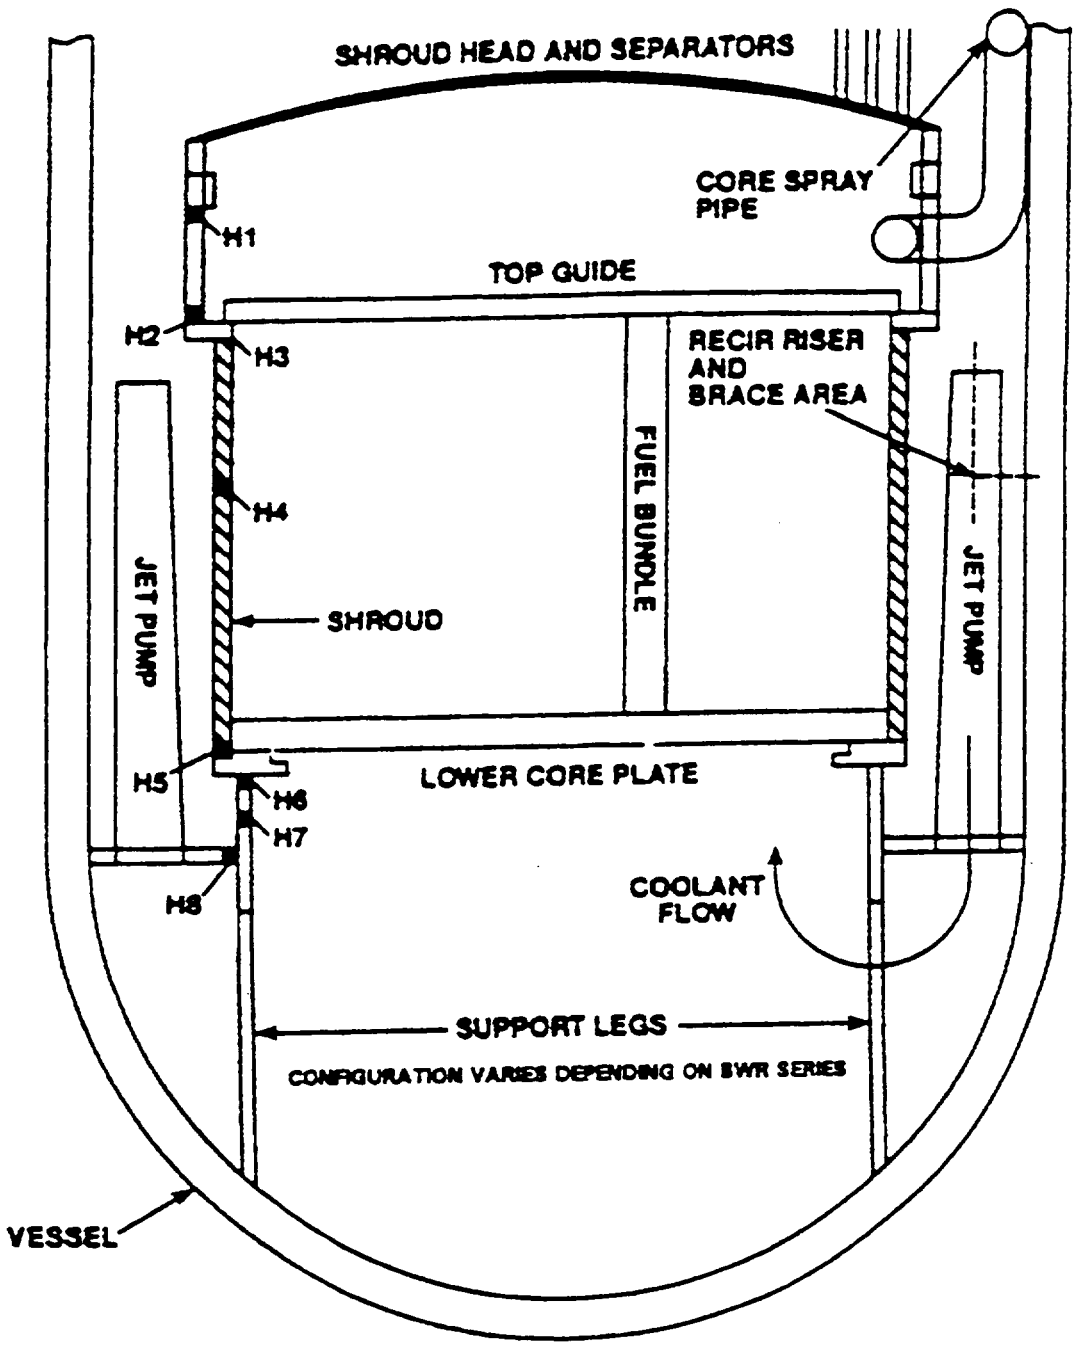
Figure 3-1. Typical core shroud weld locations.

In 1996, a 46 cm (18-in.) indication was found at the shroud horizontal plate to shroud cylinder plate weld on Susquehanna 1 (weld H-8 on Figure 3-1).

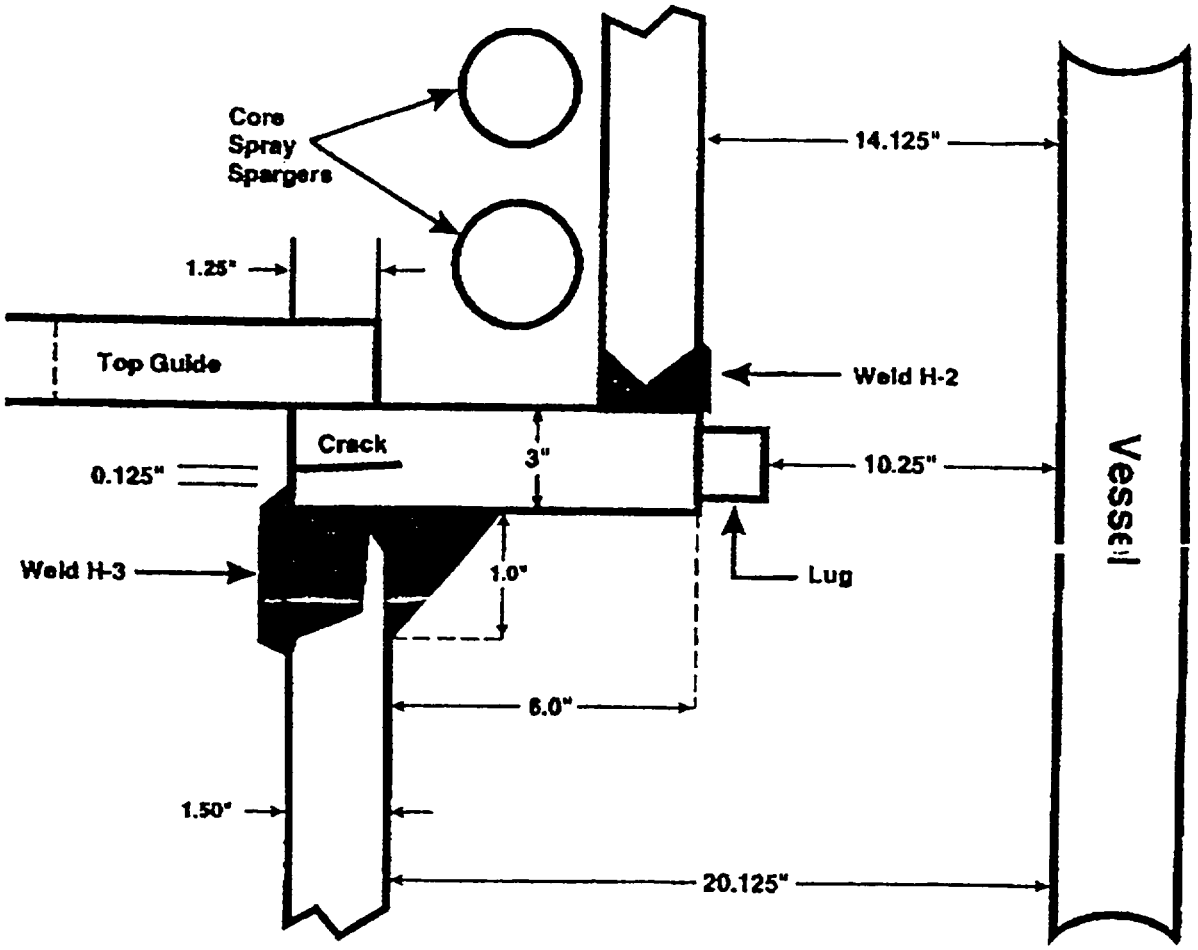
Figure 3-2. Details of Brunswick Unit 1 significant core shroud cracking.

During July 1993, the Carolina Power and Light Company (CP&L) performed visual examinations of the core shroud (per RICSIL 054) at Brunswick Unit 1. The examinations revealed numerous cracks in the core shroud. The most extended crack was located on the inside surface of the shroud near the H3

weld (Figure 3-2) in the HAZ and was assumed to extend 360 degrees around the circumference. Ultrasonic testing (UT) measurements indicated that the crack had a depth ranging from 20 to 43 mm (0.8 to 1.7 in.) in depth. As can be seen in Figure 3-2, the crack was located in the top guide support ring which is approximately 7 1/2 in. (19 cm) wide. Boat samples identified IGSCC as the cracking mechanism. In addition, both axial and circumferential cracking, although minor, was observed at the H1, H2, H4, H5 and H6 welds and at the shroud head bolt lugs, eccentric alignment pin, and the bottom of the top guide.

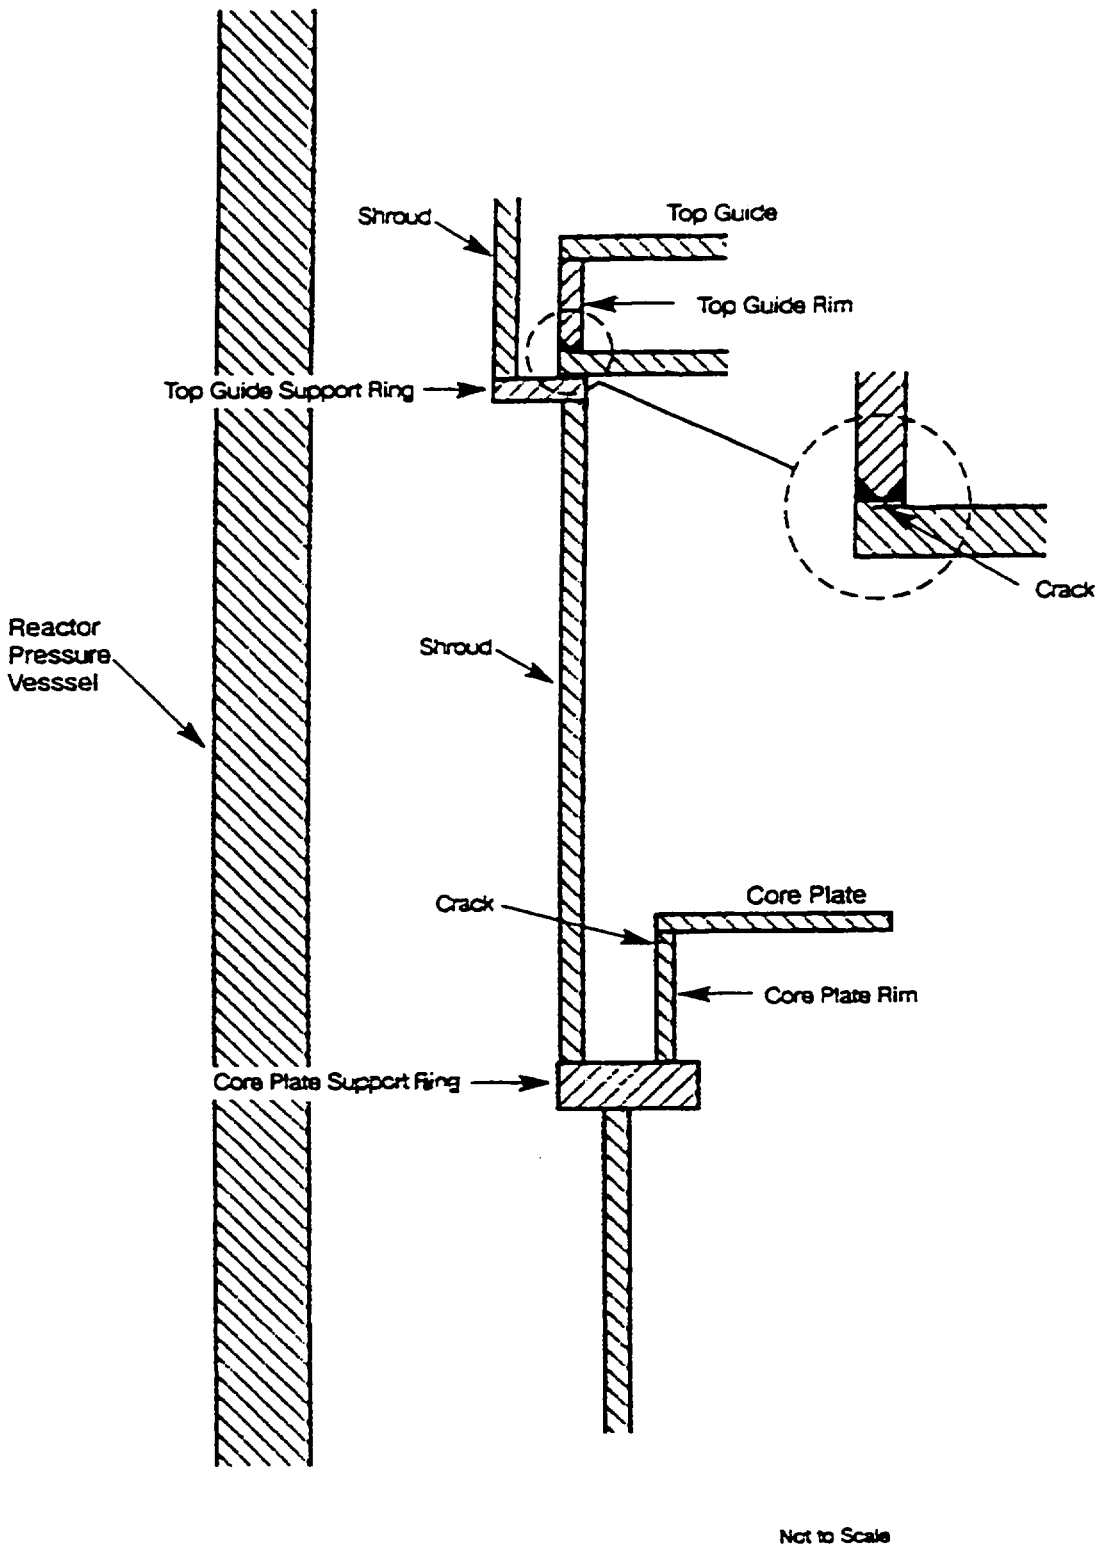
Figure 4-1. Location of cracking in top guide and core plate of overseas BWR.

For an intact top guide, the BWRVIP (BWRVIP,1995) asserts that vertical seismic plus operating dP pressure loads would not overcome the weight of the top guide. If complete ring cracking is assumed,

the top guide assembly would still react vertical loads as a single, effectively intact component, because there are about 200 welded pins connecting the top plate of the top guide to the bottom plate through the beam connections. Therefore, the BWRVIP considers that the ring weld cracking in the overseas BWR raises no new concerns relative to vertical top guide displacement. The NRC has evaluated the information supplied by the BWRVIP and has concluded that the vertical displacement associated with a cracked top guide during a design-basis loading is bounded by analyses performed during the core shroud assessments (Medoff, 1996).

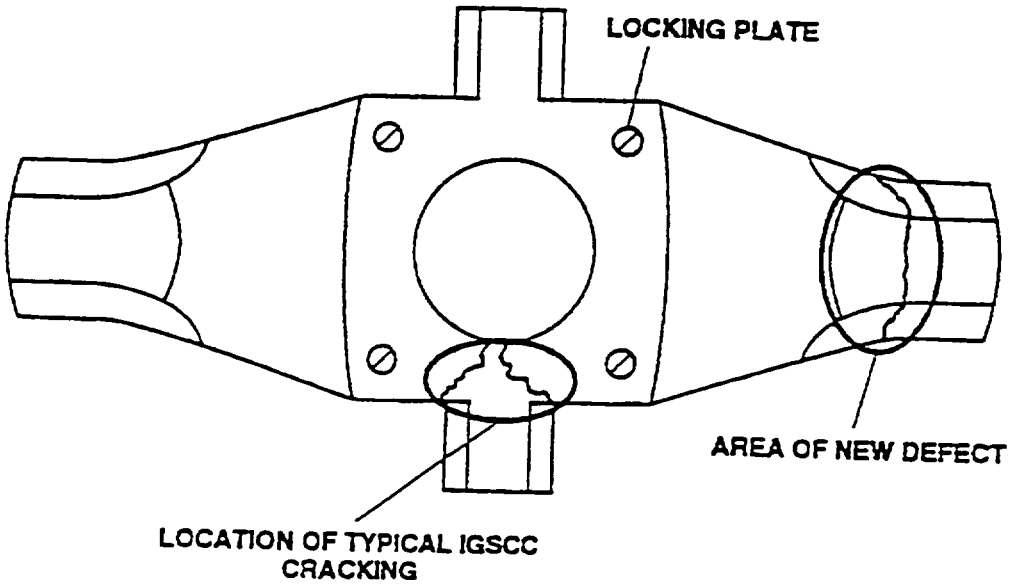
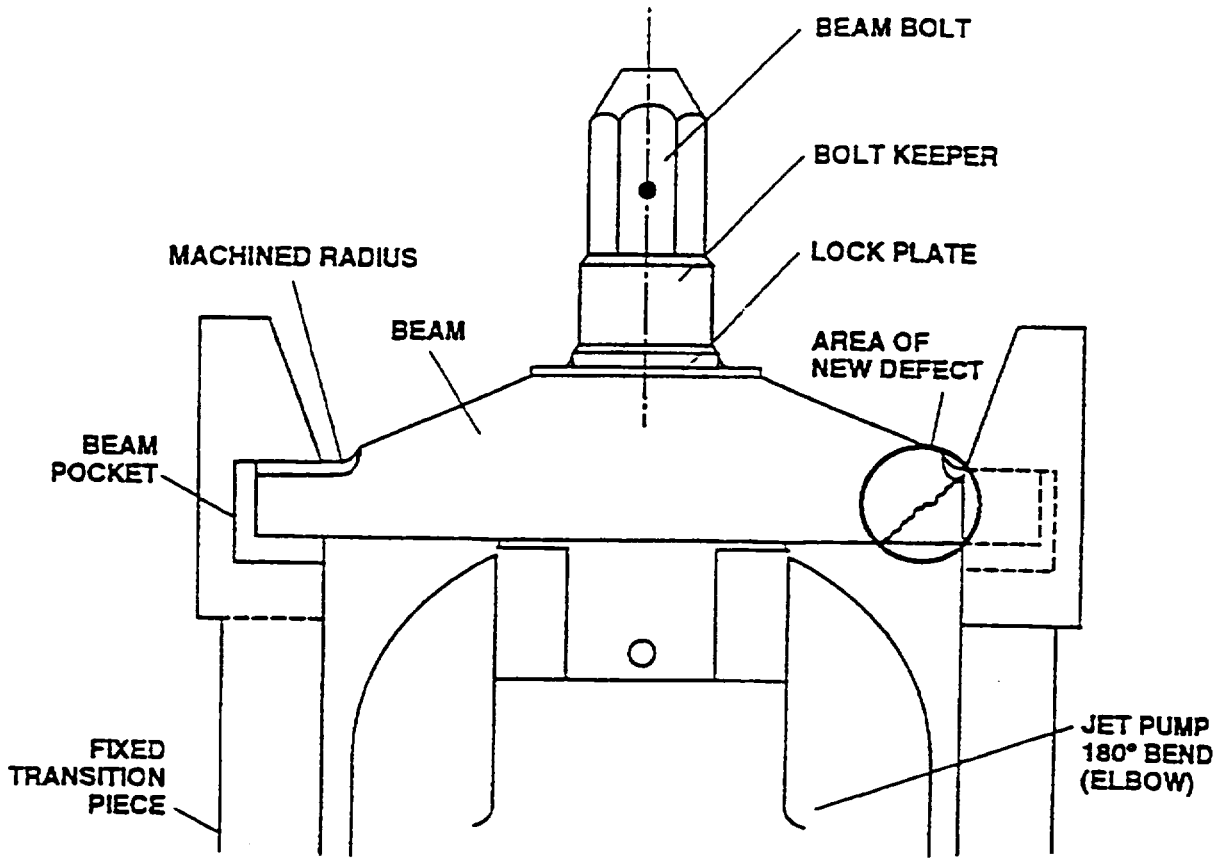
Figure 4-2. Location of cracking in jet pump hold-down beams.

Visual and ultrasonic testing (VT and UT) examinations of other beams at Dresden 3 and other operating BWRs revealed several similarly cracked beams. The NRC issued Inspection and Enforcement (IE) Bulletin 80-07 alerting licensees of the failure, and requiring visual and UT examinations of the jet pump beams in all applicable domestic BWRs (USNRC, 1980a). The IE Bulletin also required initiation of improved surveillance procedures to ensure timely detection in case of further failures. GE issued SIL 330 (GE, 1980) to recommend surveillance methods to licensees and provided a supplement to that SIL on February 1, 1981. The IE Bulletin was closed with the issuance of NUREG/CR-3052 in 1984 (Dean et al., 1984). It was thought that only the BWR/3 design would crack, that the new BWR/4 through BWR/6 design would preclude cracking, and that cracks would progress very slowly though the beam. However, in 1993 UT inspections of the Clinton (BWR/6) hold-down beams revealed that one had crack indications around the center of the bolt hole region (USNRC, 1993b). In addition, it was discovered that some Grand Gulf (another BWR/6) beams showed crack indications in the bolt hole region.

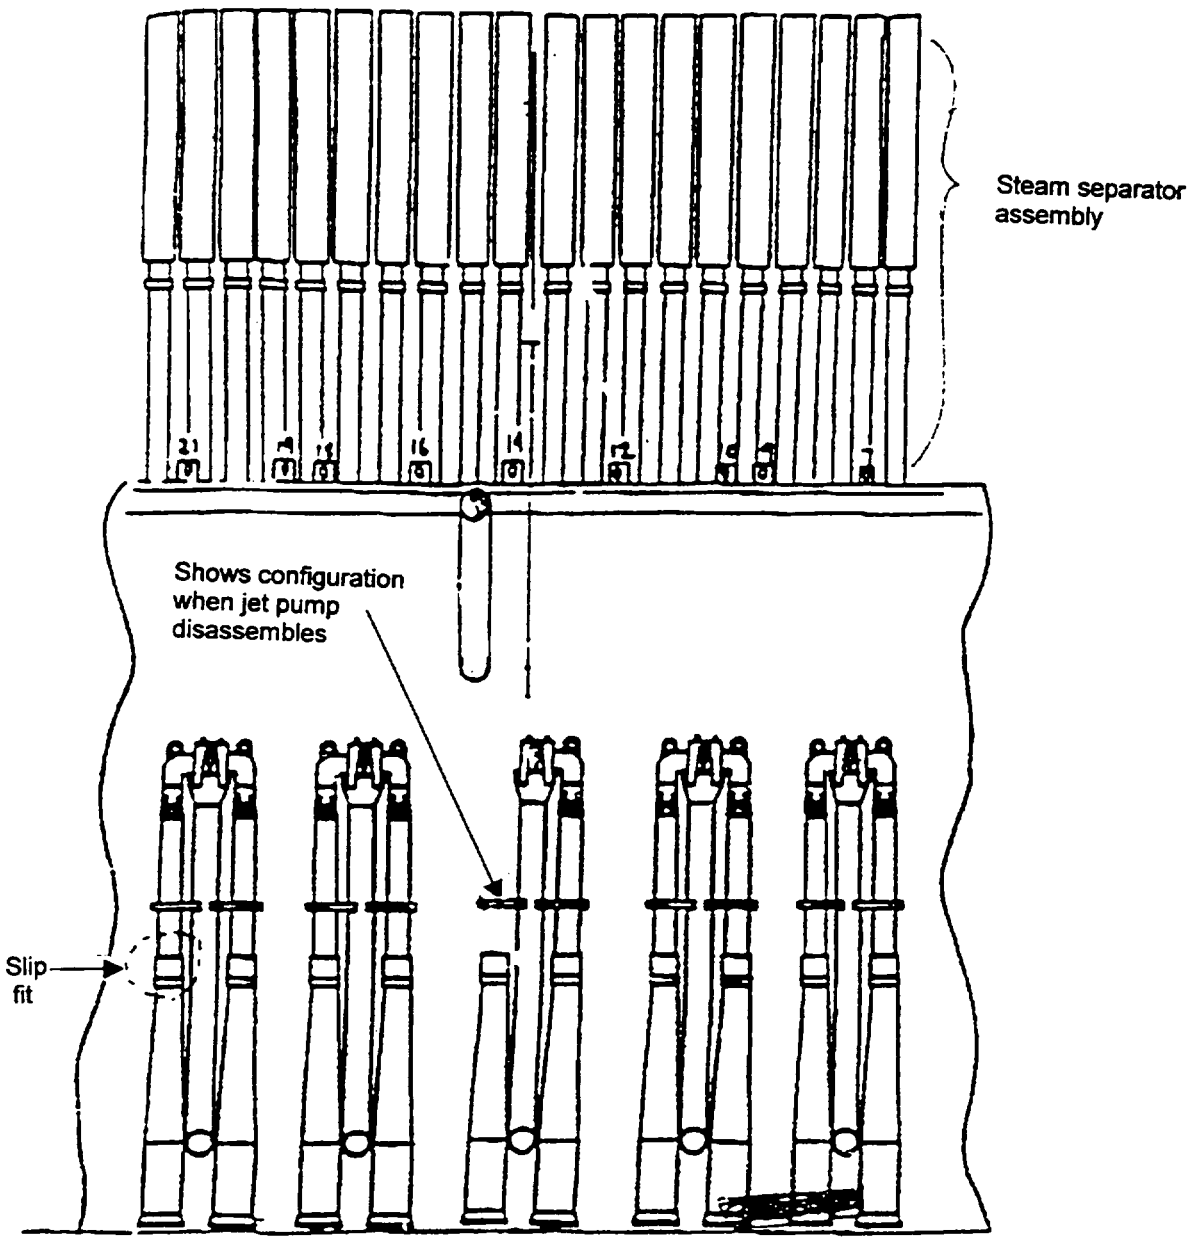
Figure 4-3. Probable jet pump disassembly from hold-down beam failure.

In 1993, Grand Gulf (BWR/6) experienced an unplanned high pressure core spray initiation that resulted in a scram (after eight years of operation). Following reactor shutdown, the licensee found that the mixer assembly for one of the jet pumps had separated from the diffuser and relocated. The cause was a cracked hold-down beam, but the failure location was unlike the previous cases. The crack was in the transition area between the main body of the beam and the end (Figure 4-2), not at the central hole area (USNRC, 1993b). One end of the beam failed completely, causing the jet pump to disassemble (five initiation sites that fused into a single crack was identified). The other end had a crack face covering more than 270 degrees of the cross section of the beam end (two initiation sites were identified). The cracks began in an area where a radius machining cut had been made in the forging. The IGSCC crack at the failed end covered over 80% of the fracture surface, with fatigue striations covering the remainder. No crack indications were identified in the previous visual inspection, including a video tape review of the previous inspection that was conducted after the failure to recheck the assessment. It appeared that a crack could propagate through the beam in less than one full operating cycle. The licensee examined other jet pump hold-down beams and found crack indications at the center bolt hole area on two other hold-down beams, consistent with that described in IE Bulletin 80-07. The NRC issued Information Notice 93-101 to alert licensees to this failure. In addition, GE issued RICSIL 065 (GE, 1993b) which recommended that plants with similar designs replace their beams after eight years of accumulated service.

With regard to the Grand Gulf beam failure, GE recommended that licensees replace the beams if (1) the beams are of the same design as Grand Gulf and (2) the beams have more than eight years of accumulated service. The aging management plan developed for the previous failures at the bolt hole is inadequate for failures at the transition region near the ends of the beams such as that found at Grand Gulf in 1993.

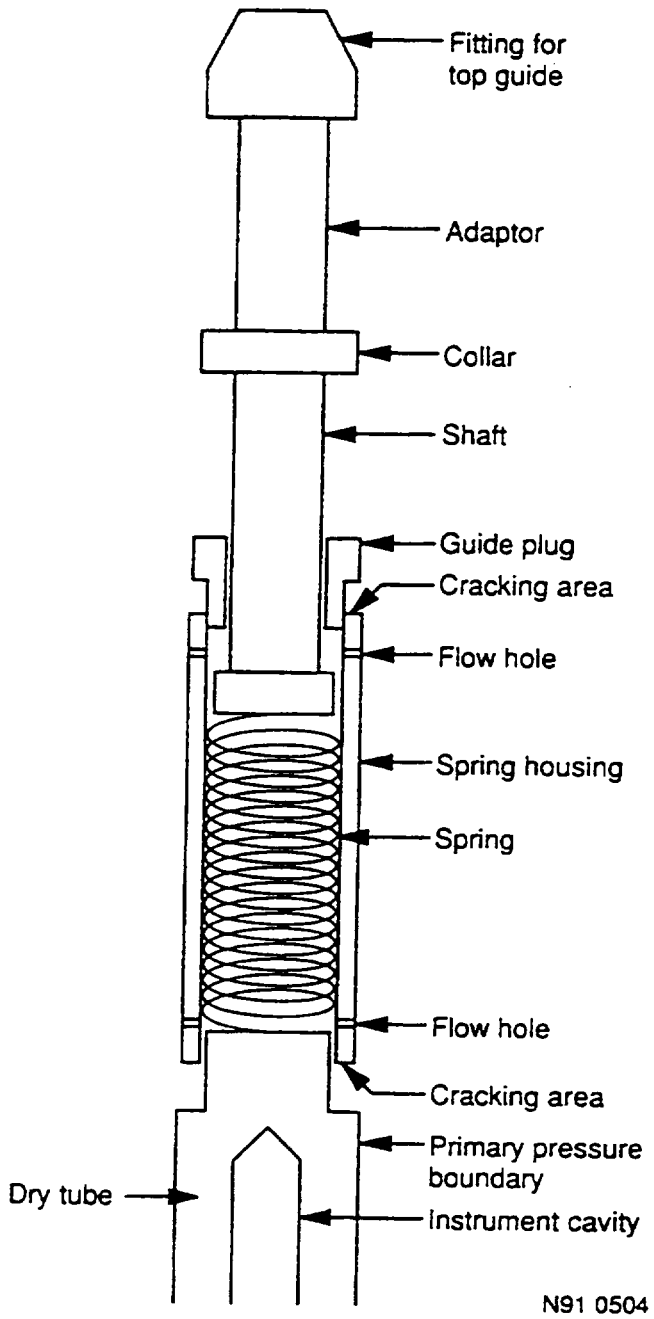
Figure 4-5. Location of dry tube cracking.

Failure of the in-core, non-pressure-boundary portion of the housing may disable the detector, but this would be promptly discovered by a loss of the monitor indication. There are several of each monitor type. Failure of the pressure boundary portion is outside the pressure vessel and therefore not a reactor internals component. Similarly, failure of a housing-to-reactor-vessel weld is considered part of the reactor vessel and therefore not a reactor internals component. Failure at either of these pressure boundary locations would result in a leak in the bottom head area.
