Quad Cities Nuclear Power Station, Unit 1
Facility Operating License No. DPR-29
NRC Docket No. 50-254

Subject: Request for Approval of Weld Repair and Pipe Flaw Evaluation

Evaluation of the Indication in Weld 02BS-F4 in the 28 inch Recirculation Piping

*GE-NE-B13-02064-00-18*
*DRF #B13-02064-00*
*Class I*
*October 2000*

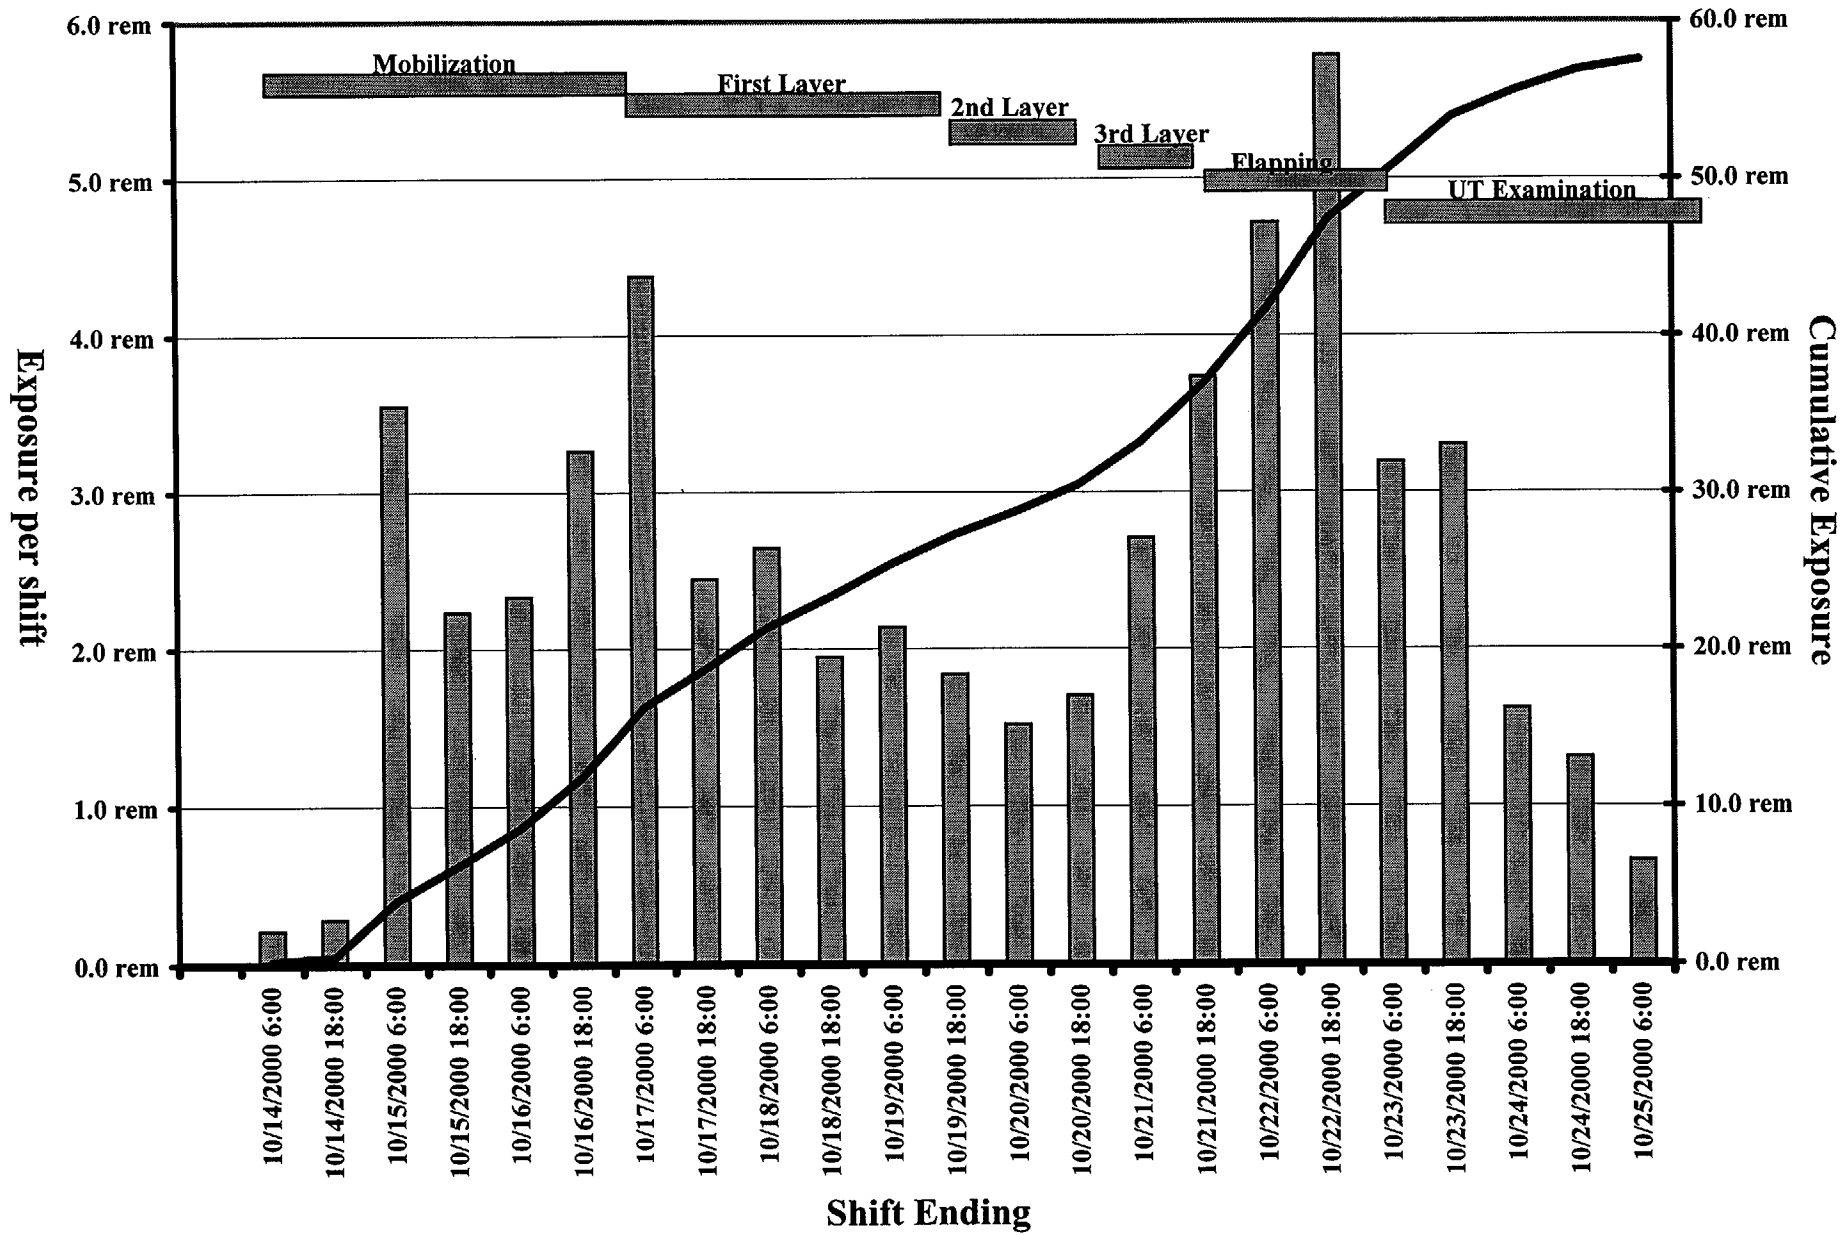
**Figure A-1: Weld Overlay 02BS-F4 Exposure**

Figure A-1 shows that an actual radiation exposure of approximately 30 person-rem was incurred to complete two of the planned seven weld layers. The figure also shows that approximately 20 additional person-rem have been incurred to prepare the partial weld overlay for ultrasonic testing (UT). These preparations included placing a cosmetic third weld layer and then grinding the overlay to produce an acceptable surface for UT.

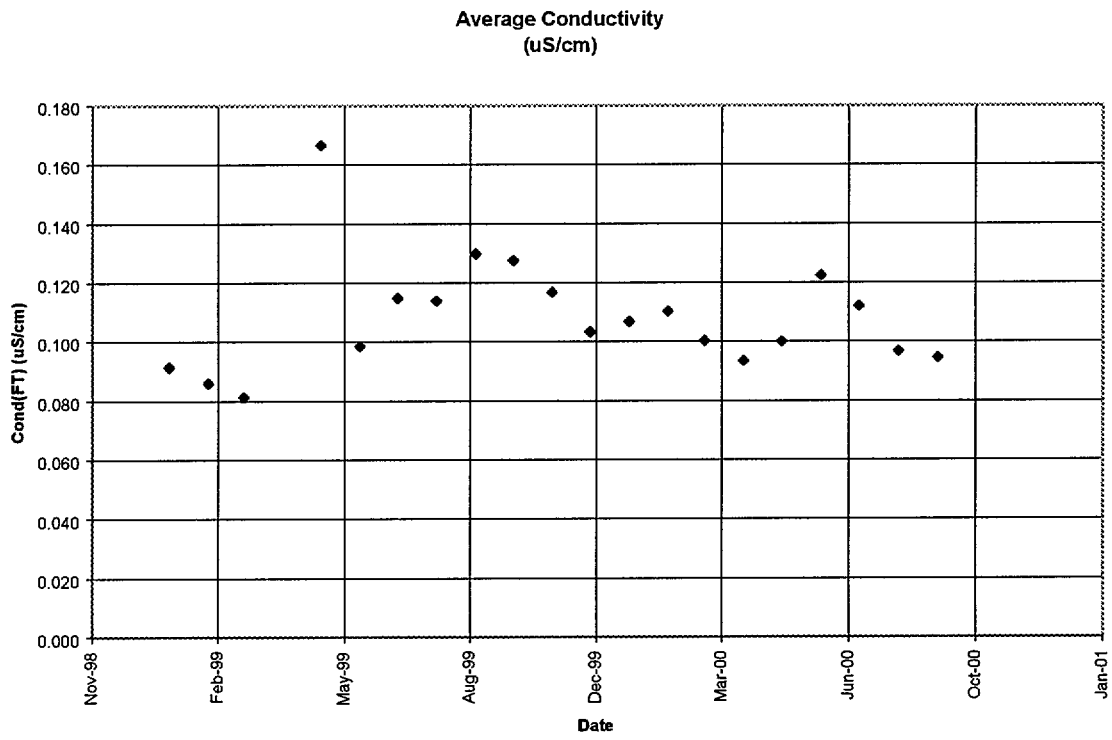
**Figure 1. Average Monthly Conductivity during the last cycle**

Quad Cities Unit 1 has been operating with excellent water conductivity. Figure 1 shows the conductivity data for the last cycle. It is seen that the overall conductivity ranges from 0.1 to 0.15 μS/cm over the last cycle. The plant has been operating with HWC since 1990 and NobleChem was implemented in April 1999. The ECP history during the last cycle is shown in Figure 2. Again, the measured ECP is well below the –230 mV SHE threshold for crack arrest. IGSCC crack growth is expected to be negligible under these conditions.

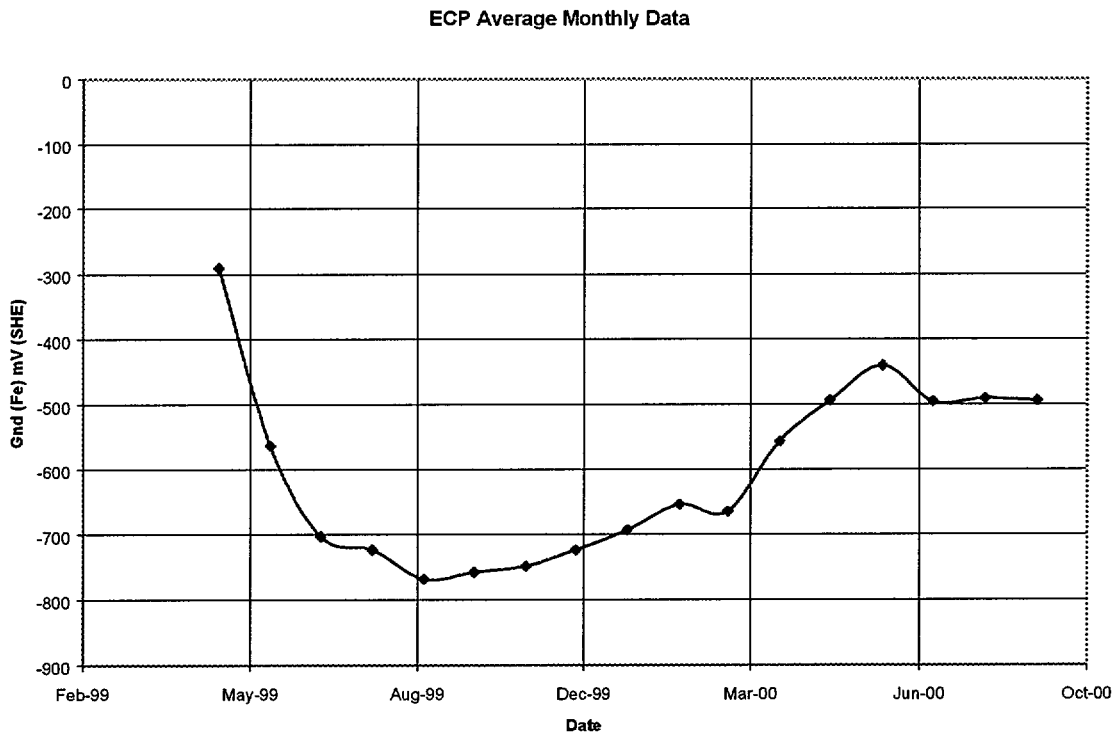
**Figure 2. ECP History during the last cycle**

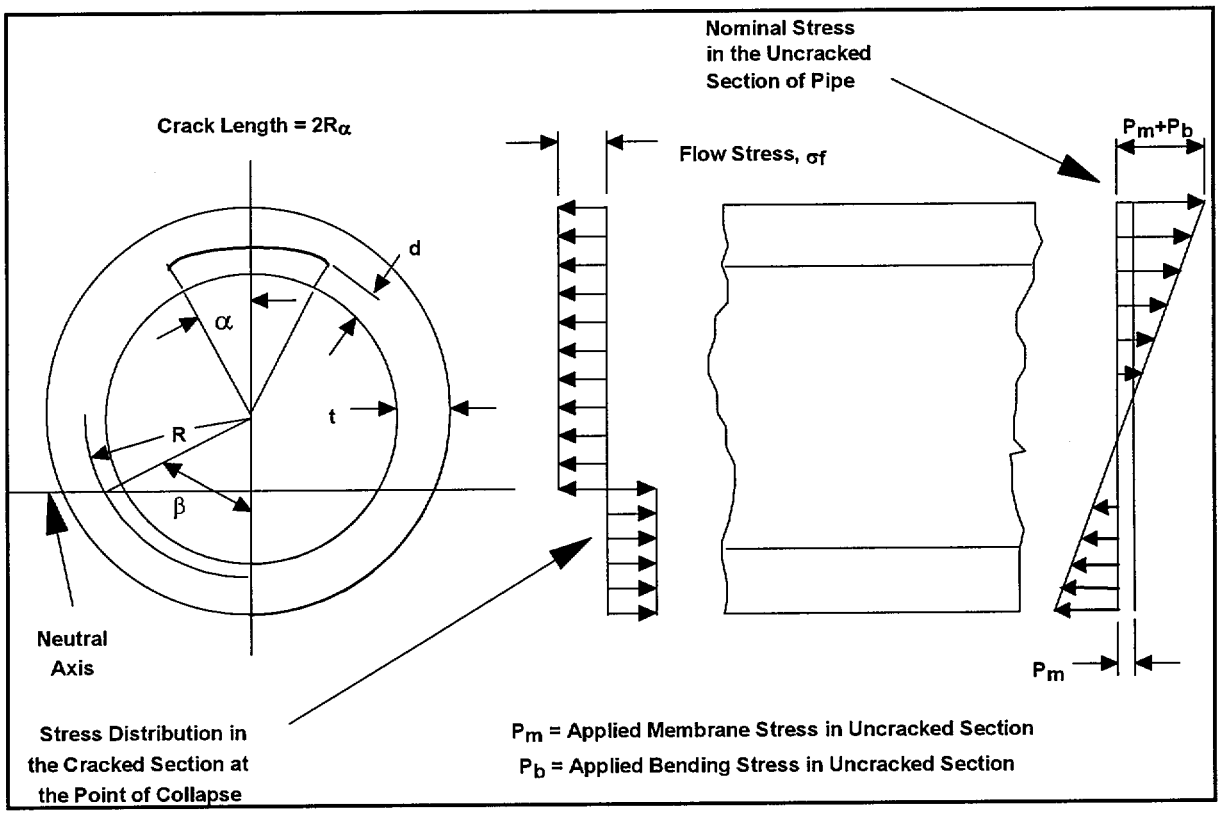
Consider a circumferential crack of length, $l = 2R\alpha$ and constant depth, d. In order to determine the point at which limit load is achieved, it is necessary to apply the equations of equilibrium assuming that the cracked section behaves like a plastic hinge. For this condition, the assumed stress state at the cracked section is as shown in Figure 3 where the maximum stress is the flow stress of the material, $\sigma_f$. Equilibrium of longitudinal forces and moments about the axis gives the following equations:

Where,
- $t$ = pipe thickness
- $\alpha$ = crack half-angle as shown in Figure 3
- $\beta$ = angle that defines the location of the neutral axis
- $P_m$ = Primary membrane stress
- $P_b'$ = Failure bending stress

**Figure 3. Stress Distribution in a Cracked Pipe at the Point of Collapse**

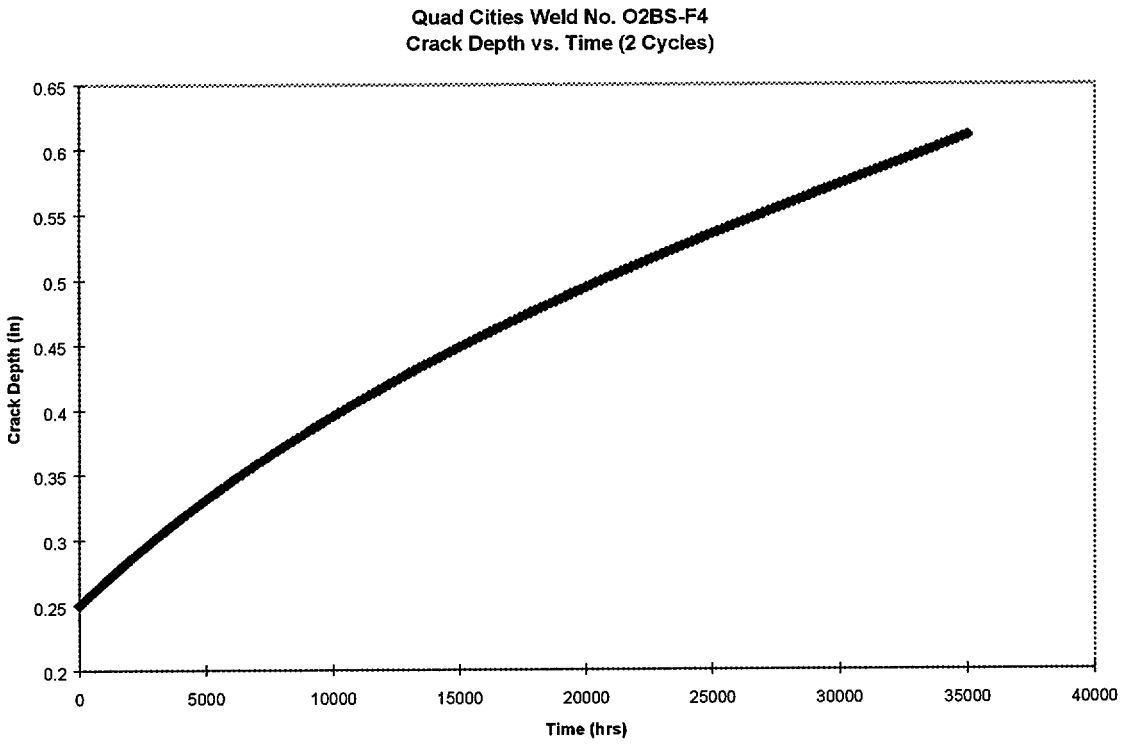
**Figure 4. Predicted Crack Growth for 2 Cycles for Weld 02BS-F4 (NWC)**

Figure 4 shows the results of the depth crack growth calculation for two cycles (35000 hours) for the 02BS-F4 weld. It is seen that the crack growth is modest even with a conservative crack growth rate relationship.

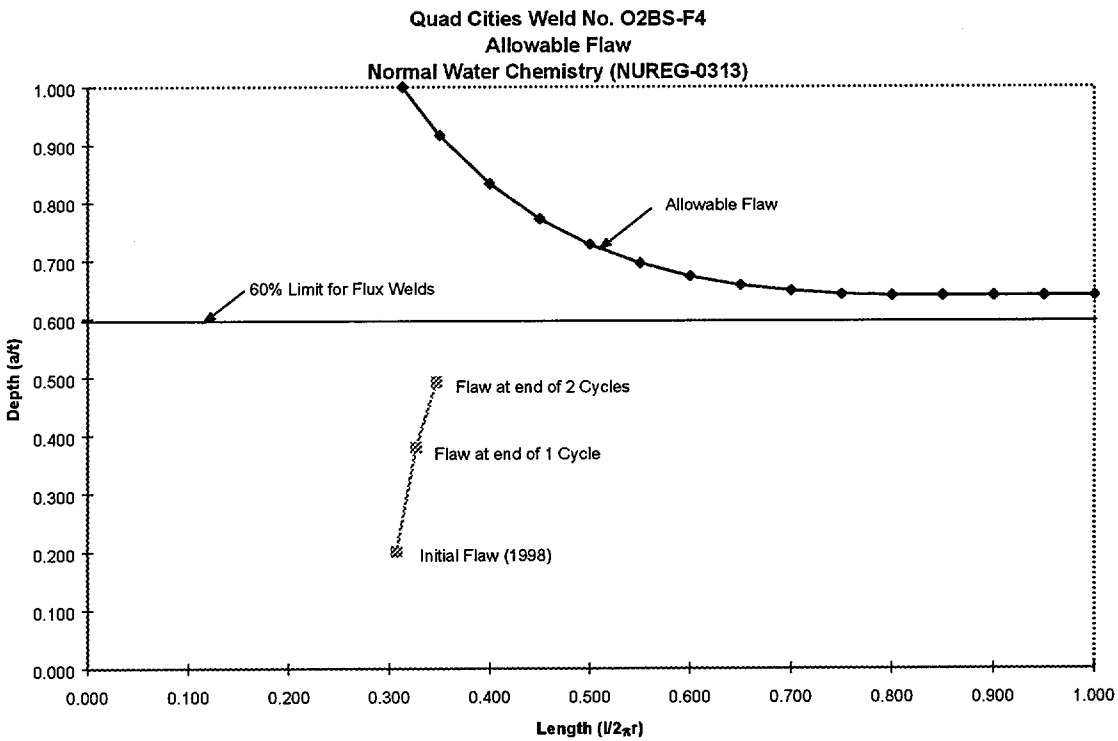
**Figure 5. Comparison with Allowable Flaw Size for Weld 02BS-F4 (NWC Crack Growth Rates)**

Figure 5 graphically shows the results of the limit load evaluation. The projected end-of-cycle depth and length of the indication is also shown on the same plot. The projected indication length was calculated using the NRC accepted $5 \times 10^{-5}$ in/hr crack growth rate. As shown in Figure 5, the calculated allowable flaw depth is greater than the maximum limit of 0.6t for flux welds, for any crack length. It should be noted that this limit has been raised to 0.75t, same as that for the base metal and non-flux welds, in the later editions of the ASME Section XI. Thus, the use of 0.6t limit is conservative.

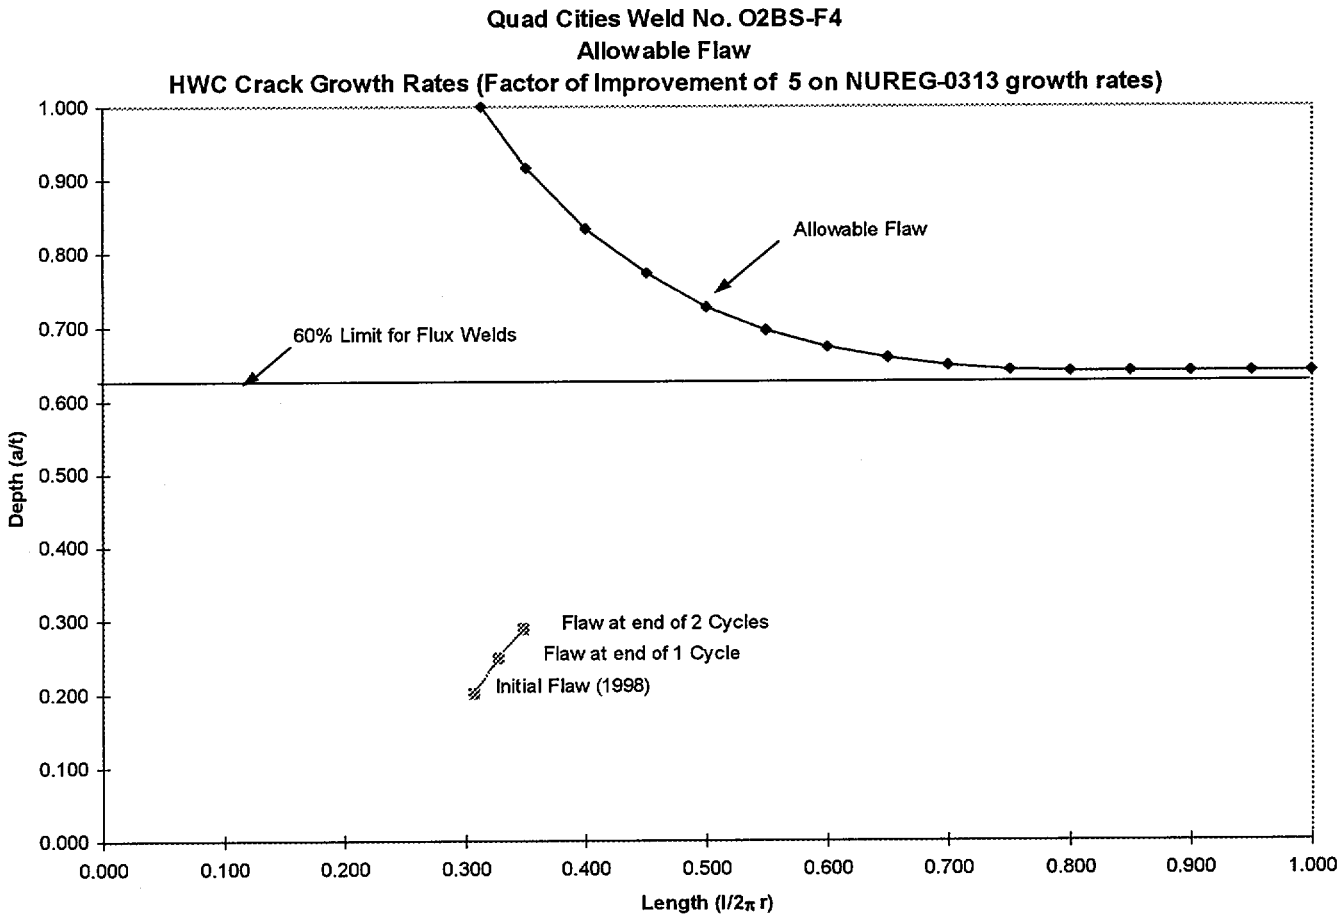
**Figure 6. Comparison with Allowable Flaw Size for Weld 02BS-F4 (HWC Crack Growth Rates – FOI of 5 on NWC growth rates)**

As described earlier, crack growth rates under HWC (especially when the ECP is below –230 mV SHE) are expected to be extremely low nearing arrest condition. This is particularly true for the recirculation piping where there no radiolysis or fluence effects (that apply to shroud cracking). Nevertheless, a conservative factor of improvement of 5 (over the NWC crack growth rate from NUREG-0313) was selected to evaluate the crack growth. Figure 6 shows the projected crack growth relative to the allowable flaw size. As expected, there is even more margin when credit is taken for the HWC benefit.
