SUBJECT: NRC SPECIAL INSPECTION REPORT - INDIAN POINT UNIT 2
STEAM GENERATOR TUBE FAILURE - REPORT NO. 05000247/2000-010

IR 05000247-00-010, March 7 thru July 20, 2000; Consolidated Edison of New York, Inc.; Indian Point Unit 2; Special Team; steam generator tube failure, visual, eddy current inspection, technique qualification, corrective actions.

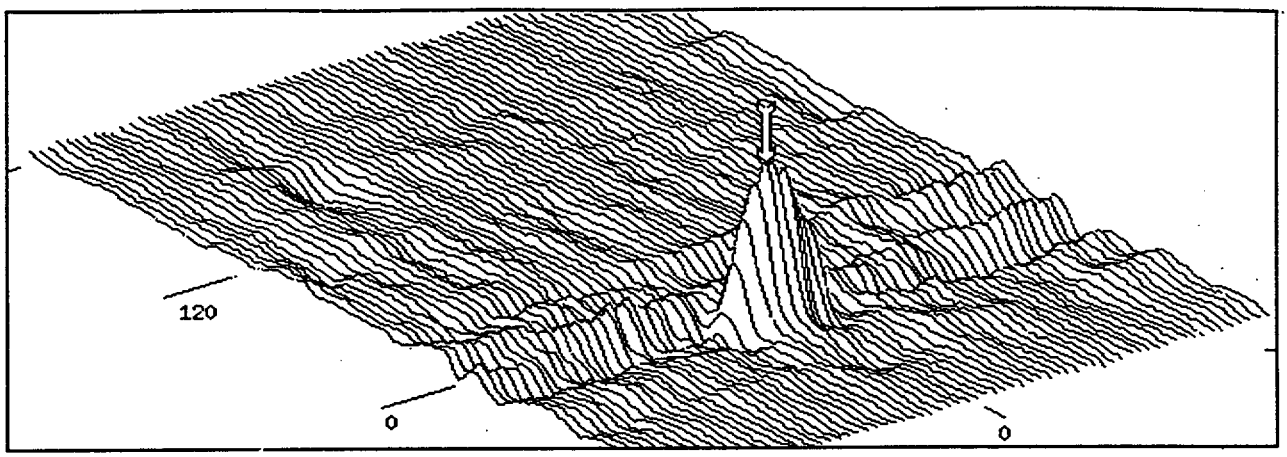
Figure 5 - Crack in tube 2-67 of steam generator 24, found in 1997.

The c-scan plot of the 1997 data from R2C67 is shown in Figure 5. The crack sits beside a ridge, in a valley, and is in an easily detectable portion of the tube. The large amplitude of the voltage signal, in relation to the standard calibration notch, would indicate that this is a "mature" crack. No year 2000 data is available since the tube was plugged in 1997.

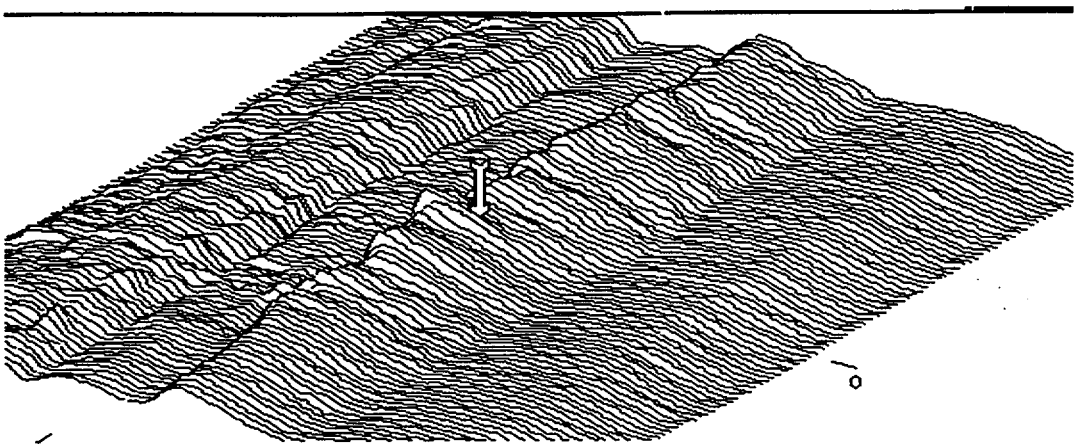
Figure 6 R2C5C-scan with1997 phase setting.

1. R2C5 in SG 24 - Figure 6 is a c-scan plot of the vertical component of the ECT voltage signal. The defect signal, indicated by the arrow, sits on a noise ridge that runs the length of the tube. This noise ridge is about 1-volt in amplitude. This ridge makes both the detection and sizing of this defect difficult, because of the very low signal to noise ratio. Figures 7 and 8 are the lissajous plots for the flaw area and the noise ridge, respectively. No year 2000 data is available since the tube failed.

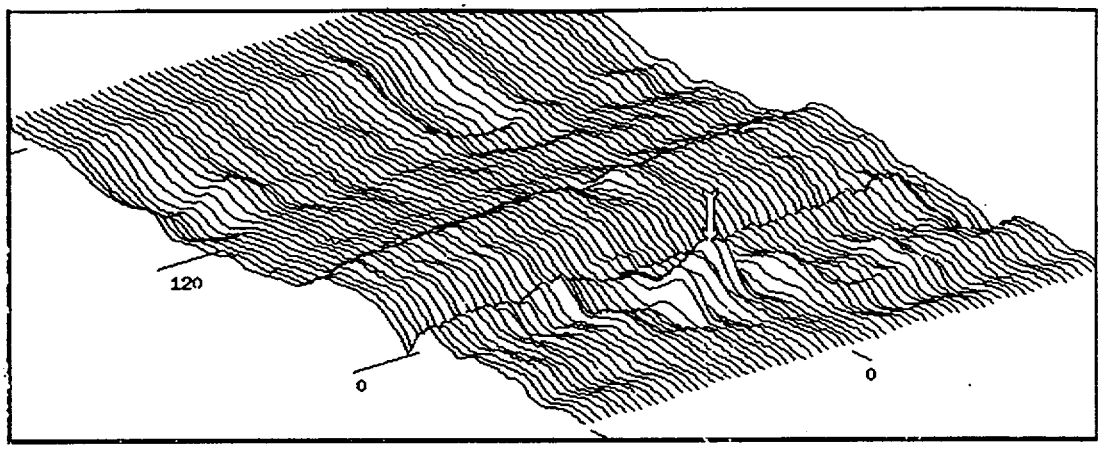
Figure 9 - 1997Mid- range scan .

2. R2C69 in SG 24 - Figure 9 shows the c-scan plot for the 1997 data. There is considerable noise present. For comparison, the c-scan plot for the 2000 data is included as Figure 10. The noise features between the 1997 and 2000 data are similar enough to verify that this is the same defect at the same location. The defect voltage is only about 1 volt, and there is a considerable amount of noise on the tube relative to the defect signal i.e., low very low signal to noise ratio.

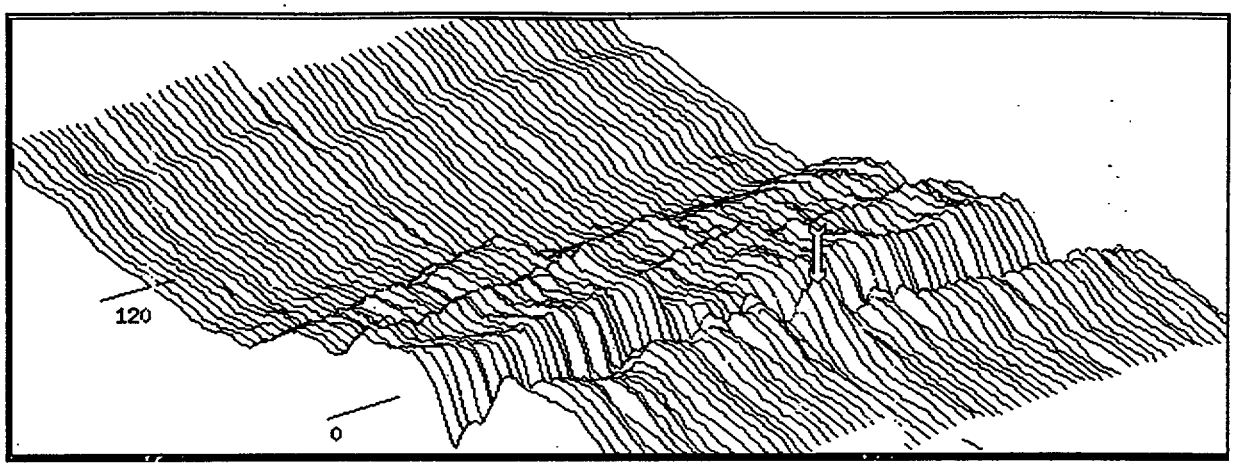
Figure 11 - 1997 scan

3. R2C72 in SG 24 - Figure 11 shows the c-scan plot of the 1997 data. There is considerable noise present. The crack is sitting in a ridge of noise and barely extends above a ridge of deposits. For comparison, the c-scan plot for the 2000 data is included as Figure 12. The crack barely extends above a 1-volt amplitude for a short length and exhibits a very low signal to noise ratio.

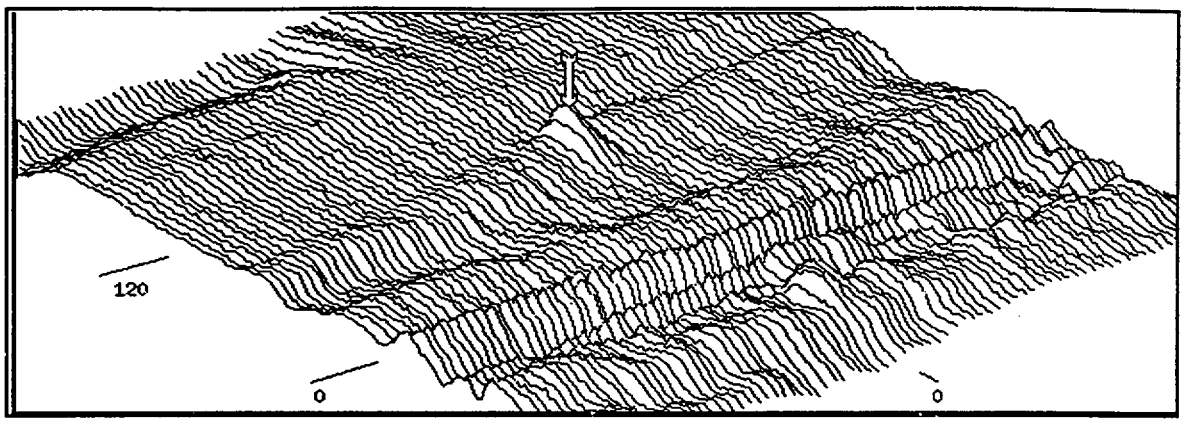
Figure 13 - 1997 scan

4. R2C87 in SG 21 - this tube was identified as having several cracks. Figure 13 shows the c-scan plot of the 1997 data. The most prominent crack is sitting in a relatively clean area of the tube. For comparison, the c-scan plot for the 2000 data is included as Figure 14.
