SUBJECT: NRC SPECIAL INSPECTION REPORT - INDIAN POINT UNIT 2
STEAM GENERATOR TUBE FAILURE - REPORT NO. 05000247/2000-010

IR 05000247-00-010, March 7 thru July 20, 2000; Consolidated Edison of New York, Inc.; Indian Point Unit 2; Special Team; steam generator tube failure, visual, eddy current inspection, technique qualification, corrective actions.

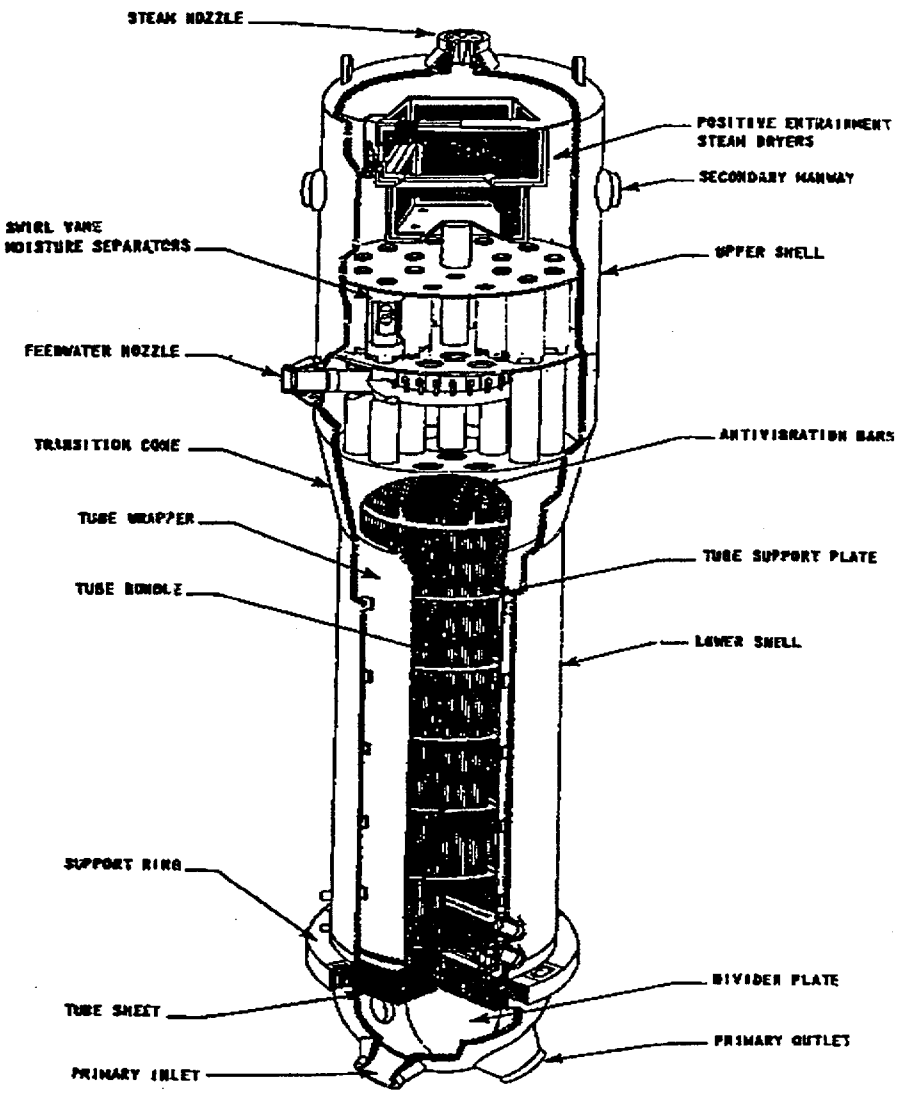
Figure 1 - Westinghouse Model 44 Steam Generator

Indian Point 2 is a four-loop pressurized water reactor, meaning that there are four SGs, one per loop, that transfer heat from the reactor coolant system (RCS) to the secondary water. This heat causes the secondary water to boil, and the resulting steam is used to turn the turbine, which turns the electrical generator. Figure 1 shows a Westinghouse Model 44 SG, like those in use at Indian Point 2. The four SGs are identified as SG 21 through SG 24.

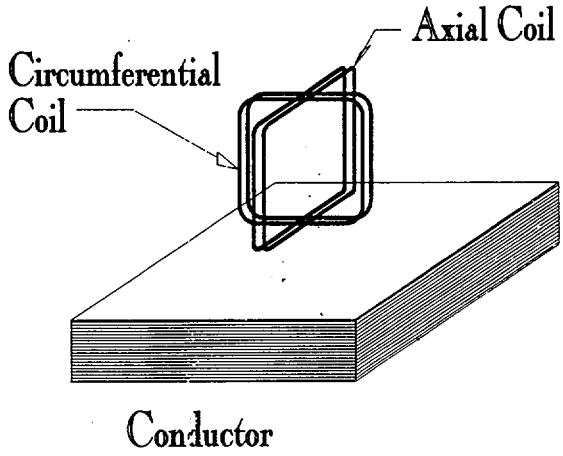
Single coil probes as shown in Figure 2 will induce the eddy current in only one direction, which is a compressed mirror image of the current in the coils. Defects that are perpendicular to the eddy current flow, interrupt the eddy current flow and the probe coil voltage will be affected. Specially designed ECT probes can classify defects as axial cracks, circumferential cracks or both.

Figure 2 Directional pancake probe

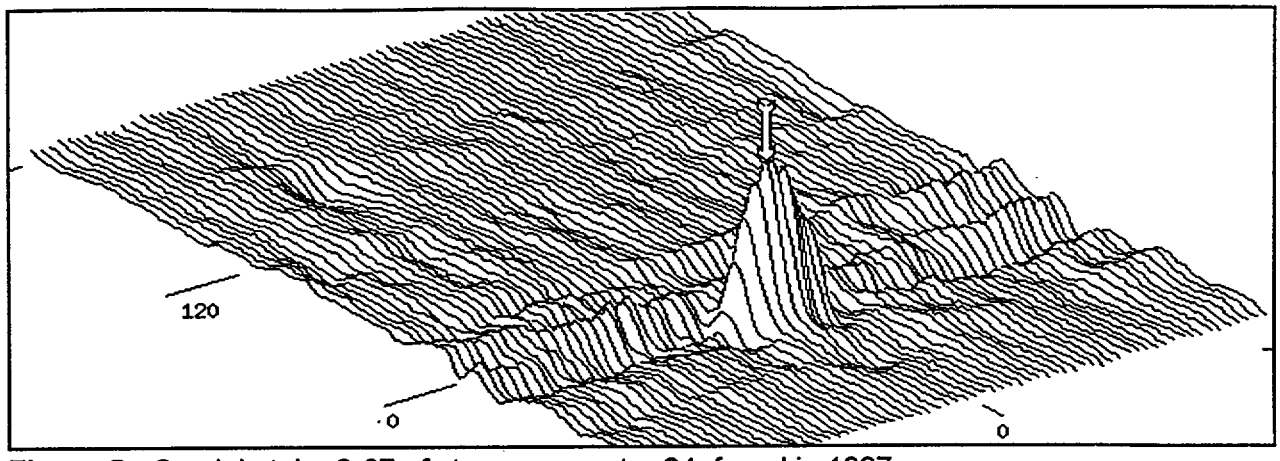
REFERENCED FIGURE **5** - Eddy Current Inspection - Tube R2C67 in SG24

The c-scan plot of the 1997 data from R2C67 is shown in Figure 5. The crack sits beside a ridge, in a valley, and is in an easily detectable portion of the tube. The large amplitude of the voltage signal, in relation to the standard calibration notch, would indicate that this is a "mature" crack. No year 2000 data is available since the tube was plugged in 1997.

Figure 5 - Crack in tube 2-67 of steam generator 24, found in 1997.

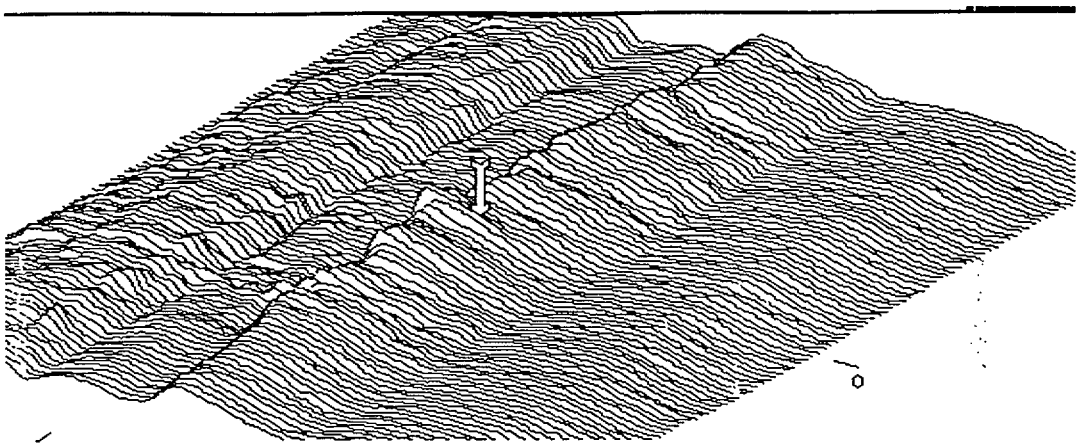
1. R2C5 in SG 24 - Figure 6 is a c-scan plot of the vertical component of the ECT voltage signal. The defect signal, indicated by the arrow, sits on a noise ridge that runs the length of the tube. This noise ridge is about 1-volt in amplitude. This ridge makes both the detection and sizing of this defect more difficult. Figures 8 and 8 are the lissajous plots for the flaw area and the noise ridge, respectively. These figures show that a flaw signal is distinguishable from the characteristic noise signal, as was the case in the other tubes profiled. No year 2000 data is available since the tube failed.

Figure 6 R2C5C-scan with1997 phase setting.

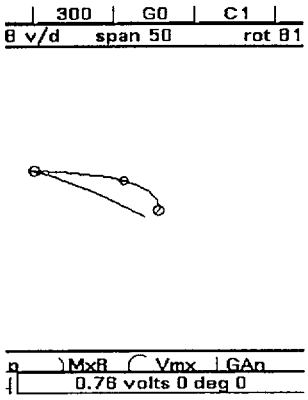
Figure 7 Lissajous of defect with 1997 phase setting.

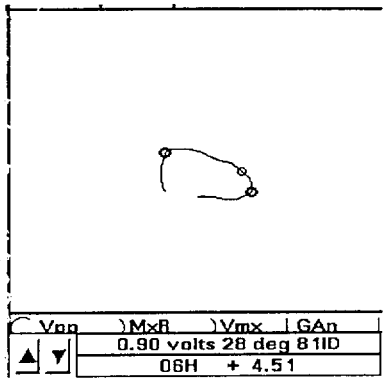
Figure 8 Noise signal that runs the length of the U-bend.

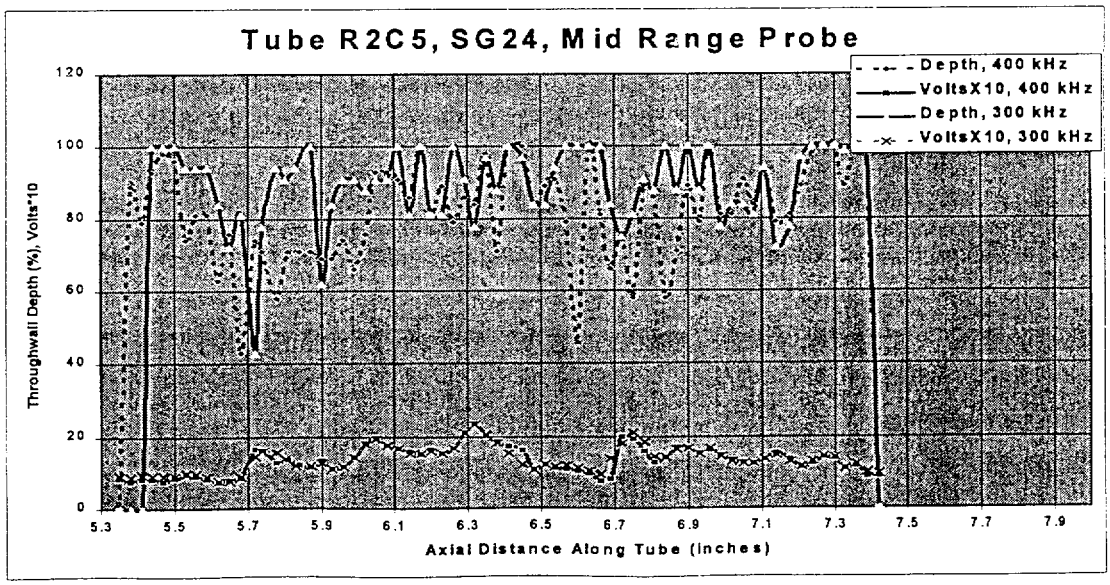
The indication has been profiled for both the 300- and 400-kHz inspection frequencies, as is shown in Figure 9. The signal-to-noise ratio is slightly better for the 400-kHz frequency than for the 300-kHz. The voltage above 2.2-volts indicates the defect; however, there is considerable noise.

Figure 9 - Contour of the crack in tube R2C5 in SG24 using the 1997 data from the mid-range plus-point probe.

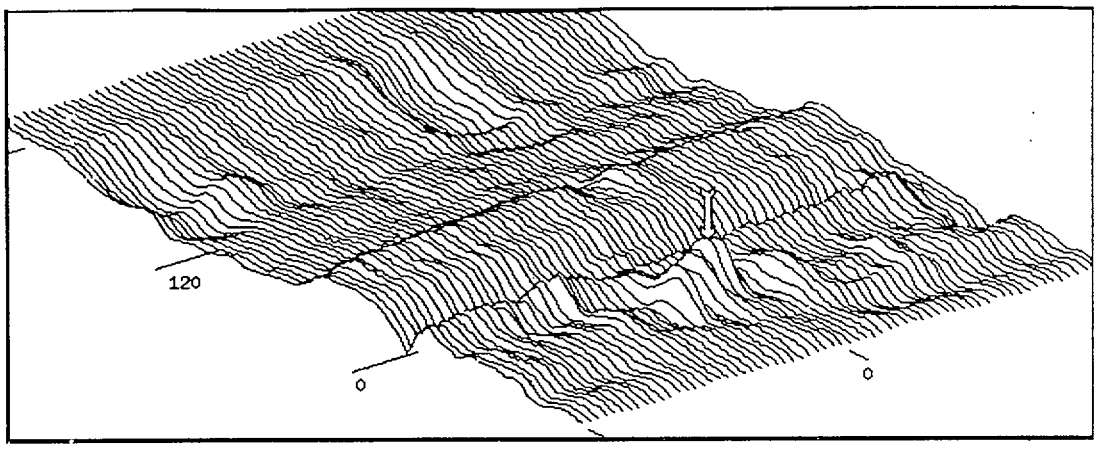
2. R2C69 in SG 24 - Figure 10 shows the c-scan plot for the 1997 data. There is considerable noise present. For comparison, the c-scan plot for the 2000 data is included as Figure 11. The noise features between the 1997 and 2000 data are similar enough to verify that this is the same defect at the same location. Figure 12 shows the profile. The defect voltage is only about 1 volt, and there is a considerable amount of noise on the tube, relative to the defect signal.

Figure10 - 1997Mid- range scan .

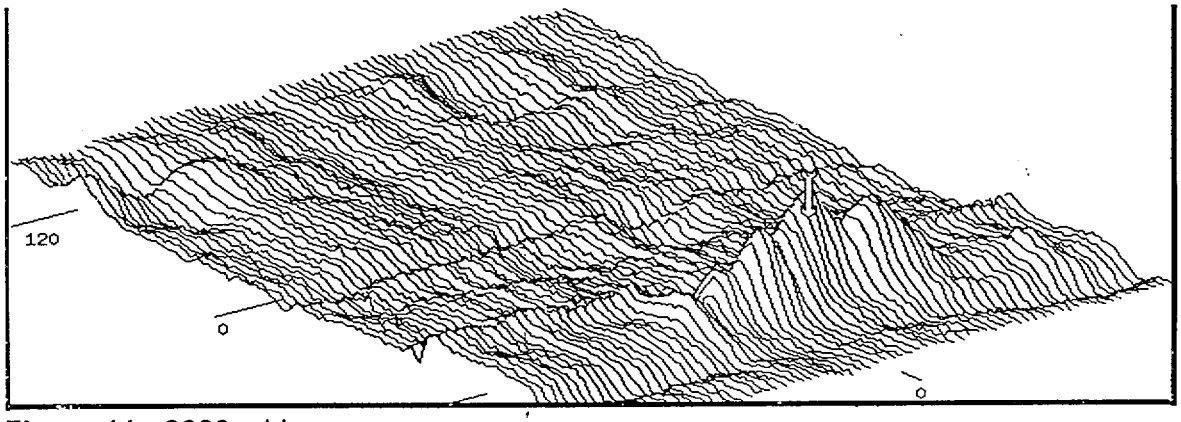
Figure 11 - 2000 mid-range scan

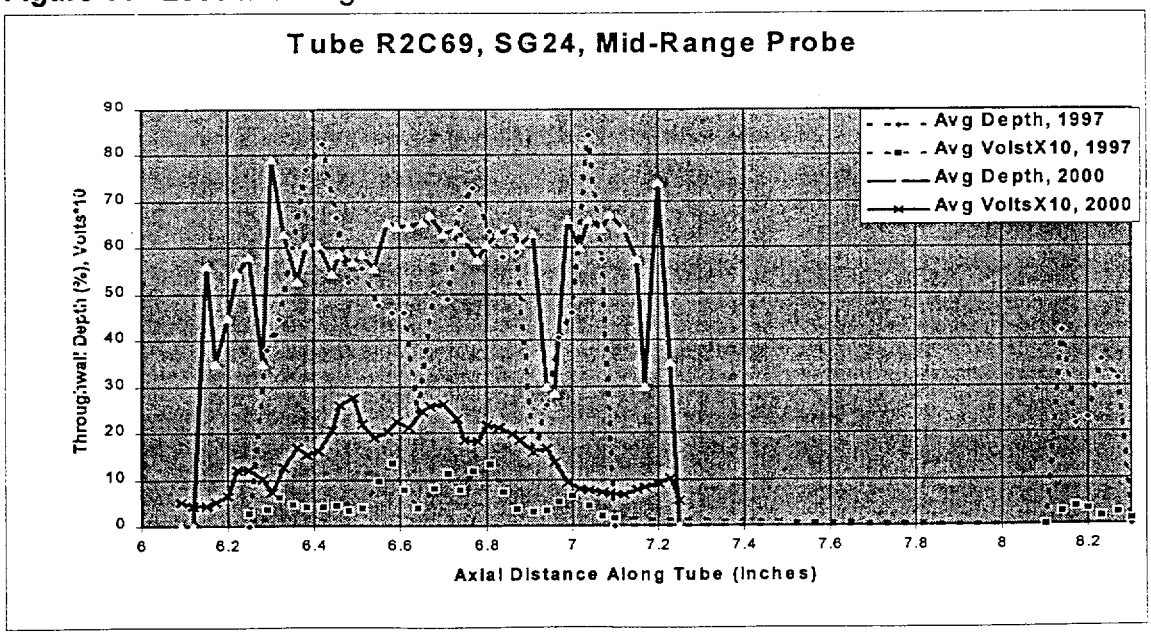
Figure 12 - Profile of Growth between 1997 and 2000

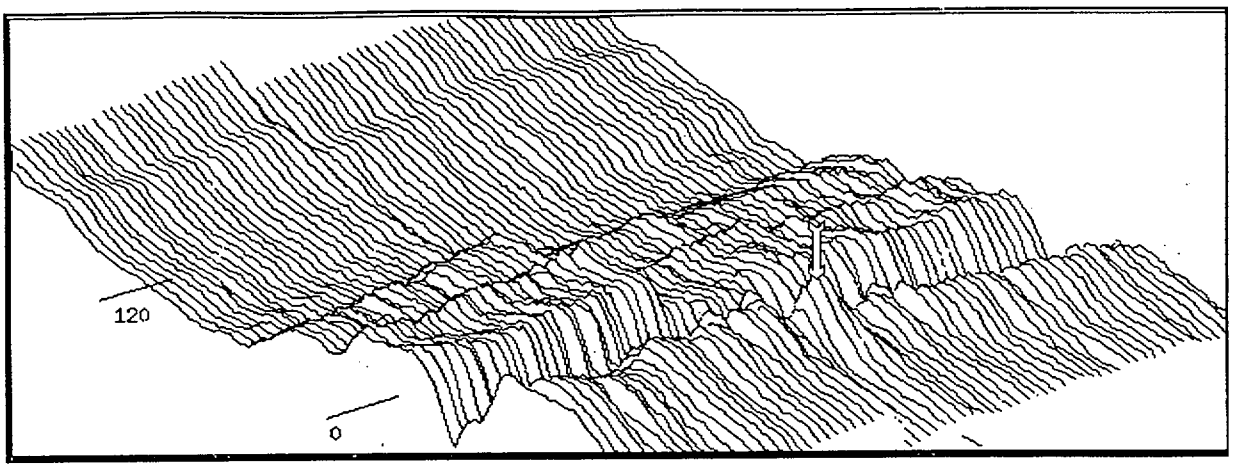
REFERENCED FIGURES **13 thru -15** - Eddy Current Inspection Tube R2C72 in SG 24

Figure 13 - 1997 scan

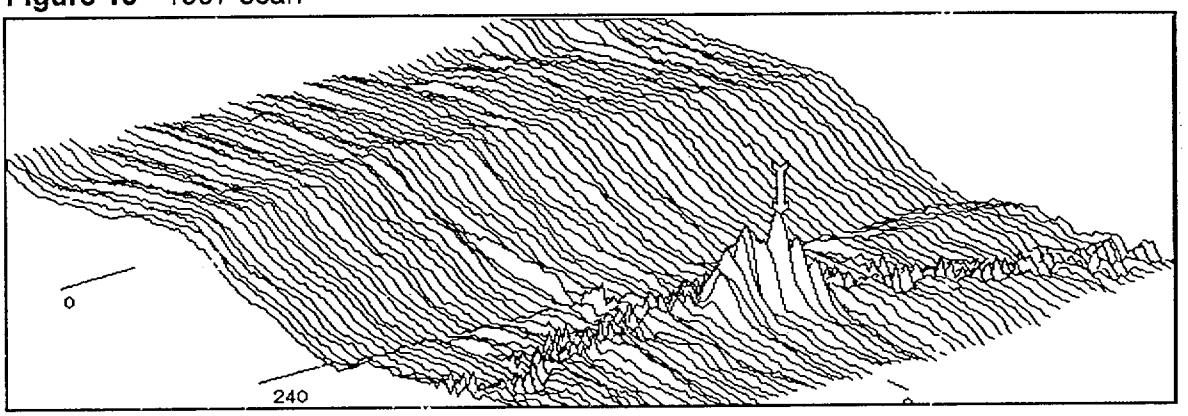
Figure 14 - 2000 scan

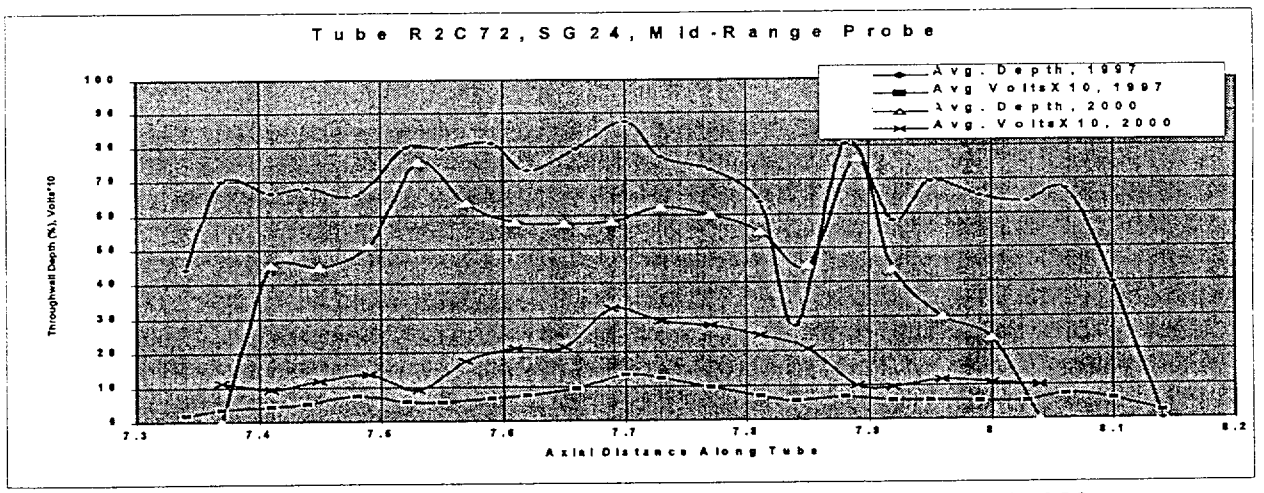
Figure 15 Profile of crack growth of tube R2 C72 of SG24 between 1997 and 2000

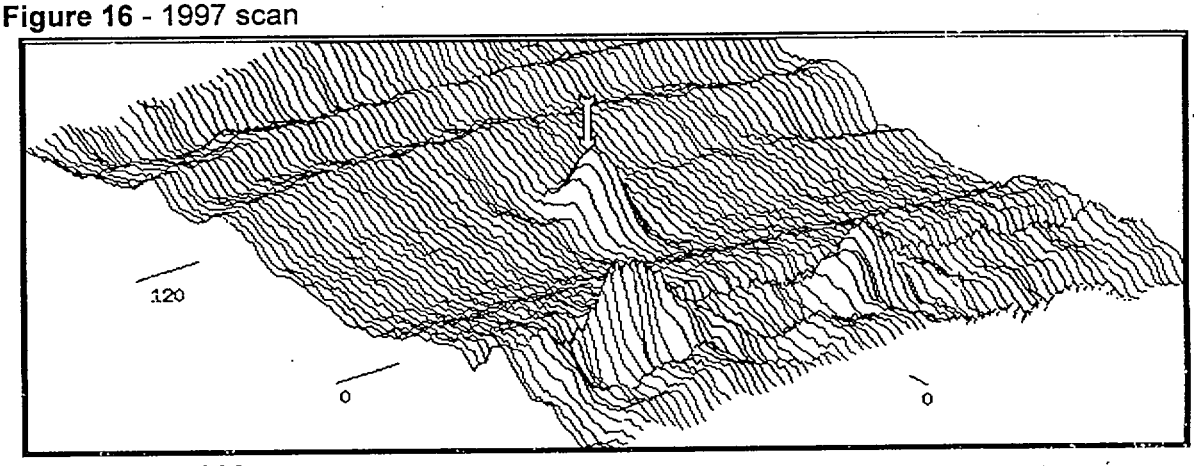
Figure 17 - 2000 scan

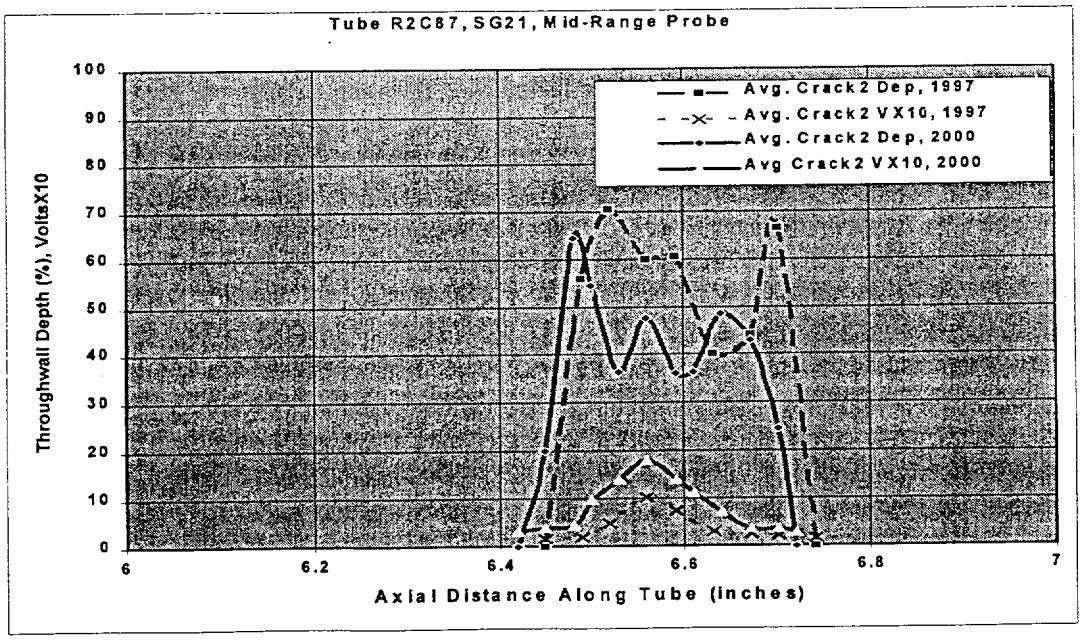
Figure 18- Profile of crack growth of tube R2 C87.
