OG-01-047 NRC Project Number 686

Subject: Westinghouse Owners Group
Revised Response to NRC Request for Additional Information on WCAP-15338, "A Review of Cracking Associated with Weld Deposited Cladding in Operating PWR Plants," (MUHP-6110)

NRC Request for Additional Information Regarding the Review of WCAP-15338

Appendix A
ASME Code Section XI Flaw Evaluation

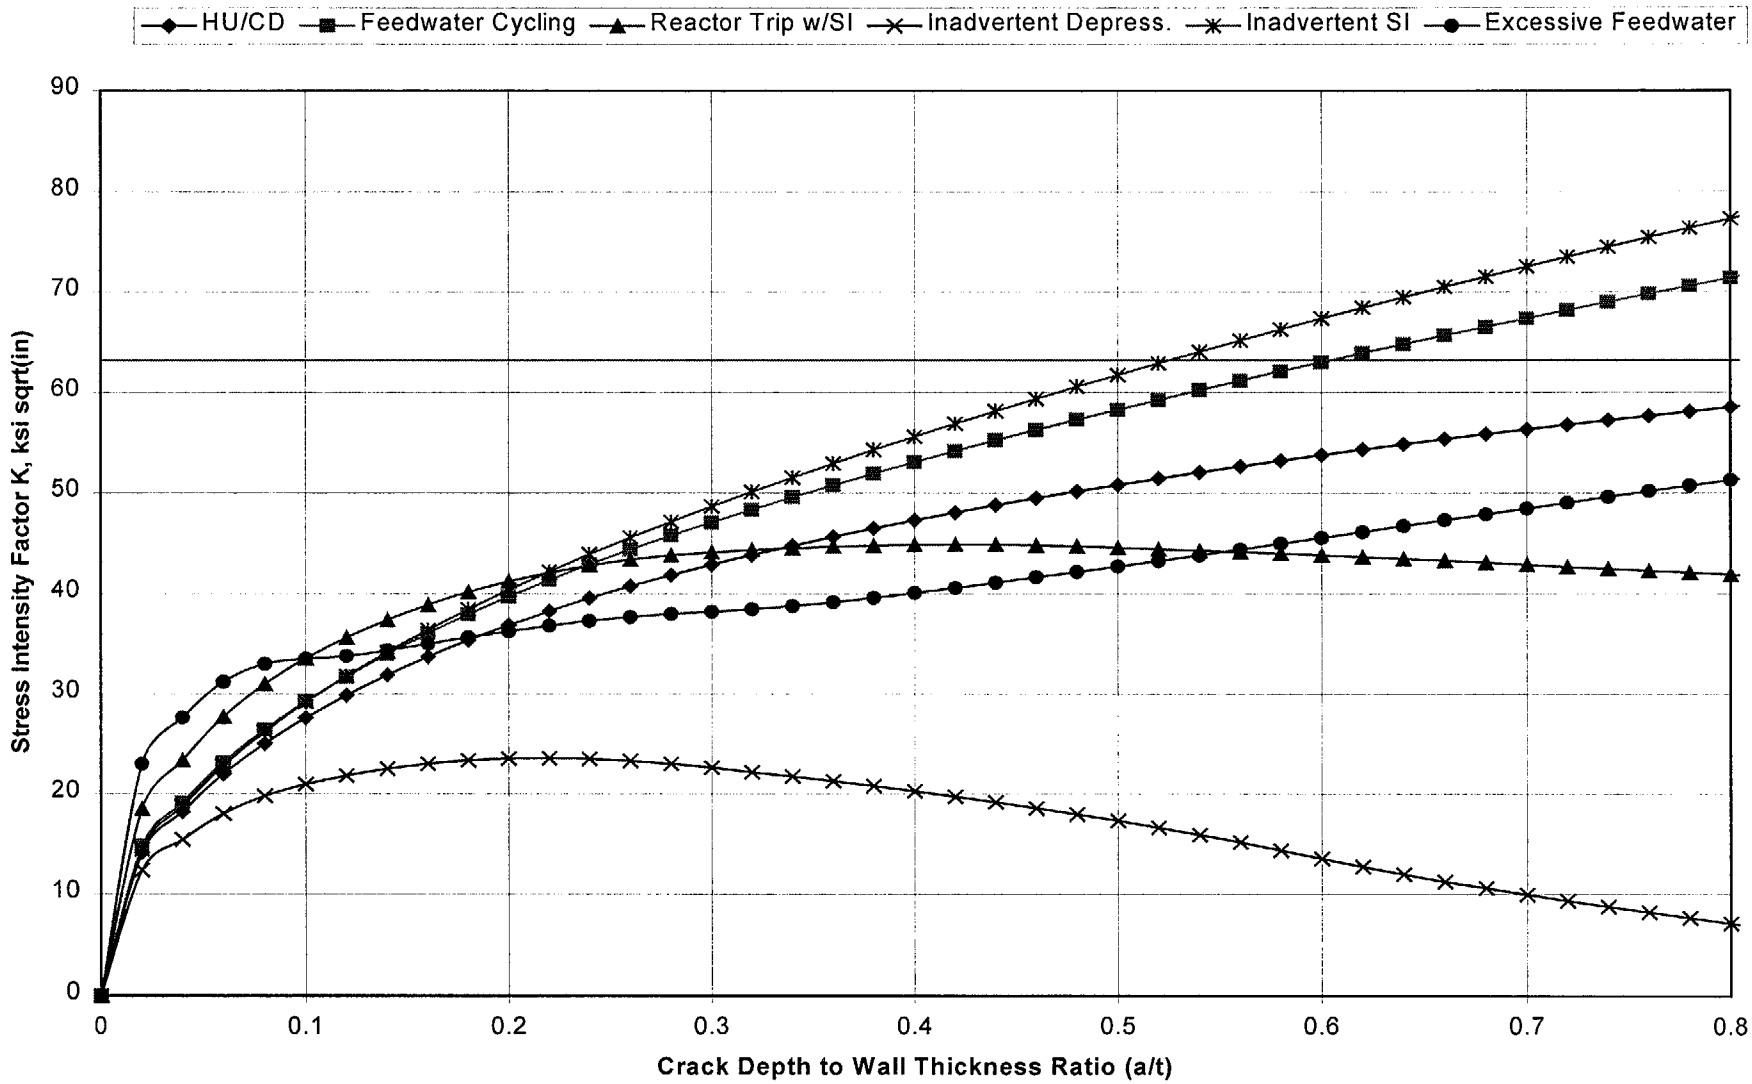
Figure A-4.1 Allowable Flaw Size Determination – Beltline Region, Axial Flaw, AR 2:1

The minimum allowable flaw size was calculated using the most governing transients under normal operating conditions for the location of interest. To select the most governing transients for the beltline region, the stress intensity factors (K_I) for several normal, upset and test conditions were calculated for axial flaws in the beltline region. The axial flaws were chosen since the hoop stresses are higher than the axial stresses in the beltline region, as can be evident from the crack growth results in Tables A-3.1 and A-3.2. The stress intensity factors are plotted in Figures A-4.1 through A-4.3 for three different flaw shapes. Note that several transients were considered for each flaw shape, to ensure that the most governing transient would be chosen. The allowable flaw depth was chosen as the intersection of the stress intensity factor curve with the allowable fracture toughness, which is $200/\sqrt{10} = 63.2\, ksi\sqrt{in}$. The minimum allowable flaw size results for normal, upset and test conditions are provided below:

Flaw Shape	Governing Transient	Allowable Flaw Size	
		inches	(a/t)
Aspect Ratio 2:1	Inadvertent Safety Injection	4.07	(0.525)
Aspect Ratio 6:1	Reactor Trip with Cooldown and S.I.	1.34	(0.173)
Continuous Flaw	Excessive Feedwater Flow	0.67	(0.086)
