Response to NRC Review Comments
Transmitted by Letter Dated June 22, 2001,
to the Nuclear Energy Institute Relating to

PWR Materials Reliability Program
Interim Alloy 600 Safety Assessment for US PWR Plants (MRP-44)
Part 2: Reactor Vessel Top Head Penetrations
EPRI TP-1001491, Part 2, May 2001

MRP 2001-050NP

June 29, 2001

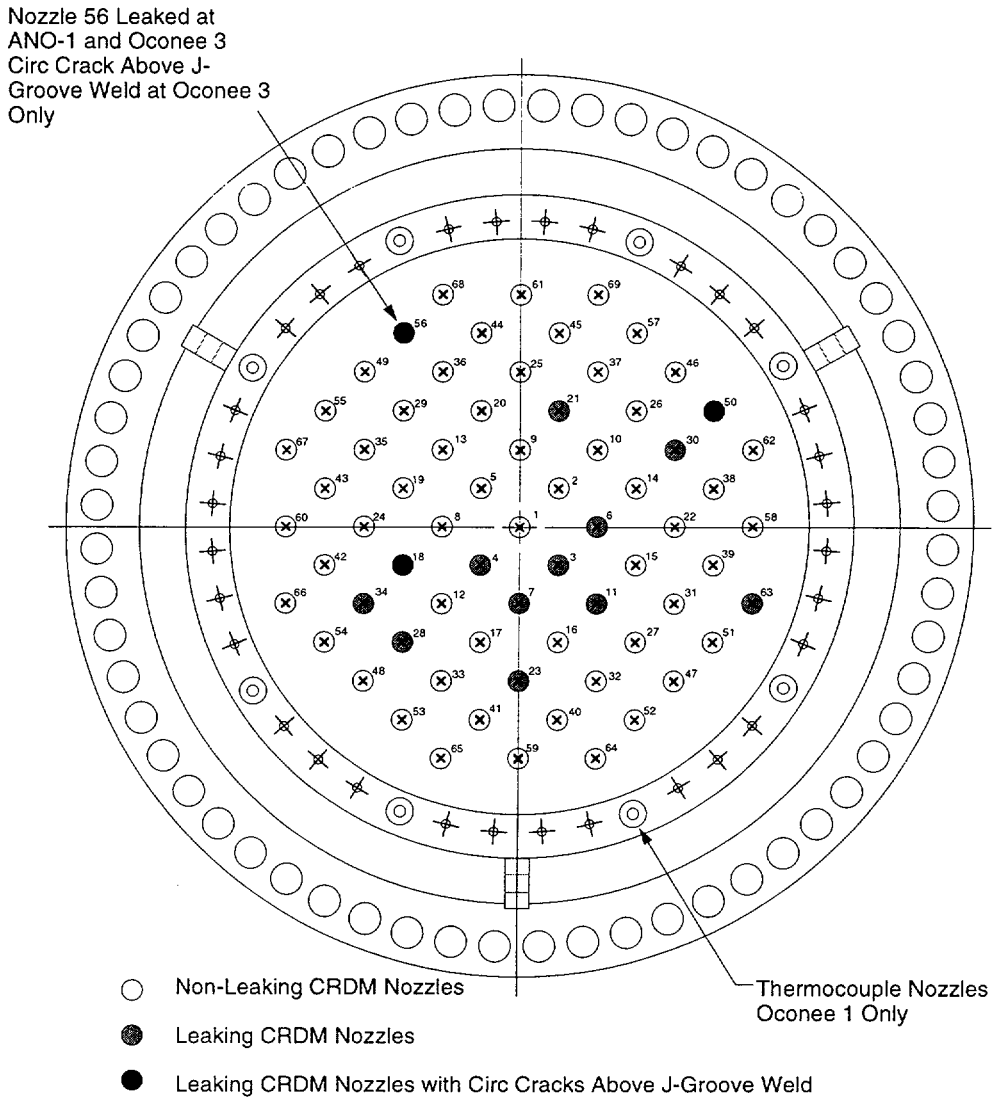
Figure 1
Locations of Leaking CRDM Nozzles at Oconee and ANO-1

- As shown in Figure 1, Oconee and ANO-1 experience demonstrates that leakage can be detected from nozzles adjacent to the central nozzle and in peripheral locations. This provides confidence that leakage can be detected regardless of location on the head.

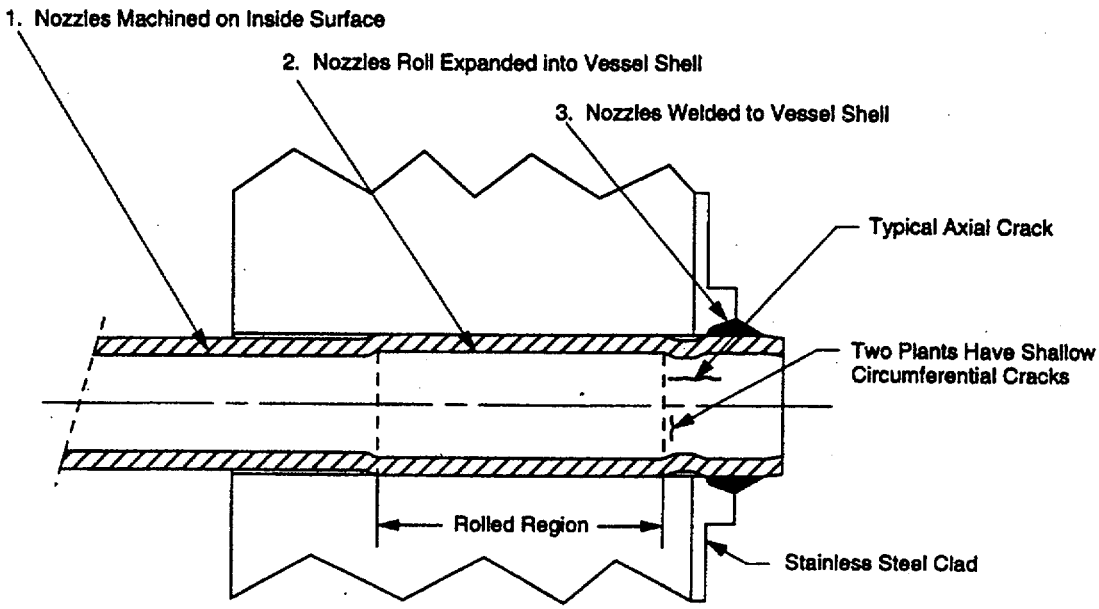
Figure 2
Rolled and Welded Pressurizer Instrument Nozzle in EDF Plants

- As shown in Figure 2, Alloy 600 pressurizer instrument nozzles in EDF plants were roll expanded into the vessel shell prior to making the J-groove weld. Leaks were discovered from nozzles in two plants (Nogent 1 and Cattenom 2) after one operating cycle. The roll expansions did not prevent leakage in these nozzles.

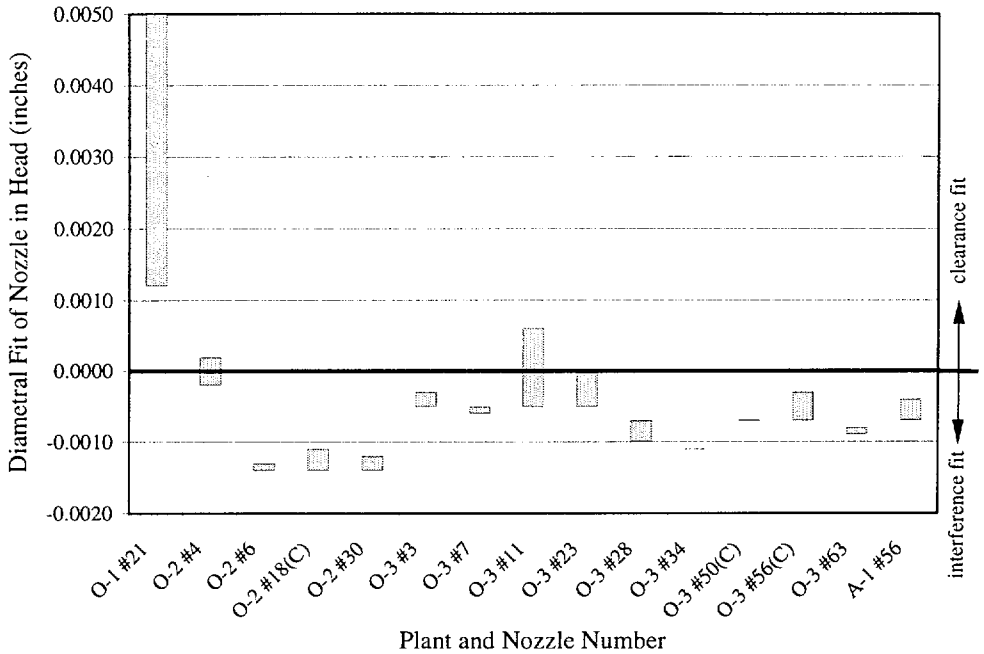
Figure 3
Actual Interference Fits of Leaking CRDM Nozzles at Oconee 1, 2 and 3 and ANO-1

Figure 3 shows the range of fits for the leaking CRDM nozzles at Oconee and ANO-1. The information provided during the June 7 meeting for Oconee 1, Oconee 3 and ANO-1 has been supplemented with data for the four leaking nozzles at Oconee 2. The three nozzles found to have circumferential cracks above the J-groove weld are appended with "(C)" in the figure.

The data in Figure 3 show that one nozzle had a clearance fit rather than the specified small interference fit. The remaining nozzles had at least one end of the interference fit region within the specified tolerance. It should be noted that three of the four leaking nozzles at Oconee 2 had interference fits of 0.0014 inches at one end and at least 0.0011 inches at the other end. In summary, leaks have been confirmed from fourteen nozzles with confirmed initial interference fits, including three nozzles with at least 0.0014 inches of assembly interference.

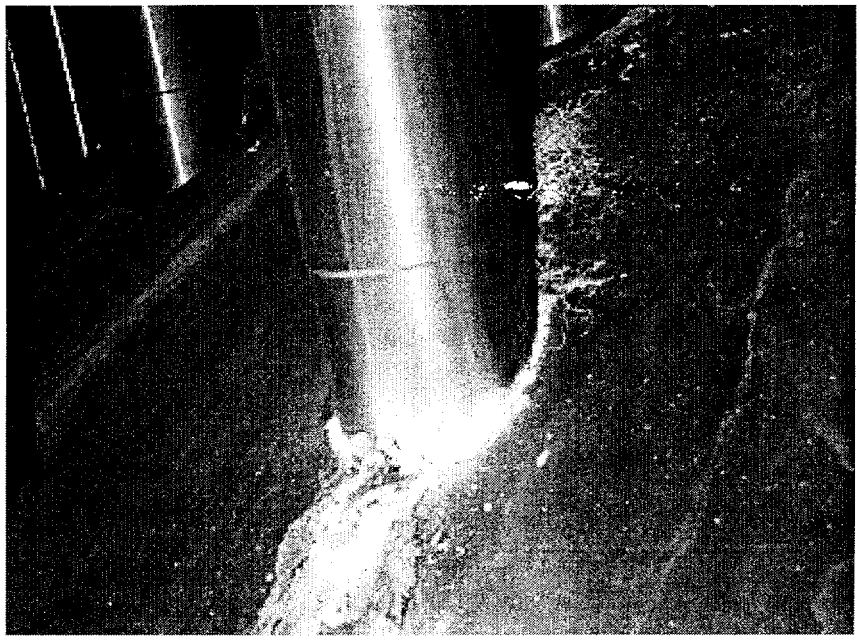
Figure 7
Visual Inspection of Oconee 3 Reactor Vessel Head (Leaking Nozzle 56)

- Figure 7 is Oconee 3, where visual inspection was performed through access ports that had previously been cut in the shroud. Leakage is clearly visible in the photograph.

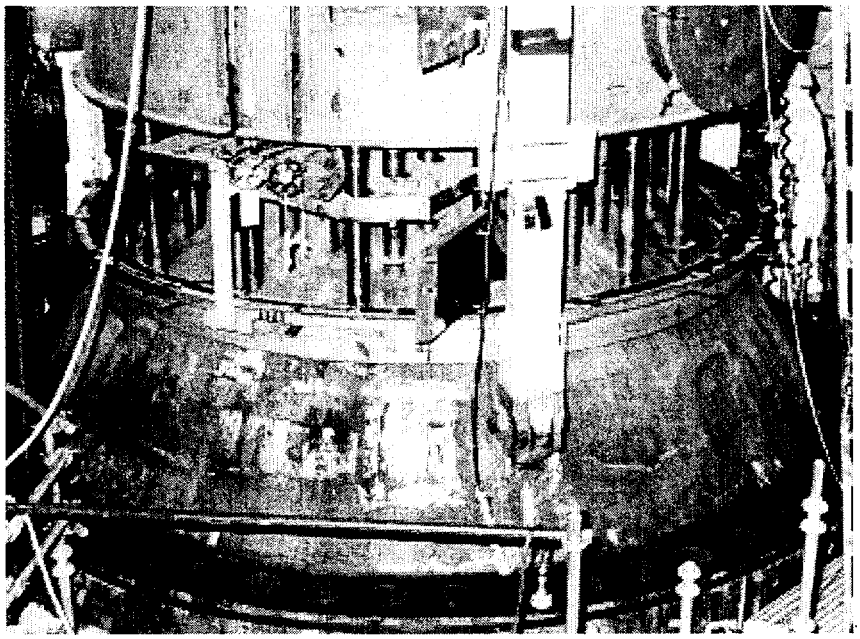
Figure 8
Visual Inspection of Salem 1 Reactor Vessel Head

- Figure 8 is Salem 1, where the shroud was raised several feet and the outer vertical panels of reflective insulation were removed. This provided excellent visual inspection conditions. No leakage was detected.

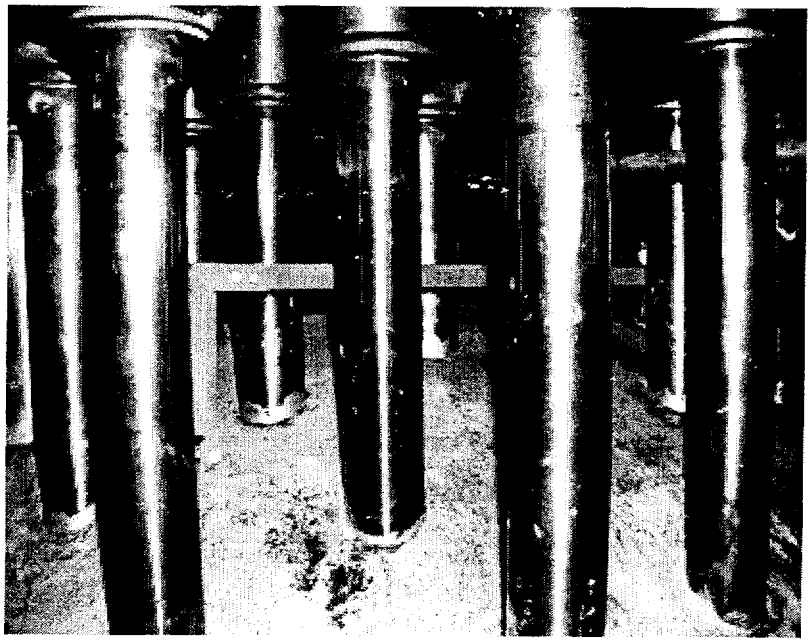
Figure 9
Visual Inspection of H. B. Robinson 2 Reactor Vessel Head

- Figure 9 is H. B. Robinson 2, where the original reflective type insulation was removed, and then replaced by blanket type insulation after the inspection was completed. No leakage was detected.

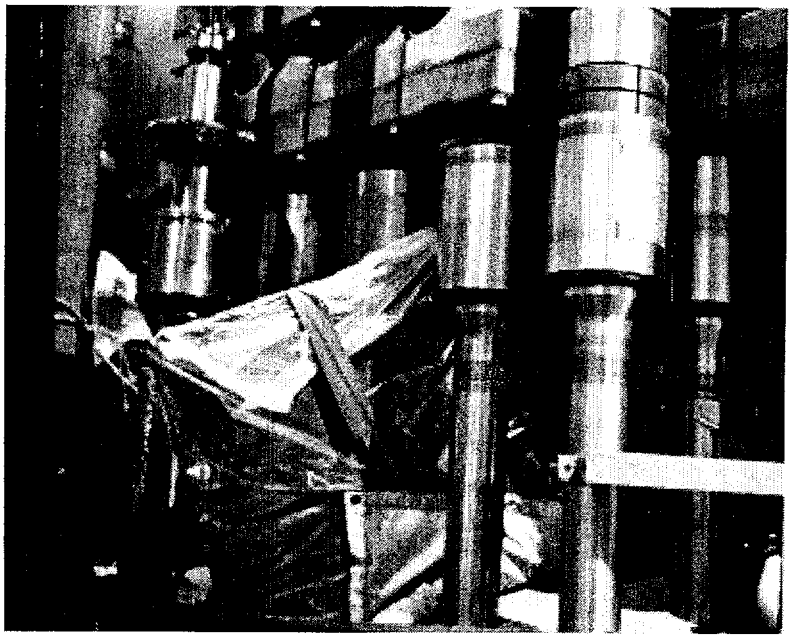
Figure 10
Visual Inspection of Prairie Island 1 Reactor Vessel Head

- Figure 10 is Prairie Island 1, where the head was modified to provide for visual inspection. No leakage was detected.

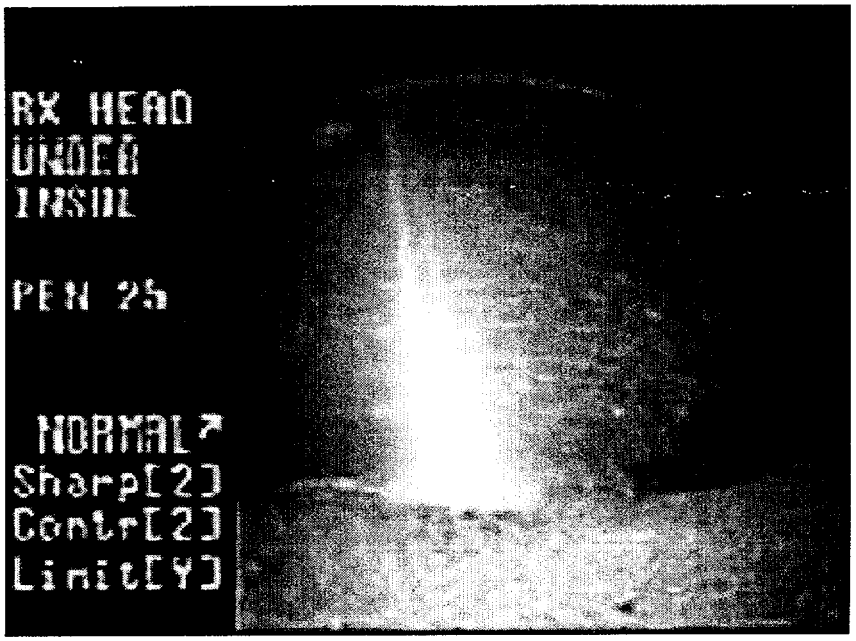
Figure 11
Visual (Video) Inspection of Farley 2 Reactor Vessel Head (Nozzle 25)

- Figure 11 is Farley 2, where the inspection was performed using a video probe inserted at joints in the metal reflective insulation. No leakage was detected.

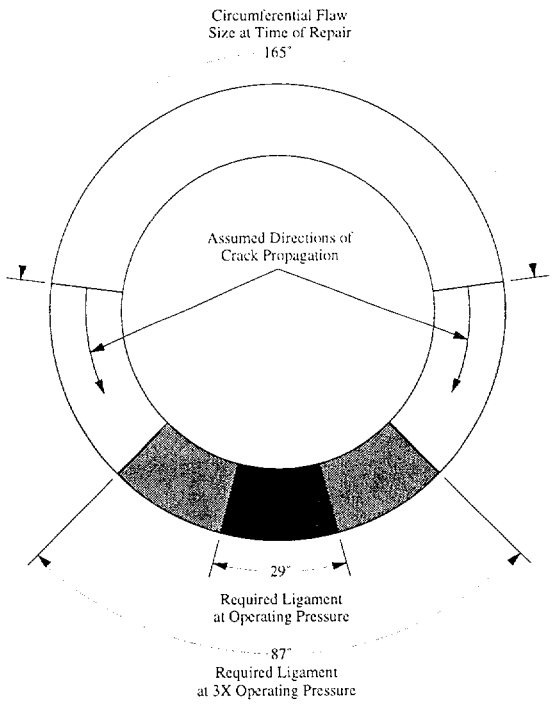
Figure 14
Direction of Crack Propagation

The time for the Oconee 3 circumferential cracks above the J-groove weld to grow from the reported 165° arc length to the allowable 273° arc length noted in Section 5.0 of MRP-44 was computed as at least 4-5 years by two independent methods.

Both calculations were performed assuming that the cracks propagate in a circumferential direction around the nozzle from both crack fronts as shown in Figure 14. This is consistent with inspection results from Oconee 3 which showed that the cracks had essentially the same arc length on the inside and outside surfaces and is also consistent with the expected direction of primary crack growth for a through-wall crack in a cylindrical shell under internal pressure loading. Note that the finite element stress analysis results reported under Section 5.0 Comment 3, show that when the crack has reached 180° arc length, the welding residual stresses have been significantly reduced such that the primary direction of crack growth is expected to be around the nozzle as shown.
